Investigation Report

Location: Leipzig/Halle Airport

Type: A300F4-622R

State File Number: BFU24-0073-1X

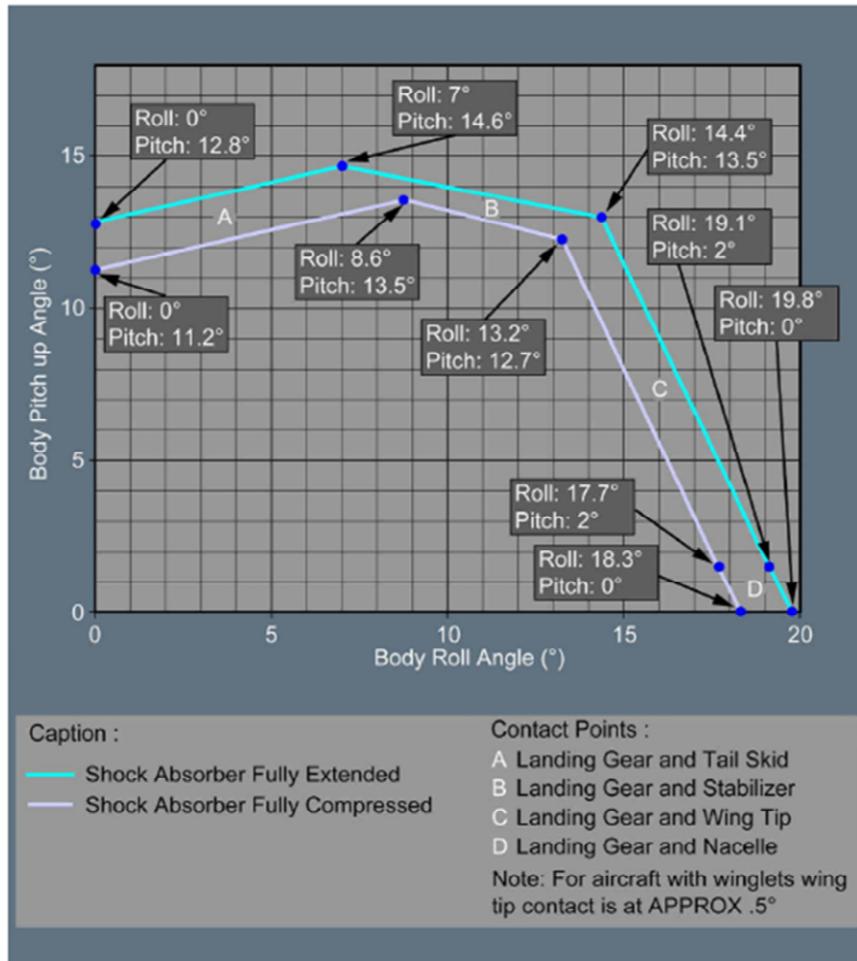
Fig. 2: DSC-20-GROUND CLEARANCE DIAGRAM

According to the manufacturer, contact with the ground can occur with the appropriate pitch and roll angles (Fig. 2).

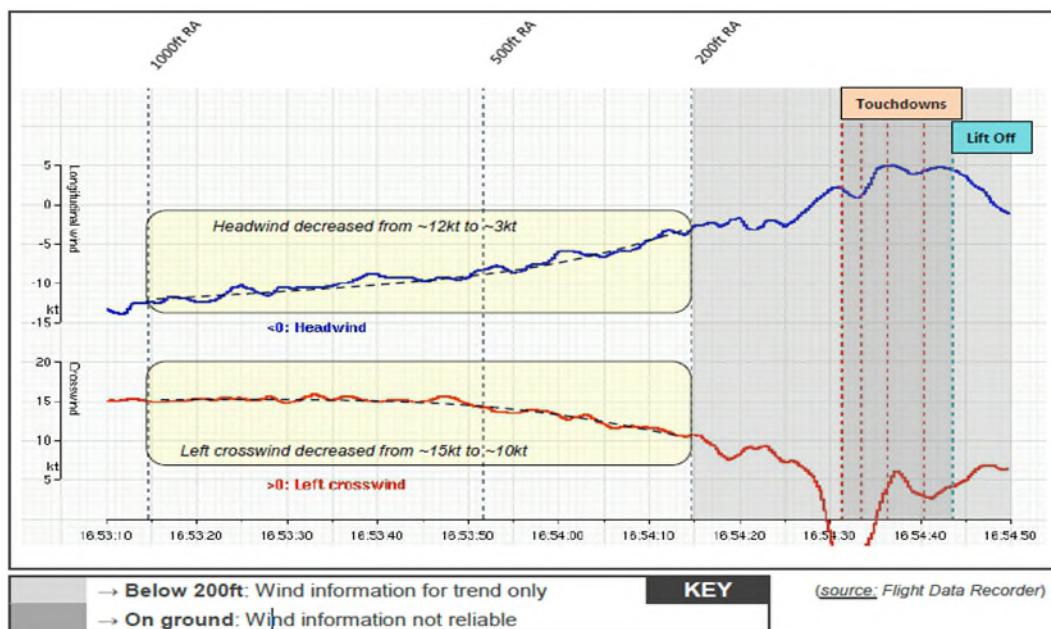
Fig. 3: Wind direction and force calculation

The wind direction and force calculation of the Air Data Inertial Reference Unit (ADIRU) determined the following values during approach and flare (Fig. 3):

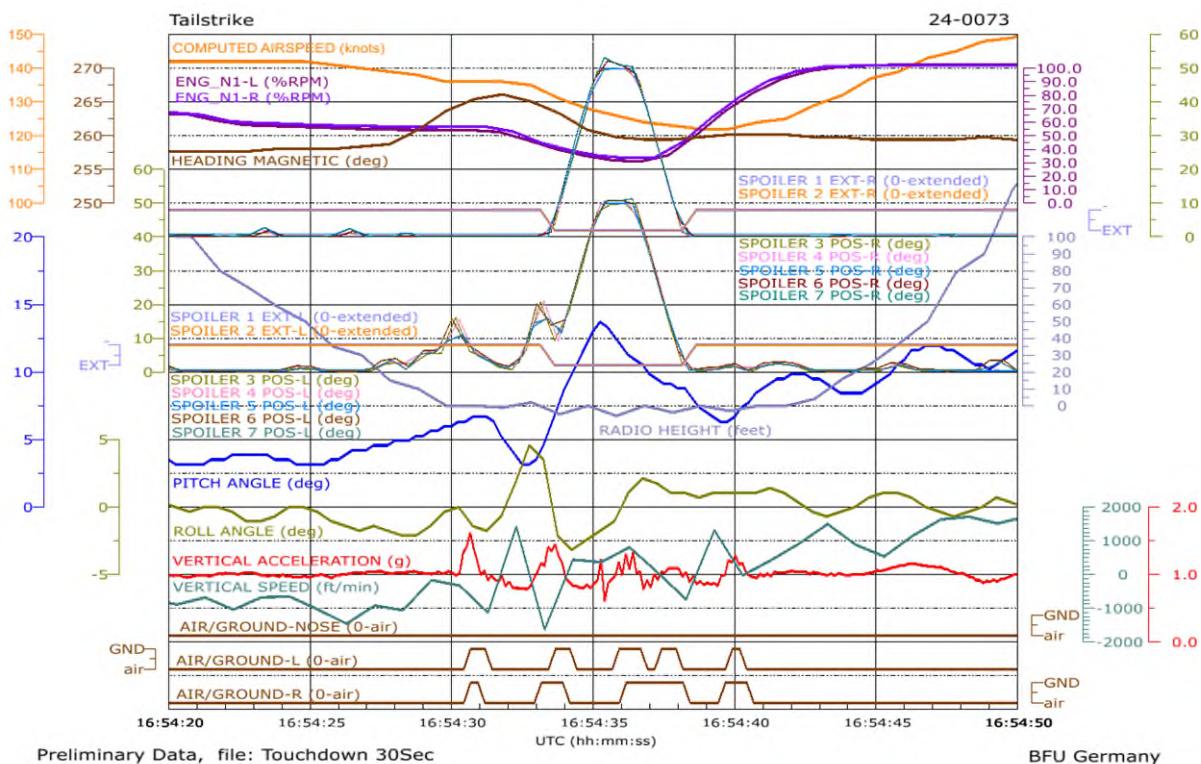
Fig. 4: Excerpt of relevant FDR data of the landing with tailstrike and go-around

The data of the aborted landing with the tailstrike and the final landing were examined (Fig. 4 and 5). According to the data, during the landing with the tailstrike an interaction

between yaw and roll movement occurred. During the flare, engine thrust was still present and speed was higher than during the final landing.

Parameter	Landing - Tailstrike	Final Landing
COMPUTED AIRSPEED (knots)	136	128
ENG N1-L / N1-R (%RPM)	56.8 / 54.1	32.5 / 32.7
PITCH ANGLE (deg)	6	7
ROLL ANGLE (deg)	-1	0
HEADING MAGNETIC (deg)	266	260
	1.62	01:22:00

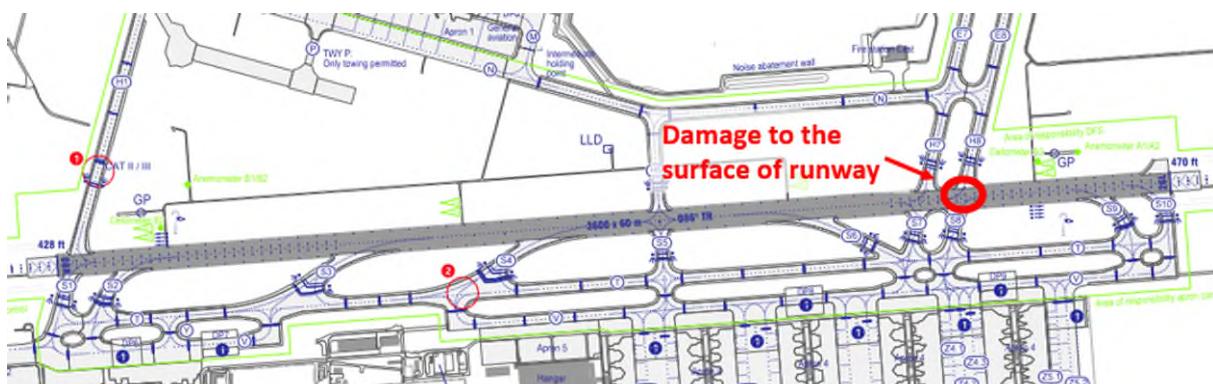
Fig. 6: Position of the damage on runway 26L

The tailstrike occurred on runway 26L of Leipzig/Halle Airport in the area of the H8 and S6 intersections (Fig. 6).

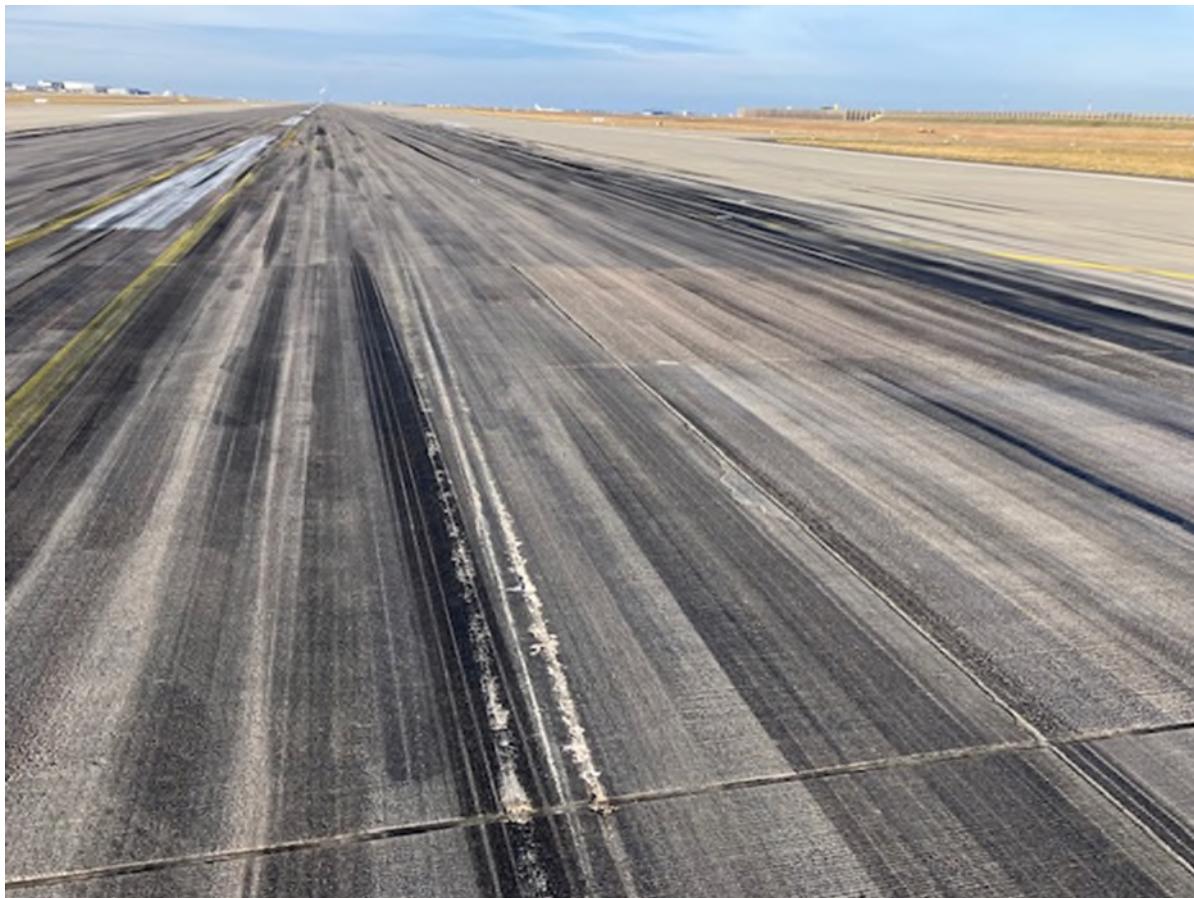
Fig. 7: Damaged surface of runway 26L, view towards the west

The runway surface was scratched on a length of several meters (Fig. 7).

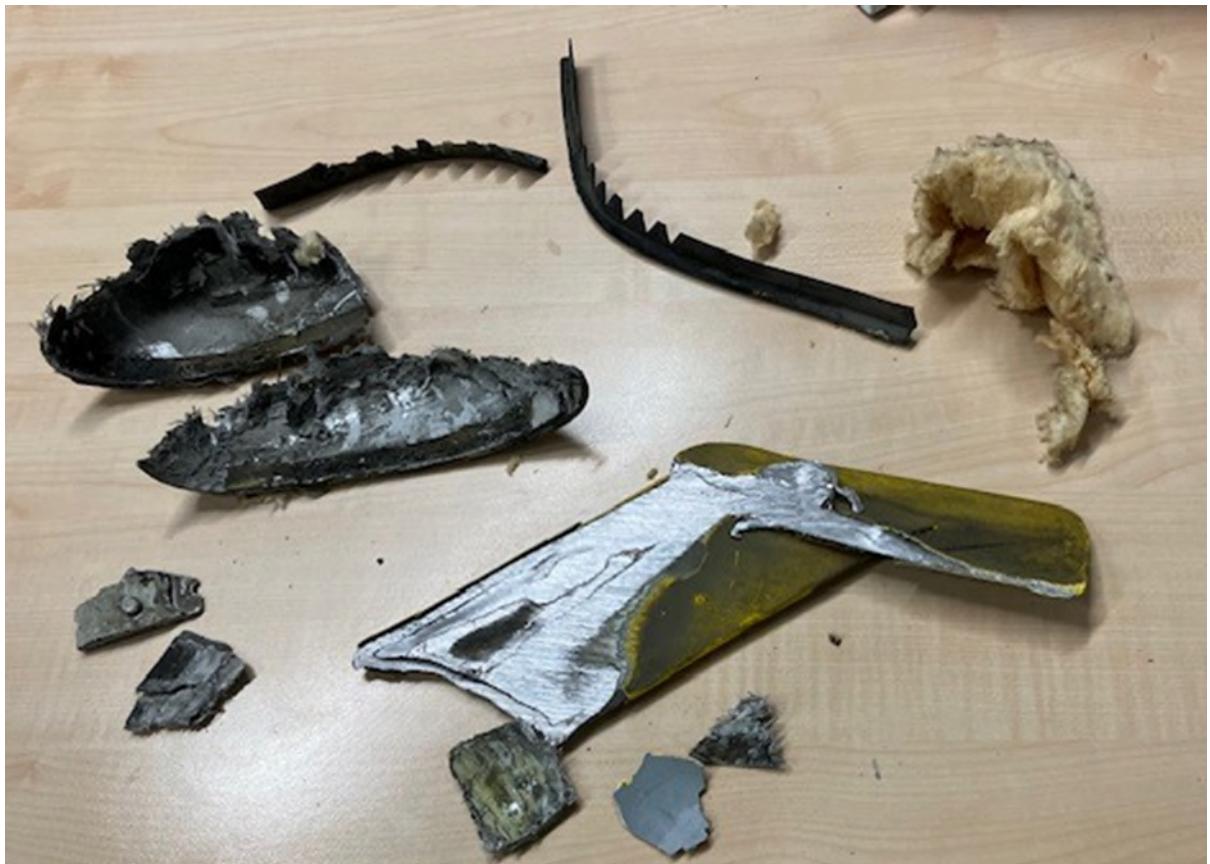
Fig. 8: Aircraft parts found on runway 26L

After the aborted landing, several small parts which could be assigned to the tail section of the airplane involved, were found on the runway (Fig. 8).

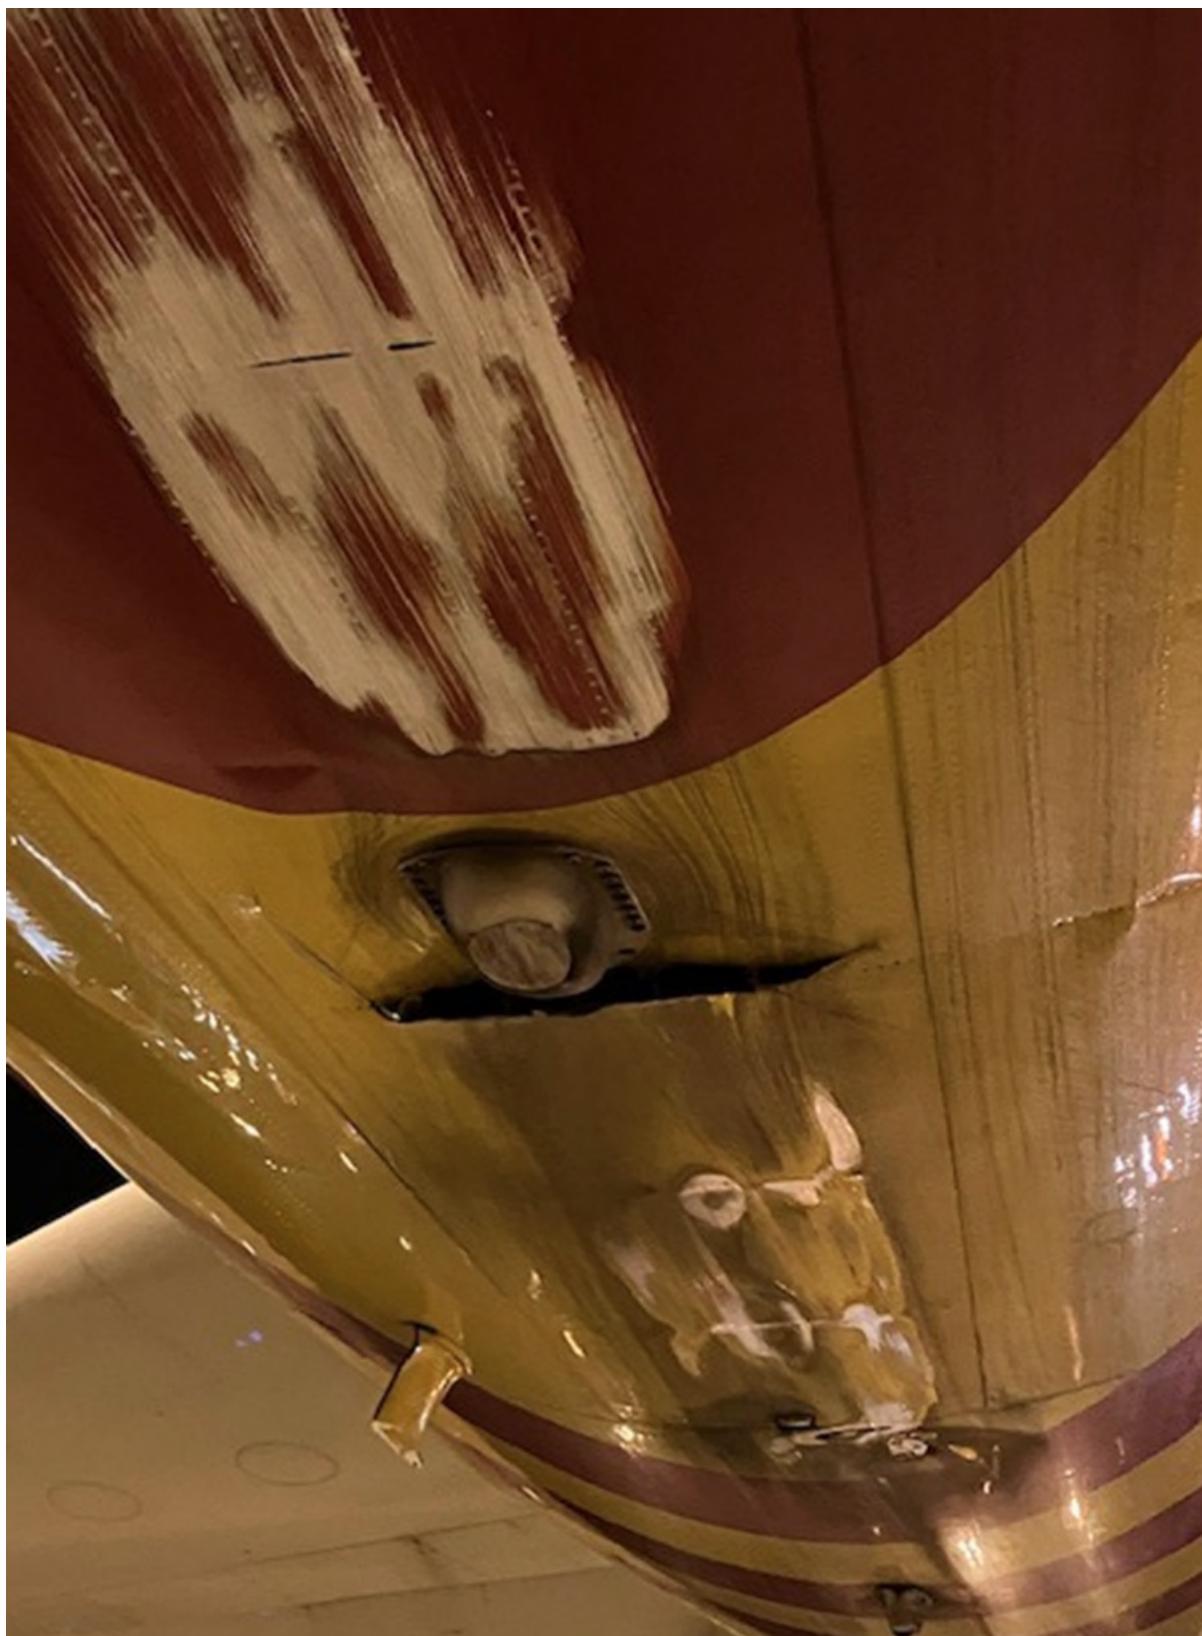
Fig. 9: Damage at the outer skin / covering at the lower aft fuselage

The outer, aft lower fuselage of the A300 showed scratch marks of several meters in length. The fuselage covering was abrade in several places. The tail bumper was pushed in and the skin / covering behind it torn (Fig. 9).

Inside the aft lower fuselage area, bent and torn structure elements (stringer, brackets, fittings, angles, sheer plates) and loose rivet joints were found.

On 26 February 2024, operator and experts of the aircraft manufacturer determined the damage and the subsequent repairs.

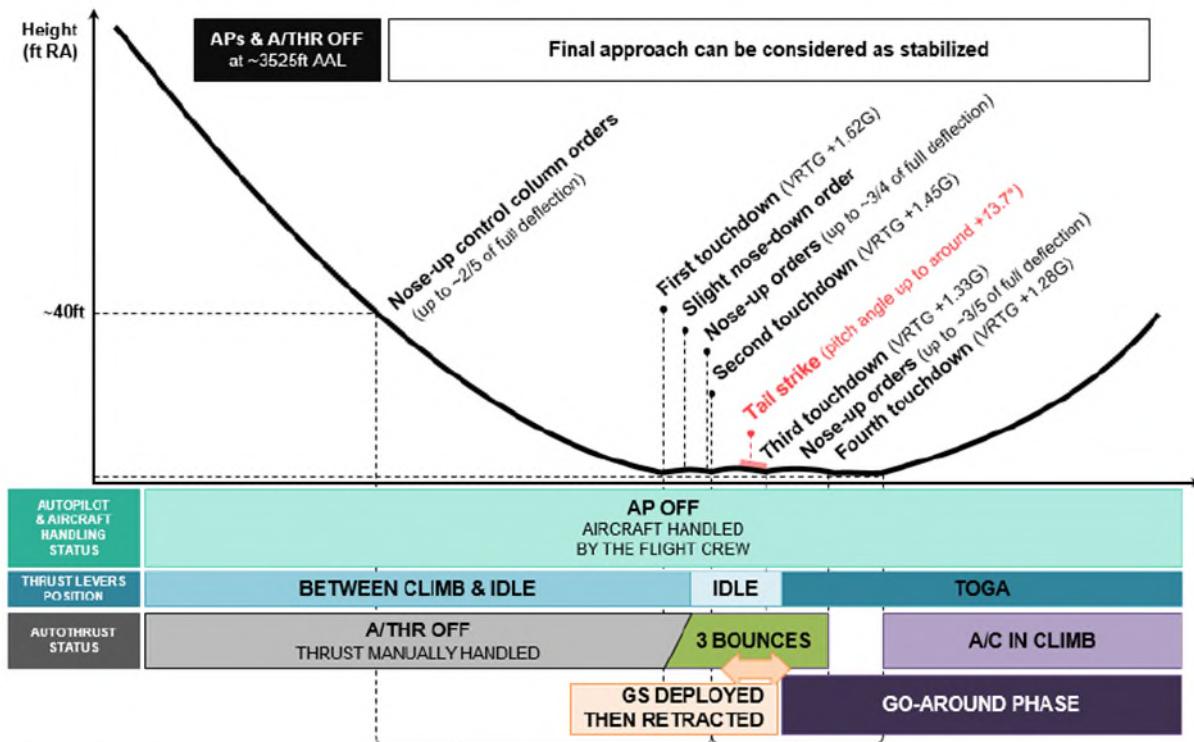
Fig. 10: EDR data analysis by the manufacturer

At ~40ft RA, several nose-up orders were applied on control column and led the pitch angle to progressively increase up to +6.5° and the rate of descent to decrease to ~400ft/min.

The aircraft touched down with the throttle levers between IDLE and CLIMB (no retard), which inhibited the ground spoilers extension.

Just after first touchdown (first bounce), a slight nose-down input was applied contributing to the decrease of the pitch angle from +6.5° to +3°

Then a nose-up order was applied on control column up to $2/4$ of full deflection.

Then during the second bounce, due to the continuous nose-up order applied on control column, the pitch angle increased from $+3^\circ$. At the same time, the ground spoilers extended and led to an additional pitch-up effect.

Both the continuous nose-up order and the pitch-up effect of the ground spoilers led the pitch angle to reach a maximum of around +13.7°: a tail strike occurred around that time. The aircraft touched down a third time and bounced.

Close to the ground, it is important to control the pitch attitude so that it does not further increase beyond the critical angle. As previously described, a continuous nose-up order applied on control column (maintained in nose-up position during the second bounce) participated to an increase of the pitch angle (up to +13.7°) close to the ground and led to a tail strike.
