Technical report

IN-024/2023

Incident on 27 August 2023 involving a Boeing 737-800 aircraft
operated by Jet2.com, registration G-DRTW, at Palma de
Mallorca Airport (Balearic Islands, Spain)

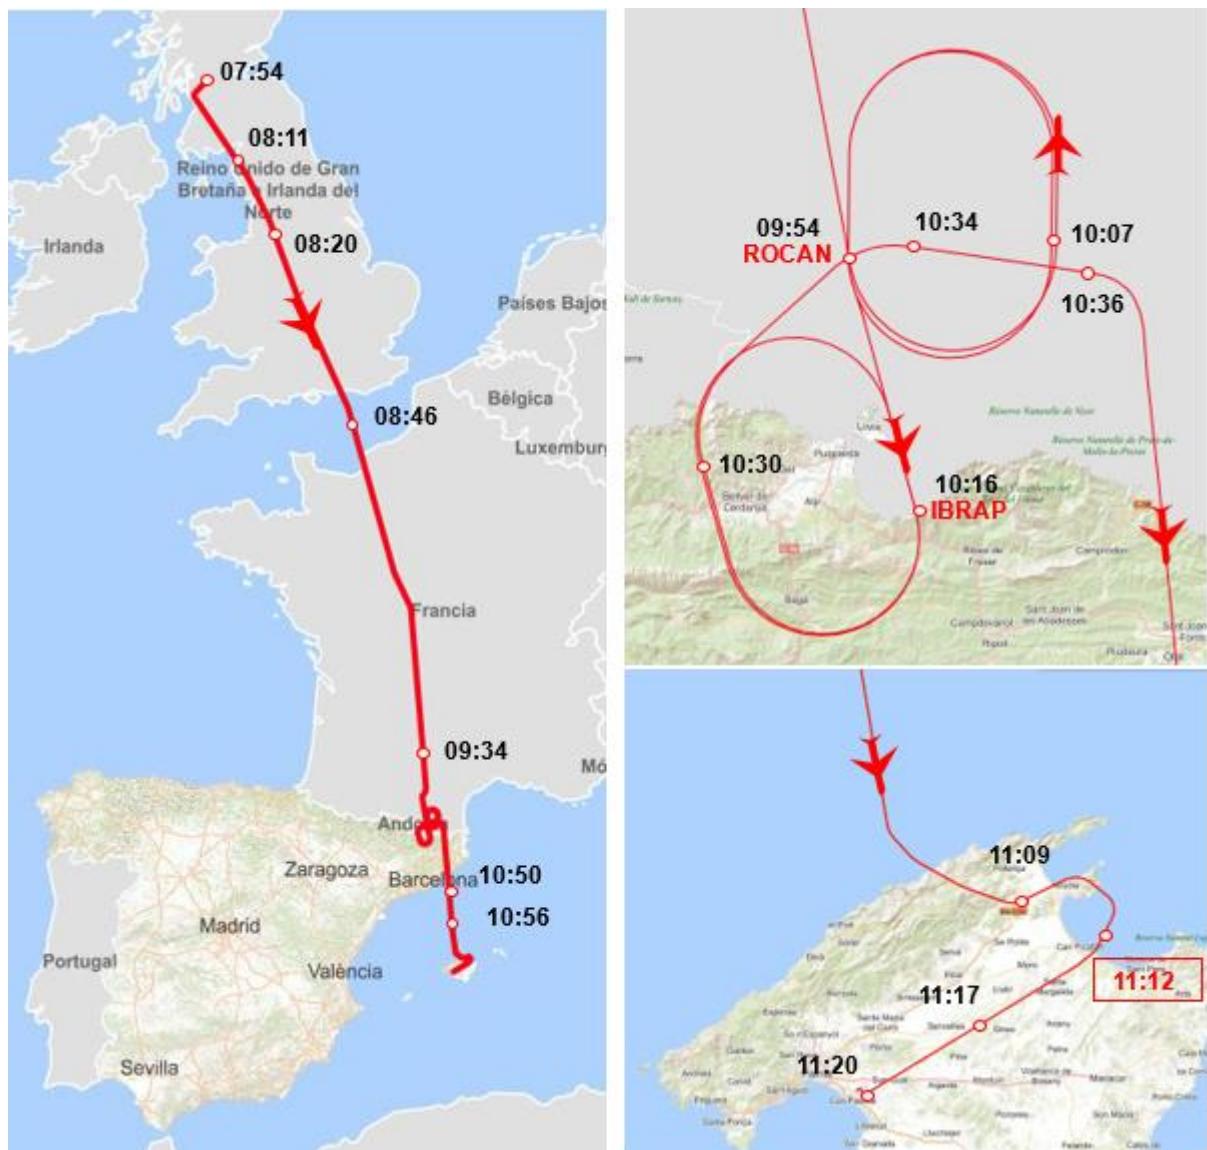
Figure 1. Full flight path of flight EXSAB

07:54 take-off
 08:11 FL330
 08:20 FL330
 08:46 FL350 aircraft with ATC France
 09:34 Palma not accepting traffic and activation of PDM
 09:54 holding patterns to the left over ROCAN
 10:07 destination change to Menorca
 10:16 aircraft to LECB and holding patterns to the right over IBRAP
 10:30 aircraft to LFBB

10:34 aircraft to LECB and Palma open
 10:36 clearance to LORES
 10:50 start of descent
 10:56 aircraft with TACC Palma
 11:09 aircraft with APP Palma
 11:12 MAYDAY FUEL
 11:17 aircraft with TWR Palma
 11:20 touchdown in Palma

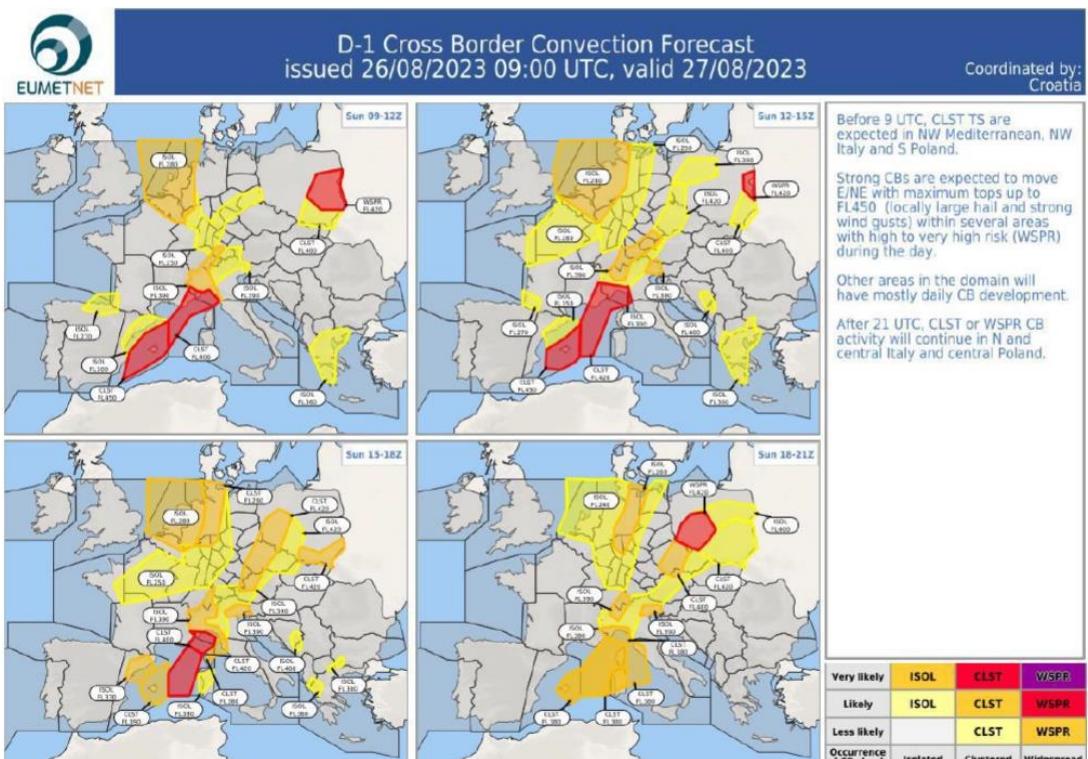
Figure 2. Significant maps issued the day before (EUMETNET)

Figures 2 and 3 show the EUMETNET significant maps which were issued the day before and on the day of the incident and which predicted strong cumulonimbus over the Mediterranean area moving E/NE with their maximum height at level 450 and local precipitation associated with large hail and strong gusts of wind.
