# Aviation Investigation Final Report

| <b>Location:</b> | Hayden, Colorado | <b>Accident Number:</b> | DCA22LA069 |
| <b>Aircraft:</b> | Airbus A320-232 | <b>Aircraft Damage:</b> | Substantial |
| <b>Defining Event:</b> | Tailstrike | <b>Injuries:</b> | 108 None |

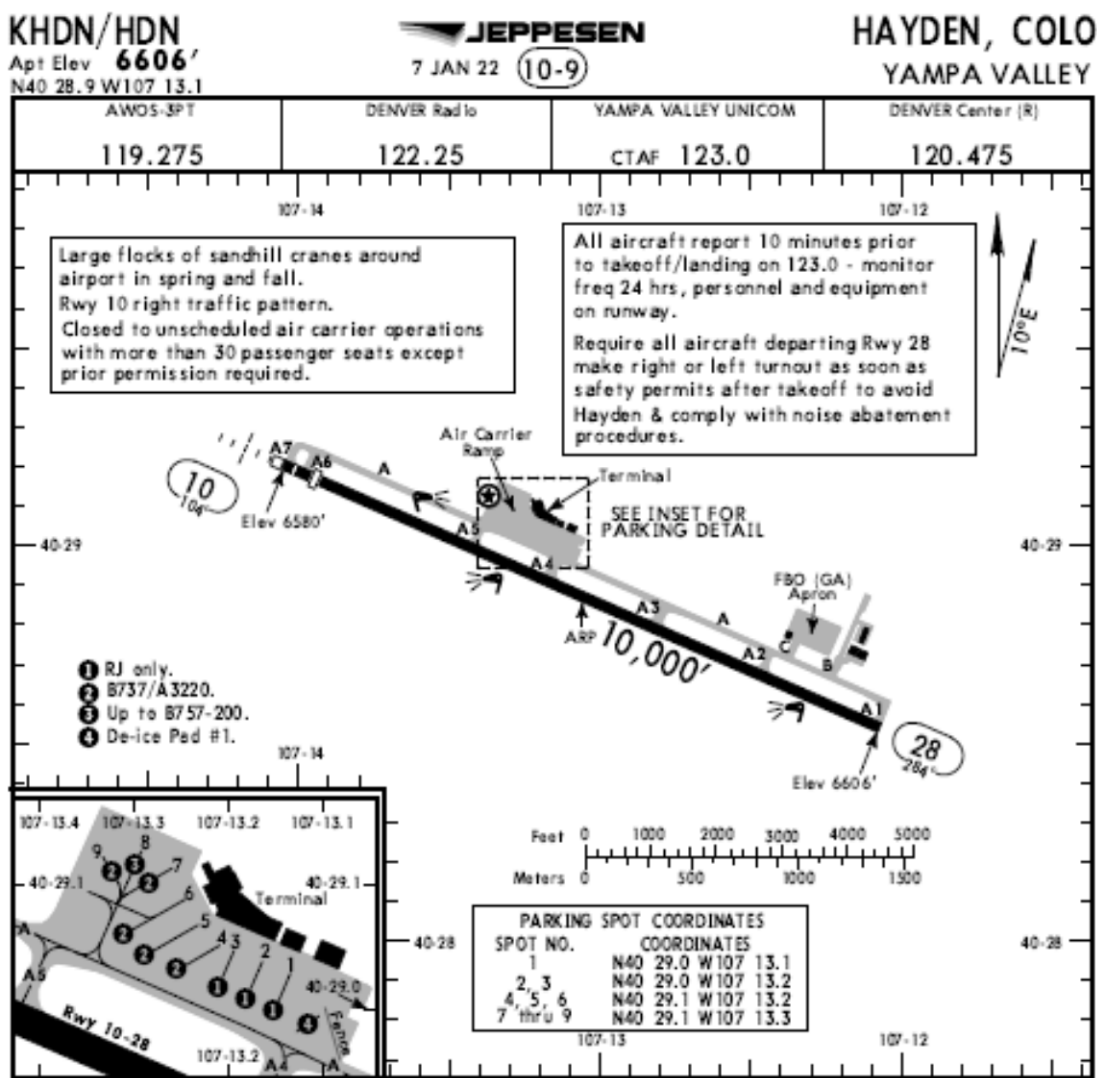
Figure 1: Excerpt from Jeppesen Airport Chart for Yampa Valley Airport (HDN).

While the JetBlue flight crew was performing an after-start checklist, the King Air announced on CTAF they were on a “12-mile final two eight straight-in”. About 45 seconds later, the King Air asked on CTAF if anyone was about to depart from runway 10, and the JetBlue flight crew replied that they intended to hold on the taxiway near the end of runway 10 and wait for a clearance from Denver ARTCC. The King Air replied they were on a “10-mile final, two eight, straight-in”. The JetBlue flight crew said “alright, copy” and that they would keep an eye out for them. See figure 1 for HDN runway layout.

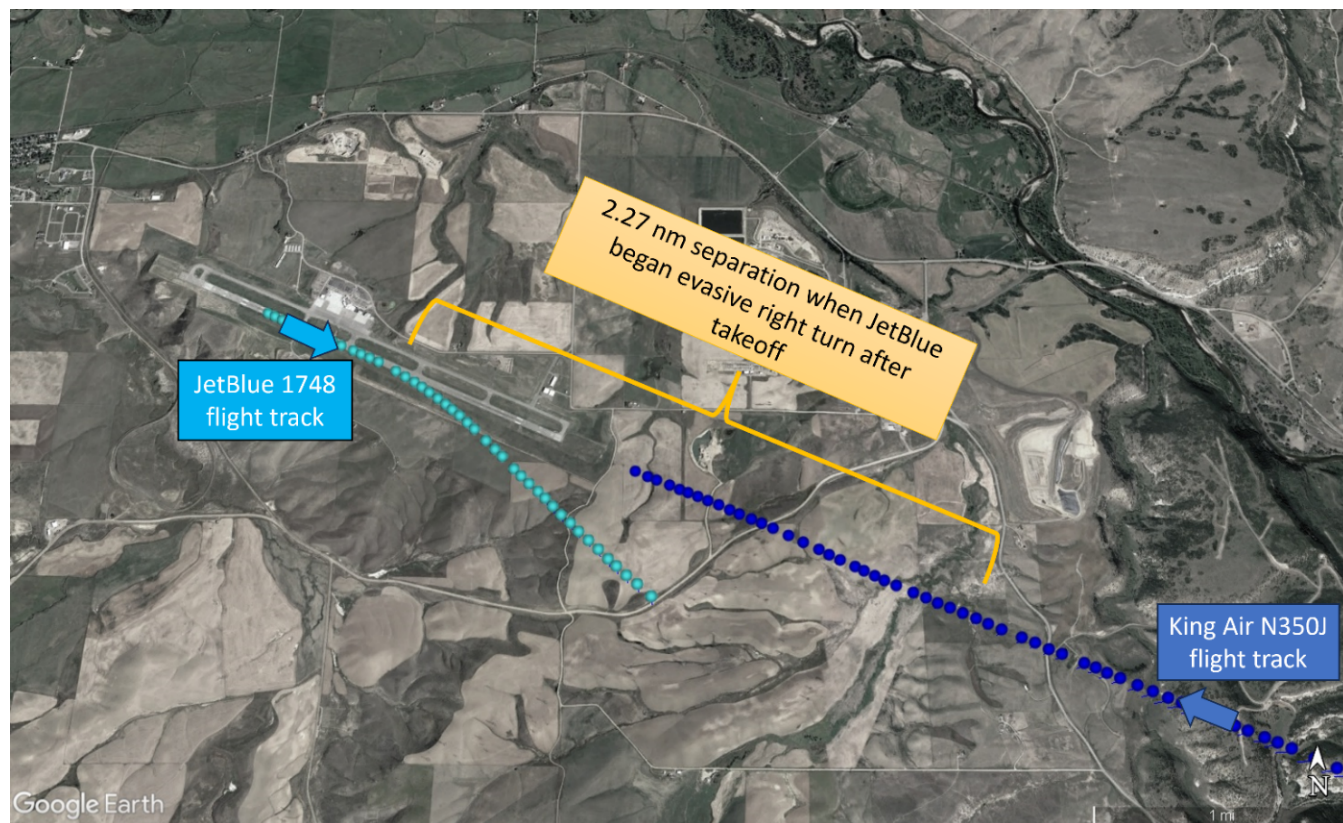
Figure 2: ADS-B data overlaid on Google Earth image.

About 20 seconds after JetBlue started their take off on runway 10, the flight crew of the King Air asked JetBlue if they were going to do a quick turn-out, to which they replied, "yes sir." Concurrent to this conversation, JetBlue's captain pitched the airplane up, 24 knots before rotation speed, to avoid the approaching King Air and subsequently struck the tail of the airplane on the runway's surface. He began a climbing right turn away from the traffic indicated on the TCAS. JetBlue's captain and first officer both stated they never visually acquired the approaching King Air. According to ADS-B data, when JetBlue began its right turn

after departure from runway 10 the King Air was on a reciprocal course with 2.27 nautical miles of separation between the converging airplanes. See figure 2.
