Havarikommissionen

Bulletin 2024-30

Serious incident to 9H-QEN (Boeing 738-8AS) in Copenhagen (EKCH) on 3-1-2024

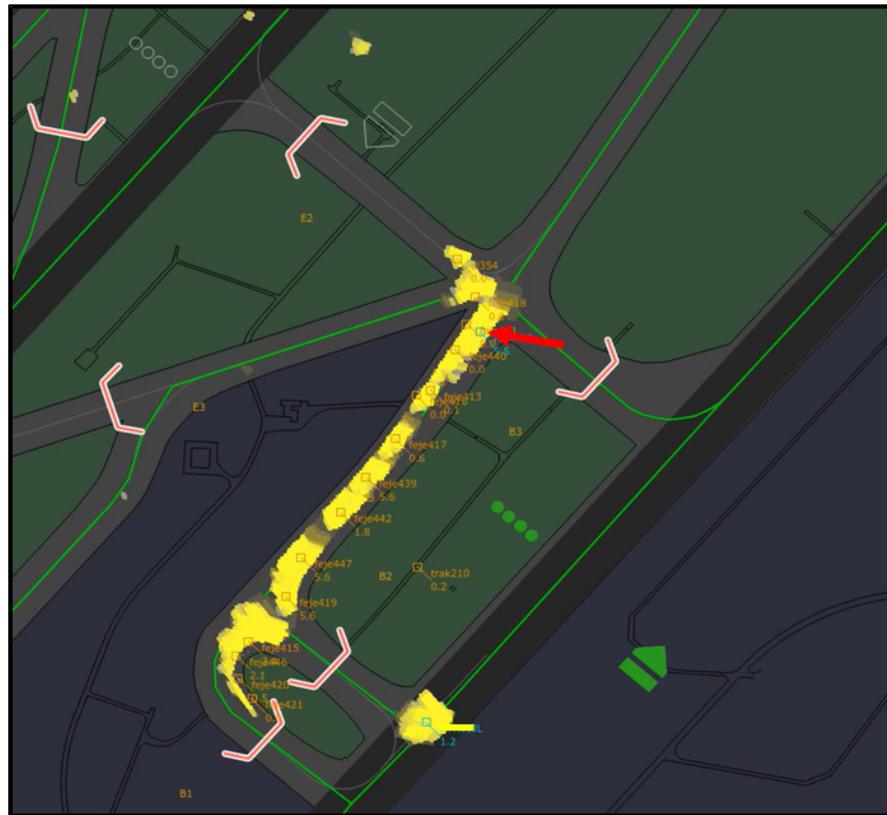
Figure 1. The position of 9H-QEN is marked with a red arrow and a blue square. The line of yellow markings on taxiway B presents the convoy of snow removal vehicles. The figure is not to scale.

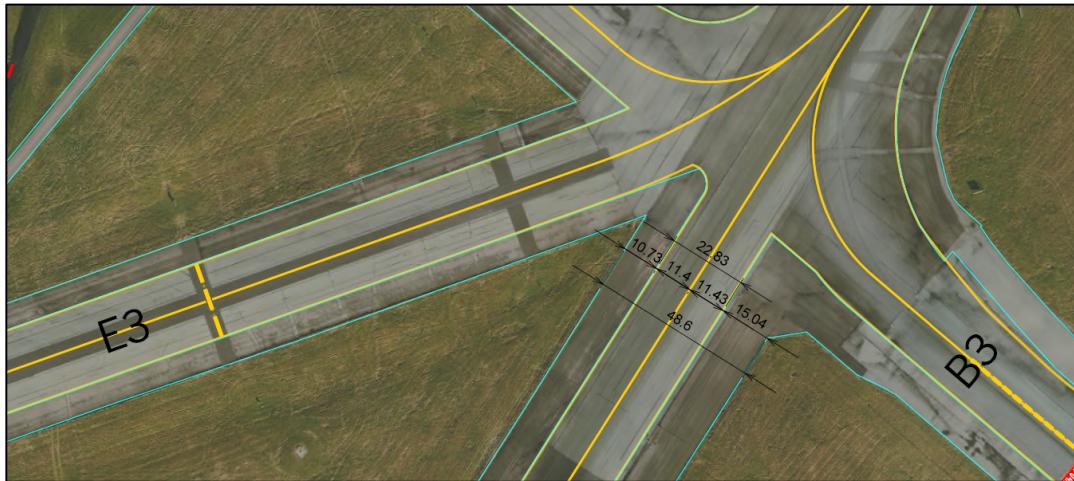
Figure 2. Measurements of taxiway B. The figure is not to scale.

- taxiway width (23 m) versus aircraft wingspan (35.79 m) versus height of the snow removal vehicles (3.74 m and unknown to the flight crew).
 - bottom of winglet height (4.06 m - 4.32 m)

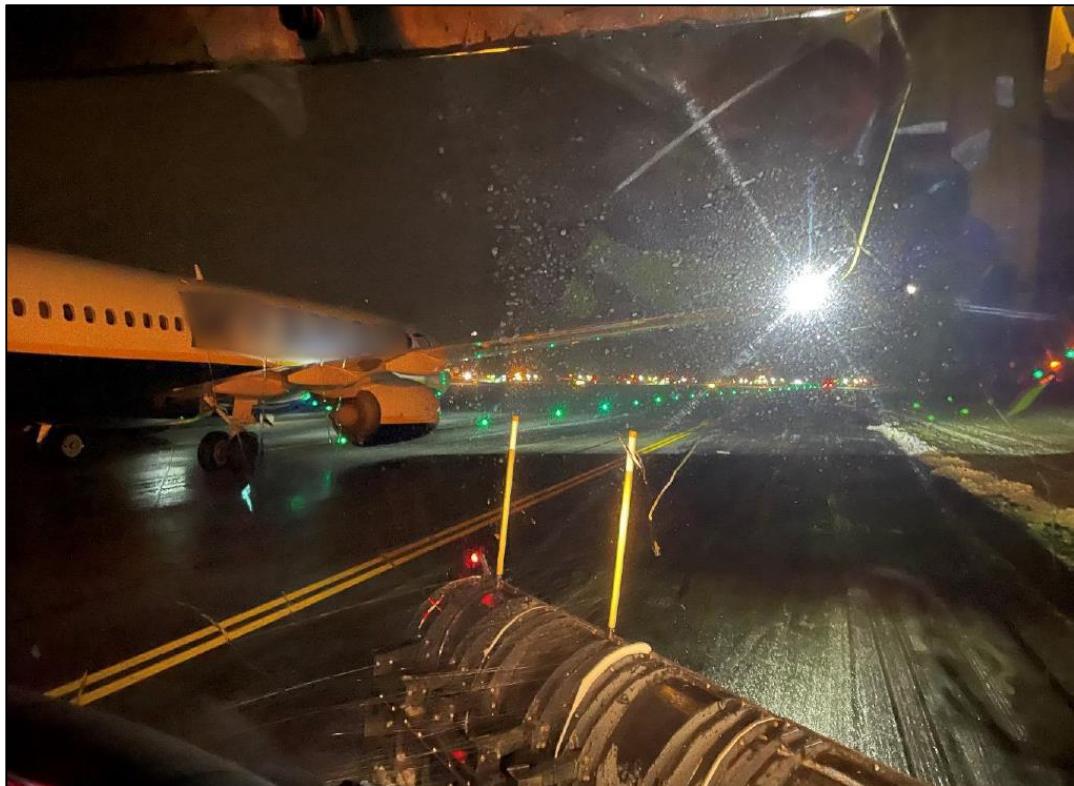
At that point, the aircraft had passed the two rearmost snow removal vehicles with marginal wing clearance.

Figure 3. The position of the aircraft and the snow removal vehicle on taxiway B just after passage of the aircraft wing right above the cab of the snow removal vehicle.

The AIB finds it most likely that the actual circumstances led to marginal clearance or a possible collision between the top of the antennas of the snow removal vehicle and the underside of the aircraft right wing.

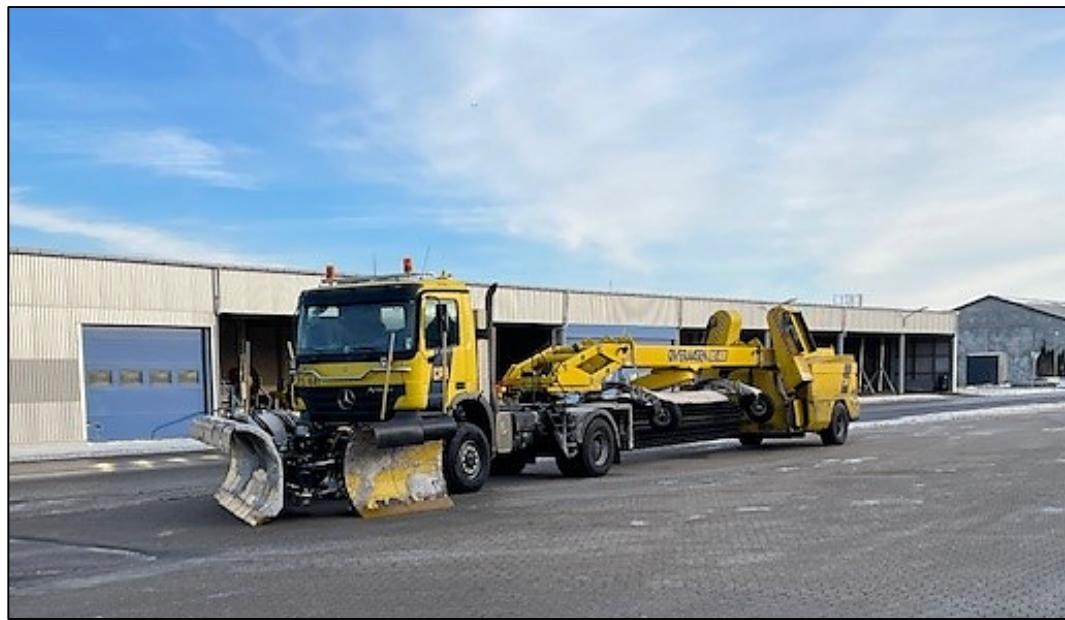
Figure 4. The involved snow removal vehicle.

The distance from ground level to the top of the antennas was 3.74 m.

The distance from the rotating lights to the top of the antennas was 0.15 m.

There were no visual damages to the rotating lights.

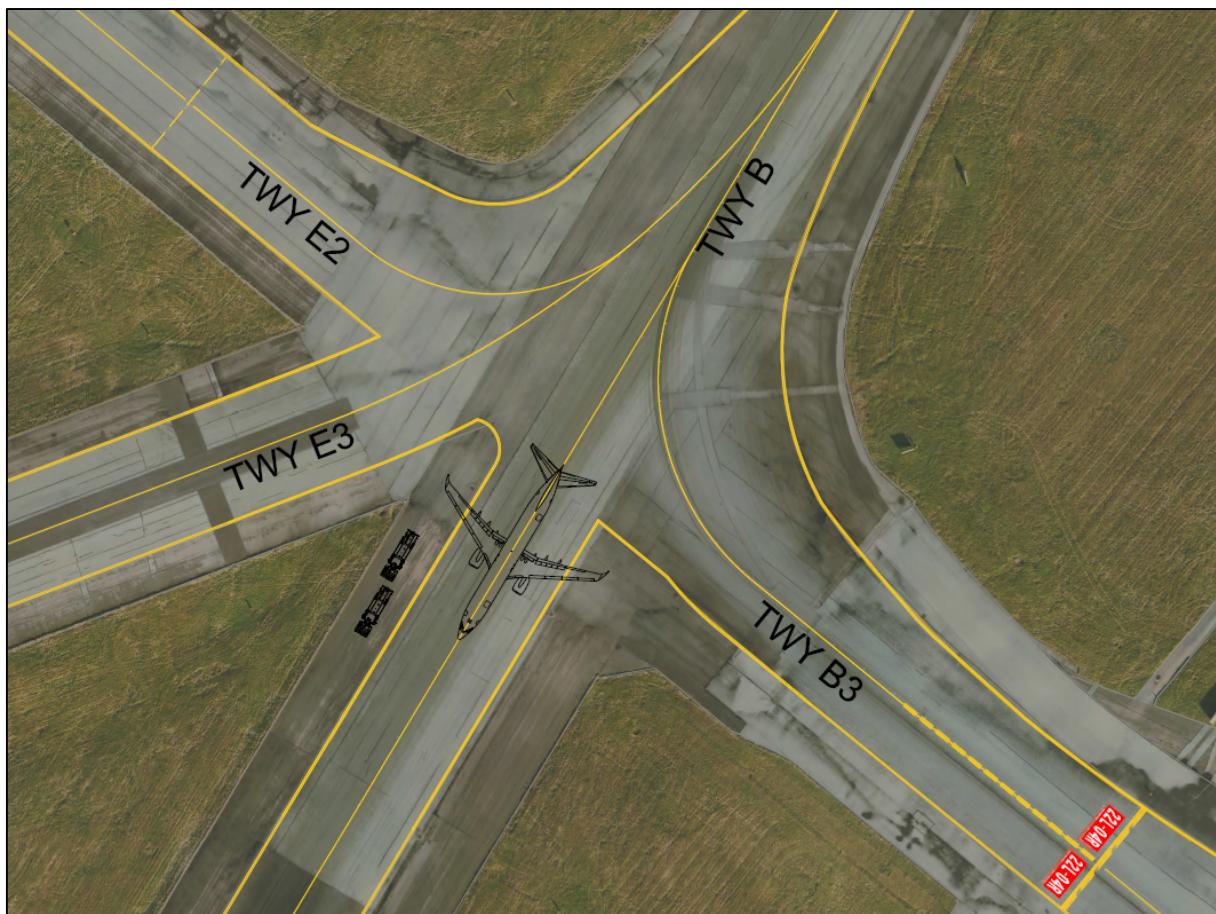
APPENDIX 1[Return to history of flight](#)

When the convoy passed taxiway B3, the two rearmost snow removal vehicles of the convoy turned slightly right to clear snow in the intersection between taxiway B and taxiway E2.

This manoeuvre caused a gap of approximately 40 meters between the third from last snow removal vehicle in the convoy down to the two rearmost snow removal vehicles and the service vehicle.

The two rearmost snow removal vehicles caught up with the rest of the snow removal vehicle convoy and stopped to the right of the taxiway edge marking (just outside the double yellow line).

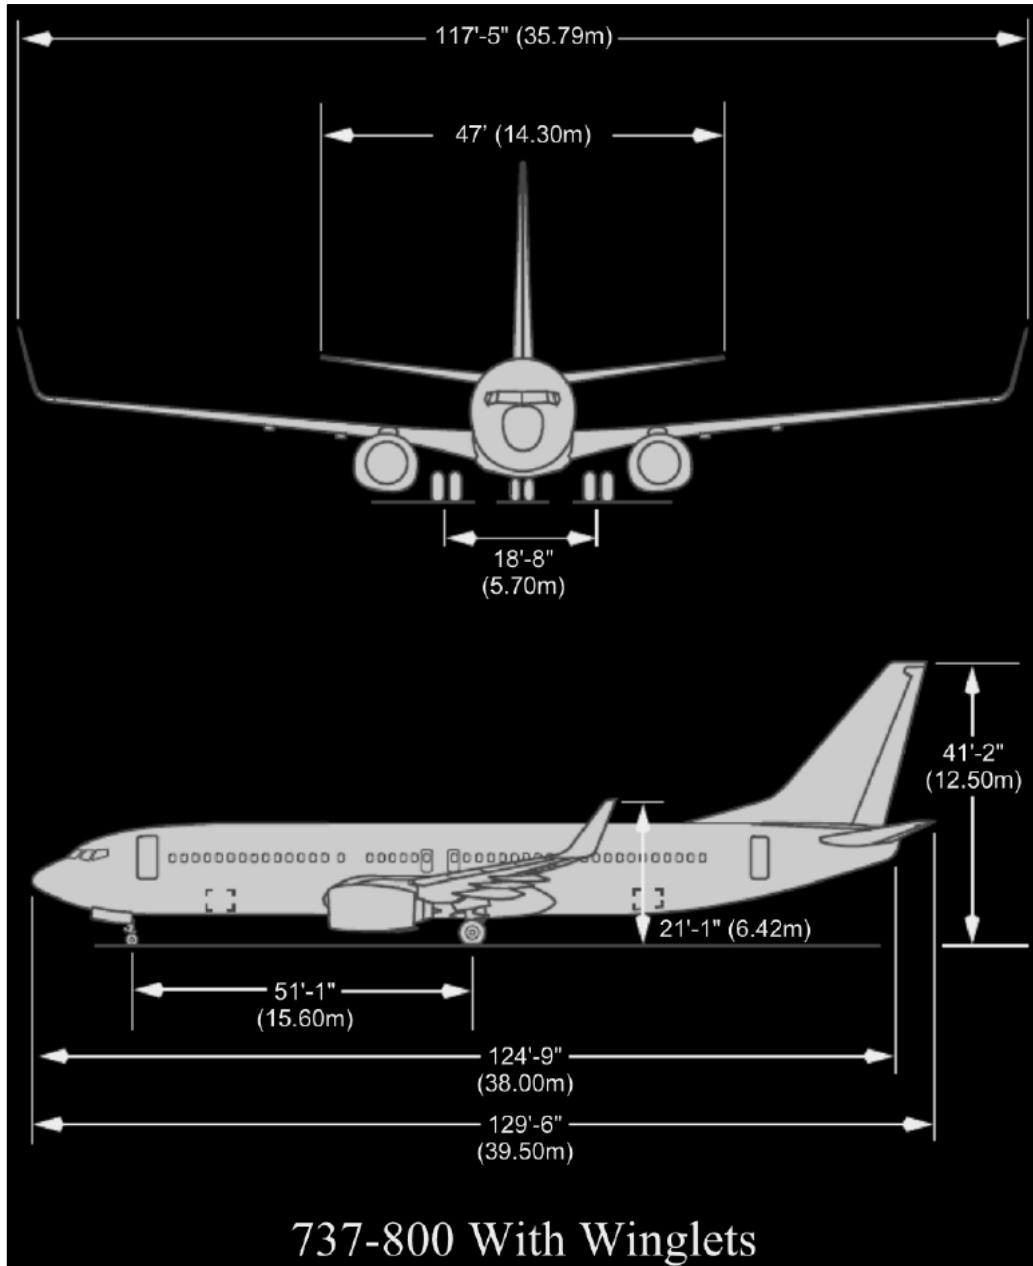
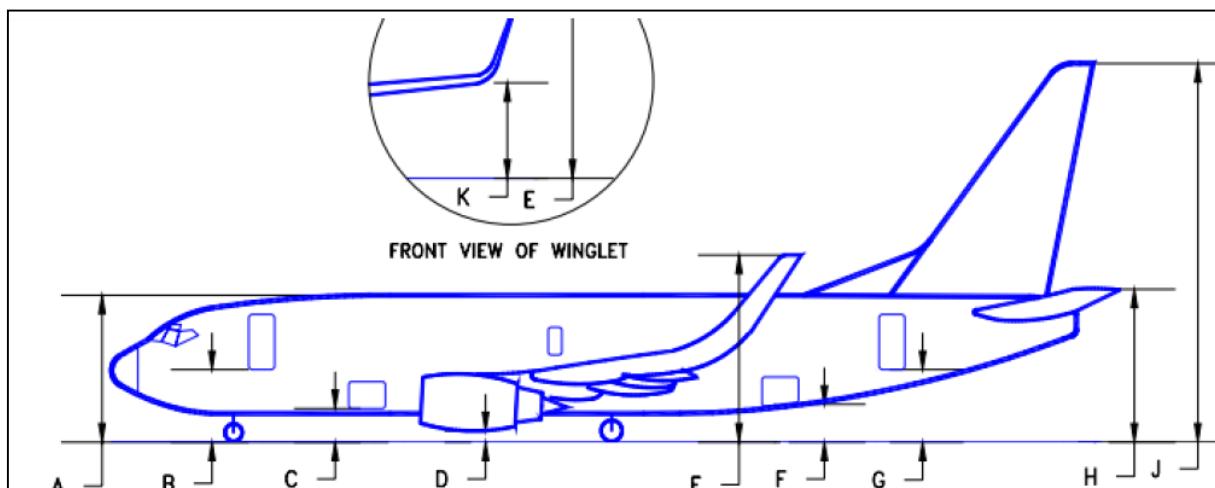
APPENDIX 2

K	BOTTOM OF WINGLET (APPROX)	13 - 9	4.19	13 - 3	4.04	14 - 2	4.32	13 - 4	4.06	14 - 2	4.32	13 - 4	4.06
