Investigation Report

Type of Occurrence: Accident

Date: 2 March 2023

Type: A330-900

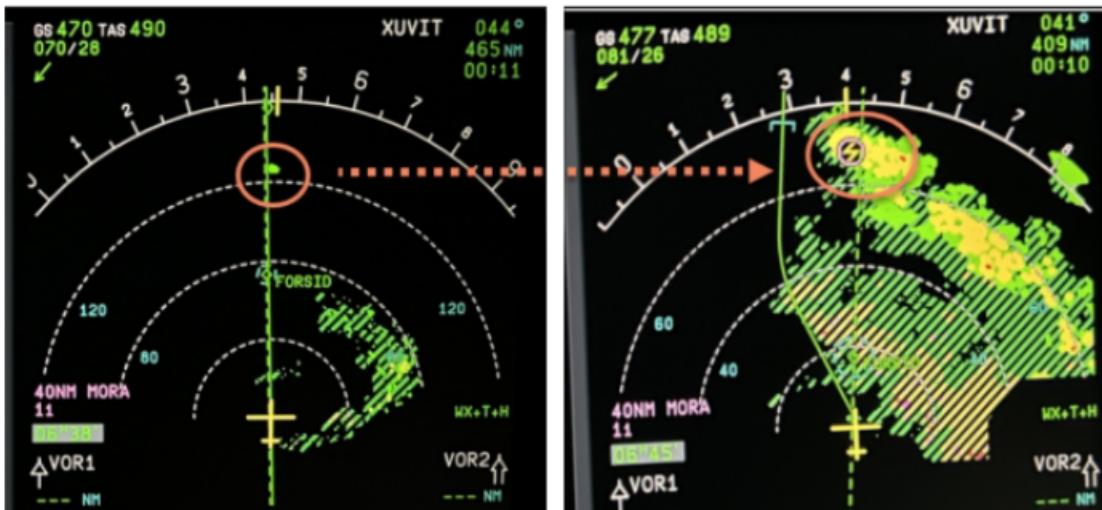
In this case, the weather condition is not shown or under-estimated by the radar at ranges above 80 NM. The weather radar display starts to be correct from ranges below 80 NM. Reports of this mis-behavior have been received mostly with the aircraft operating over open water or rain forests.

Weather display at 120 Nm from Weather condition [left] and at 70 Nm from Weather condition [right]

In case low weather radar performance is reported above 80 NM, no maintenance action is required if no WXR related fault message is recorded, as the low weather radar performance is software related and not caused by a hardware fault.

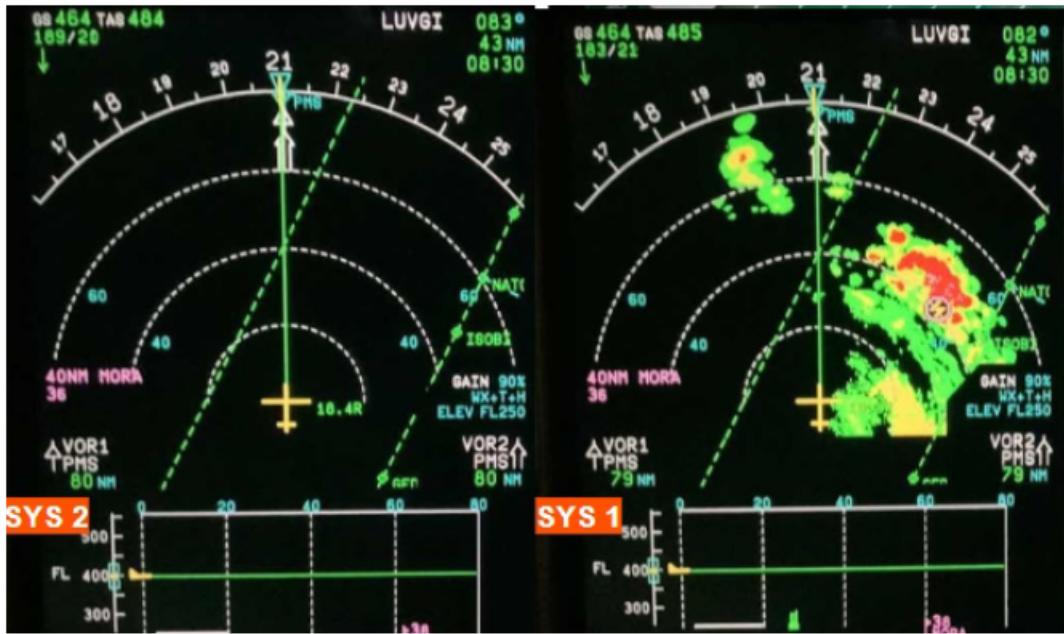
A few cases of weather conditions not shown or severely under-estimated, independently of the range and without failure indication have been reported.

Initial findings suggest that such attenuation can be caused by a degradation either within the receiver part of the RTU (receiver transmitter unit) or within the waveguide section of the WADU/DA (weather antenna drive unit/drive antenna). Such a degradation cannot in all cases be detected by the BITE. This explains why no failure message is shown in the above example. The troubleshooting manuals will be updated to address this failure mode. We will update this ISI once the target date for revision updates is available.

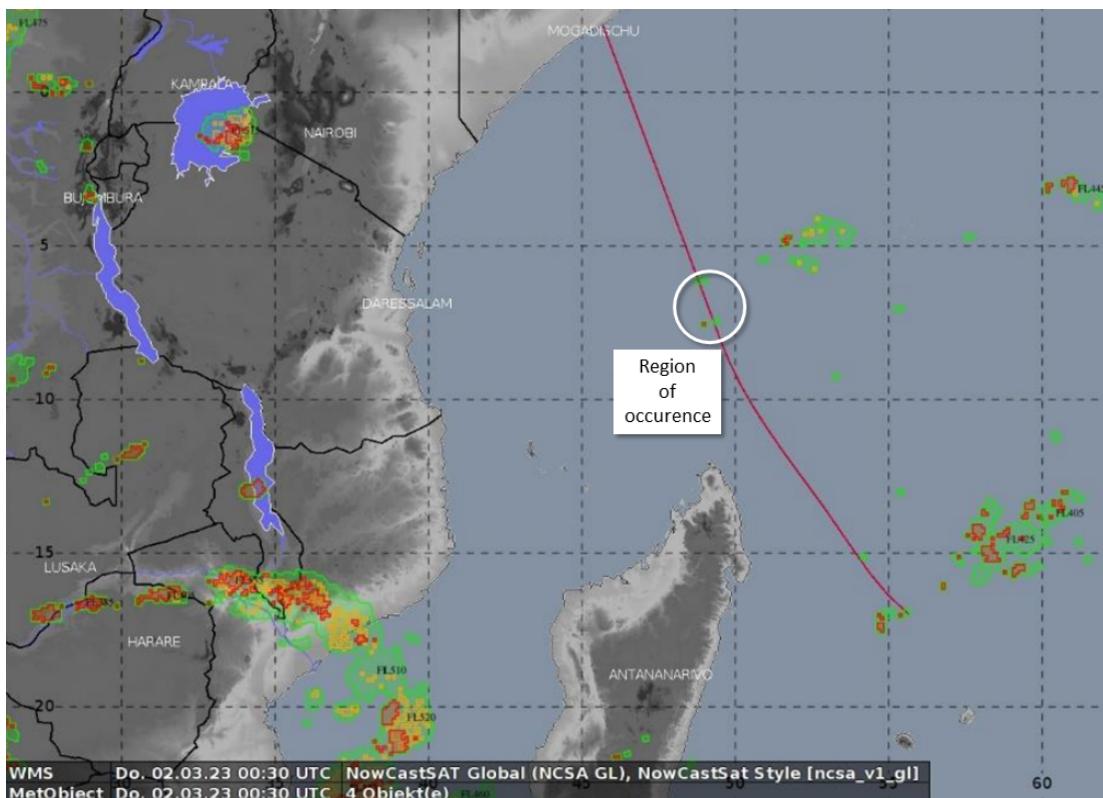
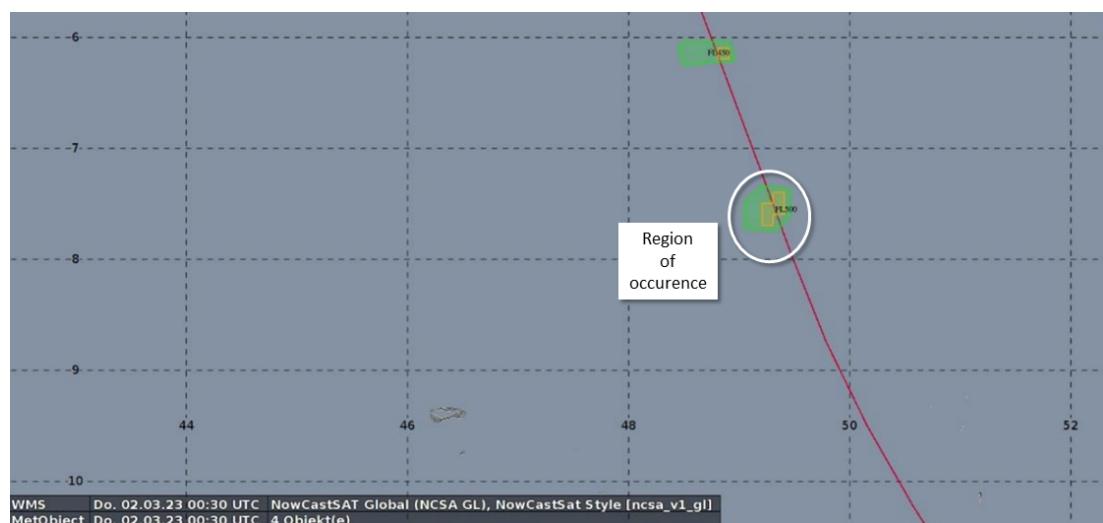
The following is an excerpt of the Nowcasting weather chart in which the DWD drew the approximate flight path. The white circle indicates the occurrence area. The chart was compiled for 2 March 2023 at 0030 UTC and shows severe convection²⁶ with an isolated flash in the occurrence region. The convective cells are depicted in green, yellow, orange and red (light, moderate, moderate to severe and severe convection).

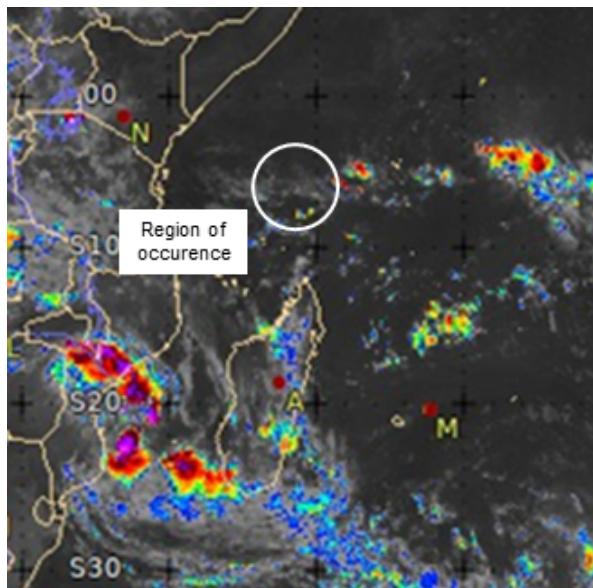
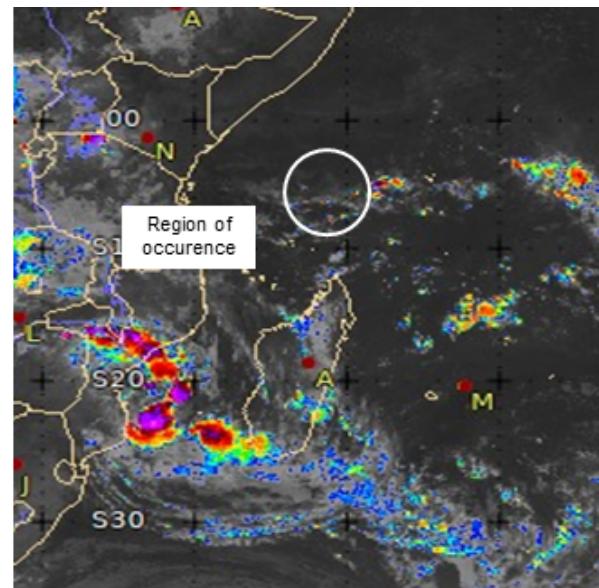
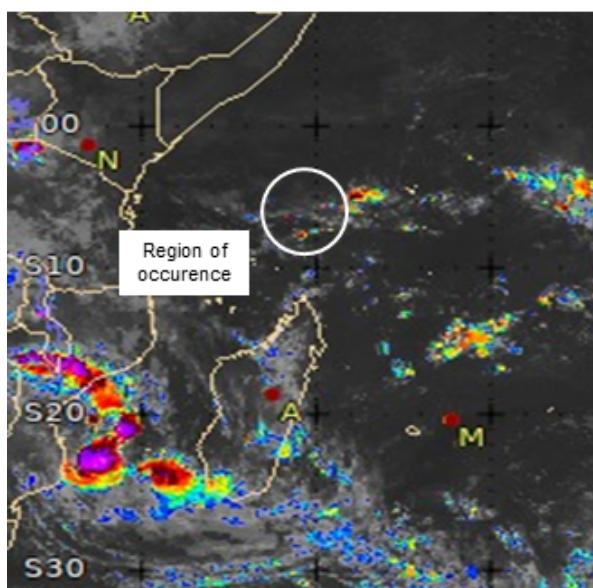
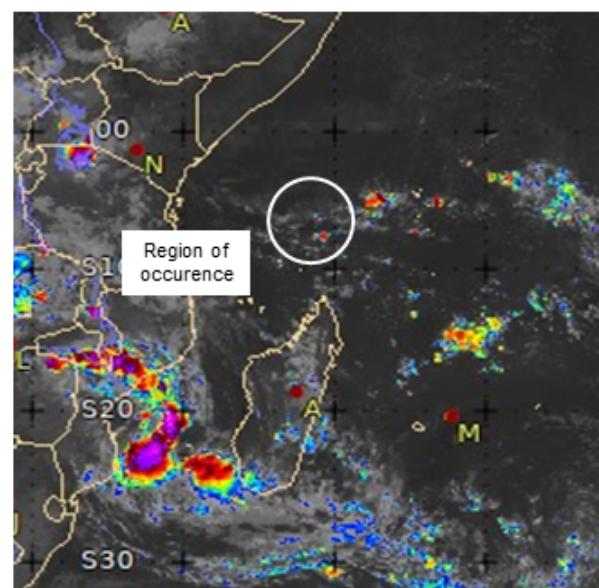
The Cumulonimbus (CB) causing the turbulence extended to FL 420 within about 15 minutes (2345 – 0000 UTC) and then up to FL 500.

Fig. 14: Satellite images of the infrared channel 10.8 μm , excerpt ICAO Area E Source: DWD, adaptation BFU

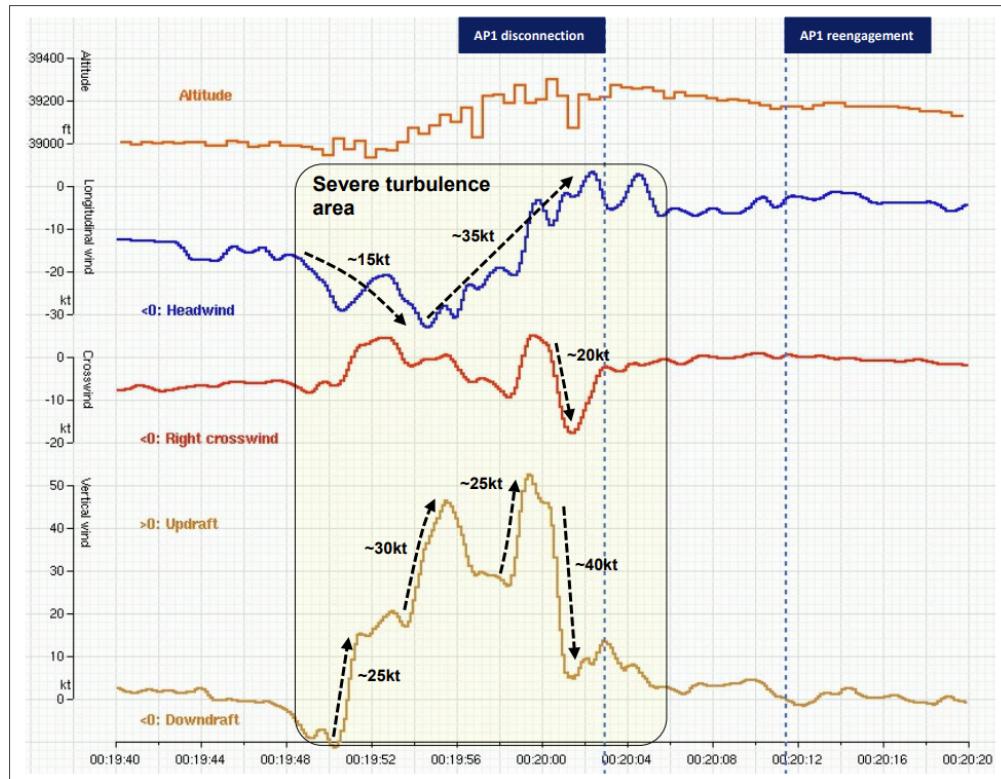
Using corrected anemometrical and inertial data of the DFDR, the aircraft manufacturer calculated the influence of the wind on the flight behaviour of the aircraft. The result of this calculation is depicted in the following graph together with the time of activation and deactivation of the autopilots.

Fig. 17: Influence of the wind on the aircraft (times in UTC)

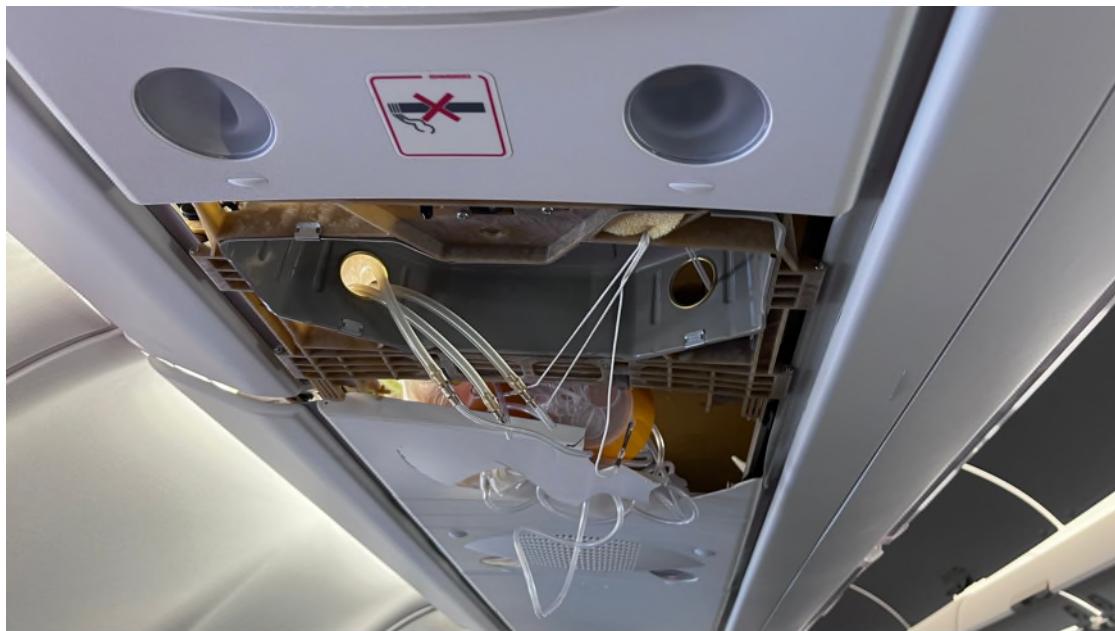
In the cabin area various types of damage occurred. The armrests of several seats had been fractured. Damaged PSU coverings were found in several rows. Cracks in the ceiling lining and damaged lighting was found throughout the cabin. The following images are examples of types of damage.

Fig. 18: Damage on passenger service units

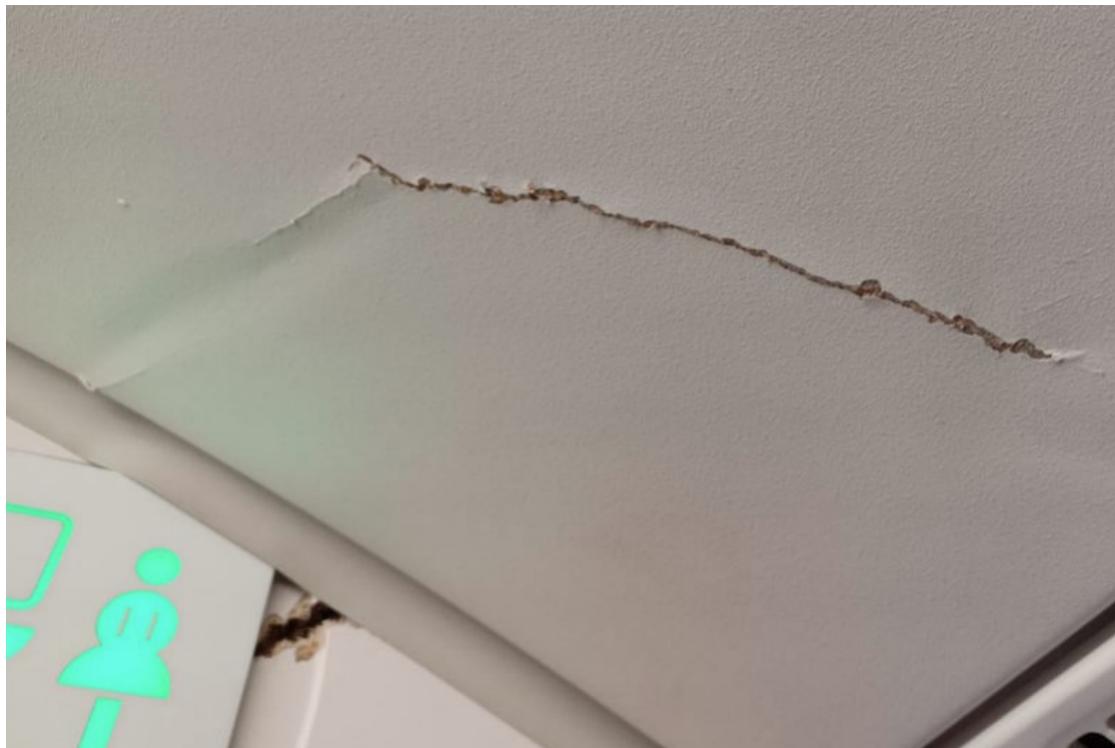
Fig. 19: Damage in the area of the ceiling lining, row 46

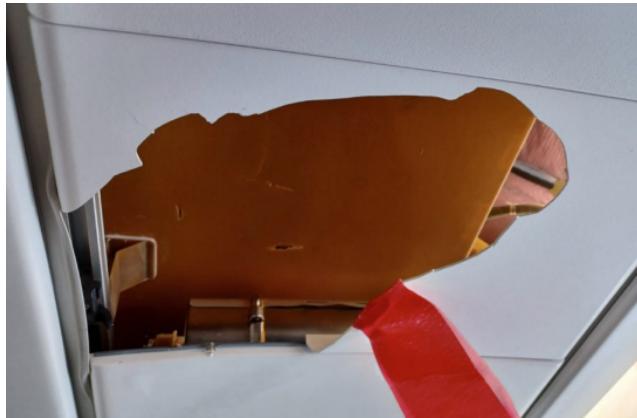
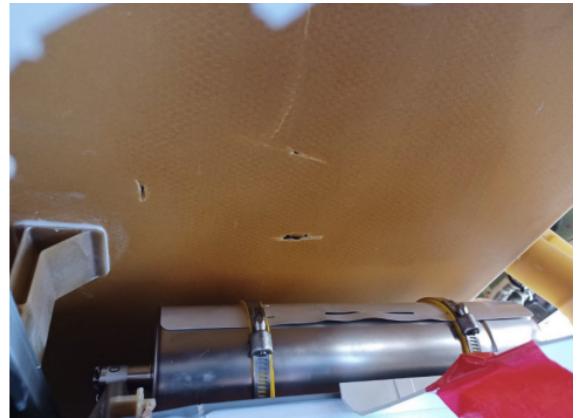
Fig. 20: Damage in the area of the ceiling lining, row 23 HK

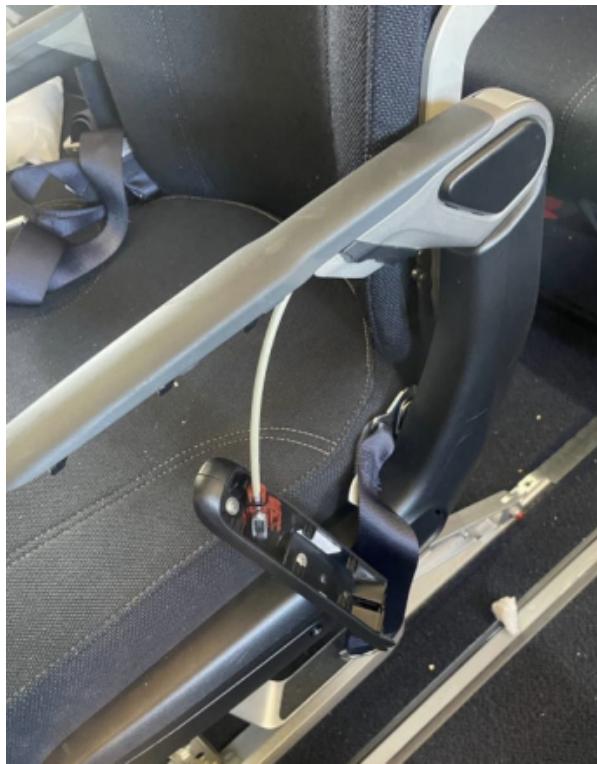
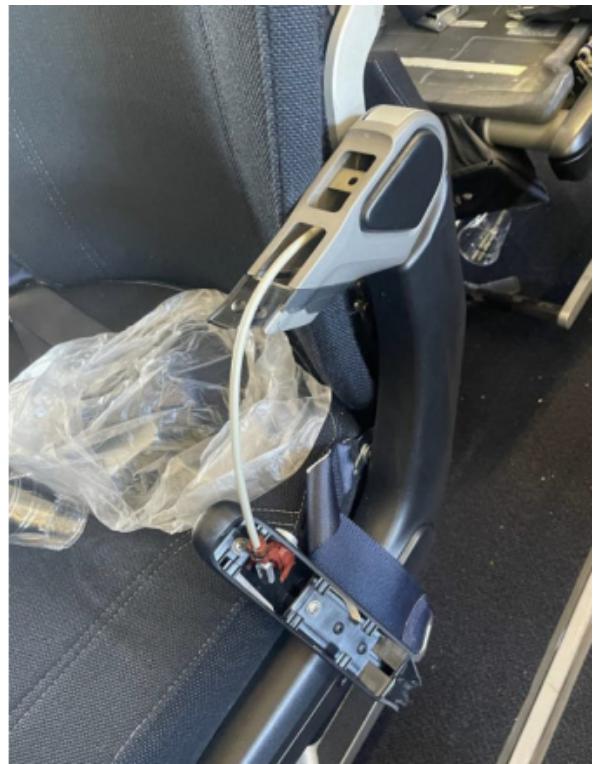
Fig. 21: Damaged seats

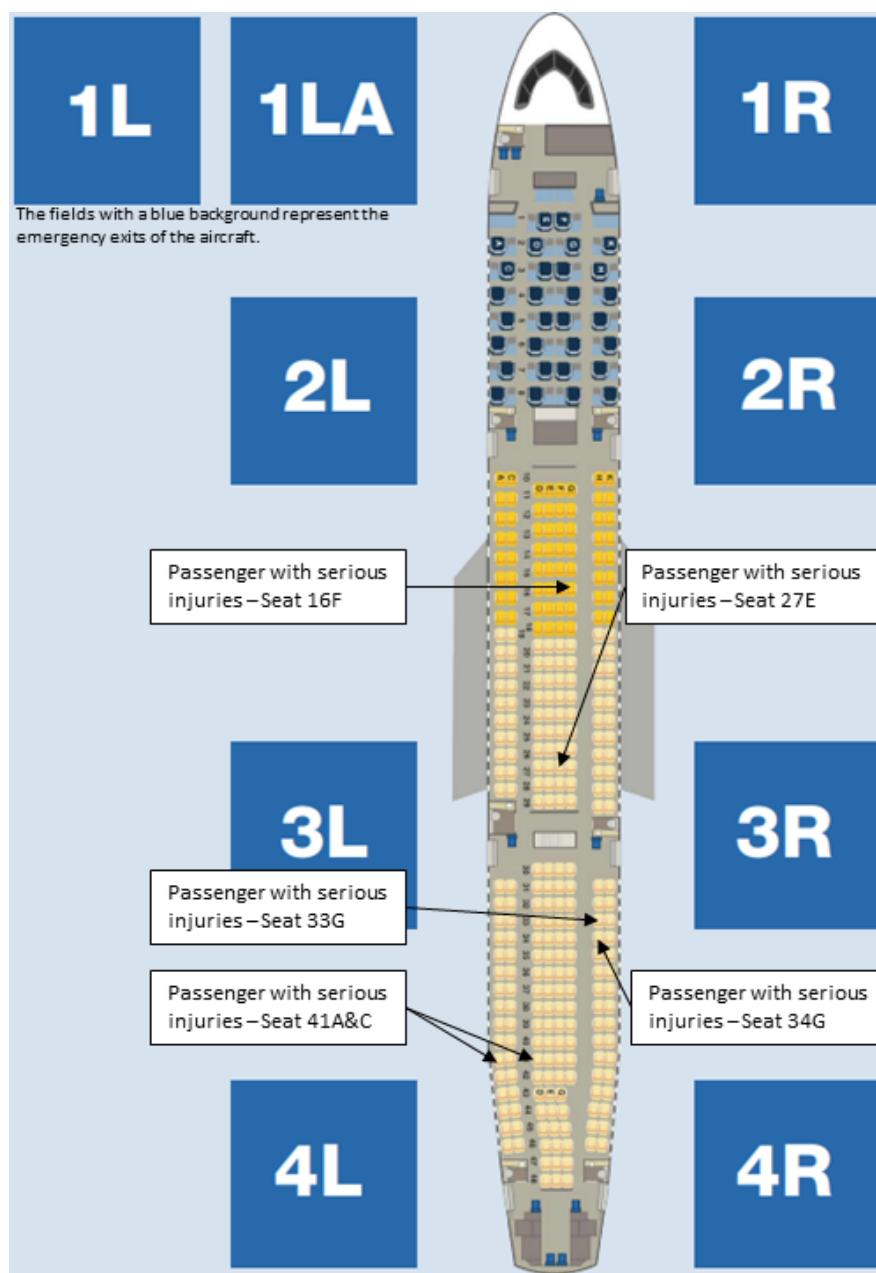
Fig. 22: Seating plan of the airplane including the marked seats of the passengers who suffered severe injuries

The persons with minor injuries suffered soft tissue defects in the sense of lacerations and abrasions as well as contusions and overstretching of the ligamentous apparatus. The persons with severe injuries suffered broken bones. There were four cases of vertebral fractures, followed by rib fractures and an ankle fracture.

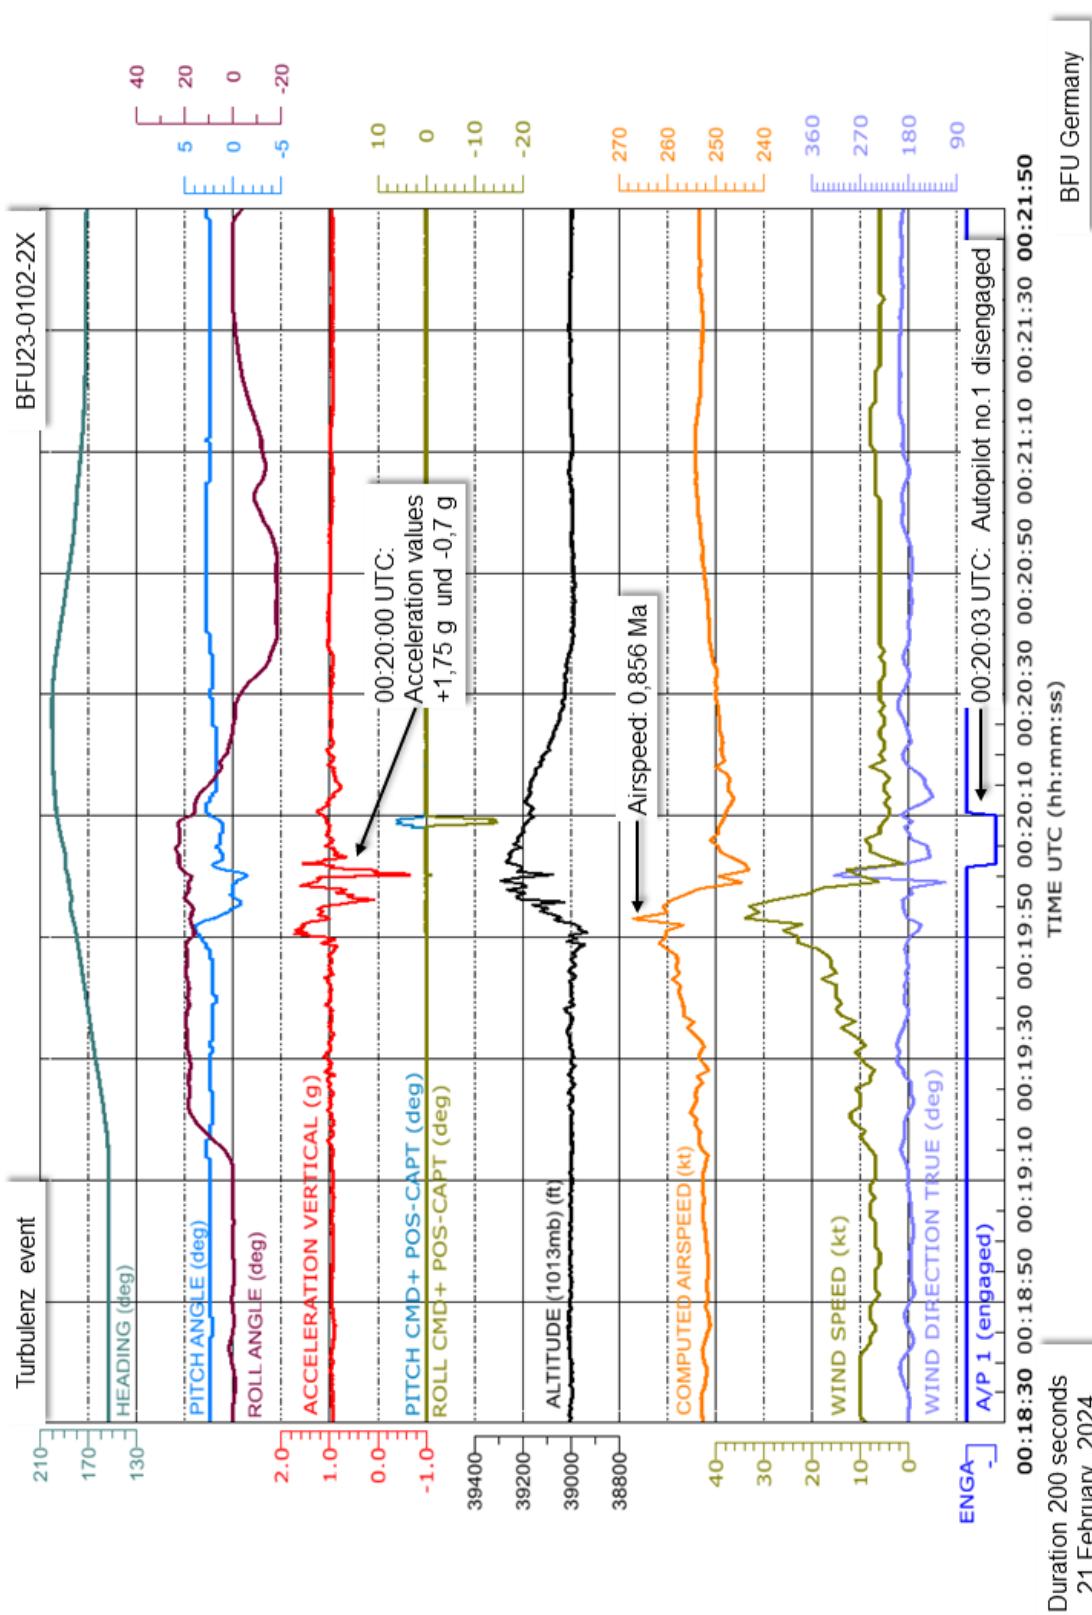
Fig. 24: FDR parameters of the occurrence during cruise flight
