Aviation Investigation Final Report

Location:	Sarasota, Florida	Incident Number:	DCA23LA179
Date & Time:	February 16, 2023, 20:59 Local	Registration:	N976NN (A1); C-FJQH (A2)
Aircraft:	Boeing 737-823 (A1); Airbus 321 (A2)	Aircraft Damage:	None (A1); None (A2)
Defining Event:	Air traffic event	Injuries:	178 None (A1); 194 None (A2)
Flight Conducted Under:	Part 121: Air carrier - Scheduled (A1); Part 129: Foreign (A2)

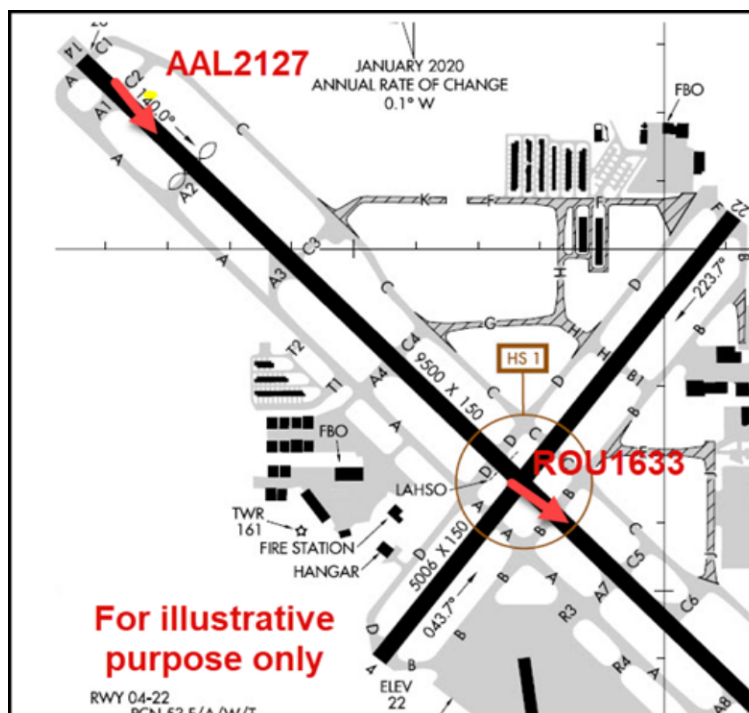
The controller relied on visually monitoring both airplanes to ensure that their courses diverged, and that lateral separation was assured. However, the local controller turned his attention to a lower priority task before confirming that ROU1633 had departed.

The estimated closest proximity between ROU1633 and AAL2172 was 0.6 miles horizontally and about the same altitude; ROU1633 was departing runway 14 and climbing through 100 feet, and AAL2172 was about 100 feet, and crossing over the runway 14 numbers.

Figure 1. Position of aircraft involved when local controller looked up and outside the ATCT cab after hearing AAL2172 report “going around”.

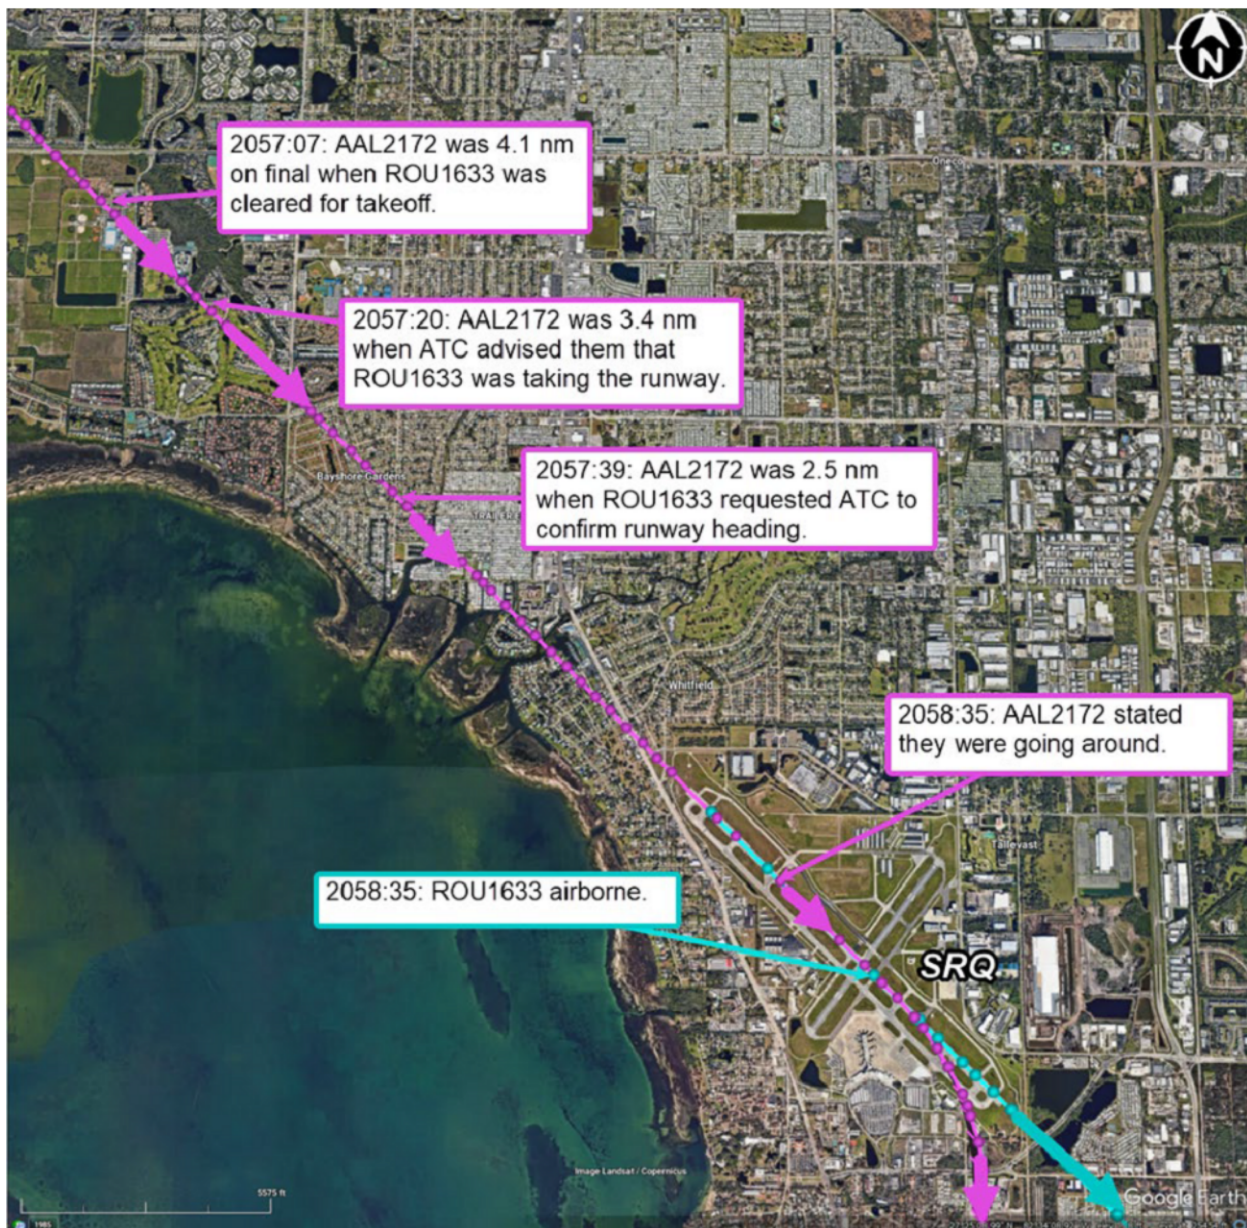
At 2057:07, the LC controller instructed the crew of ROU1633 to fly runway heading, cleared the flight for takeoff runway 14, and advised them that traffic (AAL2172) was on a 3-mile final. The crew read back “cleared for takeoff runway 14”, and at the time ADS-B data indicated that AAL2172 was about 4.1 nm from the threshold of runway 14, see figure 2.

Figure 2. Graphic depicts the location of AAL2172 and ROU1633 during noted times.

At 2057:20, the LC controller informed the crew of AAL2172 that an Airbus will be departing runway 14. The crew then acknowledged by stating their call sign. ADS-B data indicated that AAL2172 was about 3.4 nm from the threshold of runway 14.

At 2057:39, the crew of ROU1633 asked the LC controller to confirm they were to fly runway heading. The LC controller stated, “affirmative, fly runway heading”. ADS-B data showed that at the time AAL2172 was about 2.5 nm from the threshold of runway 14.

At 2058:35, the crew of AAL2172 stated they were “going around”. The LC controller stated “roger”. At that time, ADS-B data indicated that AAL2172 had crossed the threshold of runway

14 and was abeam taxiway A3, and ROU1633 was airborne from runway 14 and abeam taxiway B and subsequently departed the airport environment uneventfully.
