Report 2024-386

Accident to D-EOSE 58 nautical miles south-west of Narsarsuaq (BGBW) on 29-7-2024

An engine failure led to a controlled emergency landing on the sea (ditching).

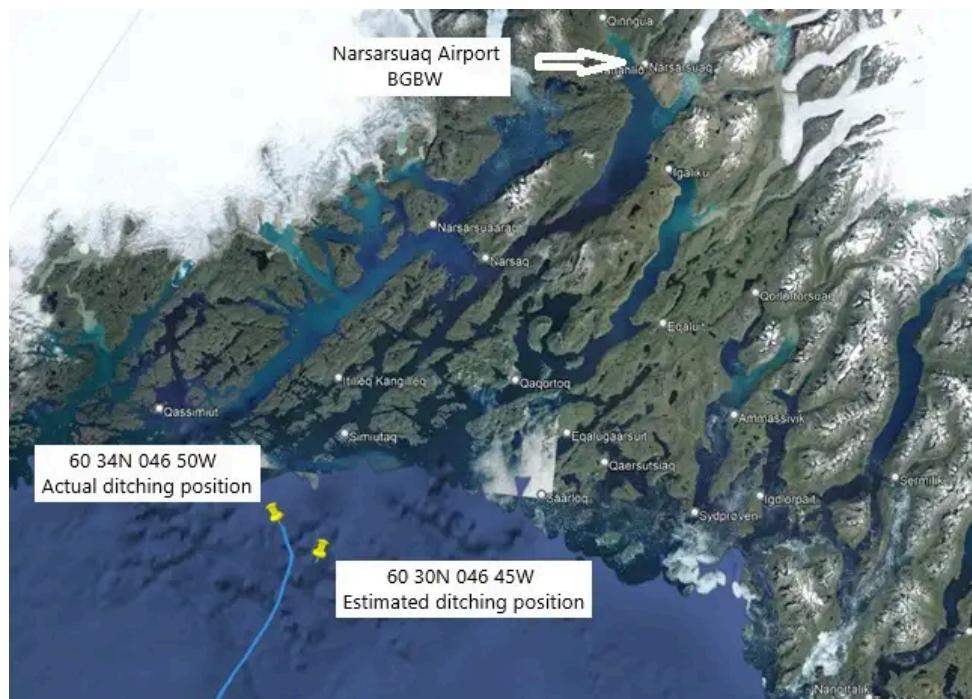
Appendix 1

The pilot observed on his knee-mounted tablet that the predicted gliding distance of the aircraft fell short of the coastline. At 13:26 hrs, the pilot informed Nuuk Information of the expected ditching position: 60 30N 046 45W. See appendix 1.

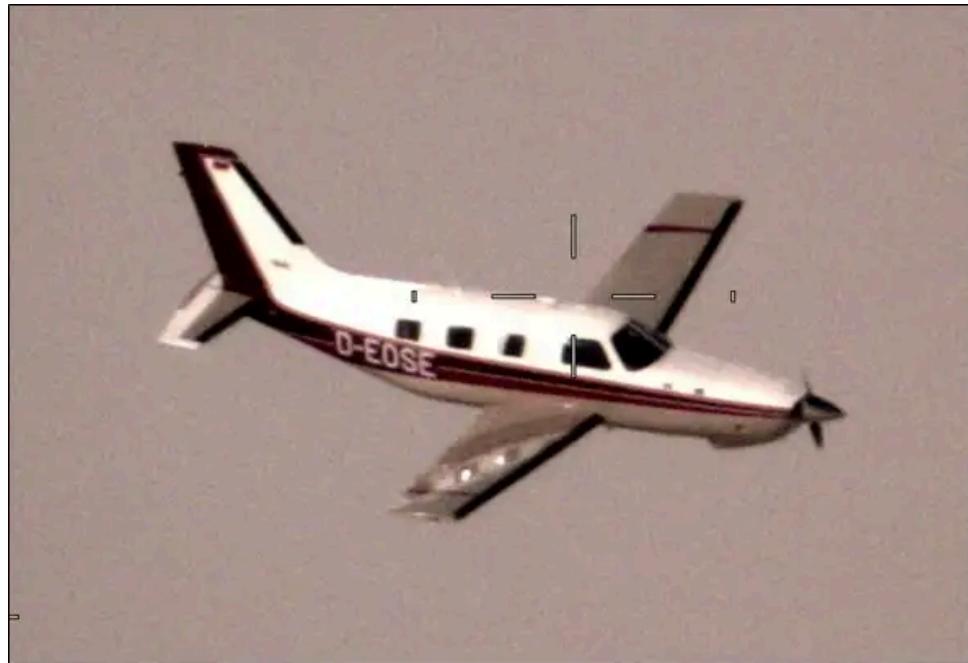
Appendix 2

At 13:29 hrs, as the aircraft was passing 3,300 ft descending, the RDAF surveillance aircraft spotted the aircraft gliding on a north-easterly course over a low overcast. See appendix 2.

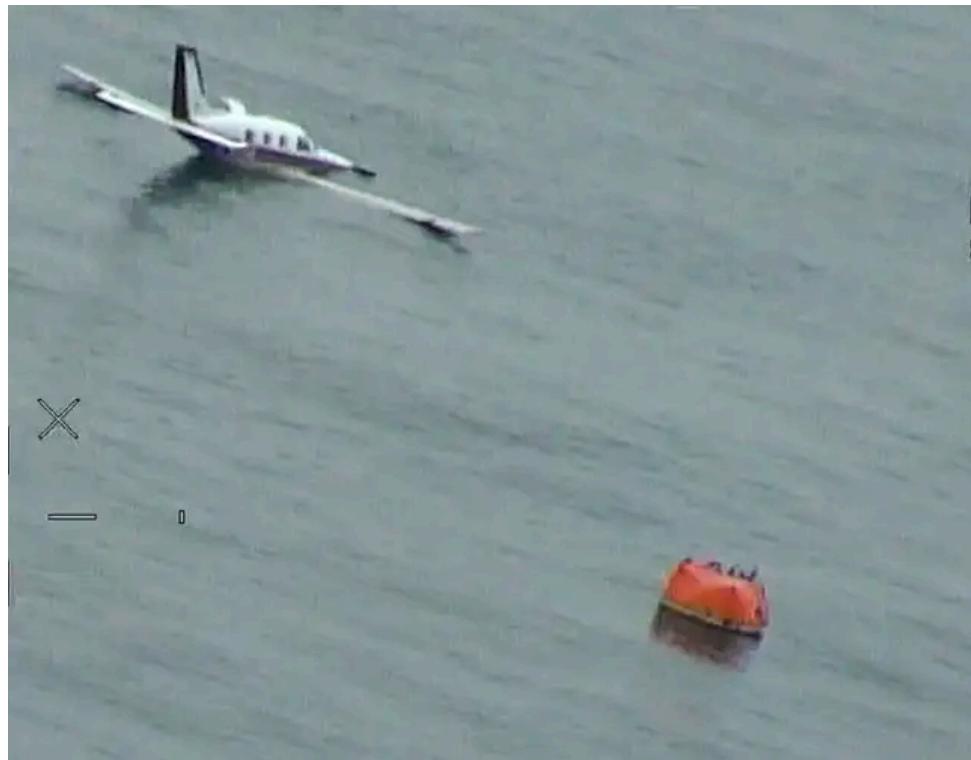
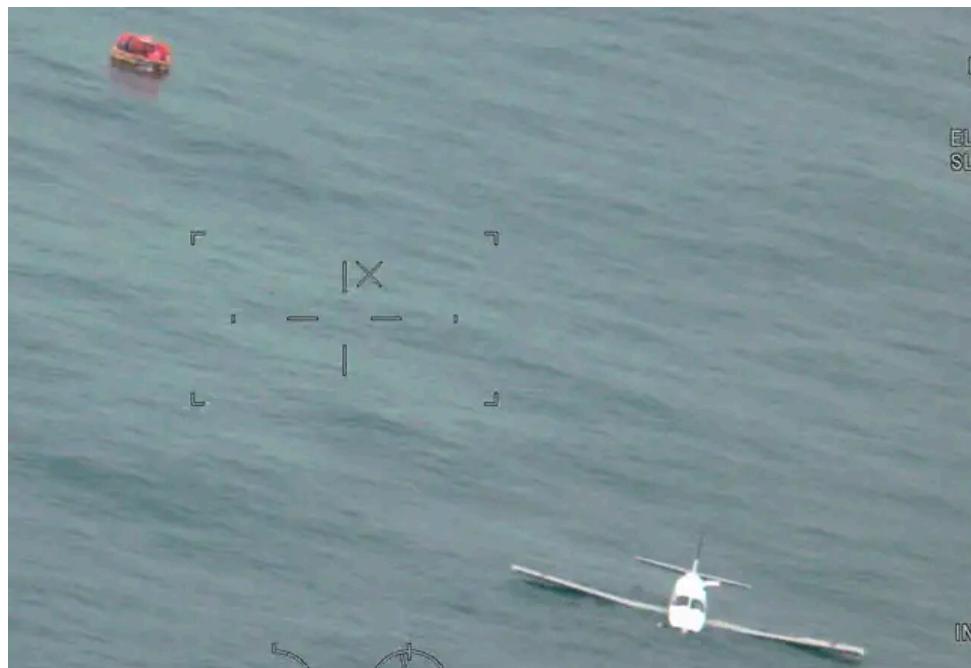
Appendix 3

At 13:40 hrs, at position 60 34N 046 50W, the RDAF surveillance crew spotted the life raft with the pilot and passenger. See appendix 3.

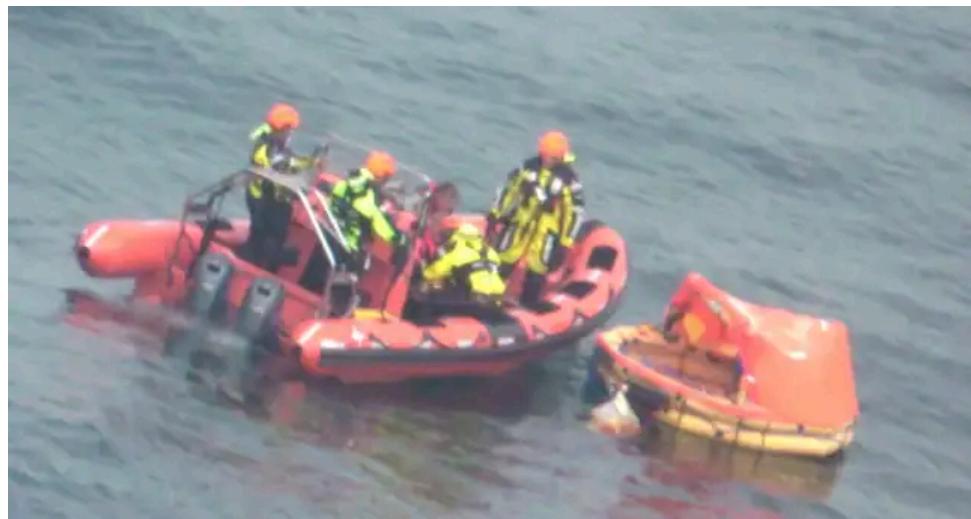
Appendix 4

At 14:23 hrs, a rescue crew in a rigid-hulled inflatable boat (RHIB) dispatched from the RDN inspection ship and picked up the pilot and passenger. See appendix 4.

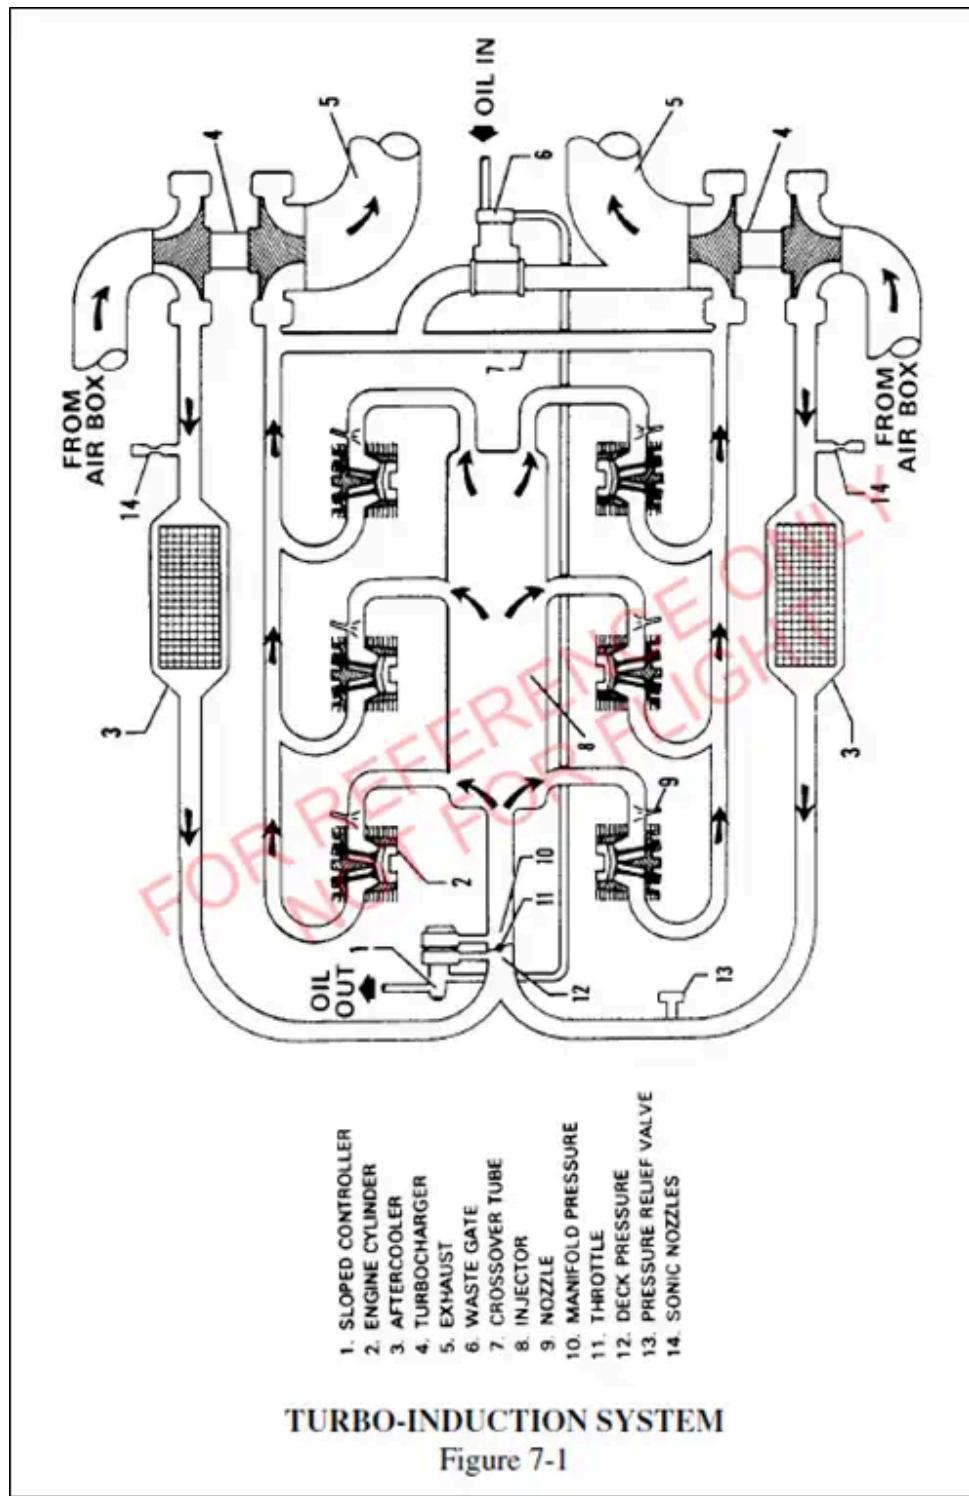
Appendix 5

The aircraft Pilot's Operating Handbook (POH) Figure 7-1 was a schematic of the turbo-induction system. See appendix 5.

A turbocharger failure, either as a result of loss of oil pressure or as a stand-alone turbocharger failure, would cause a loss of compressed air to both the aircraft cabin pressurisation system and the engine induction system.

The drop in MP was likely an indication of turbocharger failure.
