# Aviation Short Investigation Final Report

Abrupt Maneuver (Aborted Takeoff)

Boeing 737-900ER – N900DU

**AAIA Aviation Occurrence Investigation**  
**Report # OCC-2024/0011**

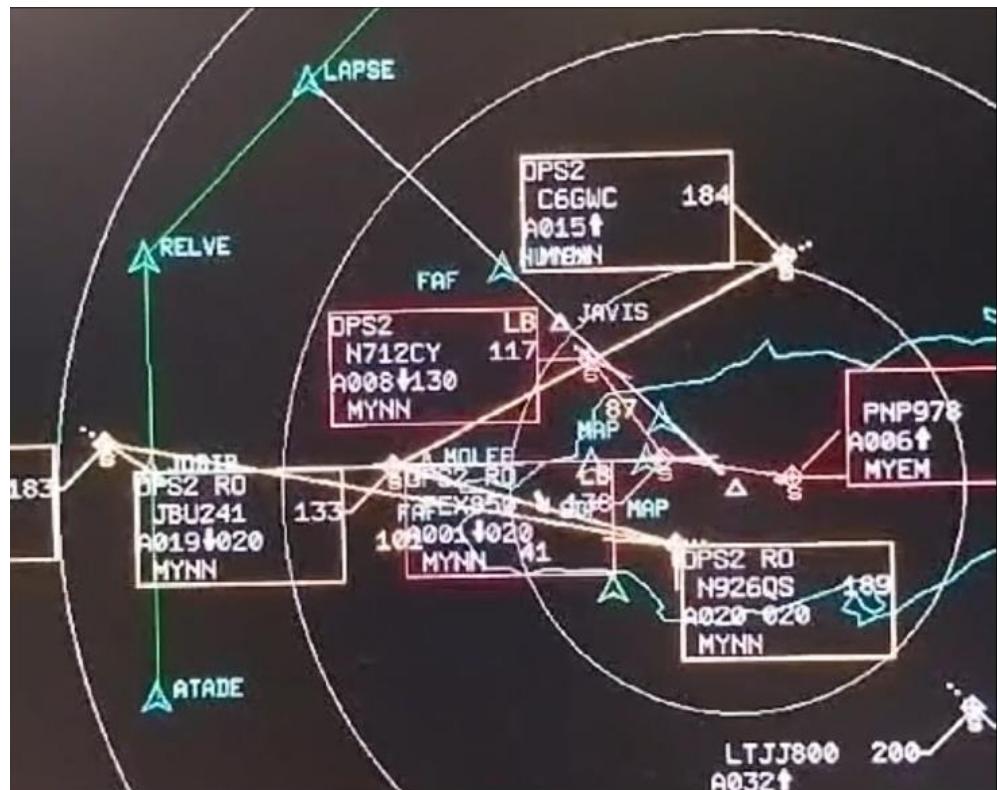
Fig.4: MYNN Radar scope at point of issuance of abort takeoff to N900DU

When a review of the air traffic control audio recording and radar playback was conducted, it was apparent that the aerodrome controller became overwhelmed after the point at which the pilot in command of N926QS was unable to accept a land and hold short of runway 14 instruction.

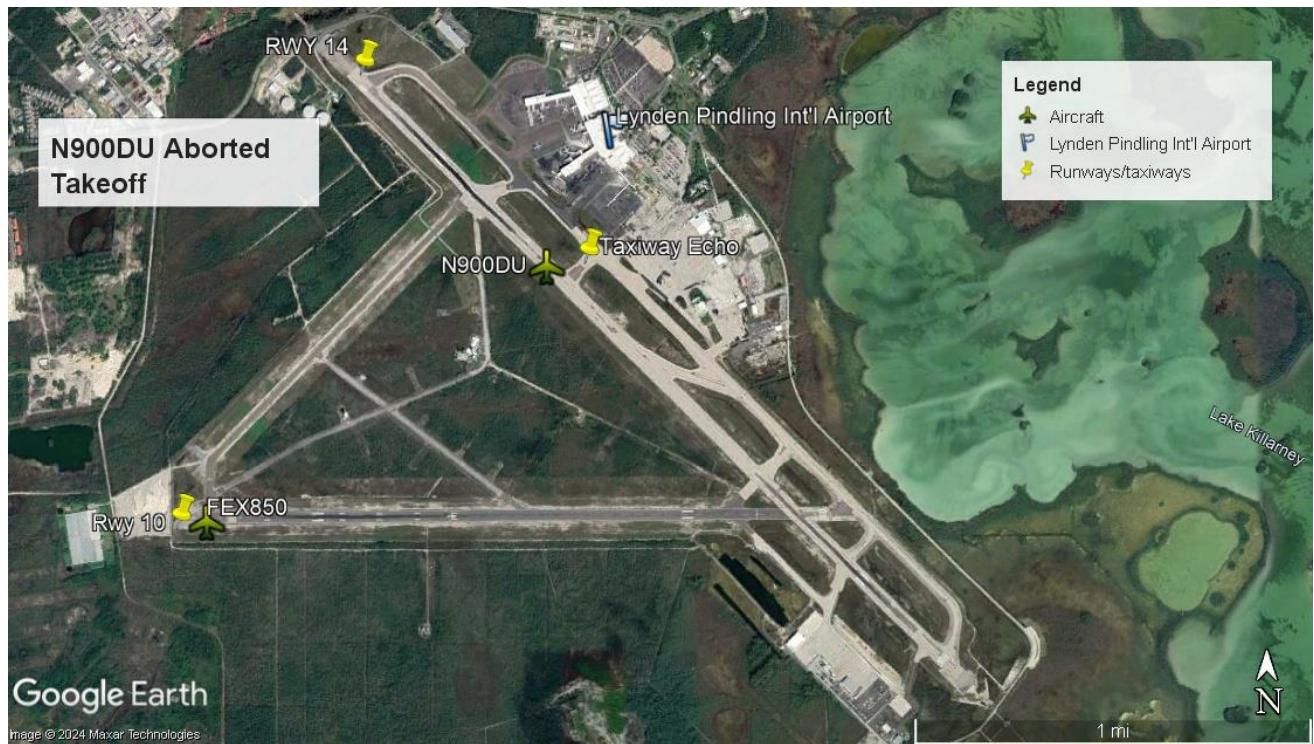
**Fig.5: MYNN Layout and aircraft positioning**

It would appear that the complex operations may have overwhelmed the aerodrome controller, having to also incorporate into sequencing, two additional aircraft as N900DU was instructed to position for a departure from runway 14 while a Beechcraft King Air 200 with United States registration N712CY was established on short final approach for landing runway 14 at a distance of approximately less than 3 NM from the threshold of runway 14.

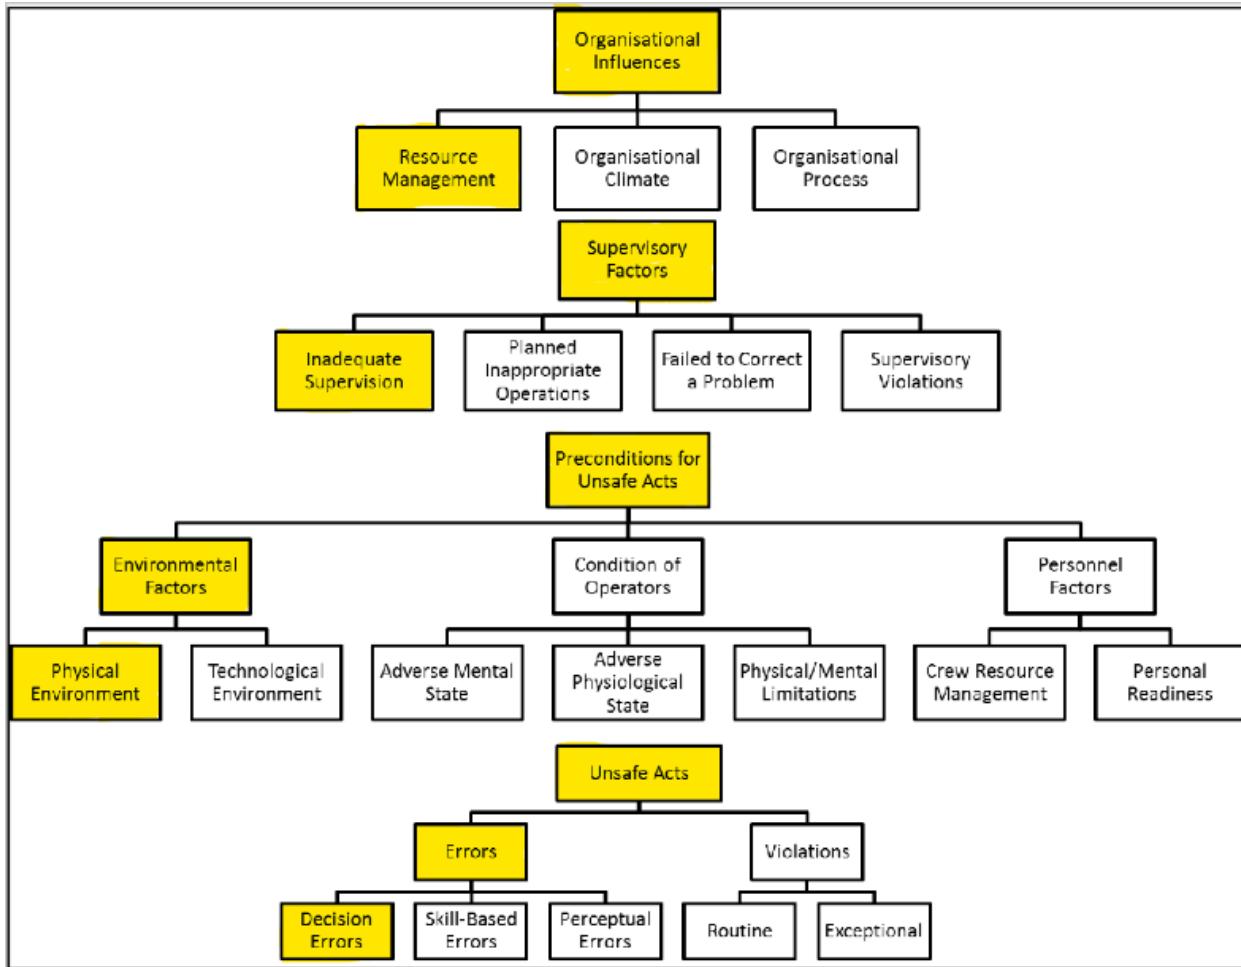
Fig.6: HFACS Framework

In keeping with the taxonomy from the HFACS framework, the ***Unsafe Act*** in this instance was identified as most applicable to ***Decision Errors*** whereby it was apparent that successive decisions made by the aerodrome controller, including not issuing landing clearances to both N926QS and C-GDTD (FEX850), where critical and the situation deteriorated in the aftermath.

With regard to the element of ***Precondition for Unsafe Acts***, what is of significant importance in this occurrence is the ***Physical Environment*** relative to the operations being conducted at the aerodrome which were impacted by the temporary closure of runway 14/32.

The **Supervisory Factors** element was identified via the lack of a Tower Cab Supervisor in the control tower which falls under the category of **Inadequate Supervision**. It would not be unreasonable to expect that the presence of a Tower Cab Supervisor would have possibly mitigated against the events unfolding in the manner in which they did.

With reference to the **Organizational Influences**, the lack of a Tower Cab Supervisor to provide adequate supervision within the control tower can be linked to the **Resource Management** of the Bahamas Air Navigation Services Authority (BANSA) as an organization, which is required to ensure that adequate human resources are in place to facilitate the safe, orderly and expeditious flow of air traffic.

- **SR2024-04** - The AAIA recommends that BANSA formulate a plan of action to ensure that there is a Tower Cab Supervisor present in the control tower during periods of peak or complex operations.
