# Technical report

## IN-016/2023

Incident on 16 July 2023 involving an AIRBUS A320-214 aircraft operated by Vueling Airlines S.A., registration EC-JTR, at Barcelona Airport (Barcelona, SPAIN)

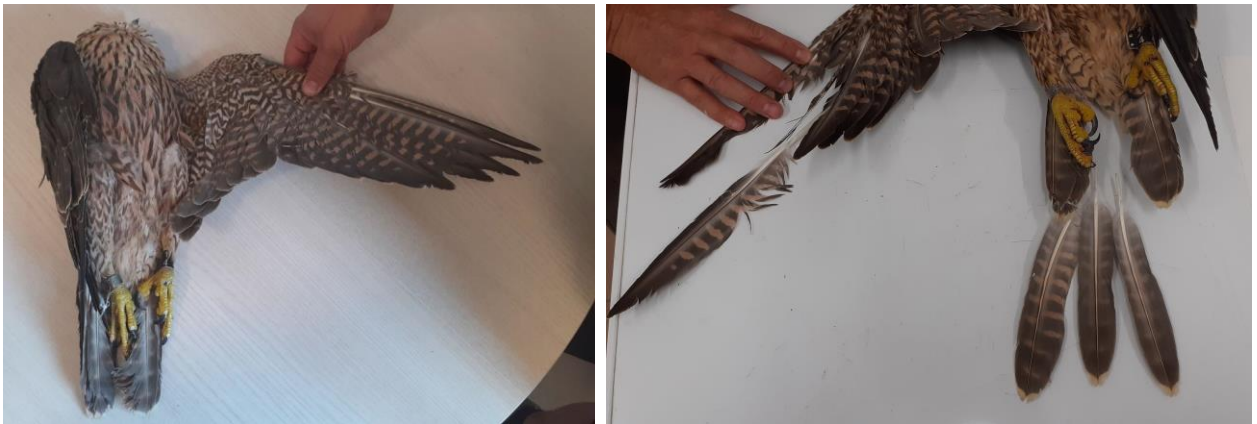
During the check carried out by the airport's wildlife control service after the impact, the intact lifeless body of a wild 900 g female ringed peregrine falcon was found, with 4 feathers missing (1 primary and 3 rectrices). It was found to the left of runway 24L, in line with rapid exit G6 (see 3 in figure 15).

Figures 1 and 2: Carcass of the bird involved in the impact with the EC-JTR aircraft.  
Figure 1 shows the bird as it was found, and Figure 2 shows the 4 feathers in their original corresponding positions.

*The primary cause of death is suspected to be trauma to the rear pelvic area. This trauma caused an intracellular haemorrhage in the renal area and very possibly paralysis of the hind limbs, rendering the bird incapable of flight control. The loss of central tail feathers and tearing to the skin suggests a very abrupt pulling of the feathers, possibly as a result of being caught in some part of the aircraft's structure.*

*The remaining skin injuries, head trauma and scapular fracture may have been sustained on impact with the ground.*

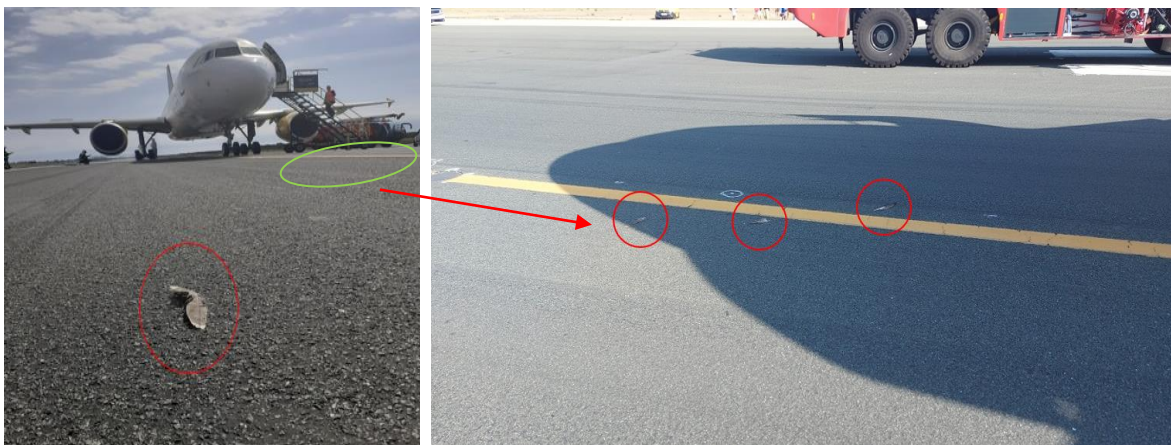
Four bird feathers were found on the tarmac a few metres in front of the nose of the aircraft, which were confirmed by the airport wildlife control service as belonging to the dead peregrine falcon found during the search.

Figures 3 and 4: Location of the four bird feathers found on the runway.

The main remains of the animal were found on the left side of runway 24L, on a level with rapid exit G6. The aircraft came to a stop at taxiway G8, where 4 feathers of the same animal were also found (see Figures 3, 4 and 14).

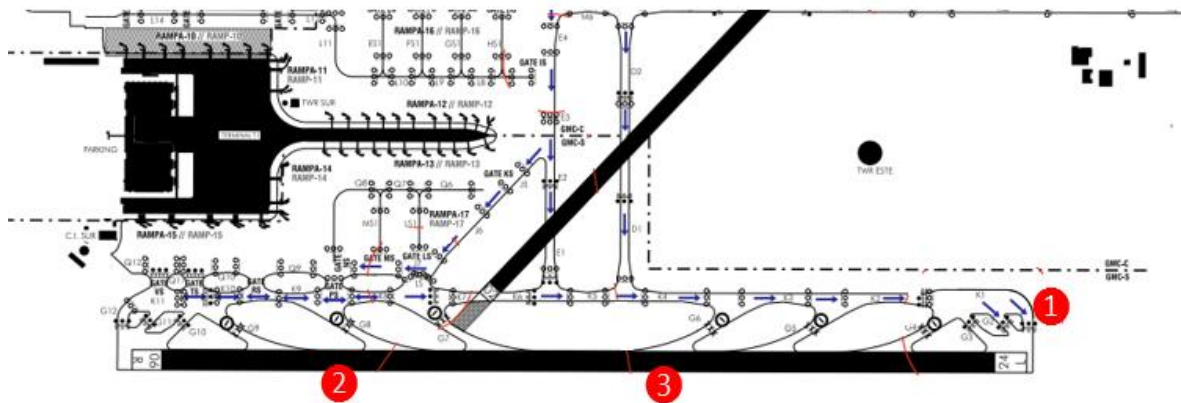
The aircraft entered the runway from taxiway G1 (see ① in the figure below) and finally came to a stop between taxiways G8 and G9 approximately 600 m from the end of the runway (see ② in the figure below). The remains of the bird were found on the left side of runway 24L, close to rapid exit G6 (see ③ in the figure below).

Figure 15: Extract from LEBL airport map the relevant positions of the EC-JTR aircraft and the bird that hit it.

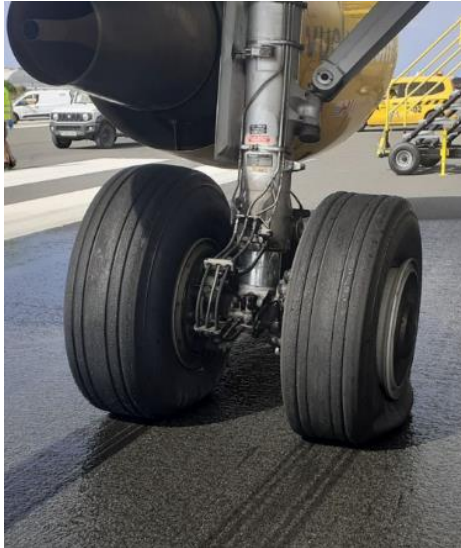
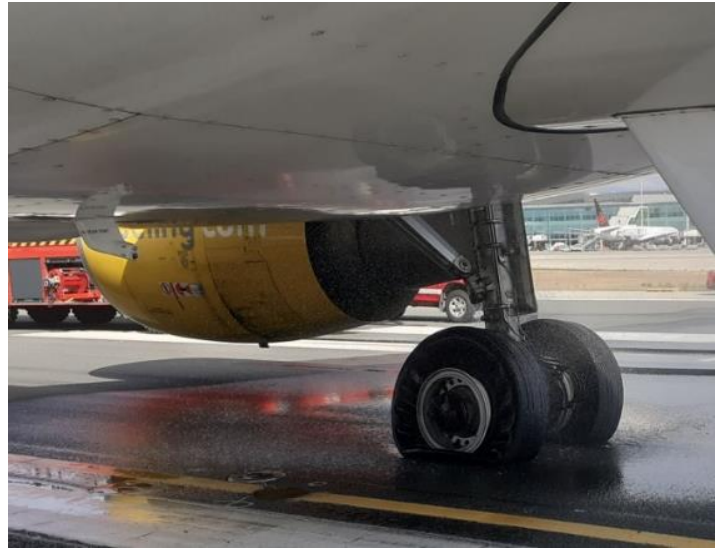
As a result of the high-speed rejected take-off, three of the four wheels (2, 3 and 4) on the main gear deflated after the aircraft had stopped due to the triggering of their thermal protection fuses. In addition, the deployment of the evacuation slides caused minor damage to the aircraft.

Figures 16 and 17: Condition of the main gear wheels after the incident. Figure 16 (on the left) shows wheels 1 and 2, and Figure 17 shows wheels 3 and 4.

The brake temperatures rose considerably, as was to be expected: at 07:46:01, the brake temperature of wheel 3 was 568°C, and the lowest temperature (wheel 1) was already at 475°C. The conditions were met for the protective deflation of the wheels.

Following the event, all the main gear wheels (left and right) and their associated brakes were replaced, in addition to the right main gear temperature connector, before towing the aircraft off the runway. The functional tests performed were satisfactory.

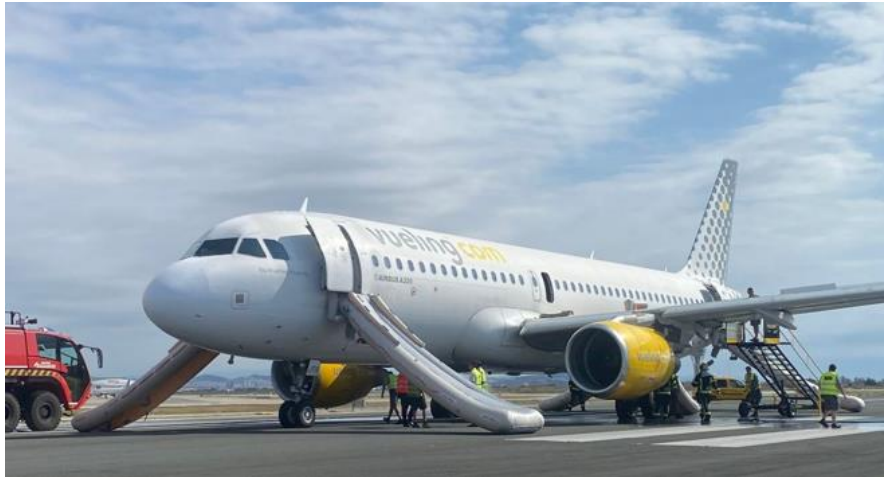
During the evacuation, 5 of the 8 available emergency exits were opened, and the corresponding slides were deployed. The 2 emergency exits positioned over the right wing and one of the emergency exits over the left wing were not opened by the passengers who should have done so. In addition, the emergency exits and ramps were checked and operationally tested and found to be satisfactory.

Figure 19: Photograph of the EC-JTR aircraft taken after the evacuation.

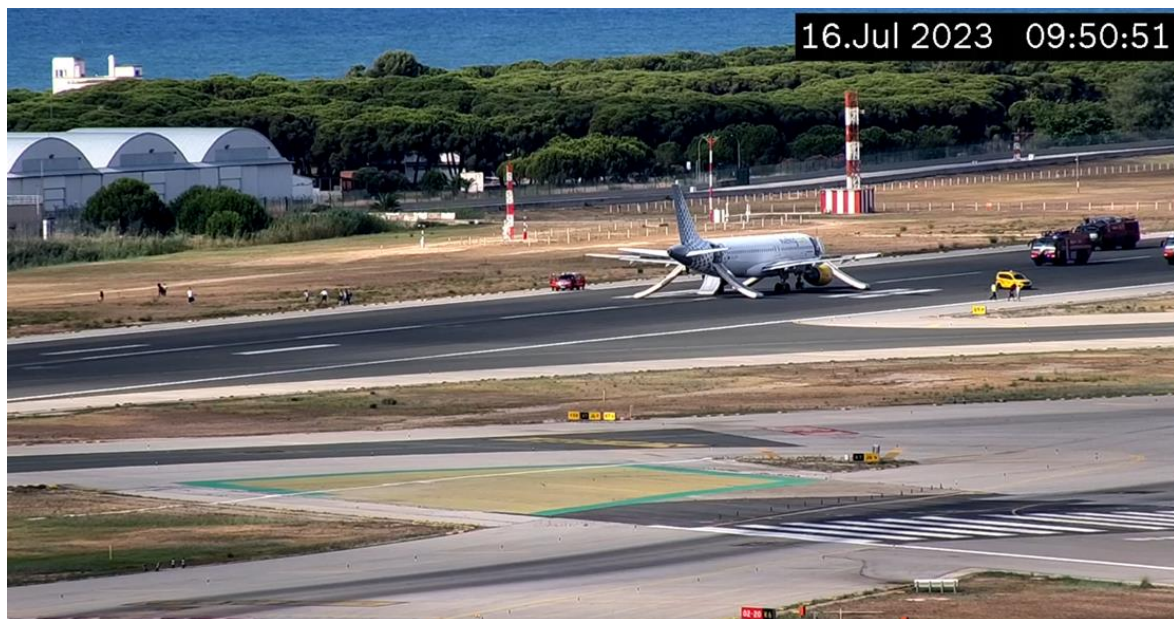
The image in the figure below shows the time (07:50:51) that the three heavy rescue and firefighting vehicles arrived at the aircraft, extracted from the airport CCTV recordings (the image shows local time).

Figure 20: Arrival of the three SSEI heavy vehicles at the aircraft. Image extracted from the airport's CCTV footage (the time shown is local time, LT)
