KOMITE NASIONAL KESELAMATAN TRANSPORTASI
REPUBLIC OF INDONESIA

Aircraft Serious Incident Investigation Report

Batik Air Indonesia

Airbus A320; PK-LUV

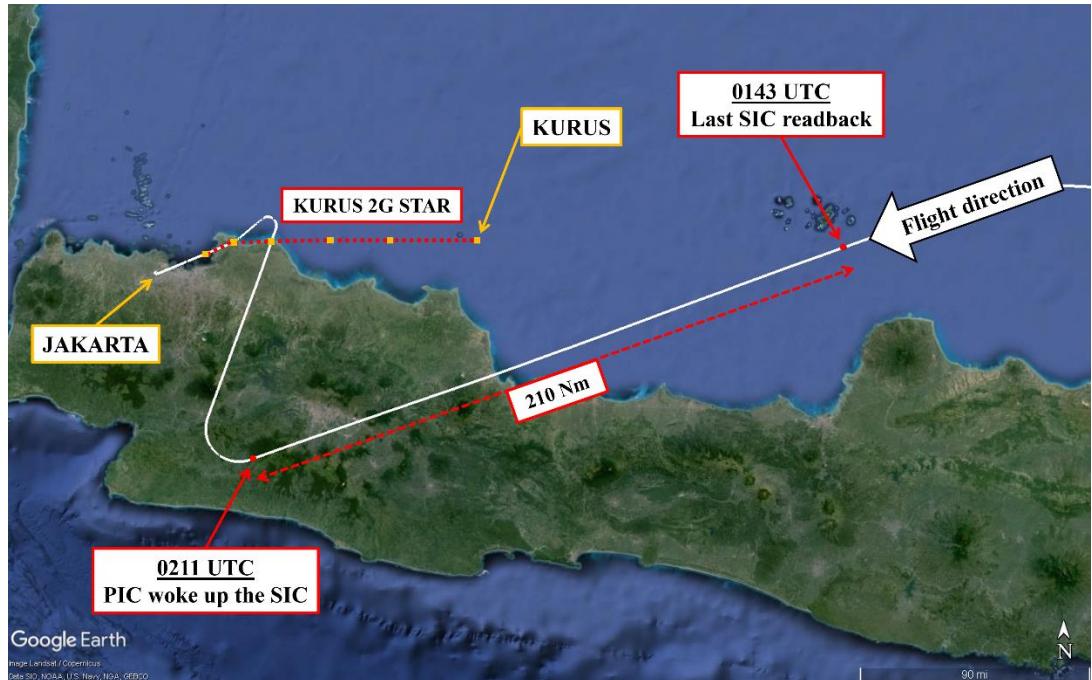
Figure 1: BTK763 flight profile

At 01:43:43 UTC, the SIC readback the Jakarta ACC instruction. At that time, the aircraft was flying on heading 250° and the position was about 125 Nm east of Waypoint KURUS. A few moments later, the SIC inadvertently fell asleep.

At 0143 UTC, the SIC made initial contact with the Jakarta ACC and was instructed to follow KURUS 2G Standard Instrument Arrival (STAR) with additional instruction to report when the aircraft was clear from bad weather conditions. At that time, the aircraft position was about 125 NM east of Waypoint KURUS, which was the initial waypoint of the KURUS 2G STAR.

The flight could not be directed to follow the STAR as the SIC was still avoiding the bad weather conditions by setting the heading selector on 250°.

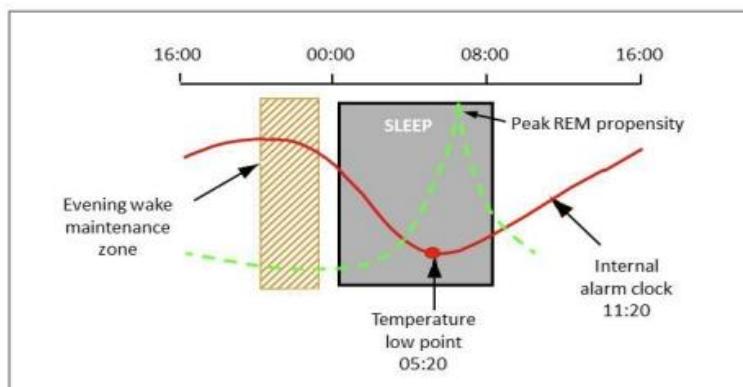
Figure 2: Relationship between normal sleep at night and the circadian body clock cycle

ICAO Document 9966: Manual for the Oversight of Fatigue Risk Management Approaches, subchapter 2.3.2 described that humans are programmed for daytime wakefulness and nighttime sleepiness by the circadian body clock. The circadian body clock also affects every aspect of human functioning, which causes cycles of high and poor performance. The period of the circadian body clock cycle when people generally feel most sleepy and are least able to accomplish mental and physical work is the time around the daily minimum in core body temperature. This is sometimes referred to as the Window of Circadian Low (WOCL). The influences of the circadian body clock on sleep at night can be seen at the picture below:

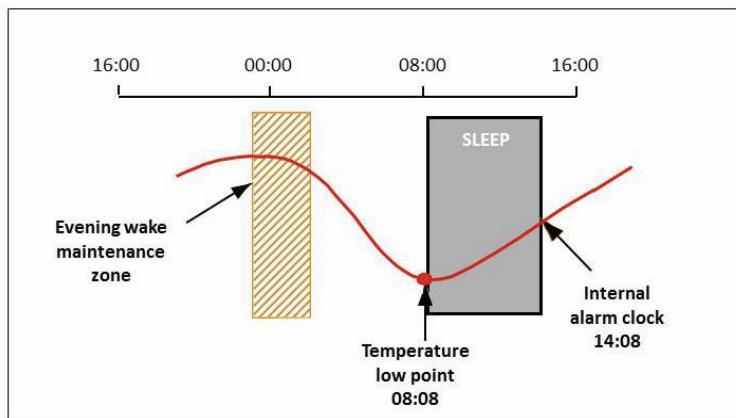
Figure 3: Relationships between sleep after night duty and the circadian body clock cycle

The ICAO Document 9966 subchapter 2.3.4 described during shift work, sleep is disrupted from the optimal phase of the circadian body clock cycle. The shift work and night work schedules cause a change in work that the circadian body clock cannot quickly adjust to. Shift work requires adaptation of the circadian clock by sleeping in a different part of the circadian body clock cycle before and after night duty. Crew members frequently operated the flight in the WOCL, when they would be anticipated to be drowsy, and had to exert more effort to maintain their performance as result of the circadian body clock's poor adaptation to night duty. For example, on off duty days, when pilot is sleeping at night, the average time of the temperature minimum is at 0520 in the morning (see figure 2). When pilot is flying at night this shift and will begin around 0808 in the morning and pilot will feel sleepy close to that time (see figure 3).

The occurrence flight was the second flight of the day, and the first flight duty was started at night and the flight was performed on early morning. According to the ICAO Document 9966, those conditions altered the circadian rhythm of the body as the pilots must awake and work during the time in the circadian body clock cycle when they would normally be asleep. Therefore, the altered circadian rhythm would shift the temperature low point to around 0808 in the morning, and pilot would feel sleepy close to that time. The SIC fell asleep sometime after communicating with Jakarta ACC at 0843 in the morning (0143 UTC).

27. Both pilots must awake and work during the time in the circadian body clock cycle when they would normally be asleep, according to the ICAO Document 9966, those conditions altered the circadian rhythm of the body. Therefore, the altered circadian rhythm would shift the temperature low point to around 0808 in the morning, and pilot would feel sleepy close to that time.
