# Aviation Investigation Preliminary Report

| <b>Location:</b> | Louisville, KY | <b>Accident Number:</b> | DCA26MA024 |
| <b>Date &amp; Time:</b> | November 4, 2025, 17:14 Local | <b>Registration:</b> | N259UP |
| <b>Aircraft:</b> | McDonnell Douglas MD-11F | <b>Injuries:</b> | 14 Fatal, 2 Serious, 21 Minor |

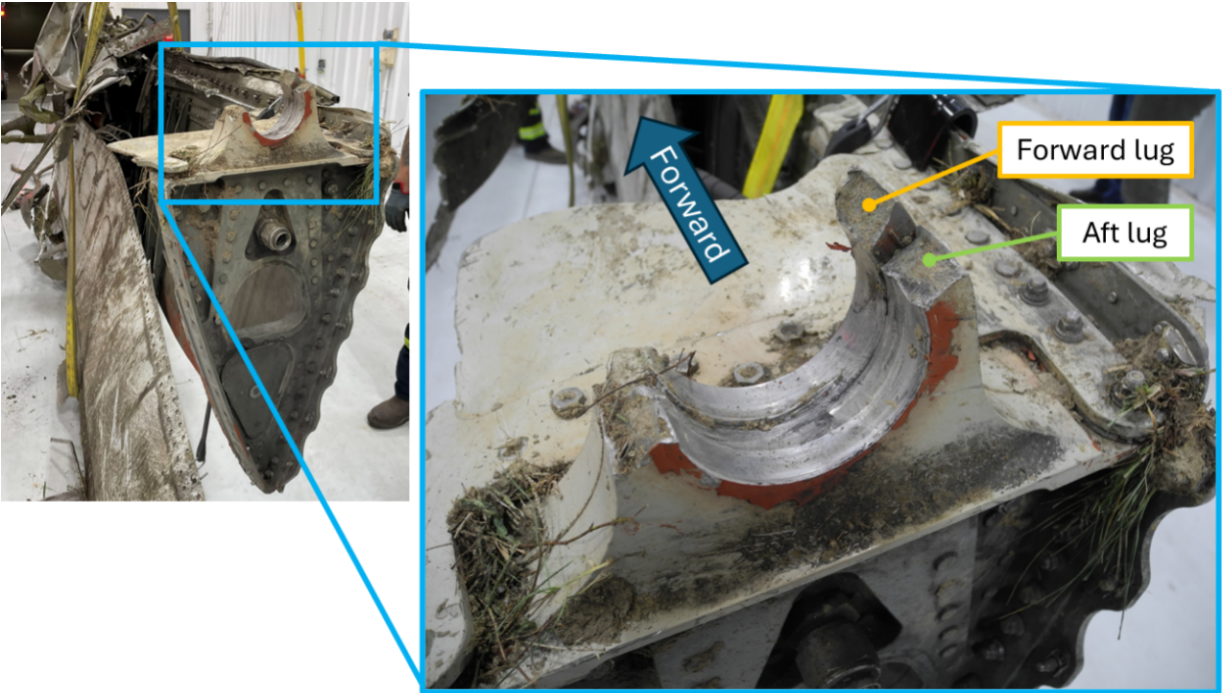
The left pylon aft mount's forward and aft lugs were both found fractured near their 2 o'clock (inboard fracture) and 9 o'clock (outboard fracture) positions when in the aft-looking-forward frame of reference (see figure 7). The fractured and separated upper portions of the forward and aft lugs were found adjacent to runway 17R. The left wing clevis, aft mount spherical bearing, and aft mount attachment hardware were found with a portion of the left wing at the accident site. The bolt, spherical bearing, and associated hardware remained attached to the wing clevis. The spherical bearing outer race had fractured circumferentially, exposing the ball element (see figure 8).

**Figure 7.** The separated left pylon after recovery (left image) and the left pylon aft mount's fractured forward and aft lugs (right/enlarged image).

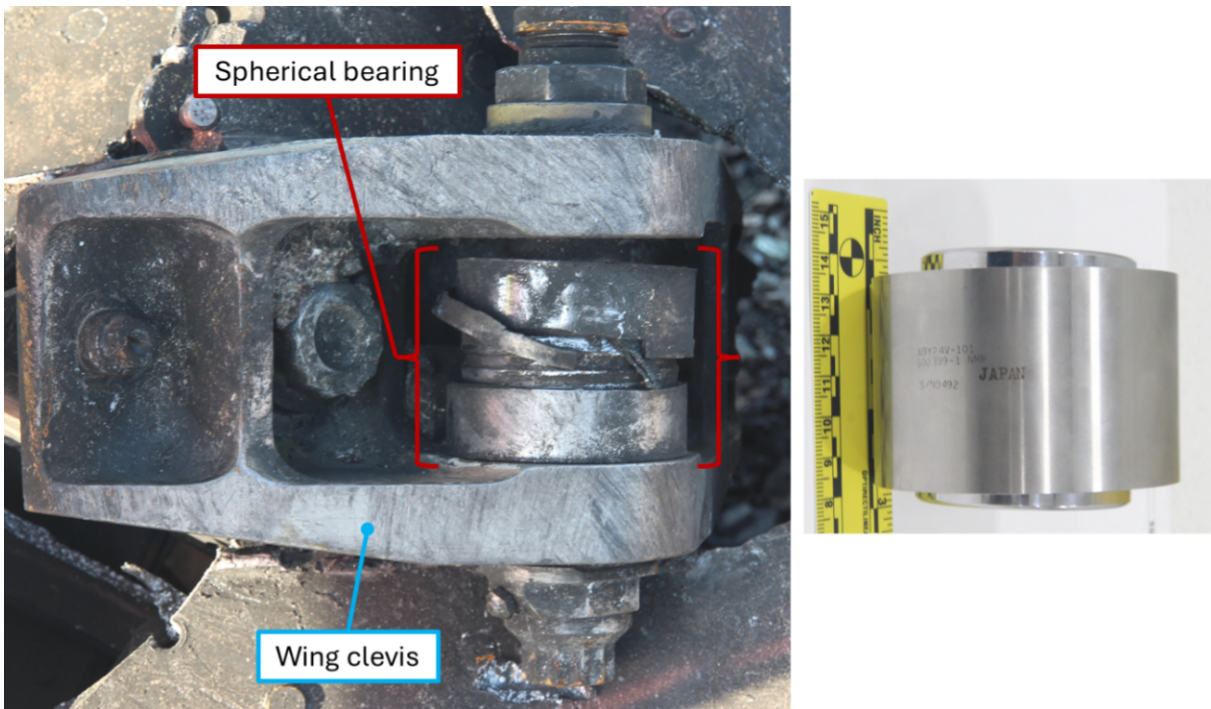
**Figure 8.** The left wing clevis, fractured spherical bearing (marked by the red brackets), and associated attachment hardware found at the accident site (left) and an exemplar spherical bearing (right).

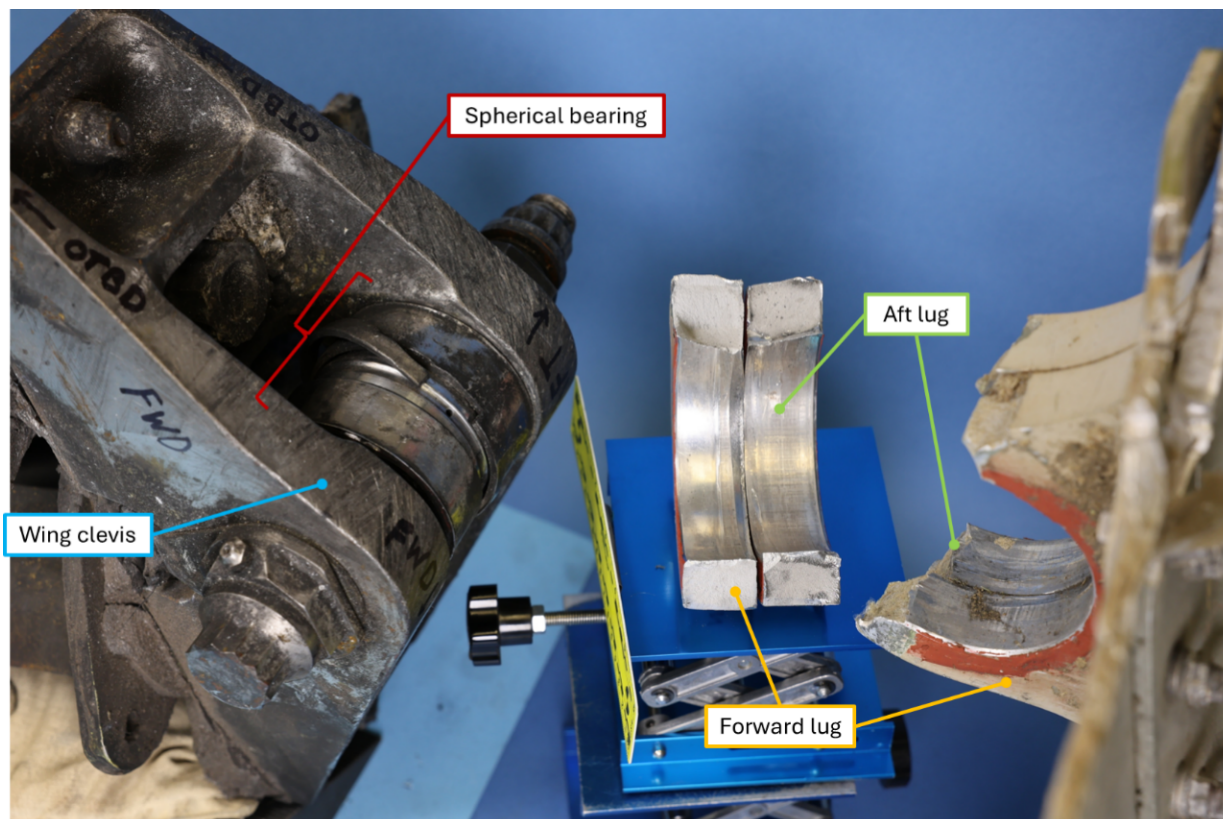
The left pylon aft mount, fractured lugs from the left pylon aft mount, and the left wing clevis (containing the aft mount spherical bearing and attachment hardware) were retained for further examination at the NTSB Materials Laboratory (see figure 9). The right pylon aft mount and wing clevis assembly as well as two engine fan blade fragments found on runway 17R were also retained for further examination at the NTSB Materials Laboratory.

**Figure 9.** The left pylon aft mount, the fractured and separated forward and aft lugs, and the left wing clevis containing the attachment hardware and fractured spherical bearing.
