Report

Insufficient rotation during take-off, Boeing 737-400, EI-STW

Amsterdam Airport Schiphol, 19 December 2023

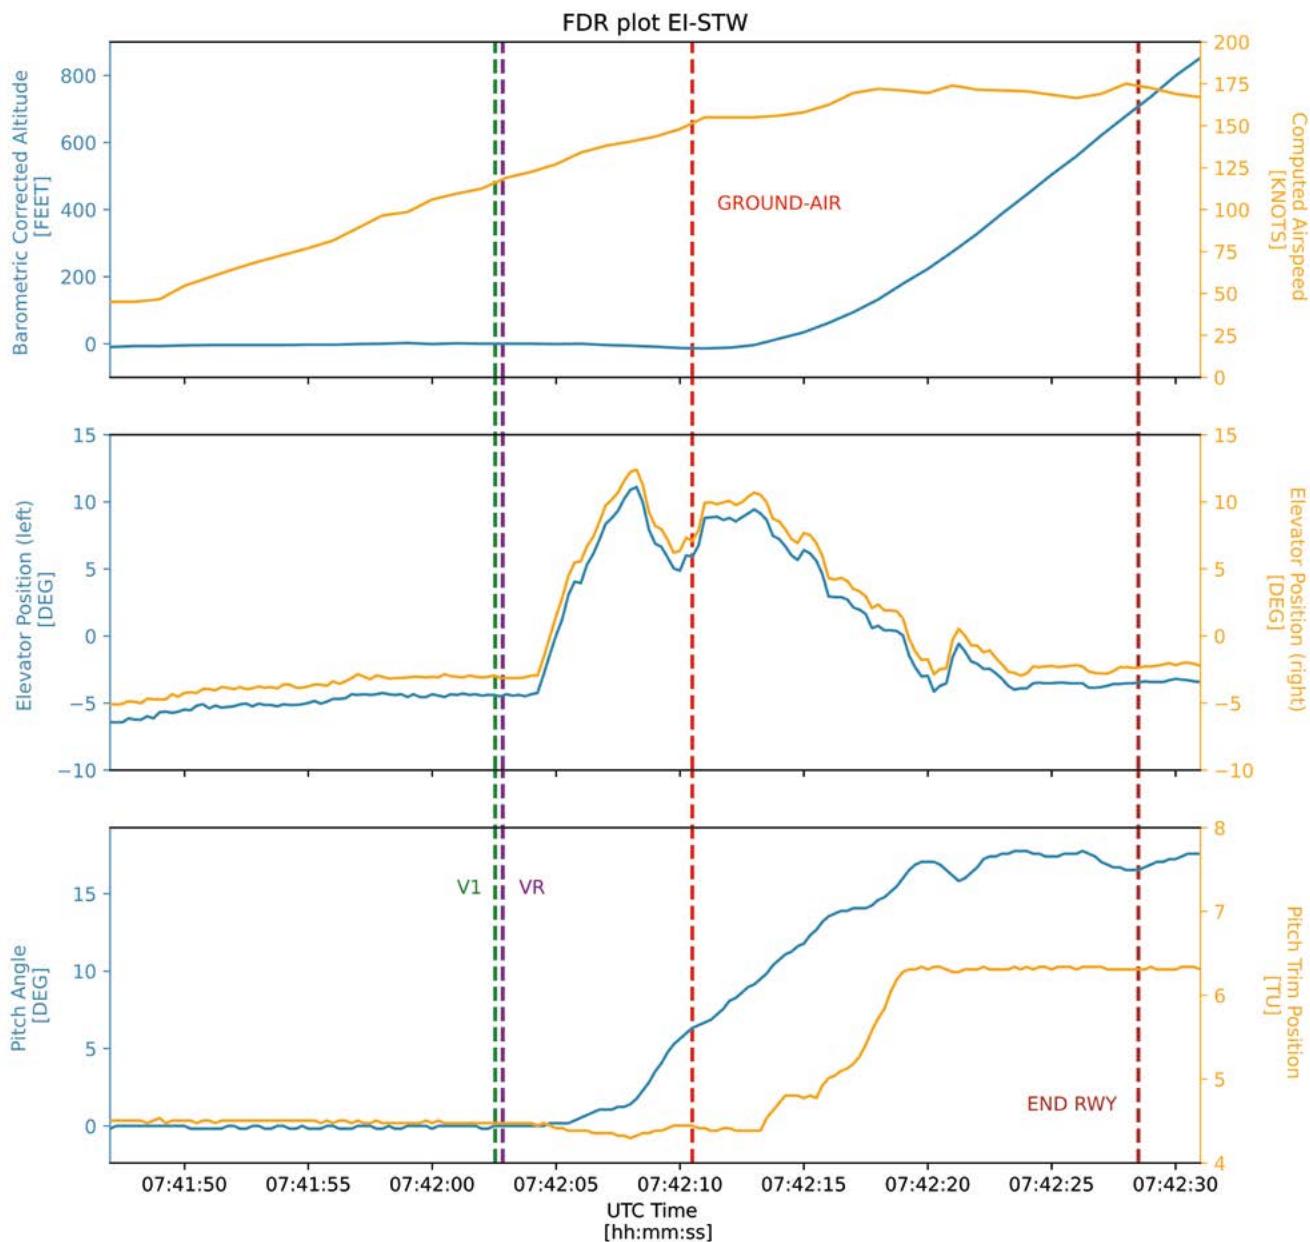
► Flight data the take-off (source: Flight Data Recorder).

The take-off was normal until the rotation speed was reached. The first officer applied almost full nose up elevator deflection for rotating the aircraft. Despite applying full nose up elevator, the aircraft did not rotate to a lift off attitude. Only when the airspeed increased from the calculated V_r of 118 knots up to a value of 134 knots, the first officer was able to rotate the aircraft into the air. With an airspeed of 150 knots the aircraft lifted-off and he used the elevator trim to reduce the required control force for elevator up. Once in trim, the control of the aircraft was normal.

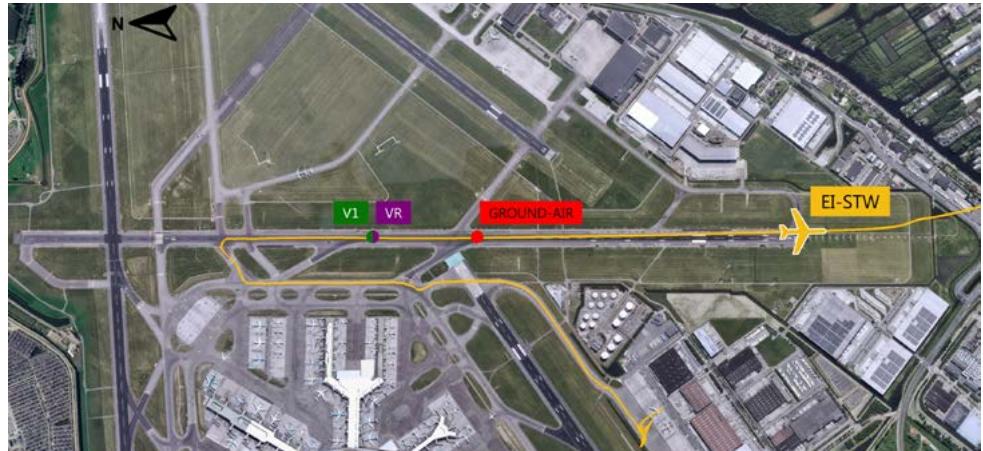
For the take-off performance calculation, the flight crew used the maximum allowable thrust reduction as the aircraft was almost empty and with a fuel load for the short flight to Brussels. Therefore, an intersection take-off was possible, which resulted in a reduced available runway length. Even with this reduced length, the aircraft became airborne before the midway point of the available runway and crossed the reciprocal runway threshold at 718 feet^{8,9}.

- Visual presentation of the take-off performance. The 'ground-air' point indicates the position where the aircraft became airborne (source: Flight Data Recorder and Google Earth).

When using intersection E4, the available runway length (TORA) and take-off distance (TODA) were adequate for the actual required runway length and threshold obstacle clearance.
