Aircraft Accident Report

**Crash into the sea during takeoff climbing
The National 119 Rescue Headquarters
EC225LP, HL9619
The East Sea near Dokdo, Ulleung-gun, Gyeongsangbuk-do
October 31, 2019**

**Aviation and Railway
Accident Investigation Board**

Aviation and Railway Accident Investigation Board, crash into the sea during takeoff climbing, the National 119 Rescue Headquarters, EC225LP, HL9619, October 31 2019, aircraft accident report, ARAIB/AAR1903, Sejong City, Republic of Korea

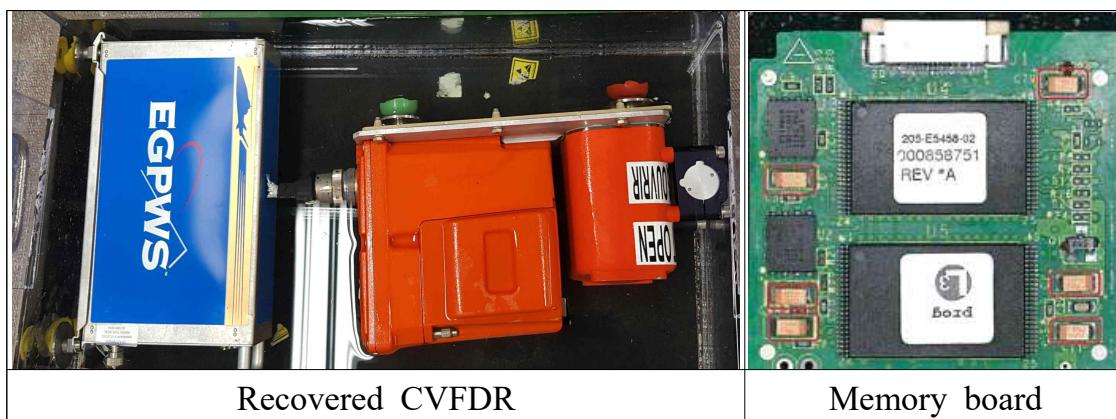
Figure 9. CVFDR and memory board

The CVFDR⁴²⁾ is a recording device that combines the FDR and CVR. It was installed inside the HL9619's rear fuselage and recovered while attached. It was submerged and exposed 77 m under the seawater and recovered 22 days after the accident. (See Figure 9.)

The ARAIB transferred the CVFDR to the specialized facility of the Bureau d'Enquêtes et d'Analyses (BEA) in France. The data input port was affected by seawater, which caused corrosion in the internal components.

Traces of salt were found on the memory board and inside the connector. To prevent further damage caused by the submersion, the investigators injected argon gas and disconnected the memory chip before extracting data.

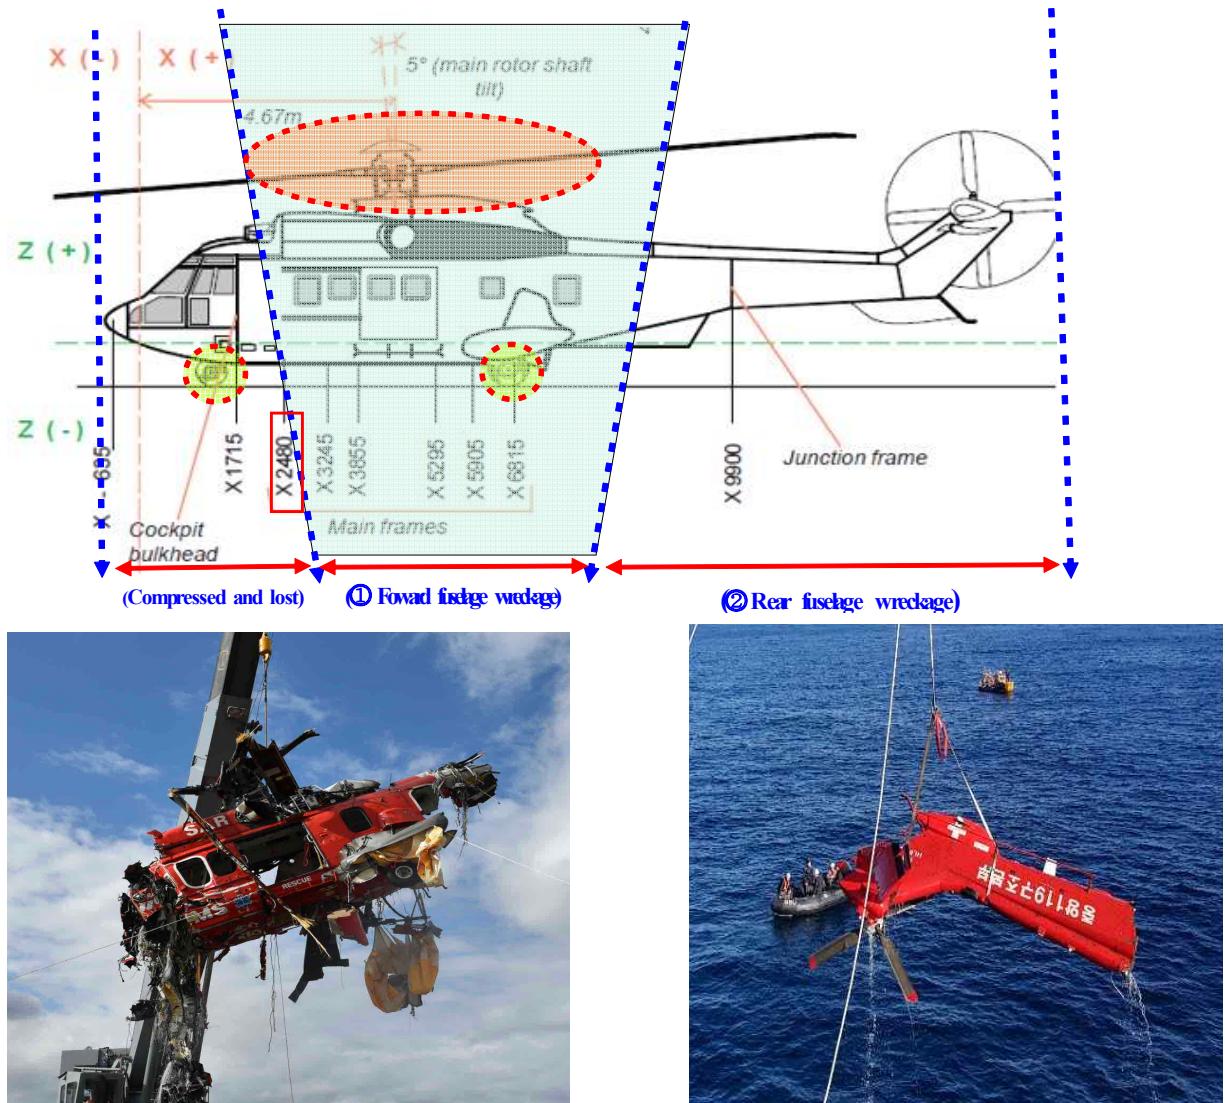
Figure 11. Lifting the HL9619 fuselage

The forward fuselage (see Figure 11, X2480)—cockpit, front windows, and wheels—were lost or compressed to the rear. Thus, only the center fuselage was lifted. The EFS on the rear section was torn entirely. The rear fuselage was pulled up separately from the forward fuselage.

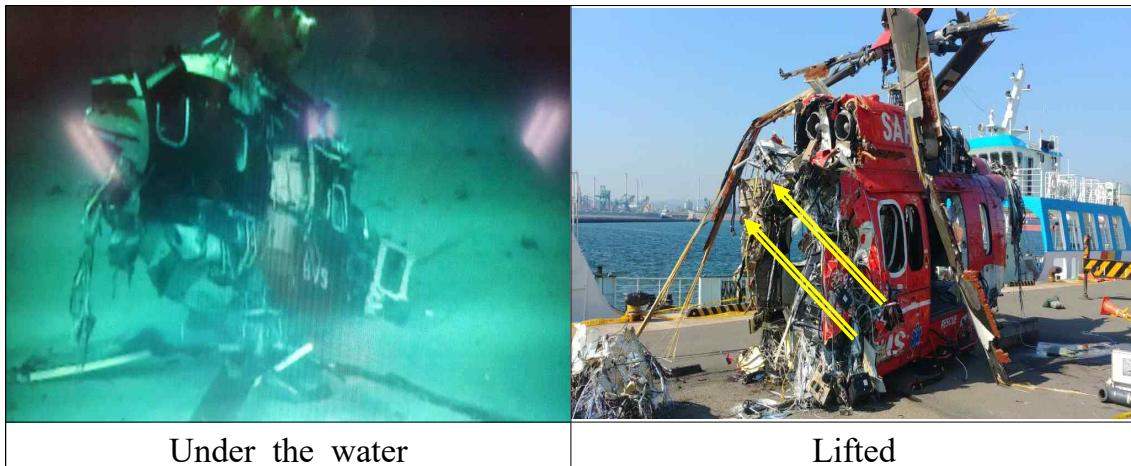
Figure 12. Forward fuselage

The co-pilot seat on the front left fuselage was fully pressed, and the pressed intensity got worse while reaching the pilot seat on the right (see Figure 12).

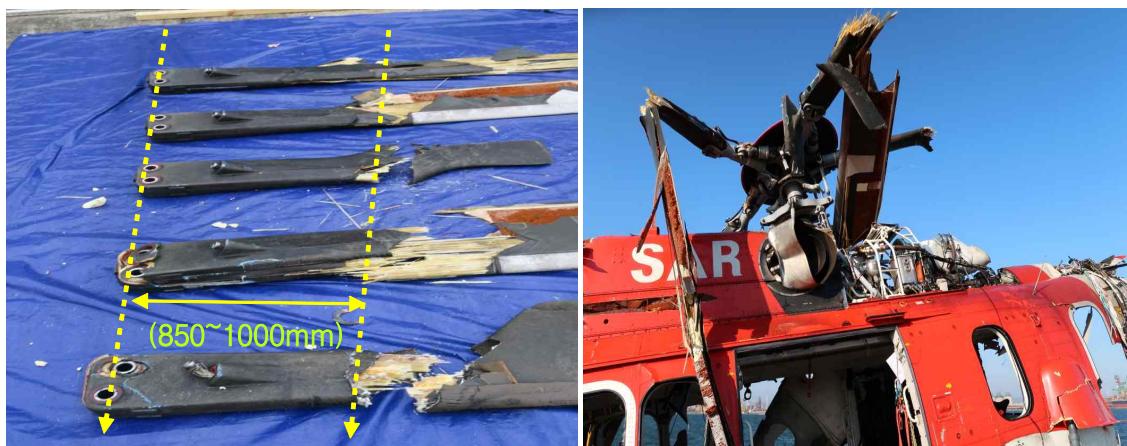
Figure 13. Main rotor damage

5 main rotors were broken due to impact with obstacles while rotating strongly with power. As a result, all 5 rotors were seriously damaged and cut at 840 mm from the hub; and traces of constant damages from 850 to 1,000 mm ranges were identified (see Figure 13).

In addition, the main rotating area bushing towards the wing root confirmed around 30 to 50 mm gaps. The damage suggests that the impact with the water was made while rotating with power. Also, some components were lost due to the main rotors' intense rotation and the impact with the water.

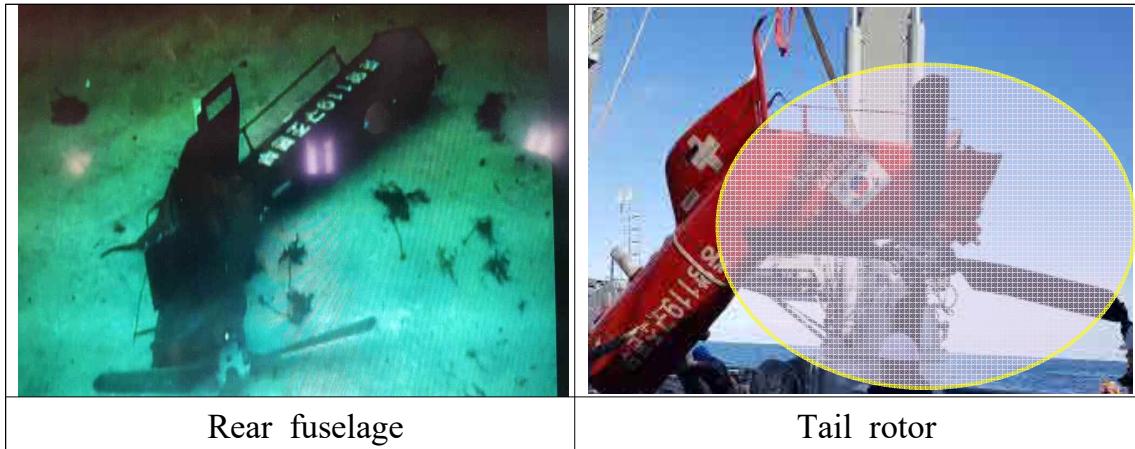
Figure 14. Rear fuselage and tail rotor

The rear fuselage was separated from the forward fuselage and fell in different directions when it crashed. However, the rear fuselage and tail rotor generally maintained good condition (see Figure 14).

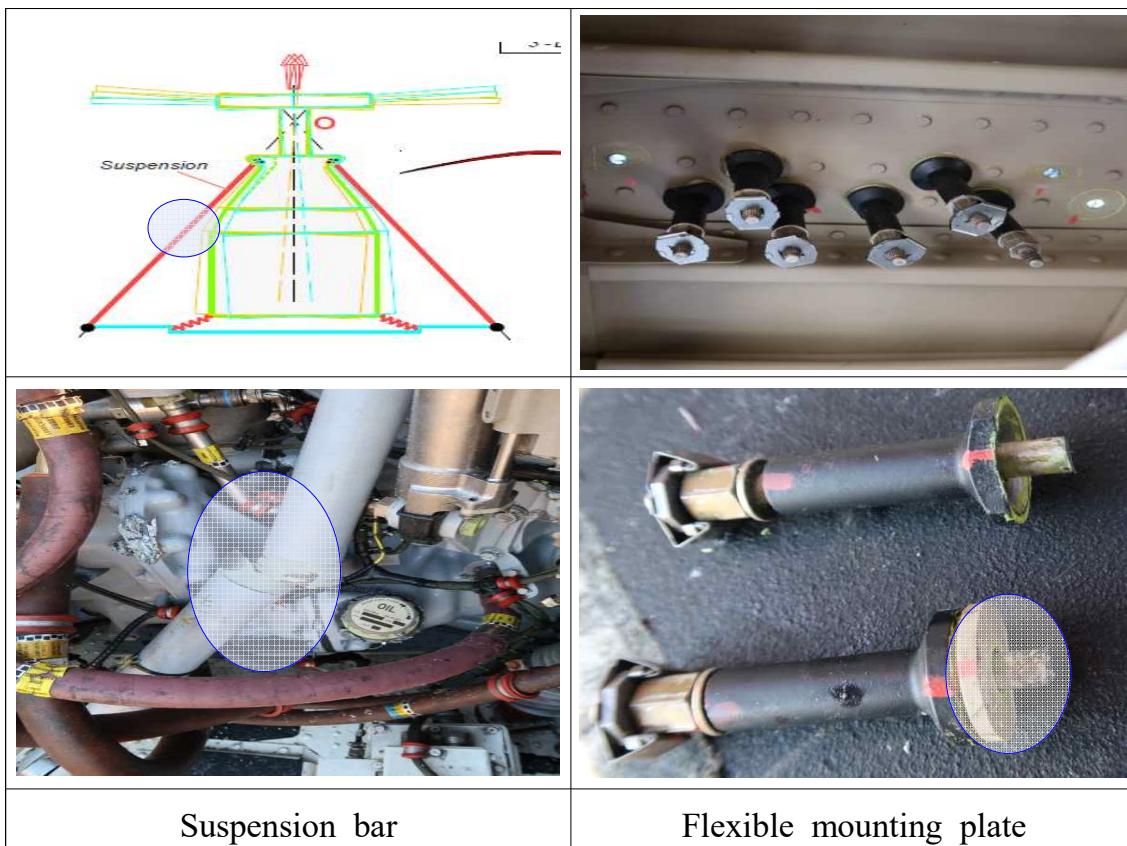
Figure 15. MGB suspensions

MGB was linking the engine coupling and the connecting shaft of the tail rotor. One among the 3 suspensions, supporting MGB, recovered bent but broken during transportation (see Figure 15).

Mounting plates on the front and rear were at their position but were found broken. For abrasion inspection of the internal MGB, full flow/bottom/epic magnetic plug and oil filter were inspected, and yet no chips were found.

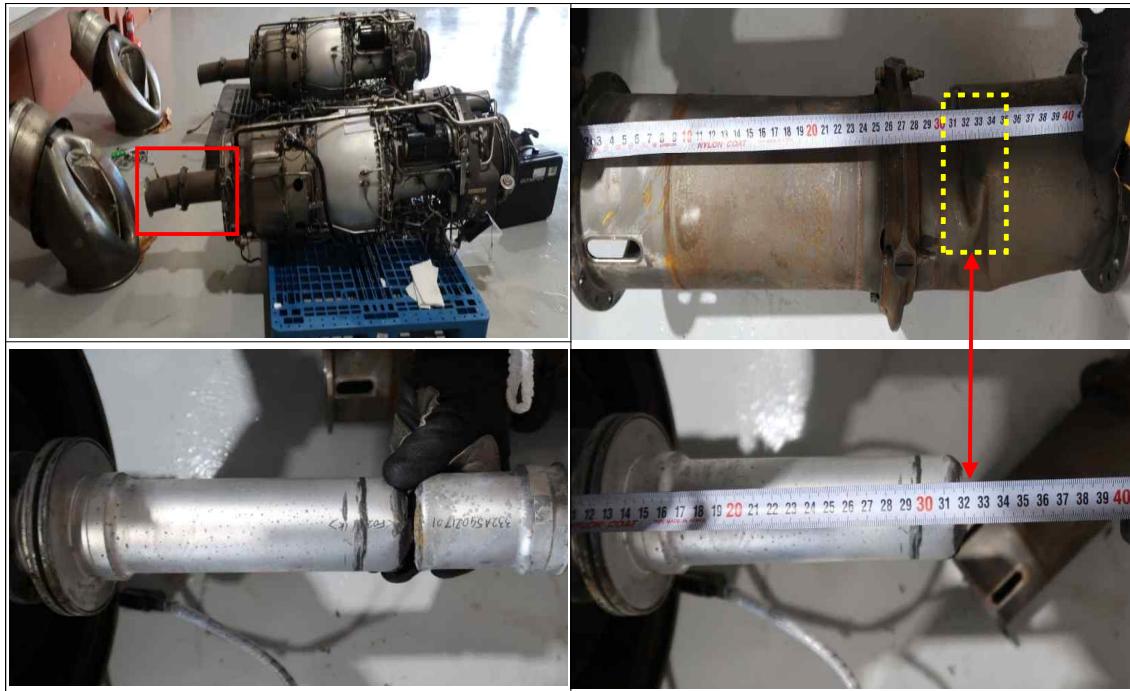
Figure 16. The severed engine coupling shaft

Coupling shafts transmit power to MGB from each engine, and the coupling tubes, wrapping externally from the shafts, function shaft protection. The right engine (T2) shaft ruptured, and the external tube confirmed buckling. The buckling point matching the point of shaft rupture (see Figure 16) implies the external impact applied on the tube at the crash caused the shaft, rotating at high speed, to rupture.

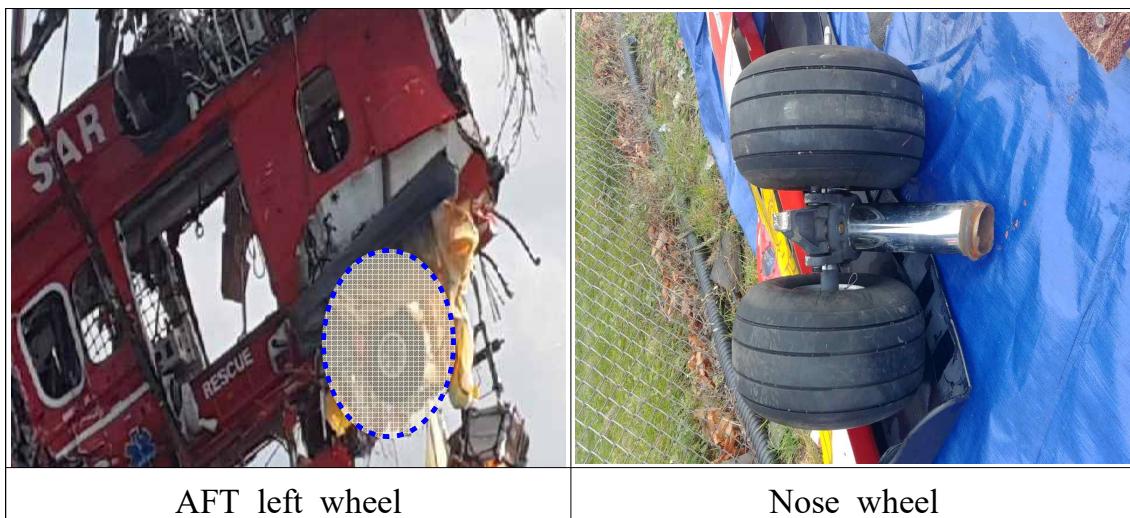
Figure 17. Landing gear of HL9619

The landing gear is wheel type and consists of 3 wheels, one in the front and two on both sides of the rear. The nose wheel (front landing gear) was broken and recovered while floating on the sea. The left rear wheel was attached to the frame (Figure 17, left), while the other on the right rear was lost. Around 200 mm above the center of the nose wheel was cut evenly and separated from the airframe (Figure 17, right).

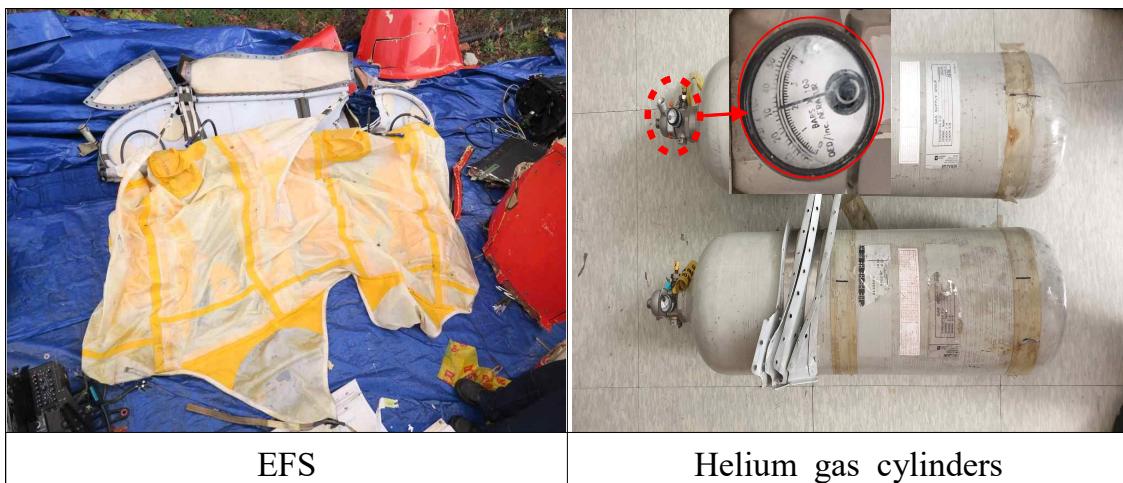
Figure 18. The EFS recovered

EFS was equipped on HL9619. The wreckage of the systems, which did not operate at impact, was found separated from the fuselage and destroyed.

Also, 3 helium gas cylinders, supposed to remain attached to the EFS, were separately found apart from the fuselage (see Figure 18). The pressure figures of all those cylinders indicated their normal range.

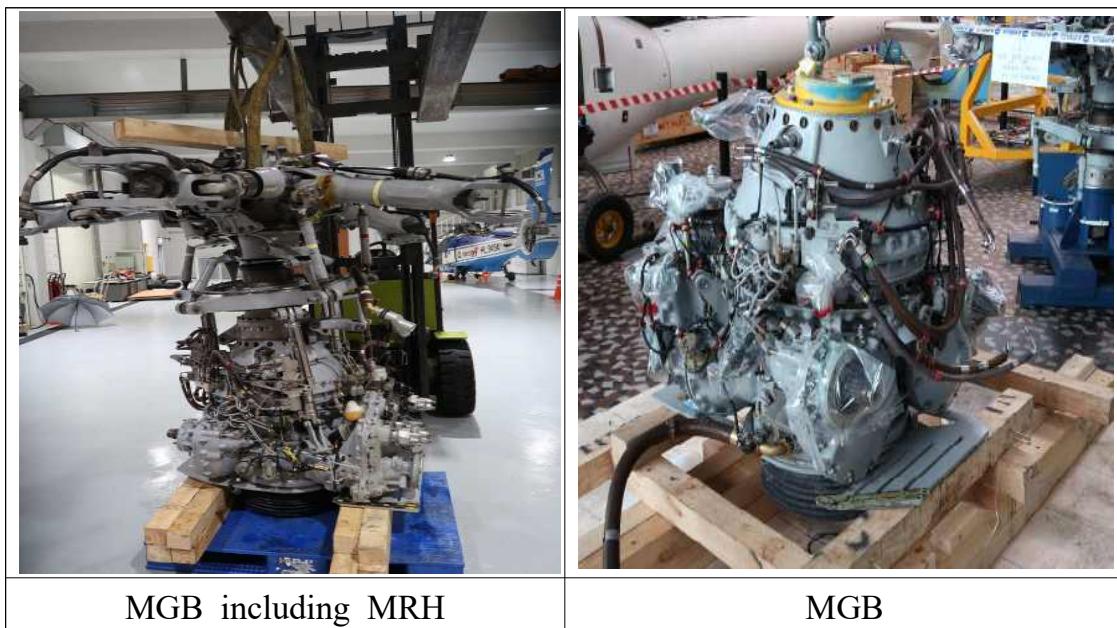
Figure 21. MGB and MRH

Disassembling the main rotor head (MRH) showed no pre-impact damage on the MRH components (see Figure 21).

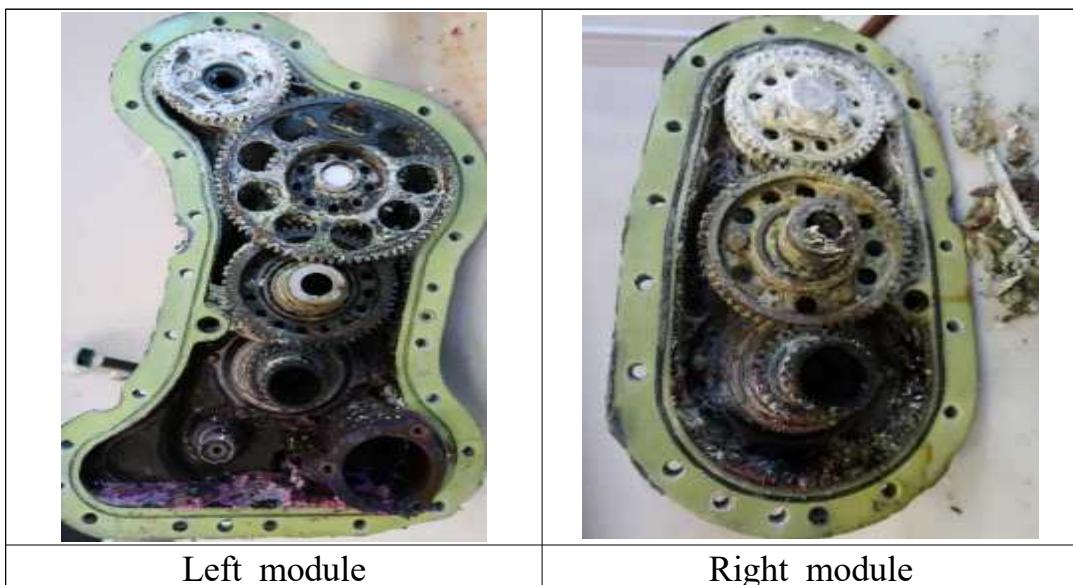
Figure 23. Internal examination of L/H and R/H accessory modules

There were no mechanical damages, and the tightening torque (of nuts) was within a normal range (see Figure 23). All the gears and bearings were in good condition and could transmit the power.

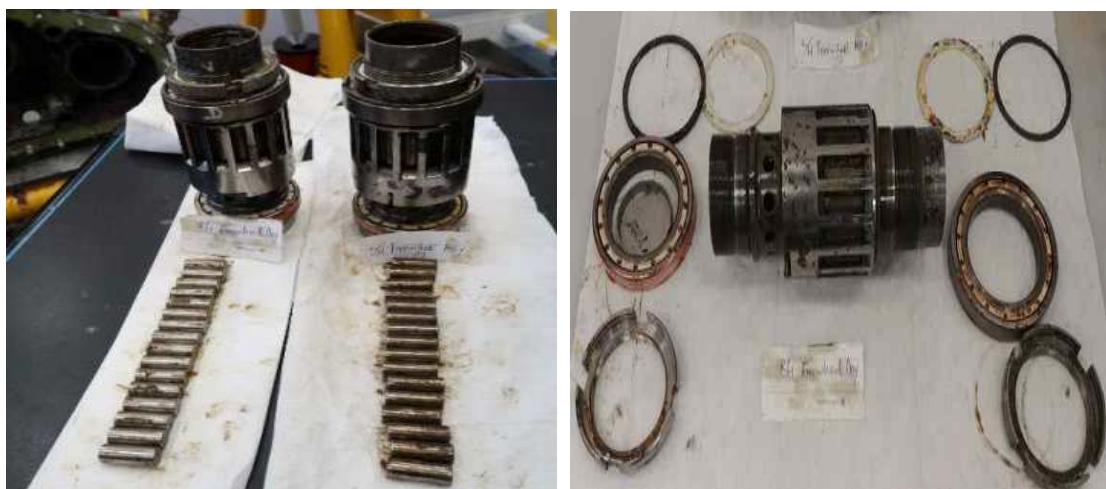
Figure 24. Freewheels (L/H, R/H)

Both freewheels were disassembled to verify the condition of different elements, including the ramps and the rollers (see Figure 24). They both turned out to be operating and properly transmitting power until the accident.

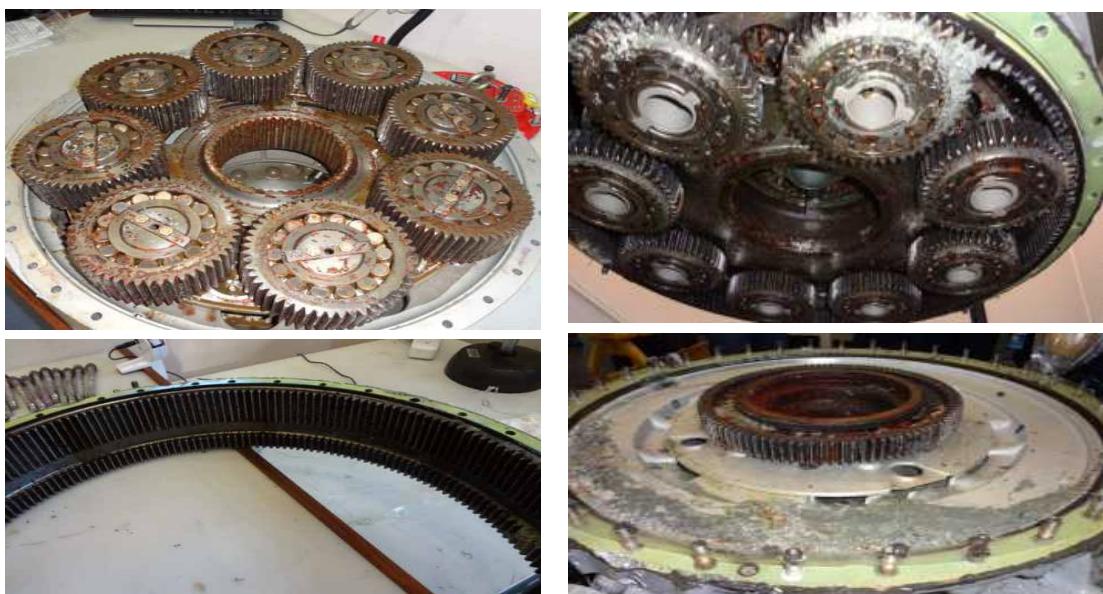
Figure 25. Epicyclic module

The investigation of the oil pump, main bevel wheel, and 23.000 RPM input pinion revealed no mechanical damage; all the gears and bearings consisting of the main module were in good condition (see Figure 25).

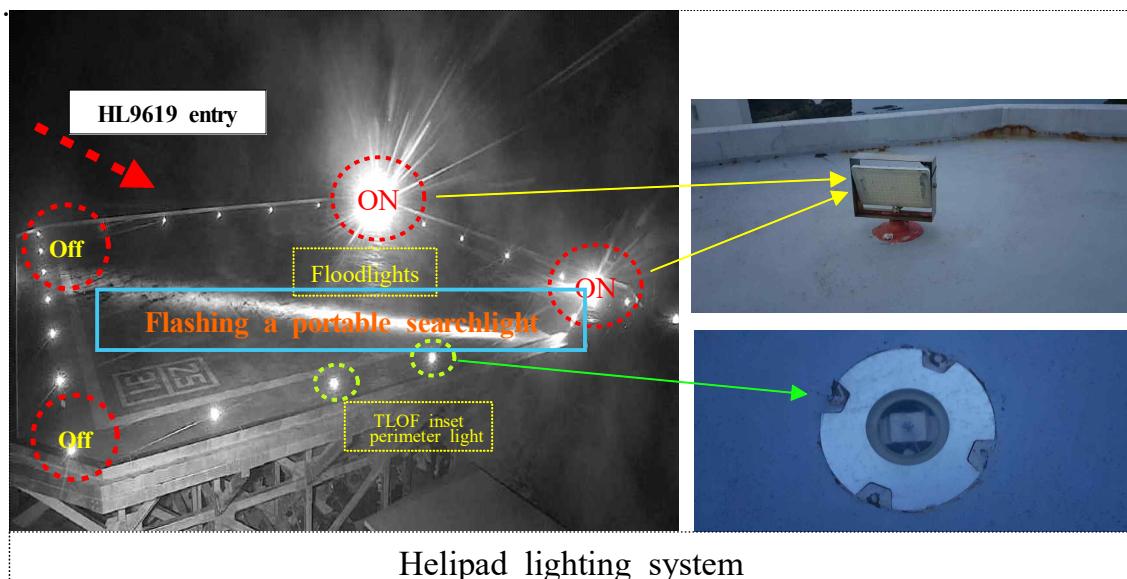
Figure 35. Helipad lighting conditions when HL9619 approaches

As HL9619 approached the helipad, the officer standing at the front right of the helipad flashed a portable searchlight to guide the aircraft to its location by waving it towards the helipad floor (see Figure 35). However, there is a possibility that the searchlight may have flashed into the cockpit, even indirectly, and temporarily hindered the pilot's vision

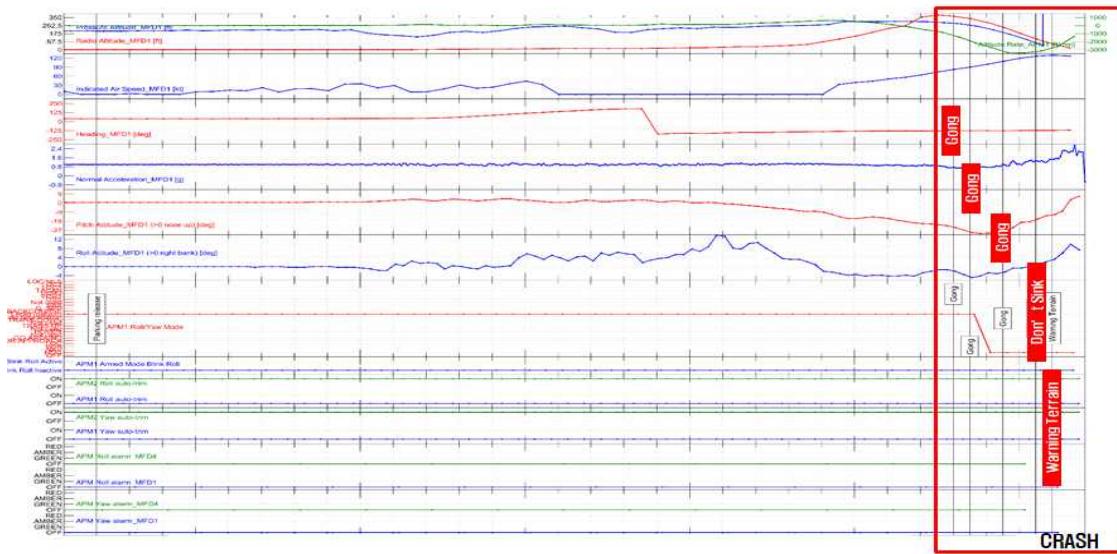
Figure 41. Exceeding operating limitations and EGPWS warning

The descent continued at high speed after taking off from the Dokdo helipad. Just before the crash, the pilot rapidly raised the collective, exceeding operating limitations. EGPWS rang when the aircraft came near the water surface (see Figure 41).

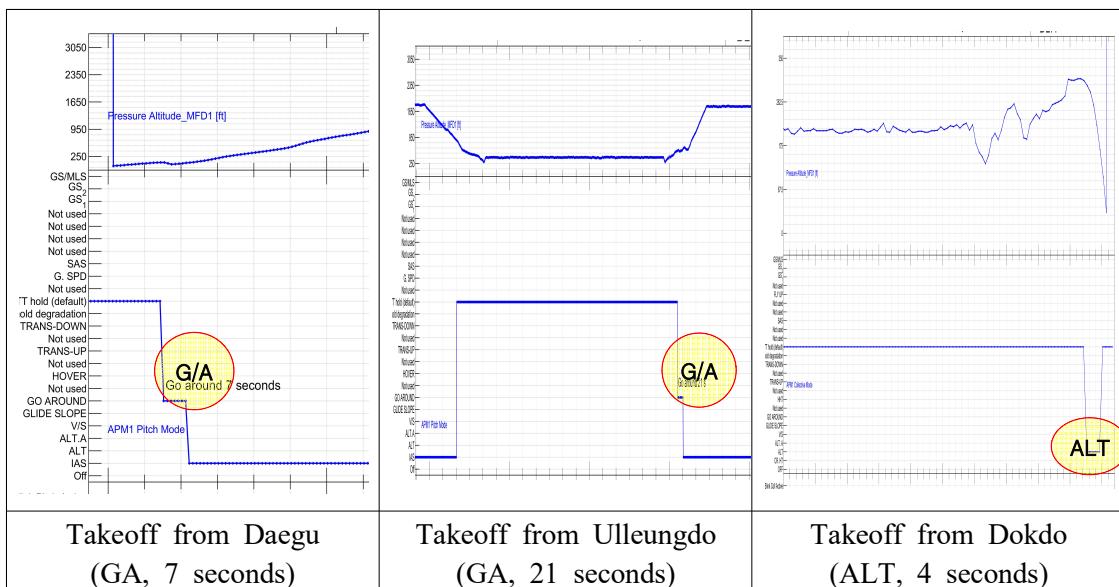
Figure 42. GA mode used when taking off

However, the GA did not operate when taking off from Dokdo (see Figure 42). Seemingly, it was not deliberate; the pilot seemed to think he was applying the GA.
