Investigation Report

| Kind of Occurrence: | Accident |
| Location: | Nthungwa Forest, Nkhata Bay (Republic of Malawi) |
| Type: | Dornier 228-202(K) |

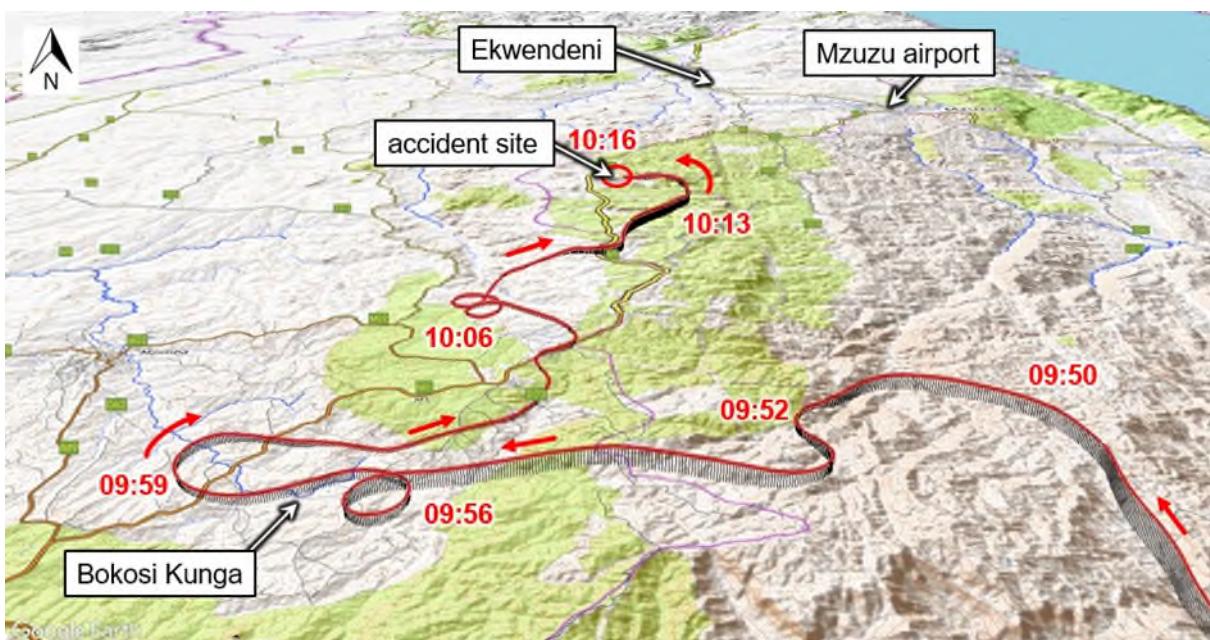
Fig. 2: Flight path according to GPS data between 0950 hrs and 1016 hrs

According to the GPS data, the airplane was flying north and at 0932 hrs, it was 3 NM west of waypoint NALSA at about 7,500 ft. At 0937 hrs, it began to climb and within 3 min it reached about 8,600 ft. At 0944 hrs, the airplane entered descent. At 0950 hrs, at about 1.5 NM north-west of the village Fumbawowa, it began to deviate from the direct course to the destination airport by entering a left-hand turn (Fig. 2 and GPS altitudes in Appendix 1).

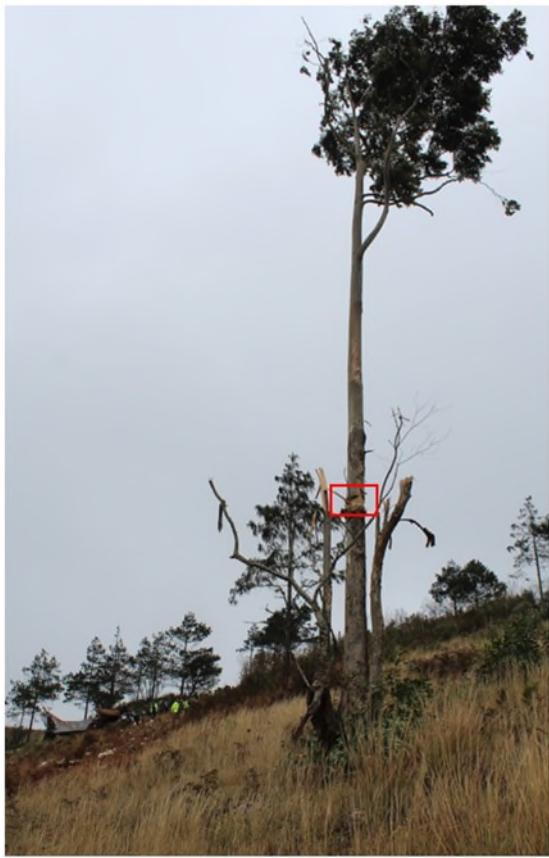
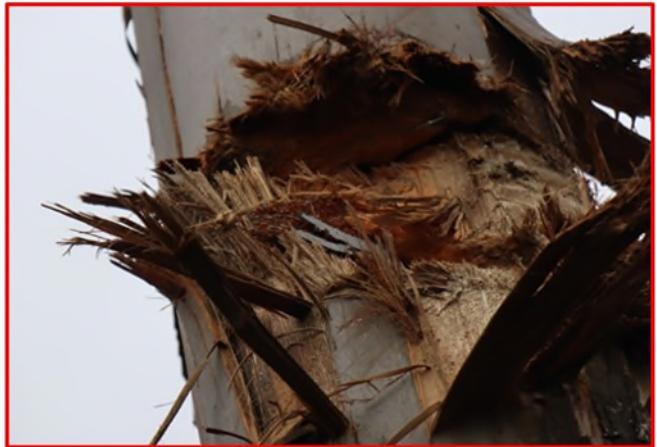
Fig. 9: Traces of collision with a tree (marked in red), close-up on the right

First, the aircraft's outer part of the right wing collided with a tree trunk at a height of about 4.5 m above ground. Part of the honeycomb structure of the wing stuck in the tree trunk (Fig. 9). Based on the traces on the tree trunk and the right wing, it was determined that the aircraft did not have any recognisable bank angle at the time of the collision.

The traces found at the accident site, the distribution of the debris and the damage to the aircraft indicate that the aircraft flew into the ascending terrain at relatively low sink rate and high forward speeds. This resulted in a clearly visible mark of the first impact of the aircraft fuselage on the ground and a subsequent disintegration of the aircraft with a "fan-shaped" wreckage distribution. This corresponds to the typical characteristics of a Controlled Flight Into or towards Terrain (CFIT).

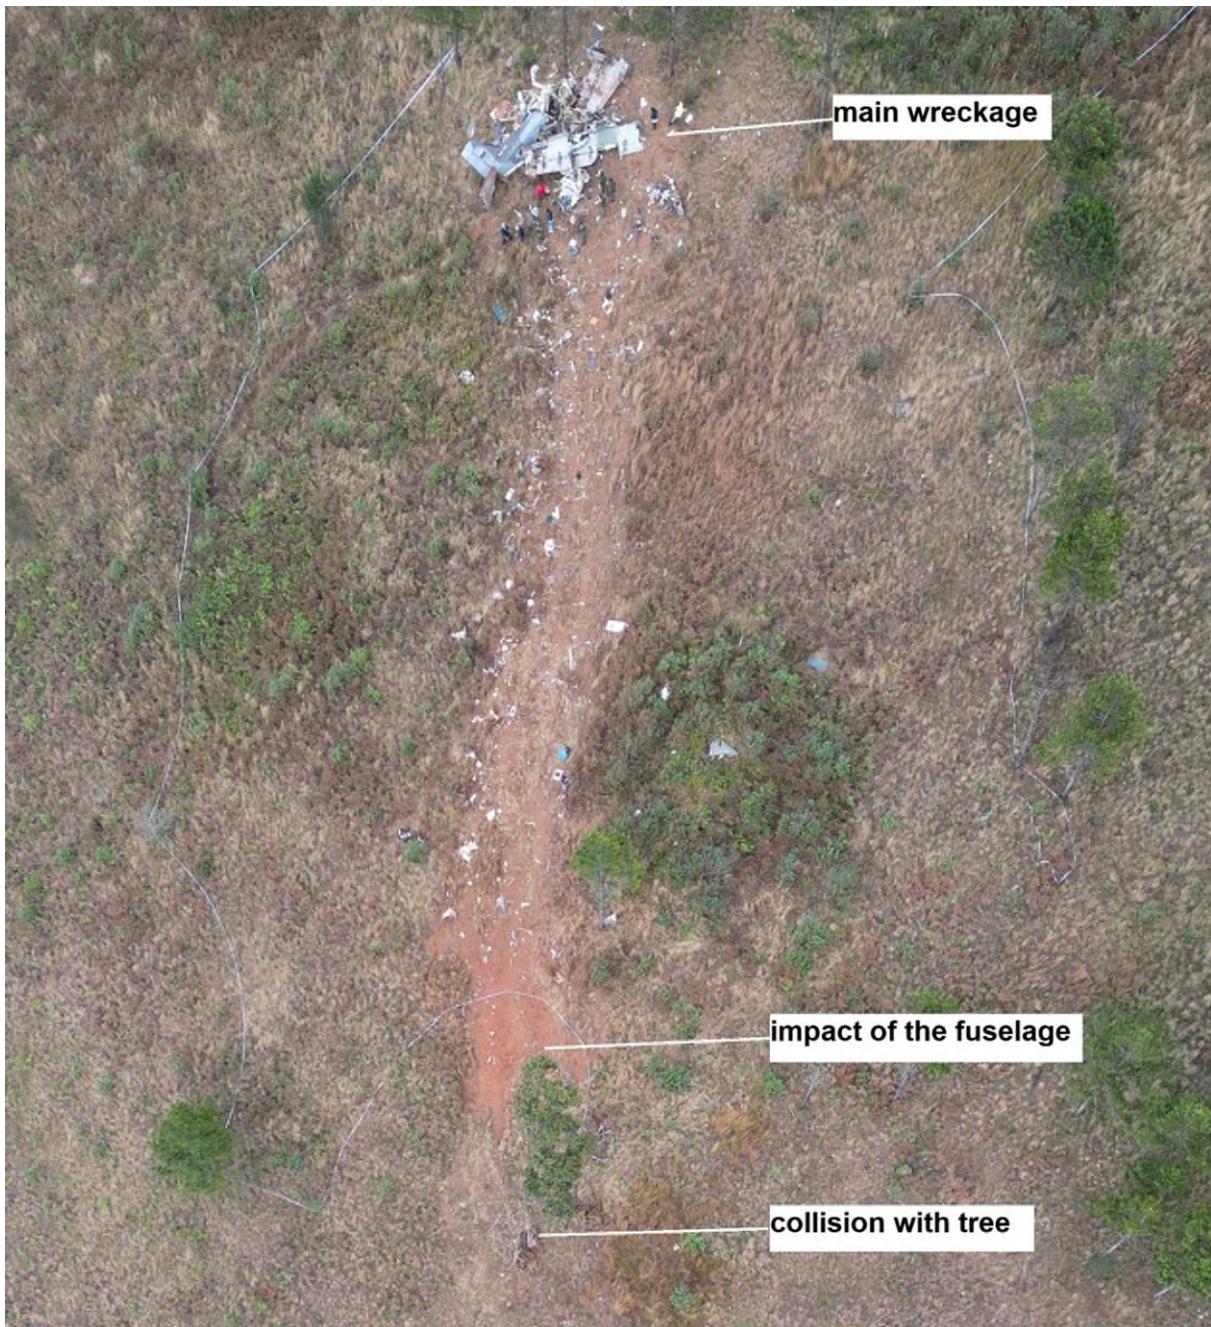
Fig. 10: Overview over the accident site

The right-hand wing tip and the right aileron lay north-west of the impact site of the fuselage. Parts of the interior and some cockpit instruments were scattered over an area of about 60 m x 25 m.

The main wreckage had come to rest on the slope about 80 m from the tree it had collided with (Fig. 10). The fuselage had come apart and the engines were torn off the wings. The cowling of both engines had fractured abreast of the first compressor stage. The propellers of both engines were torn off the shafts.

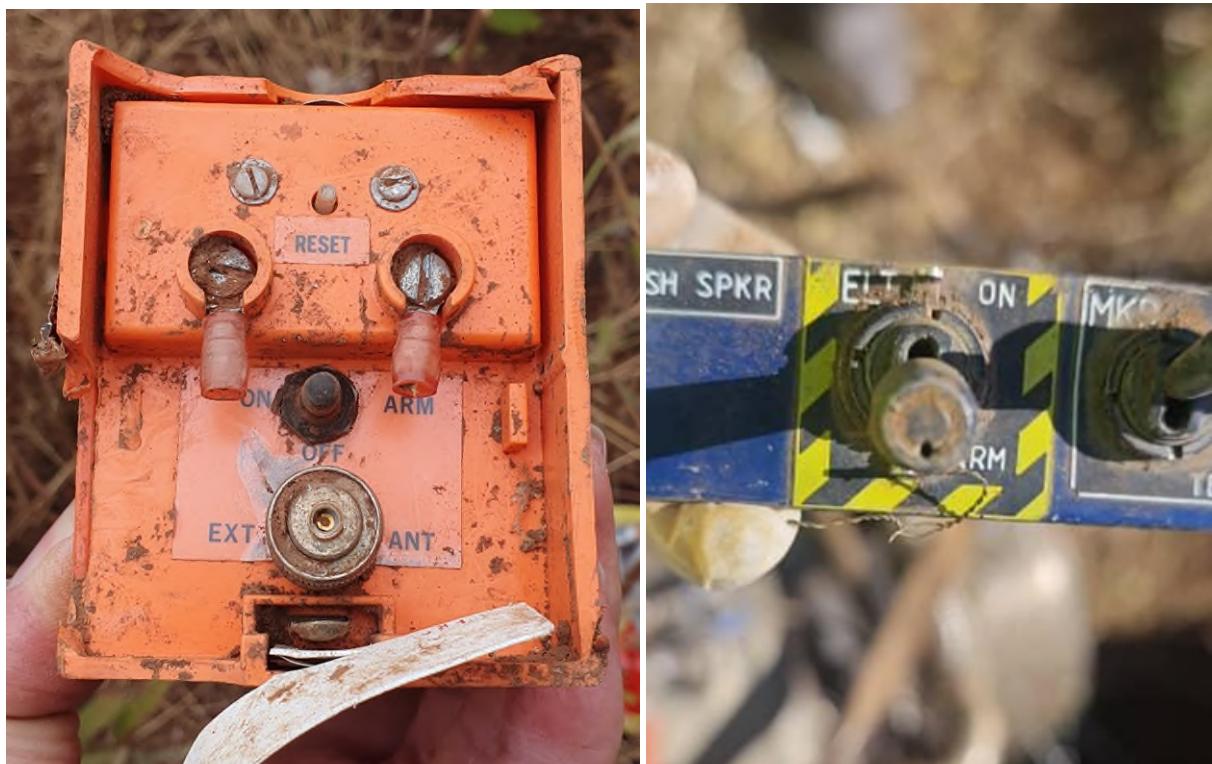
Fig. 11: Switch on the ELT in position 'OFF' (left), switch in the cockpit in position 'ARM'

The Emergency Locator Transmitter (ELT) was found in the wreckage. The switch in the cockpit was in position 'ARM', the switch on the device itself was in position 'OFF' (Fig. 11). The device was secured by the BFU.

The fact that the copilot did not tick "ELT" in the flight plan indicates that the pilots and engineers of the squadron were aware that the installed ELT was without function. The flight plan was filed in the AIS office and was available to air traffic control. However, this did not result in the Rescue Coordination Centre being informed about the missing ELT.

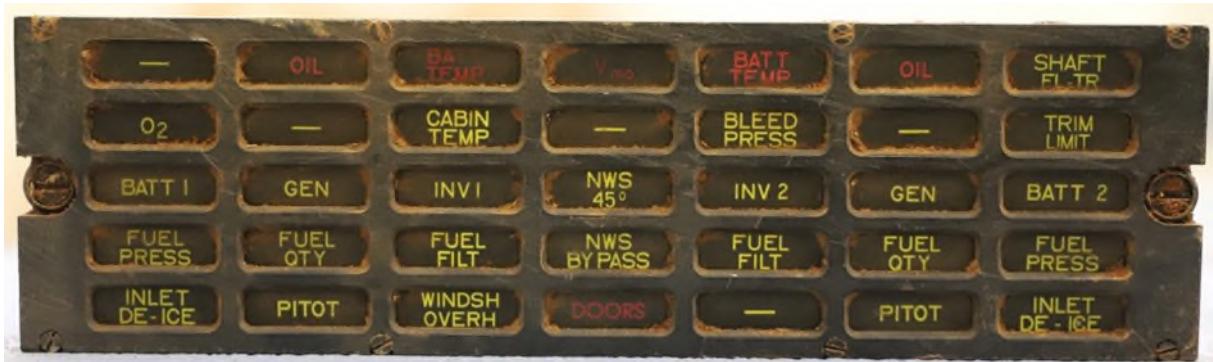
Fig. 13 Warning and Caution Panel

The Warning and Caution Panel had 6 warning indicators (red). These were the oil warning left and right, the BATT TEMP warning left and right, the V_{MO} warning and the DOORS warning. There were also 24 Caution indications (amber). Of the 35 possible display fields of the Warning and Caution Panel, 30 were occupied (Fig. 13). When disassembling the device, there were 46 light bulbs in the respective slots, while 10 light bulbs were found loose in the device. The 5 unoccupied display fields had light bulbs in the respective slots, 4 of these had 2 light bulbs and one of the unoccupied displays had one light bulb installed (Fig. 14). Thus, of the total of 70 probably installed light bulbs, 14 were missing.

Examination of the light bulbs of the Warning and Caution Panel retrieved from the cockpit revealed no evidence of any technical malfunction. The fact that 14 light bulbs were missing in the panel which was damaged during impact of the aircraft, opens a few theoretical scenarios.

No light bulbs were found in 8 display fields after the accident. The theoretical possibility that one or more of those 8 display fields had no light bulbs (out of the 2 it can hold) before the accident is very unlikely. On the one hand, the function of the indicator lights had to be checked on every flight before starting the engines. The pilots, as well as the engineer flying with them, would have noticed if the indicator lights were missing or inoperative. On the other hand, according to the maintenance staff and the flying staff of the squadron, the aircraft was in good technical condition. In addition, no technical defects were described at any time before or after the flights on the day of the accident or the day before in the telephone conversations with air base personnel.

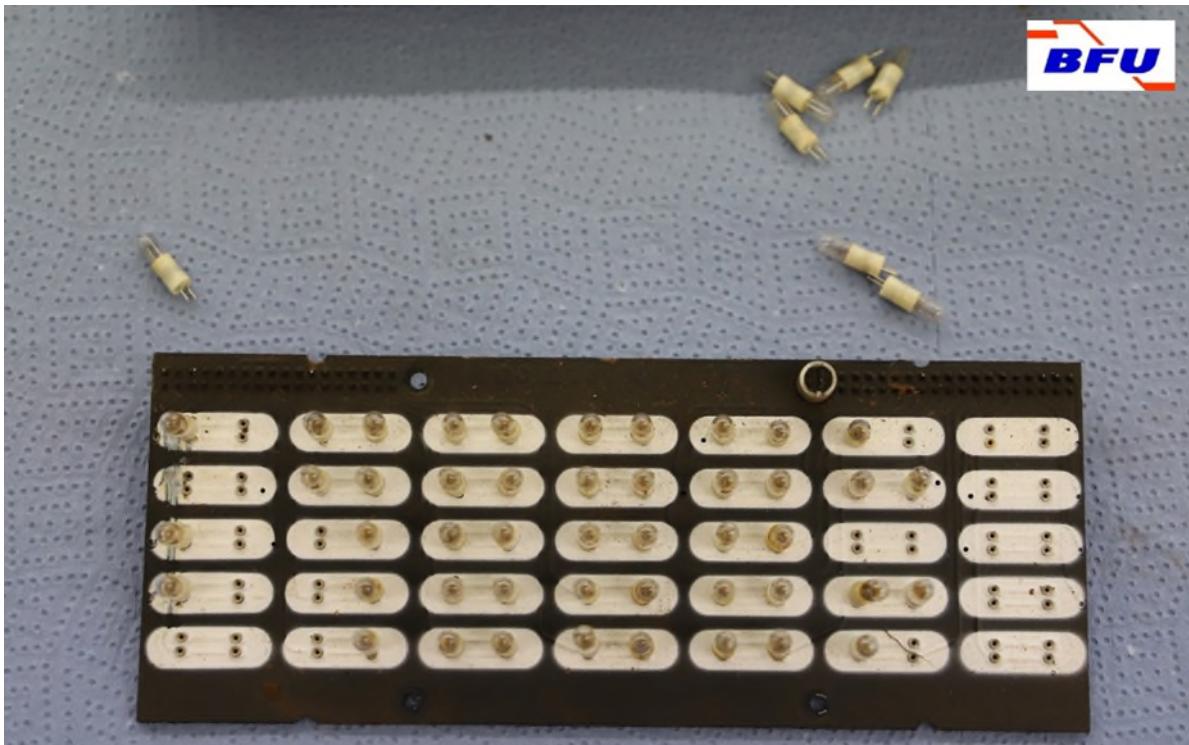
Fig. 14 Warning and Caution Panel lamps

All 56 light bulbs were examined under the microscope. None of them showed an elongation of the filament. Six of the light bulbs had a broken filament. As a result of the investigation, it can be concluded that none of the 56 light bulbs examined was illuminated at the time of the impact of the aircraft.

At 8 display fields, only one light bulb was found in its slot. One of these fields was not occupied. The 7 other display fields were BATT 1, FUEL PRESS left, GEN left, FUEL QTY left, PITOT left, OIL right, and PITOT right.

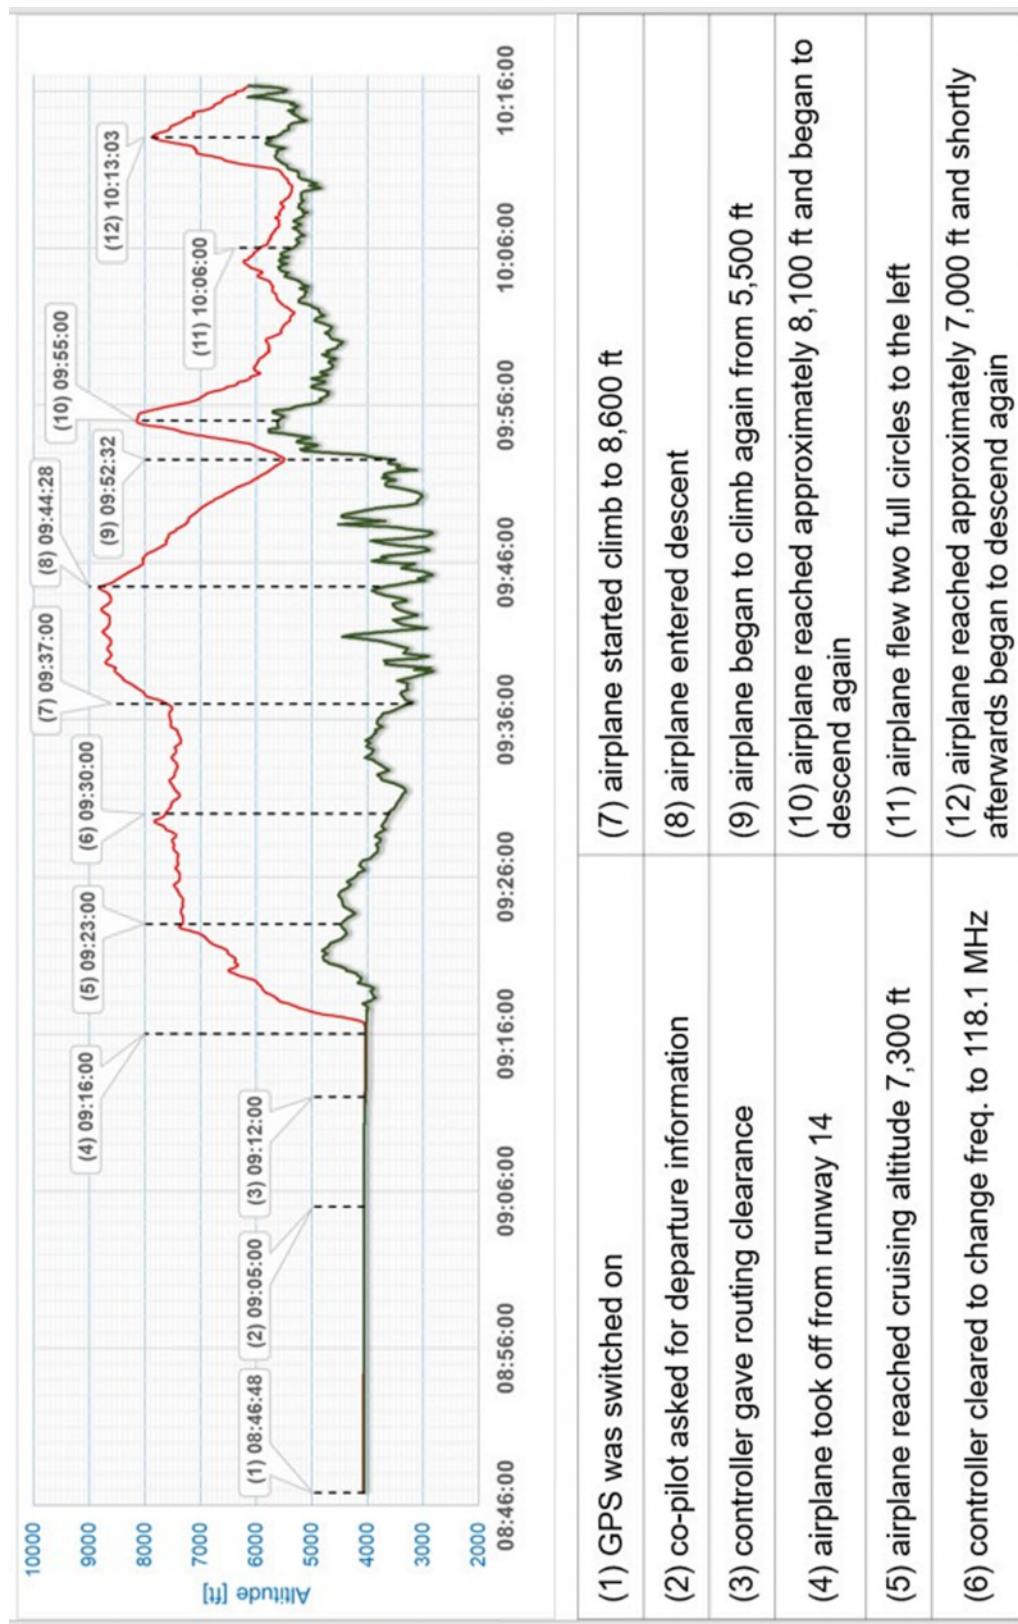
Appendix 1 Altitude and elevation during the accident flight over time

The aircraft impacted the ground approximately 70 m below the top of the hill and a further 30 m below the top of a mobile phone mast standing on the summit. The BFU is convinced that the pilots were unaware that the aircraft was just about to collide with the ascending terrain. This can be explained by the fact that, in the last seconds of the flight, they went into instrument meteorological conditions.
