# Investigation Report

Type of Occurrence: Serious Incident

Date: 5 December 2022

Location: Dortmund Airport

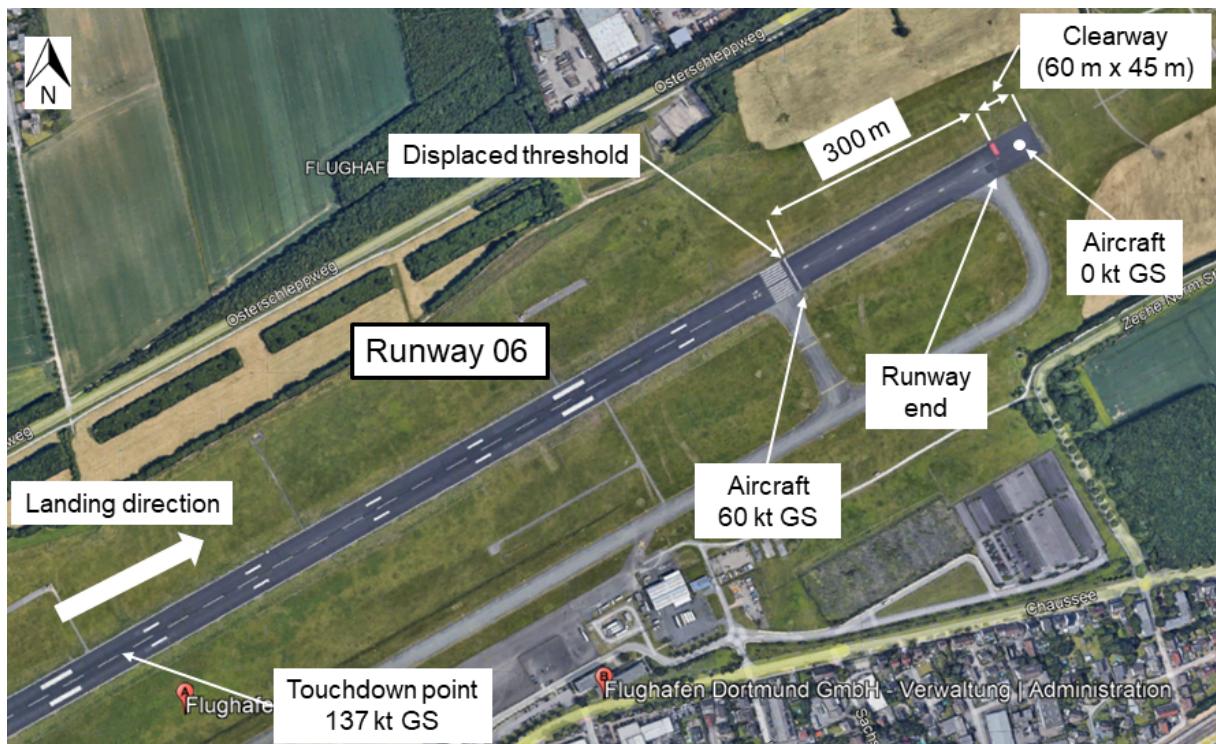
Fig. 1: Overview of Dortmund Airport with DFDR data and distances

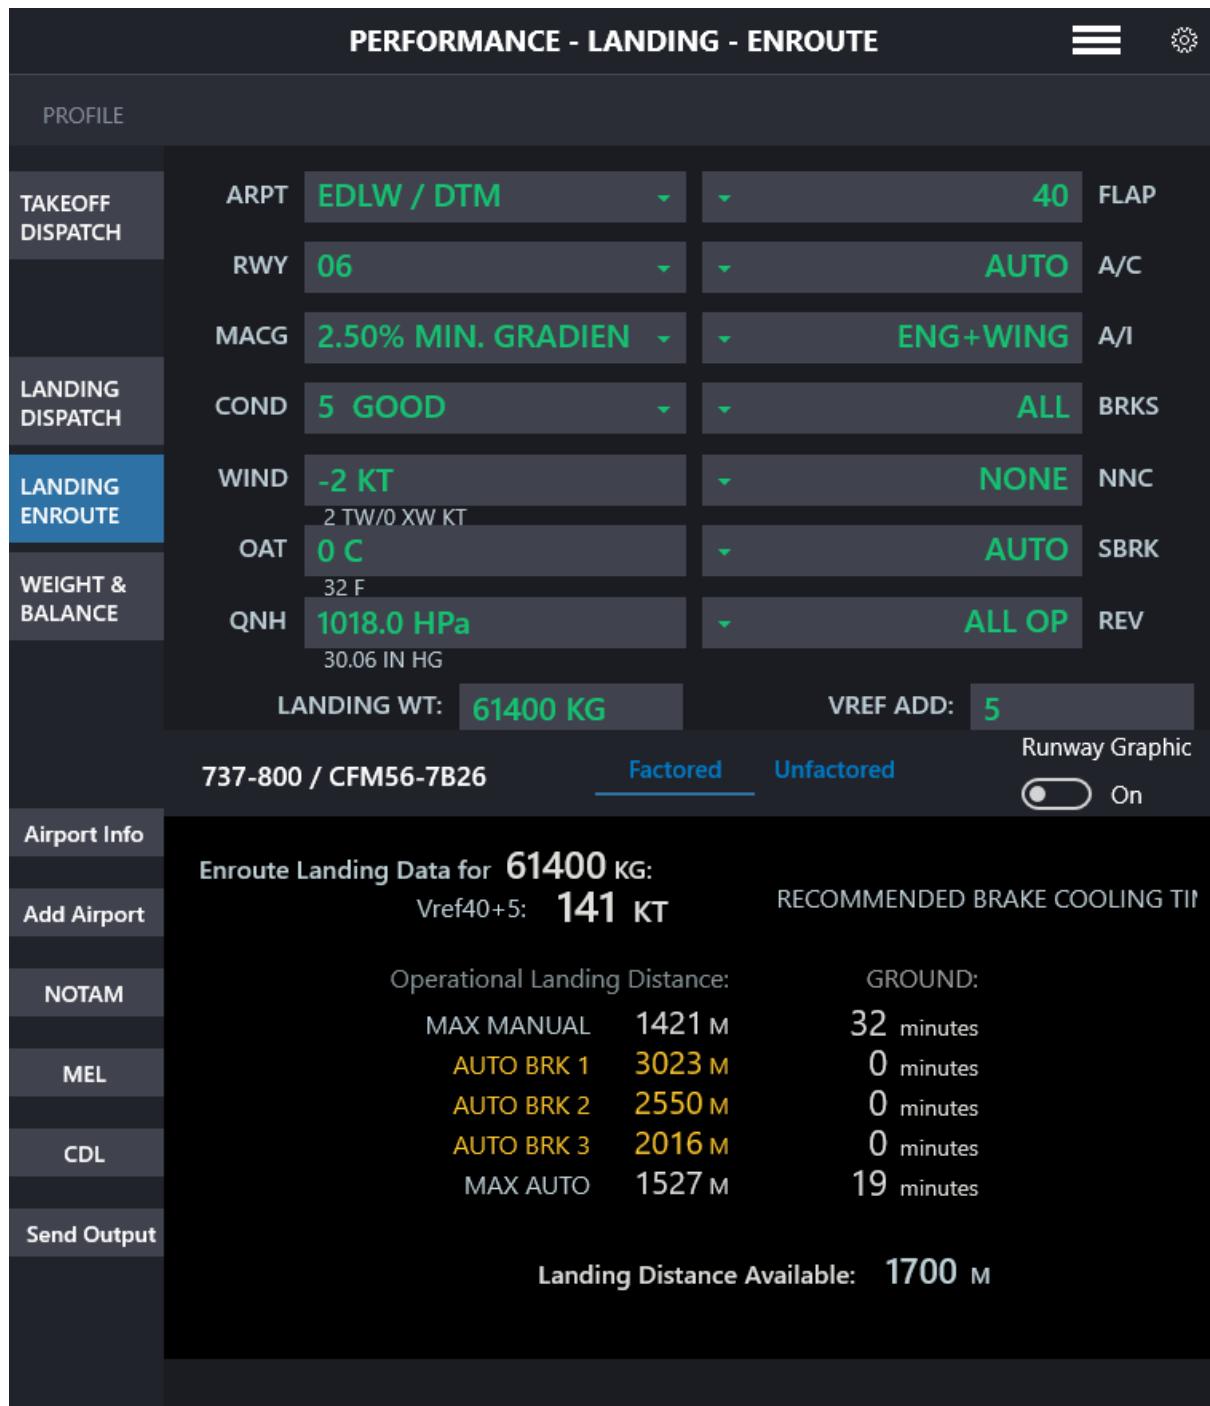
To the LDR of 1,527 m with Auto Brake position MAX AUTO the Boeing OPT software had calculated, the Auto Land safety margin (Flaps 40) of 140 m had to be added. This resulted in a factored LDR of 1,667 m compared with an unfactored LDR of 1,438 m (1,298 m + 140 m). The landing distance available was 1,700 m. According to the flight crew's statement, they had entered a landing speed of  $V_{ref40} + 5$  kt, equals 141 kt IAS, into the MCP.

Fig. 6: Copy of the Boeing OPT Landing distance calculation, created after the event

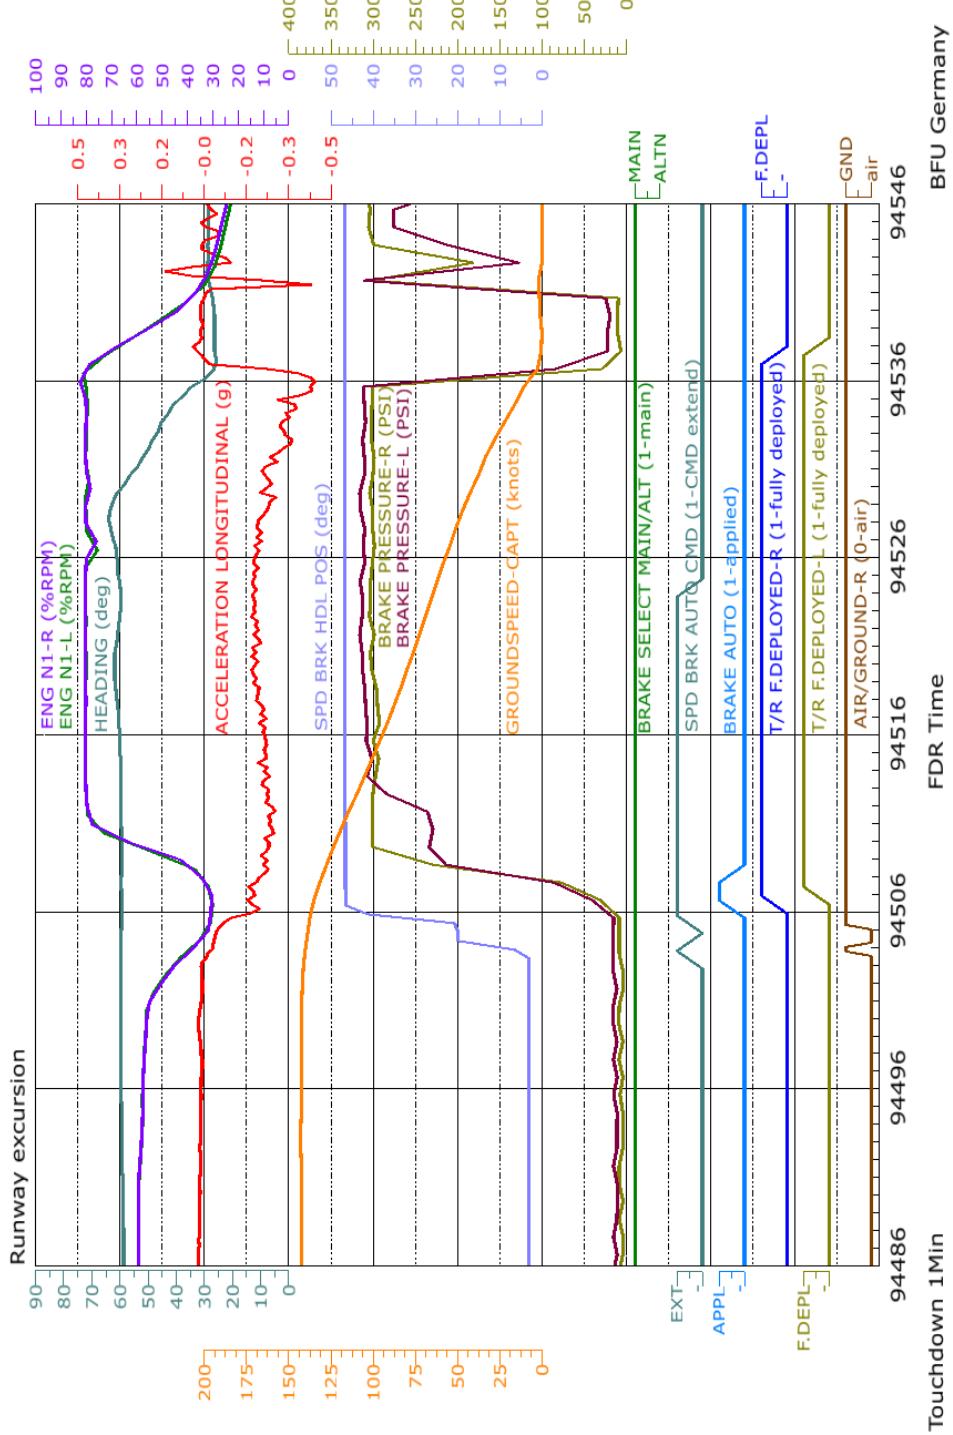
Fig. 8: DFDR parameters between touch-down and standstill

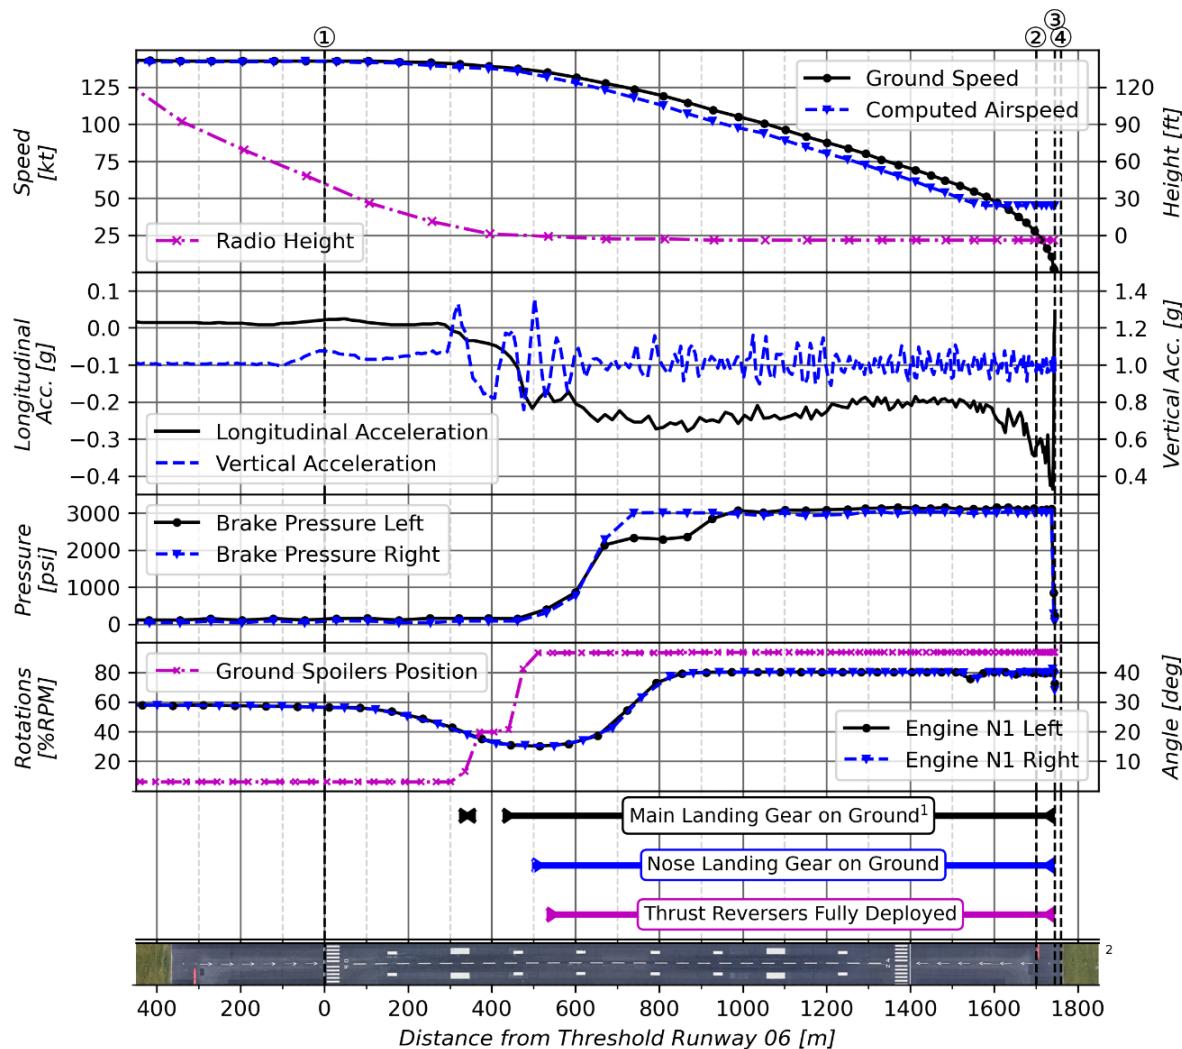
<sup>1</sup> The air/ground sensors on left and right main landing gear detected ground contact from 320 m to 360 m and after 430 m distance from runway threshold.
