**KOMITE NASIONAL KESELAMATAN TRANSPORTASI
REPUBLIC OF INDONESIA**

KNKT.22.07.10.04

Aircraft Serious Incident Investigation Report

Airbus A320-200; PK-GLW

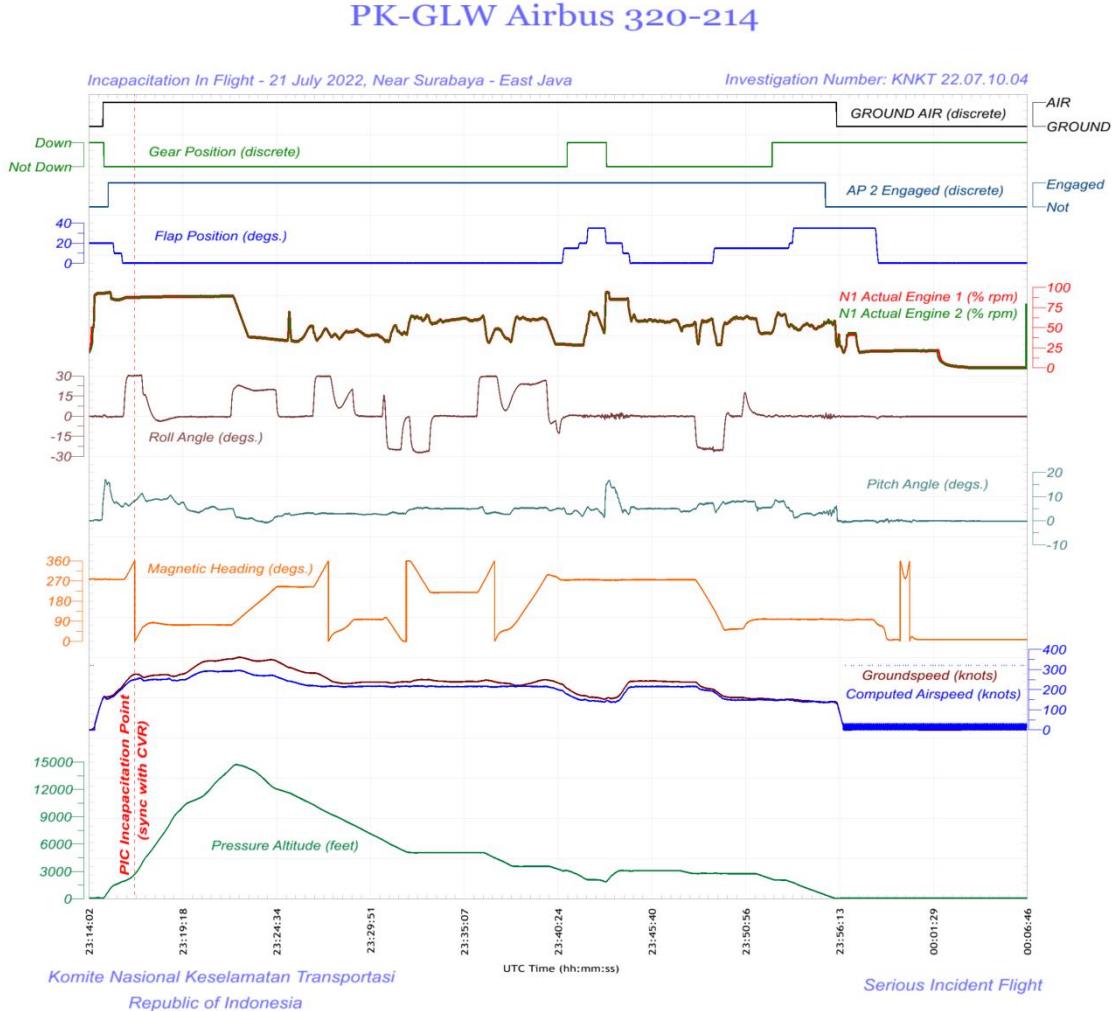
Figure 1 The significant FDR parameters of flight instrument of the serious incident flight

The FDR labelled in UTC time and the local time was UTC +7. The FDR data showed that:
