## Maintenance Briefing Notes

### Uncommanded Ram Air Turbine (RAT) extensions

The purpose of this Maintenance Briefing Notes note is to summarize the RAT extension logic for the individual Airbus aircraft programs, and then provide a summary as to likely causes of uncommanded RAT extensions.

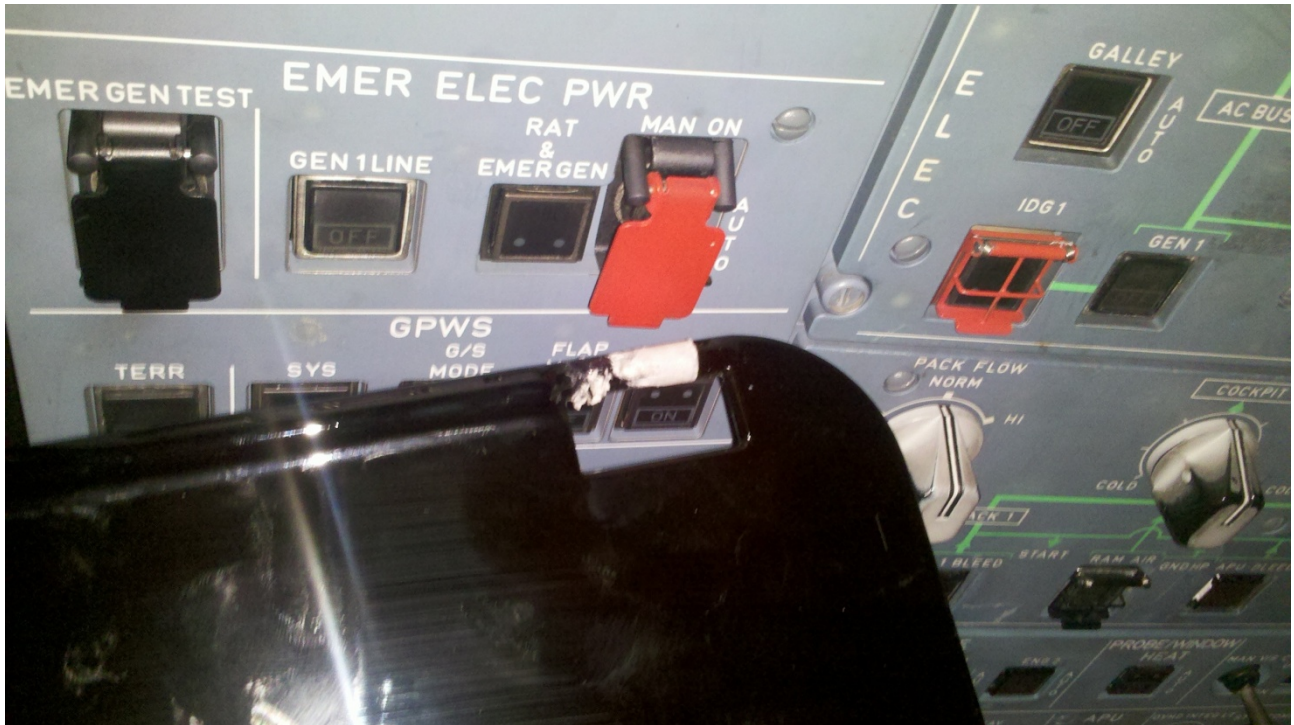
**Figure 1: Interference between Visor and RAT MAN P/BSW**

*“This was an uncommanded extension in flight. XXX reported that while the captain was adjusting the sun visor, the visor caught the cover, and then the button was brushed as visor was moved and was sufficient to deploy RAT. See Figure 1:”*
