*Accident  
on 25 May 2000  
at Paris Charles de Gaulle (95)  
to aircraft  
F-GHED operated by Air Liberté  
and  
G-SSWN operated by Streamline Aviation*

**REPORT**

## **FOREWORD**

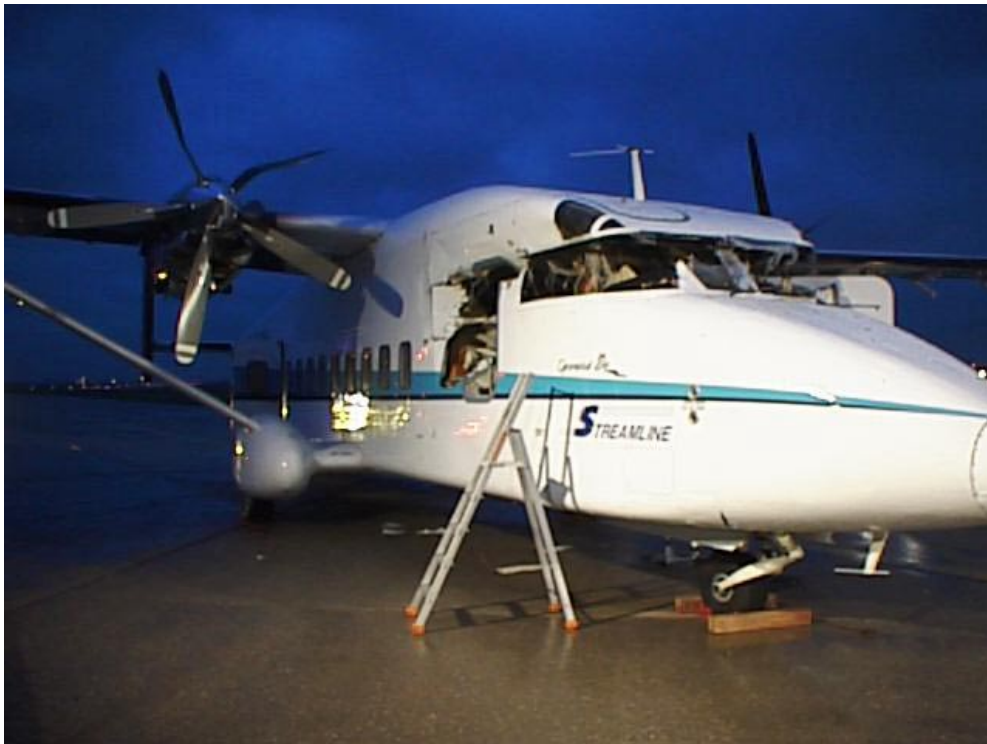
The right-hand wing brace bore friction marks which were caused by the right wing tip of the MD 83. These marks are located on the lower surface of the brace, approximately 70 cm from the junction with the wing spar, and approximately three meters up. They are straight and clearly show the direction of the friction movement.

The wing was not struck directly. A slight folding of the covering at the front of the junction with the fuselage indicated it was pushed in to the front.

On the starboard engine nacelle, the lower part of the cowling was damaged, and the air inlet situated 2.8 meter from the ground was torn and pushed upwards. Two of the propeller blades were damaged. The propeller cone was undamaged.
