A1. Factual information

A1.1 Background and course of the accident flight

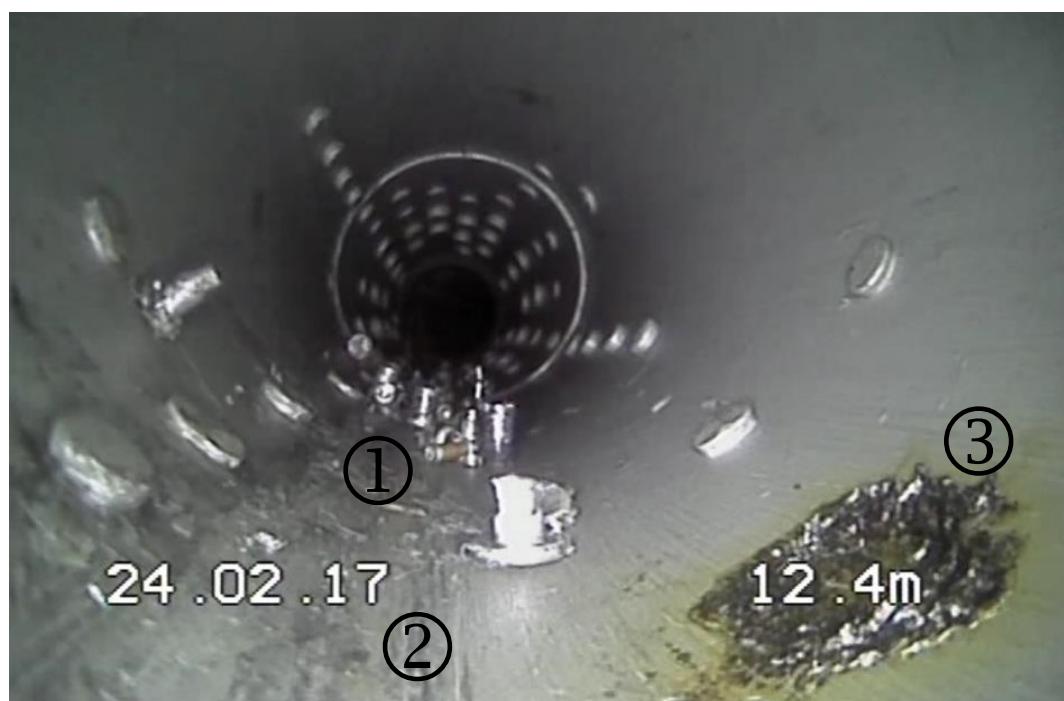
When reviewing these recordings, the STSB detected large quantities of drilled-out rivets, swarf and rivets that had fallen out by themselves in the spar tubes (see figures 40 to 42). Dirt deposits and flaking anti-corrosion paint were present in places. In some places, small quantities of the ACF 50 corrosion inhibitor applied during the borescope inspection on 9 January 2006 were still visible in the tubing (see figure 40). The condition of the tubing under this layer could not be assessed. The borescope's camera lens was moved at relatively high speed through the spar tubes during the inspection on 24 February 2017. This led to insufficient image and video quality, meaning that it was not possible to assess the condition of the spar tubes more precisely.

Figure 40: Left-hand outer wing, lower spar I – various rivets lying around (1), partly flaked off anti-corrosion paint (2) and dried ACF 50 corrosion inhibitor (3). Photograph provided by Ju-Air.

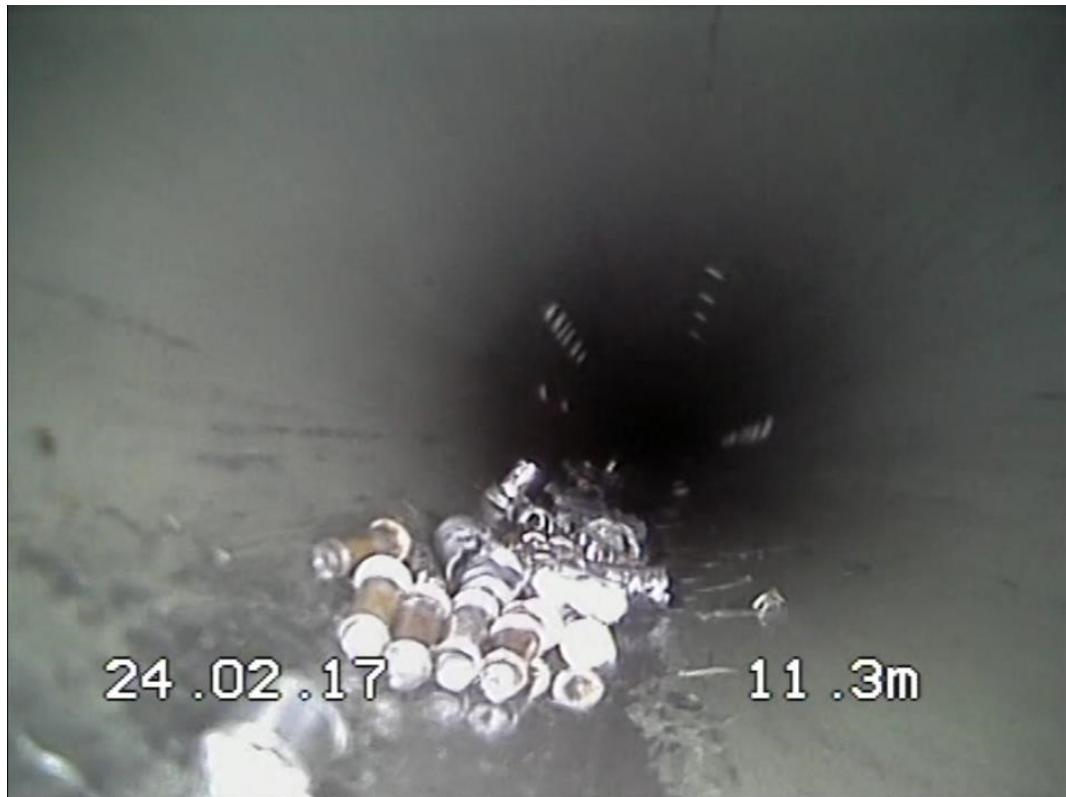
Figure 41: Left-hand outer wing, lower spar II – large quantity of rivets. Photograph provided by Ju-Air.

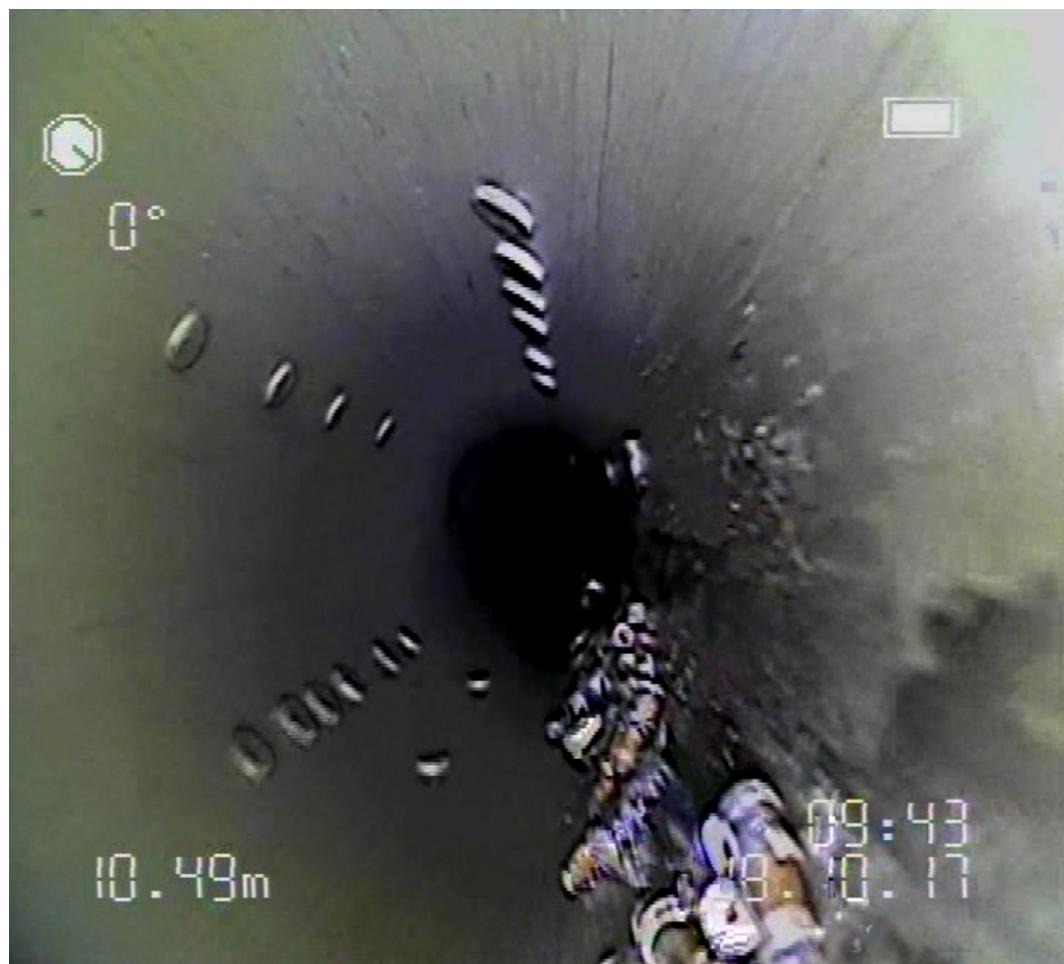
The review of these recordings by the STSB revealed that the situation in the spars on 18 October 2017 was the same as had been detected during the borescope inspection on 24 February 2017 (see figure 43). This shows that these deficiencies had not been remedied in the meantime.

Figure 43: Left-hand outer wing, lower spar II. Photograph provided by Ju-Air.

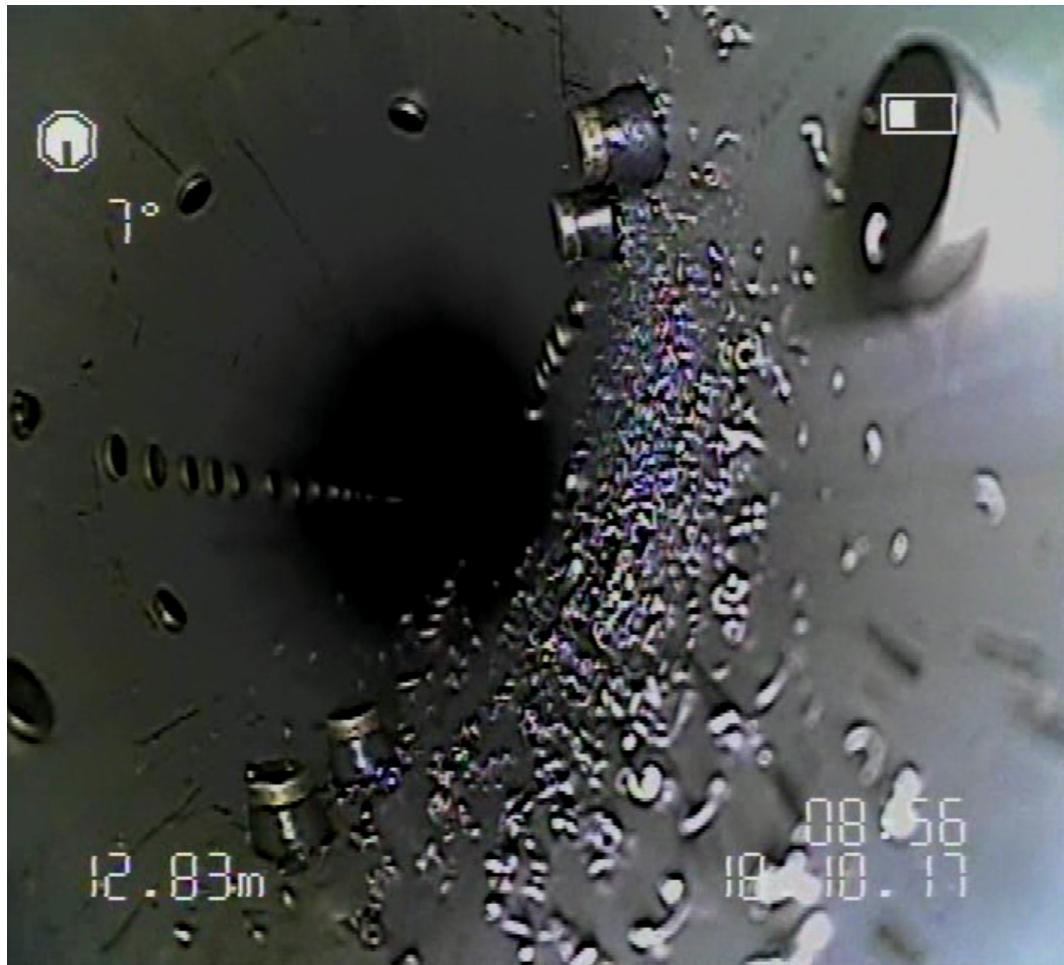
In the area where the spar had been repaired in May 2017, there were many loose rivets and large quantities of swarf in the spar tube (see figure 44). This is further indication of the poor quality of the repair work.

Figure 44: Centre wing, lower spar I, after repair. Photograph provided by Ju-Air.

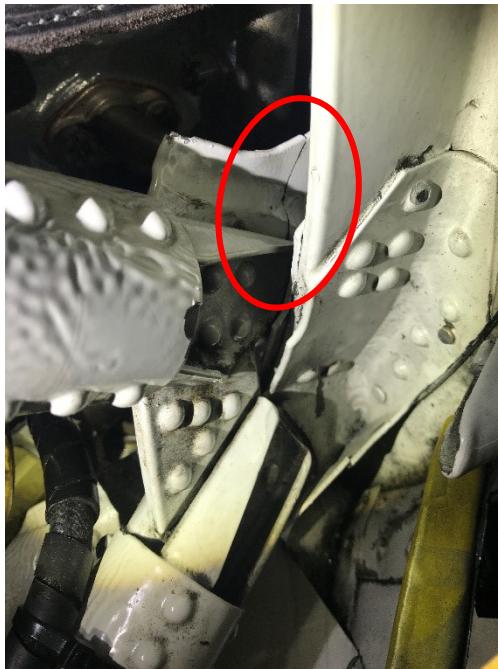
During a progressive inspection of HB-HOT's centre engine at the end of May 2018, approximately two months before the accident, a crack was detected on the engine frame in the lower-right mounting frame attachment (gusset plates) (see figure 45). To allow the repair to be carried out with the engine frame in place, the corner tube between the engine mount and the firewall was cut through (see figure 46). The cracked gusset plate was replaced by a remanufactured part, welded aluminium sheets with subsequent heat treatment (see figure 47). The severed corner tube was reattached using a doubler consisting of two manufactured U-shaped wraps. Corrosion protection was not applied (see figure 48). The repair was carried out by Kaelin Aero Technologies GmbH. According to the work report, the repair was carried out based on the "*Reparaturanweisung Ju 52/3m*" (Ju 52/3m repair instructions').

Figure 45: Crack in the mounting frame gusset plate (red circle). Photograph provided by Ju-Air.

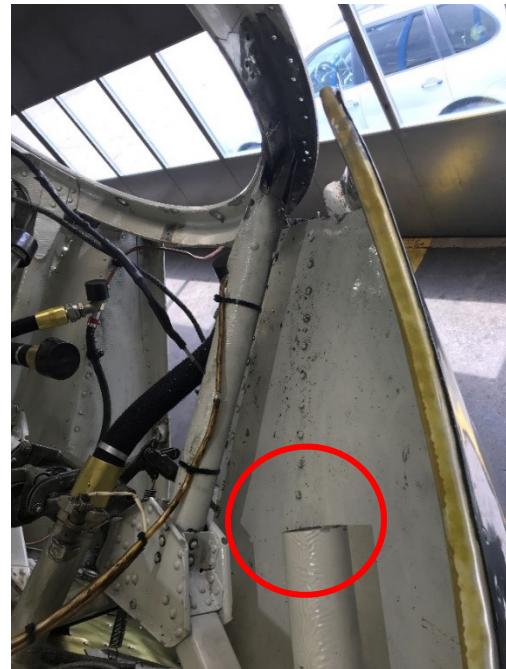
Figure 46: Cut strut tubing (red circle). Photograph provided by Ju-Air.

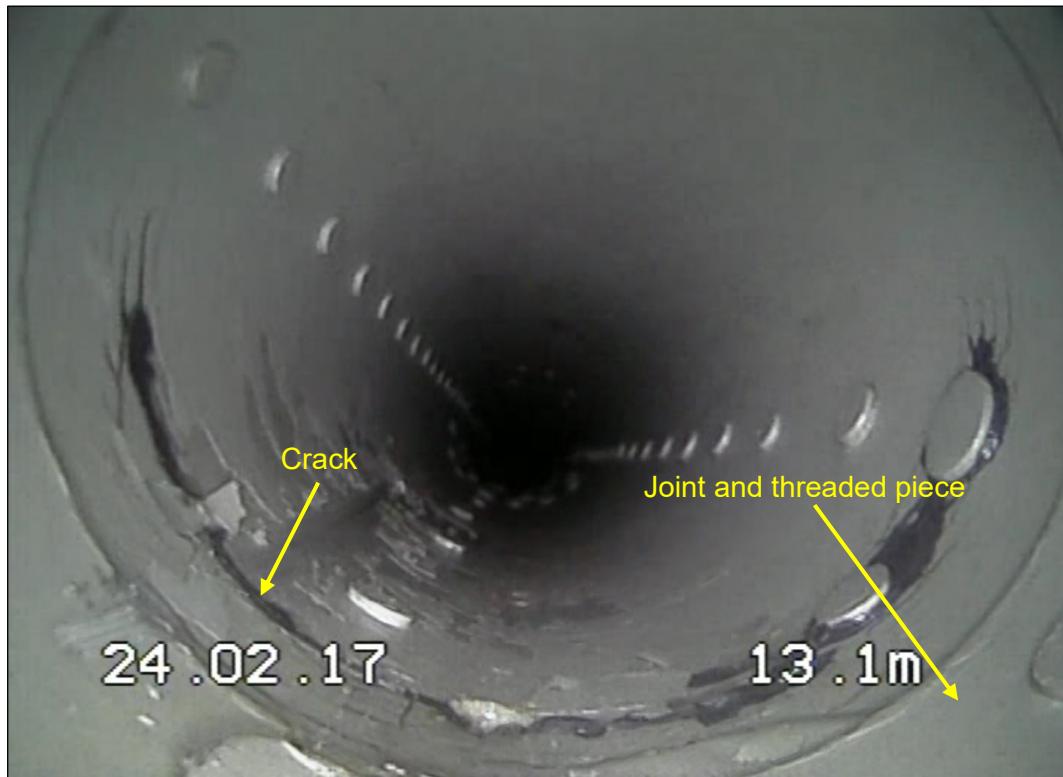
Figure 49: Interior view – crack in lower spar I of the centre wing, immediately next to the left-hand joint and threaded piece (borescope image). Photograph provided by Ju-Air.

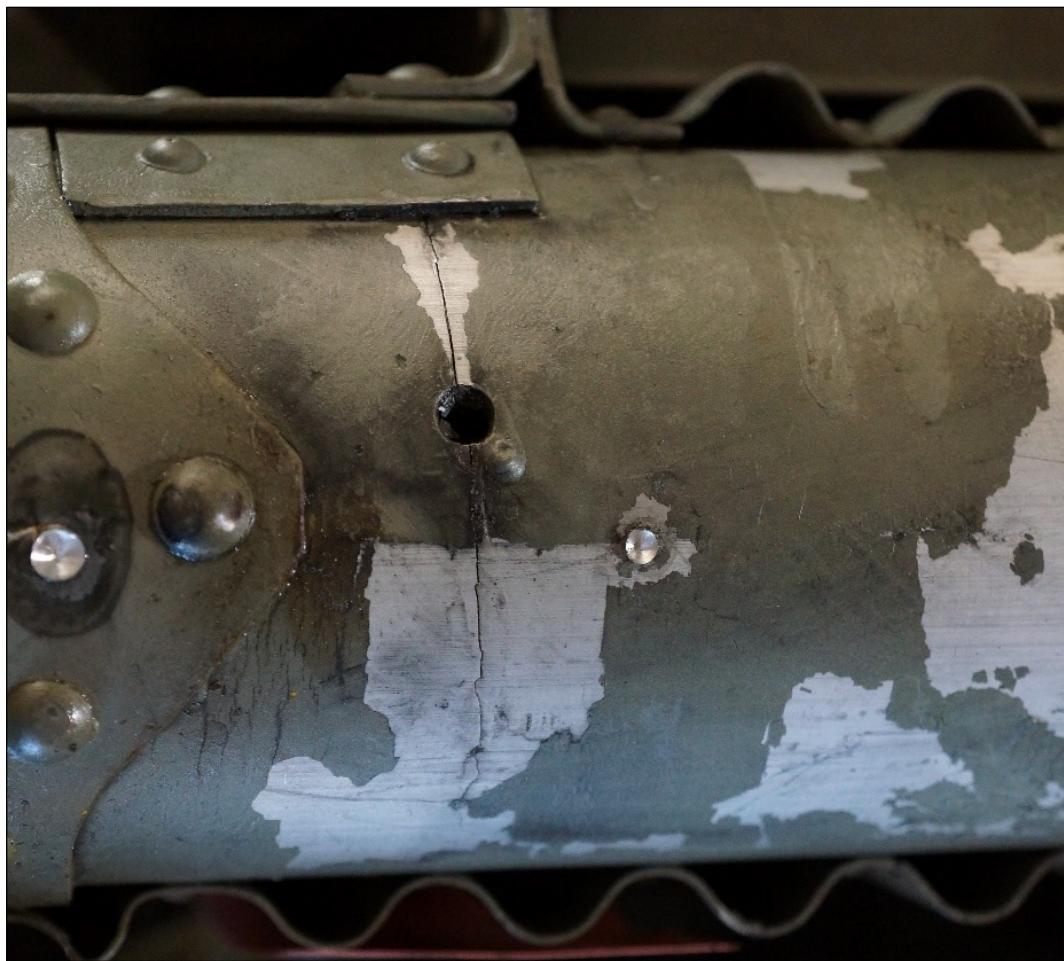
Figure 50: Exterior view – crack in lower spar I of the centre wing. Photograph provided by Ju-Air.

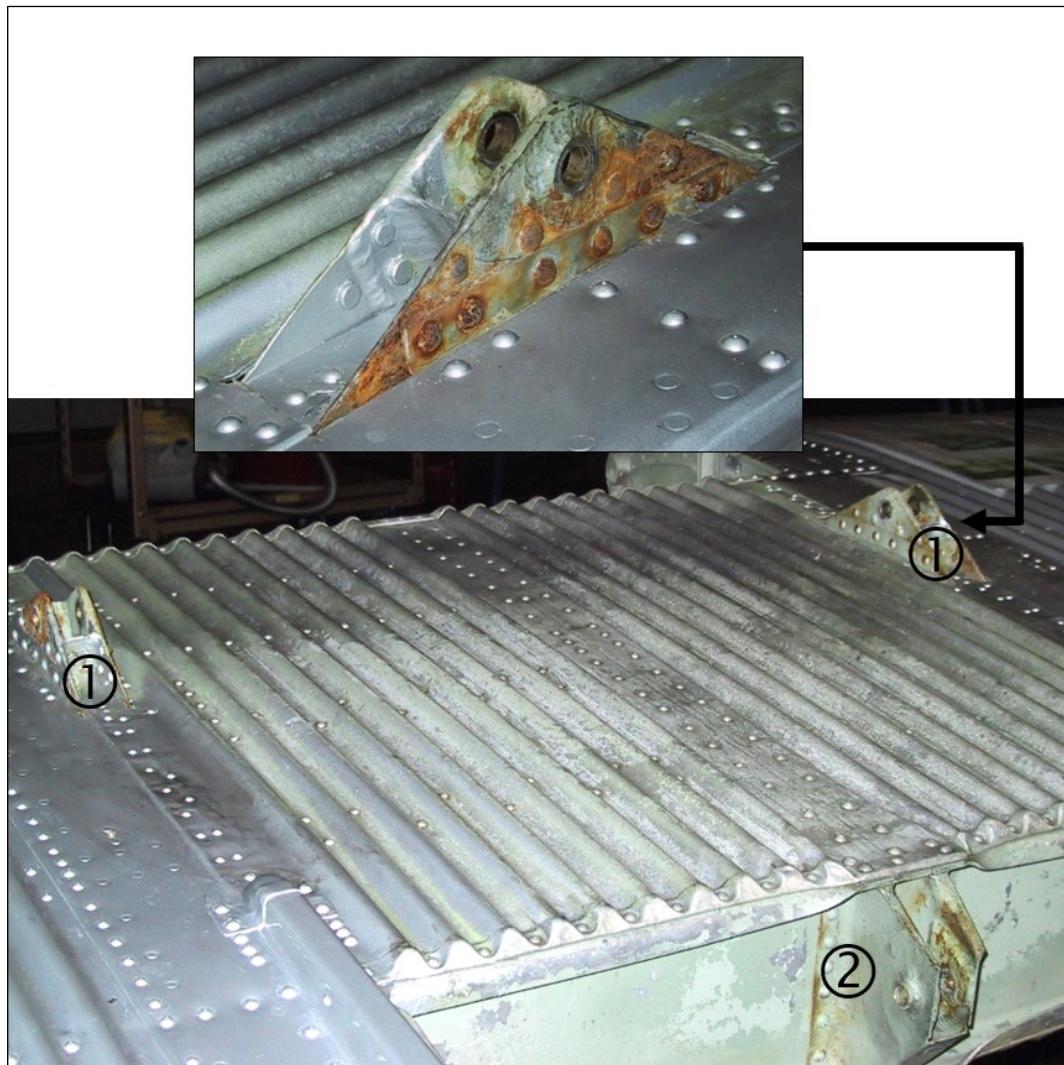
Figure 52: Horizontal stabiliser with severely corroded joints (1), bearing bracket (2) and panelling. Photograph provided by Ju-Air.

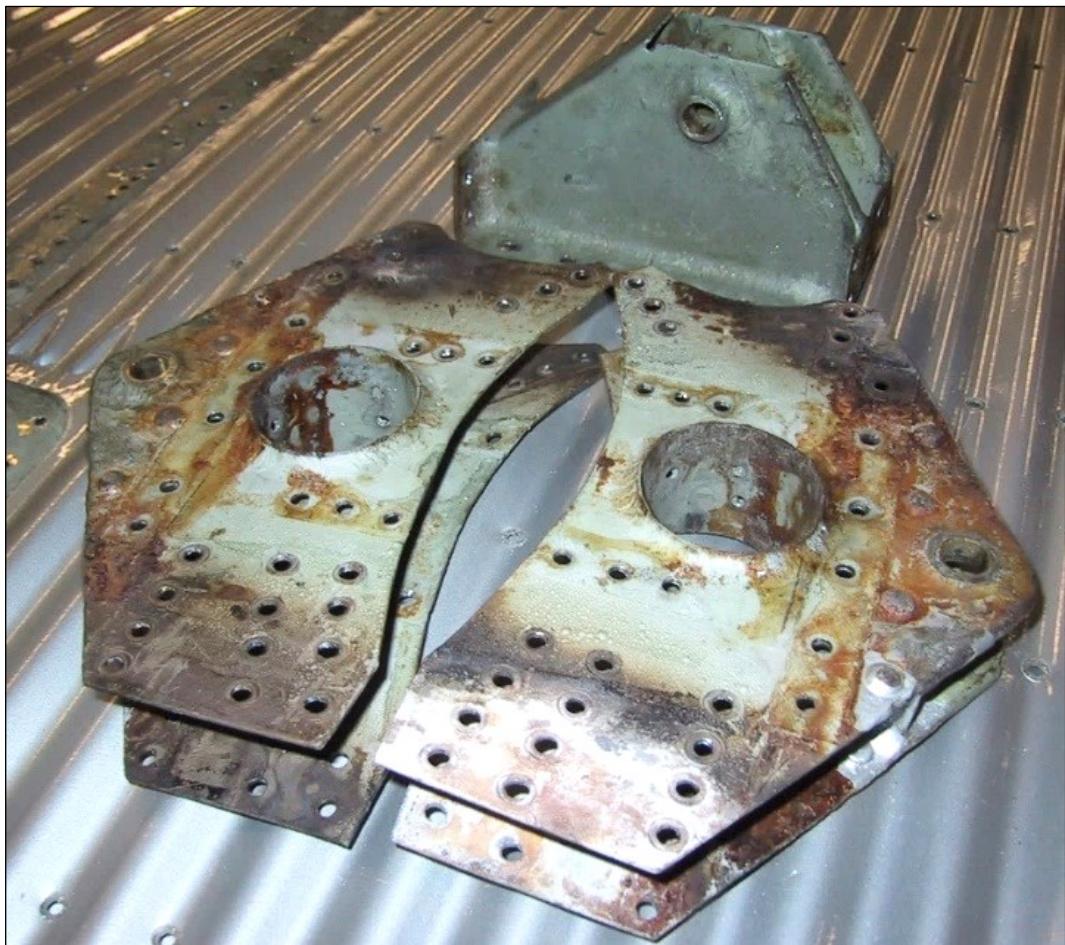
Figure 53: Removed, severely corroded components from the horizontal stabiliser. Photograph provided by Ju-Air.

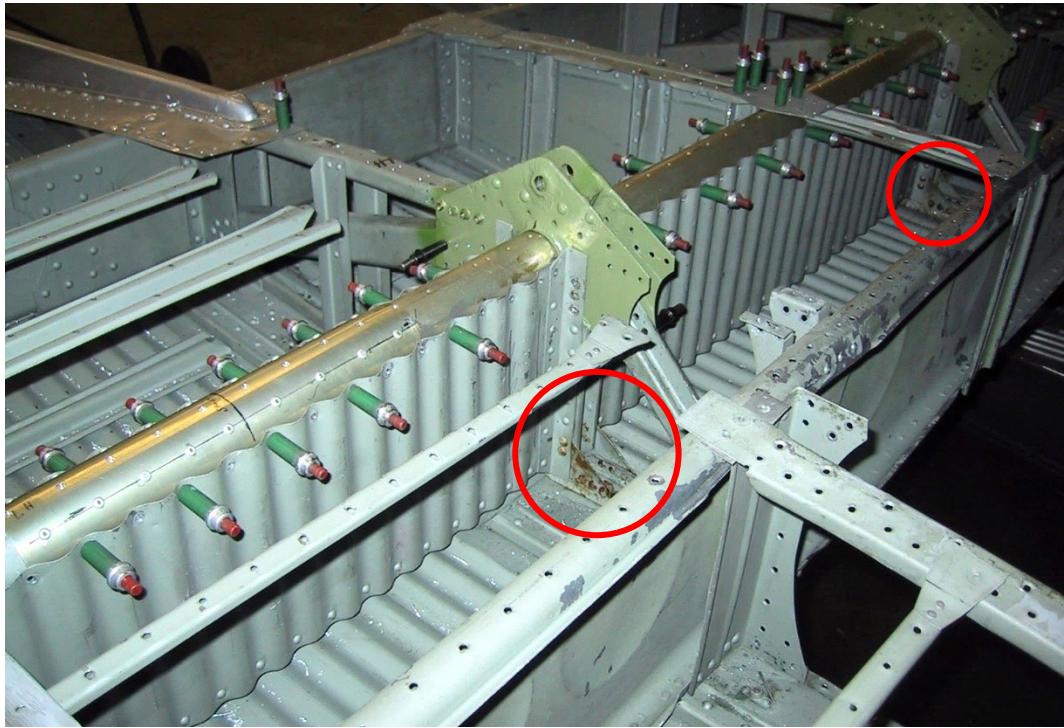
Figure 54: Reworked components in the horizontal stabiliser with new spar tubing. Circled in red are other severely corroded components that have not been treated or replaced. Photograph provided by Ju-Air.

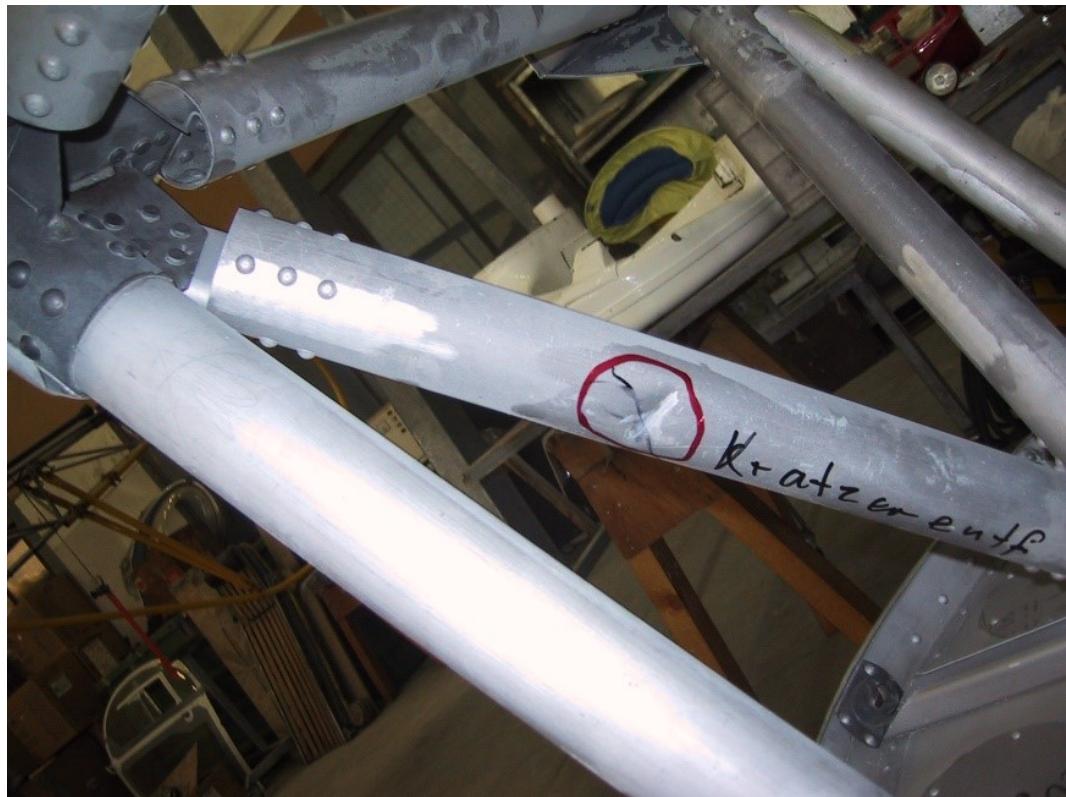
Figure 58: Damaged strut tubing (diagonal tube). Photograph provided by Ju-Air.

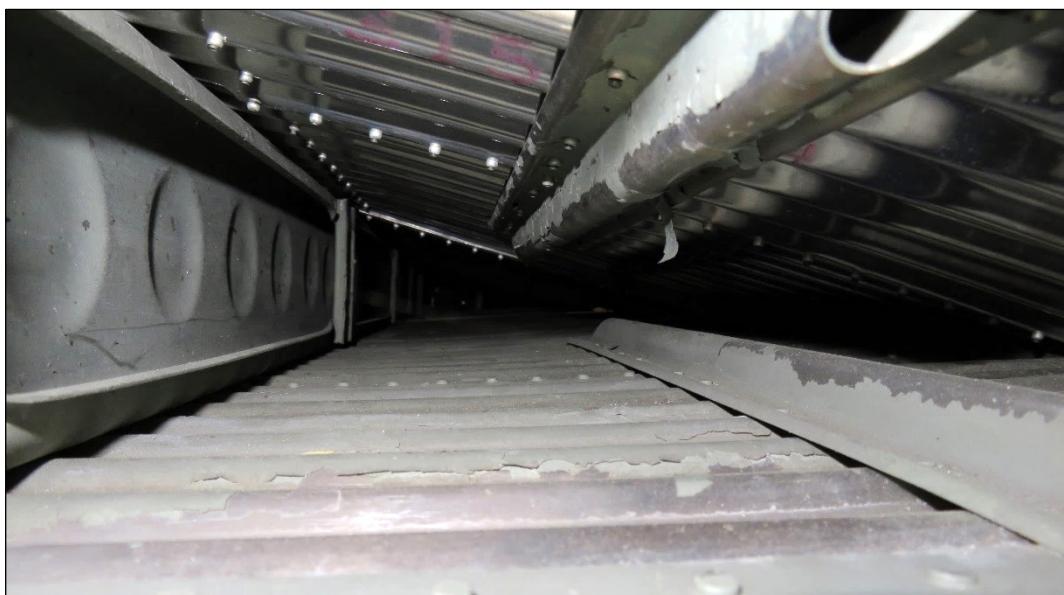
Figure 66: Surface flaking and a lack of anti-corrosion paint on the inside of HB-HOS's left-hand horizontal stabiliser.

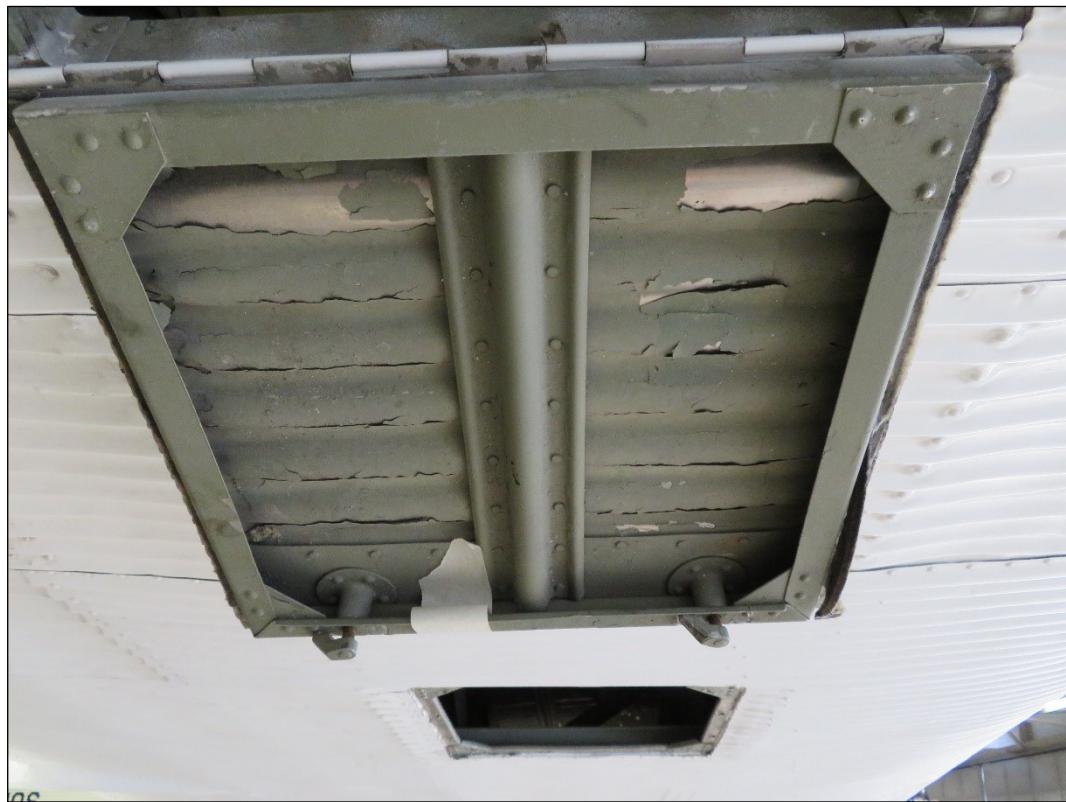
Figure 67: Surface flaking and a lack of anti-corrosion paint on the inside of HB-HOS's right-hand outer wing.

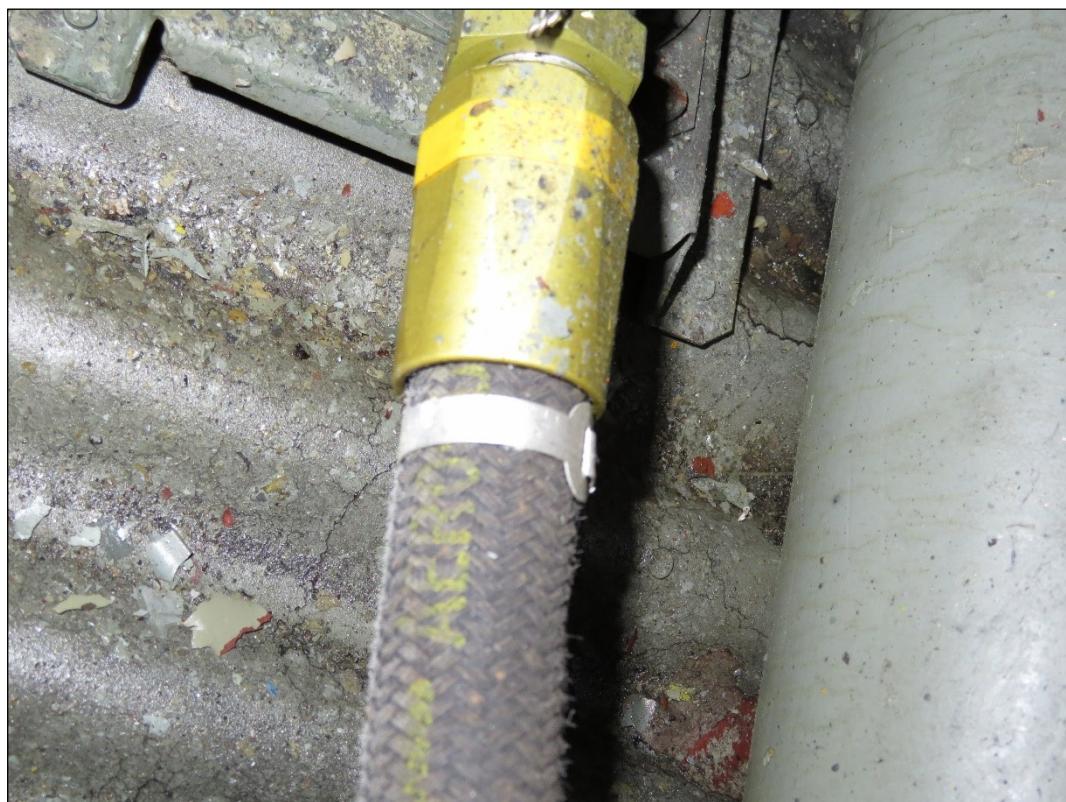
Figure 68: Flaking anti-corrosion paint and severe contamination on the inside of HB-HOP's left-hand outer wing, and fuel line from 1989.

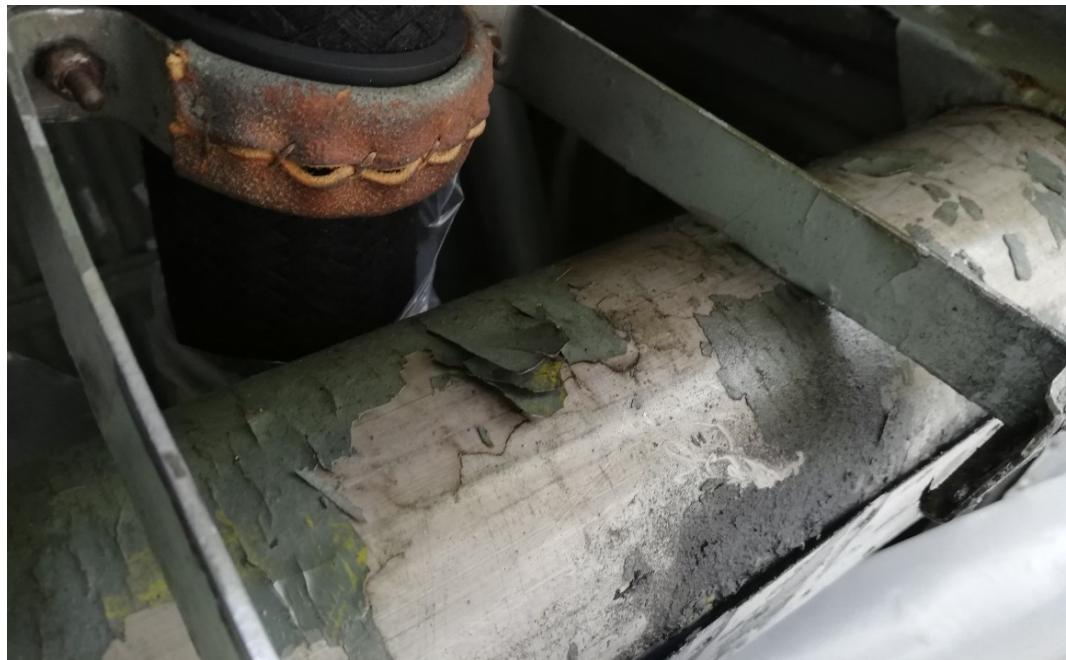
Figure 69: Lack of anti-corrosion paint on a spar tube in HB-HOP's left-hand outer wing.

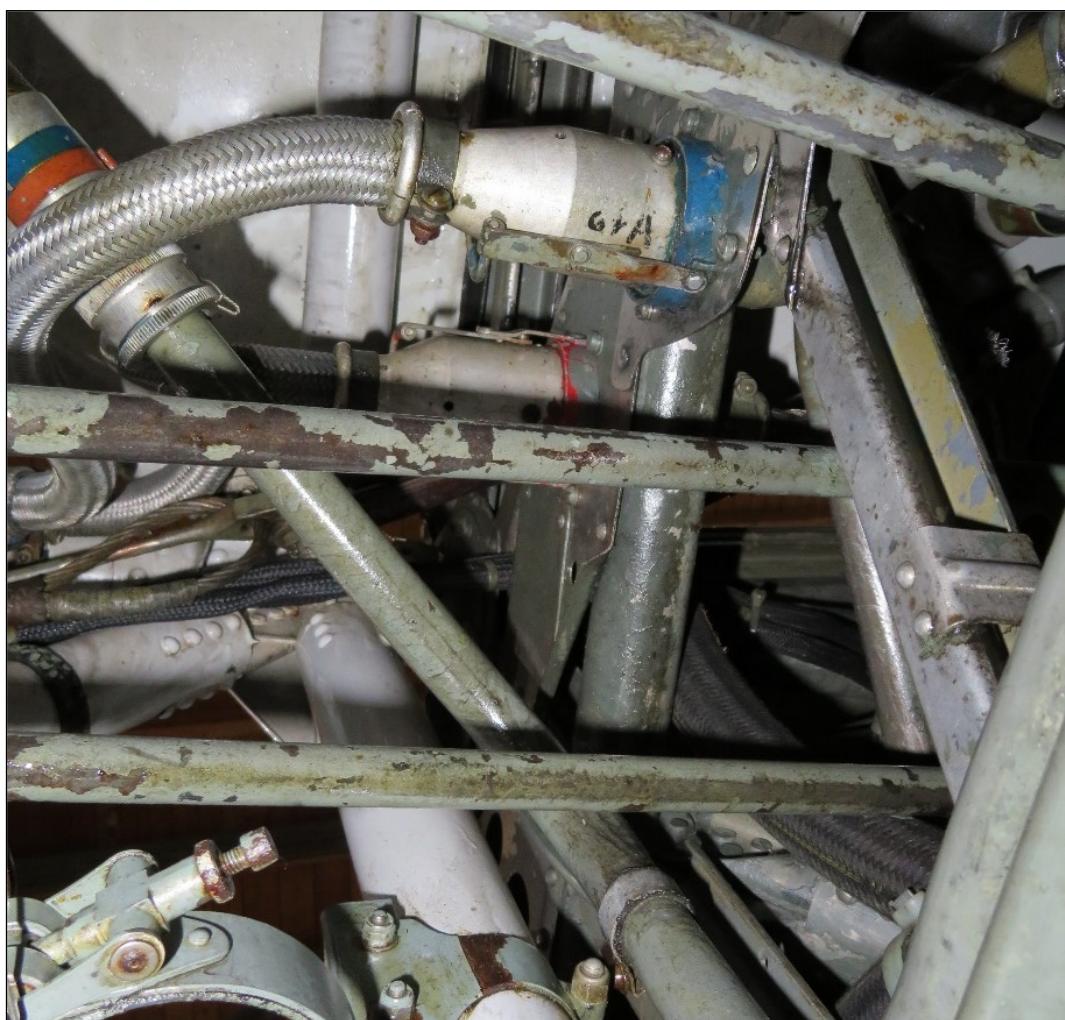
Figure 70: Corroded components and a lack of anti-corrosion paint on the inside of HB-HOP's left-hand outer wing.

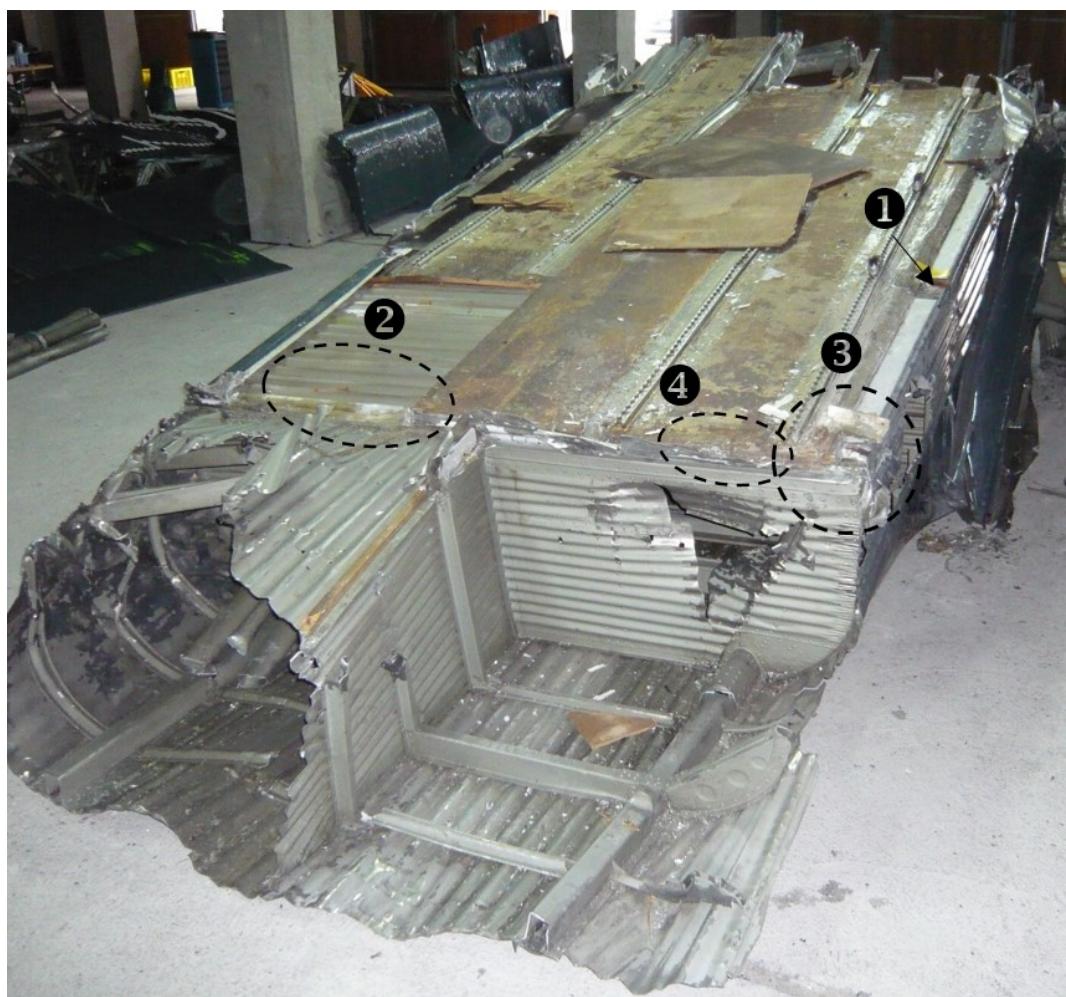
Figure 2: Aft bottom fuselage including cabin floor – severely corroded hinges of the cargo door (1) and (3), as well as severely corroded fuselage structure (2), (3) and (4).

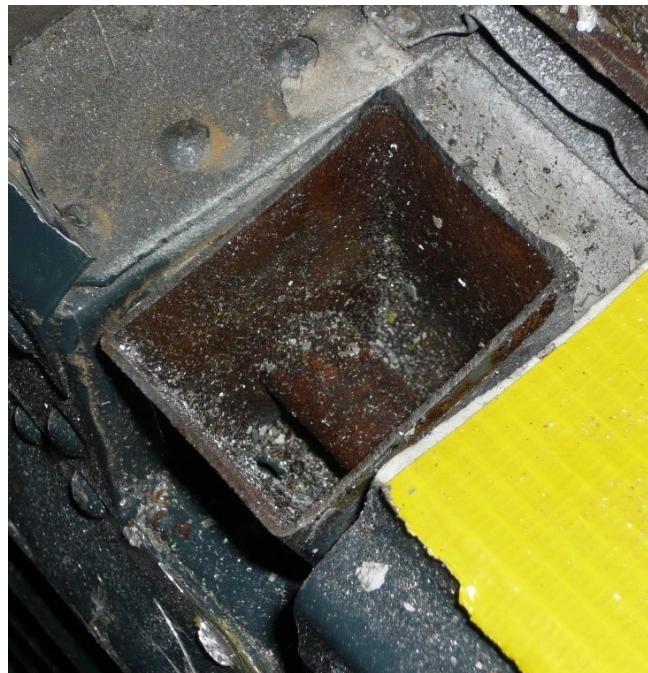
Figure 3: Close-up of figure 2 number (1) – severely corroded hinge of the cargo door on the right-hand side of the fuselage.

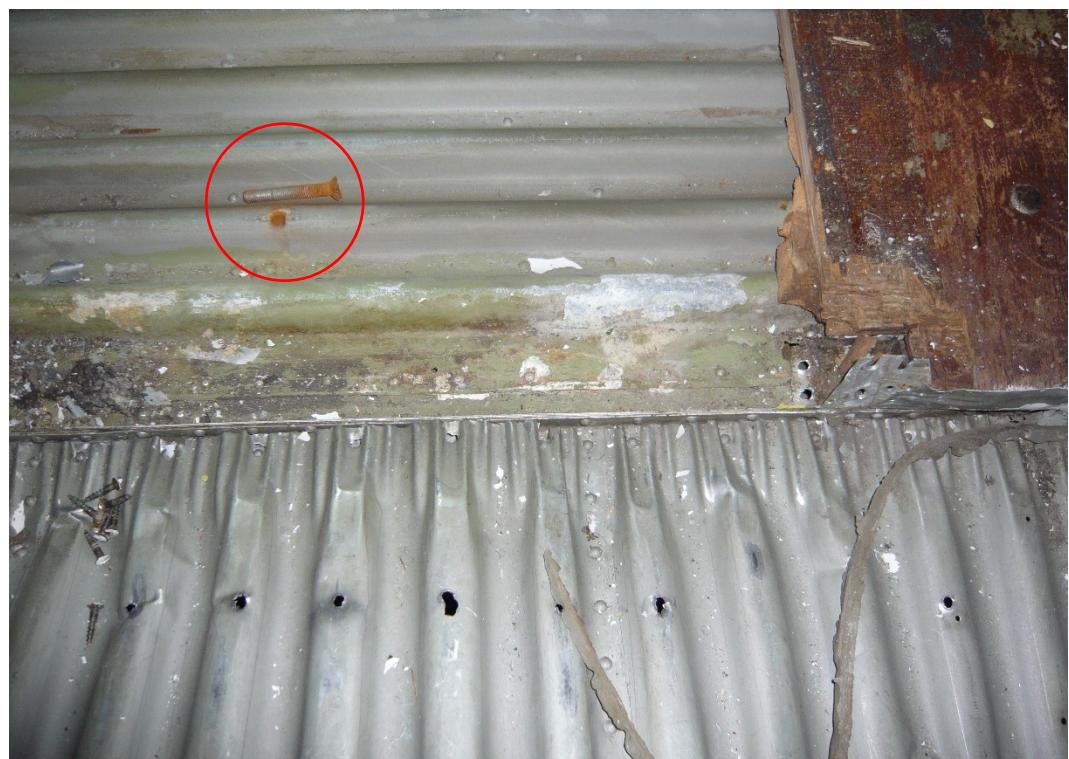
Figure 4: Close-up of figure 2 number (2) – severely corroded floor structure and bolts (red circle).

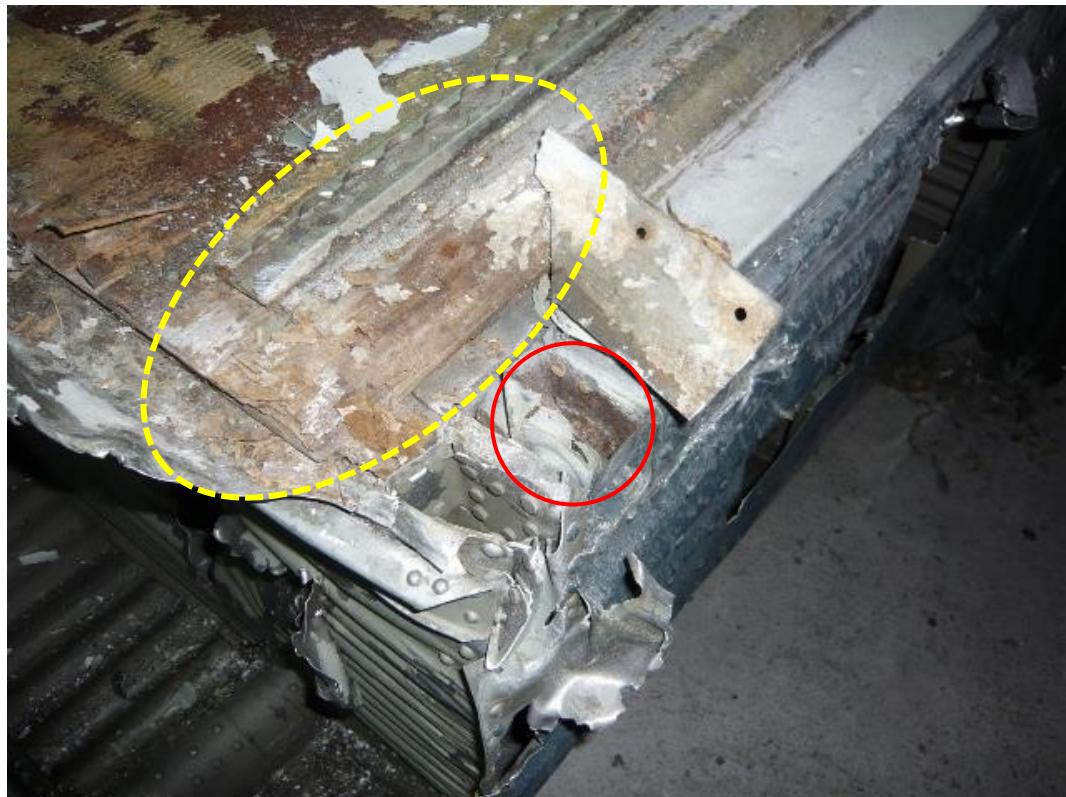
Figure 5: Close-up of figure 2 number (3) – rotten wooden floor (zone marked in yellow), severely corroded hinge of the cargo door (red circle) and severe corrosion on the fuselage structure (powdery, whitish patches of aluminium oxide).

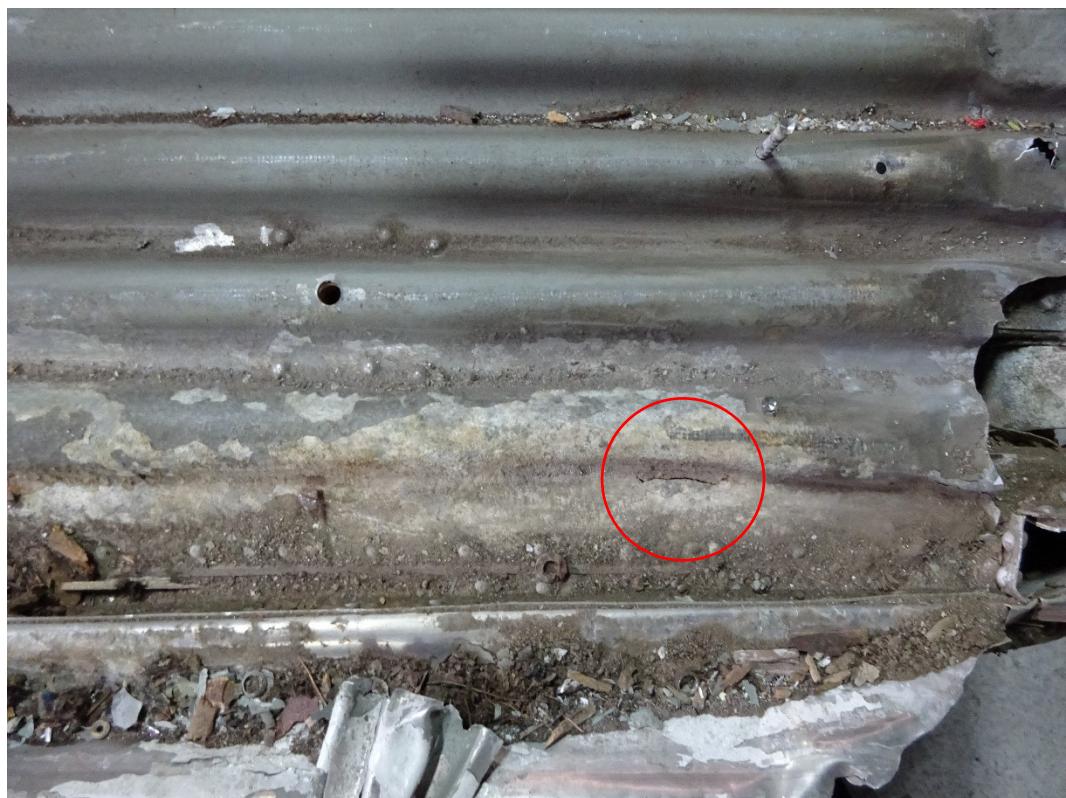
Figure 6: Close-up of figure 2 number (4) – severely corroded floor structure with fracture (red circle).

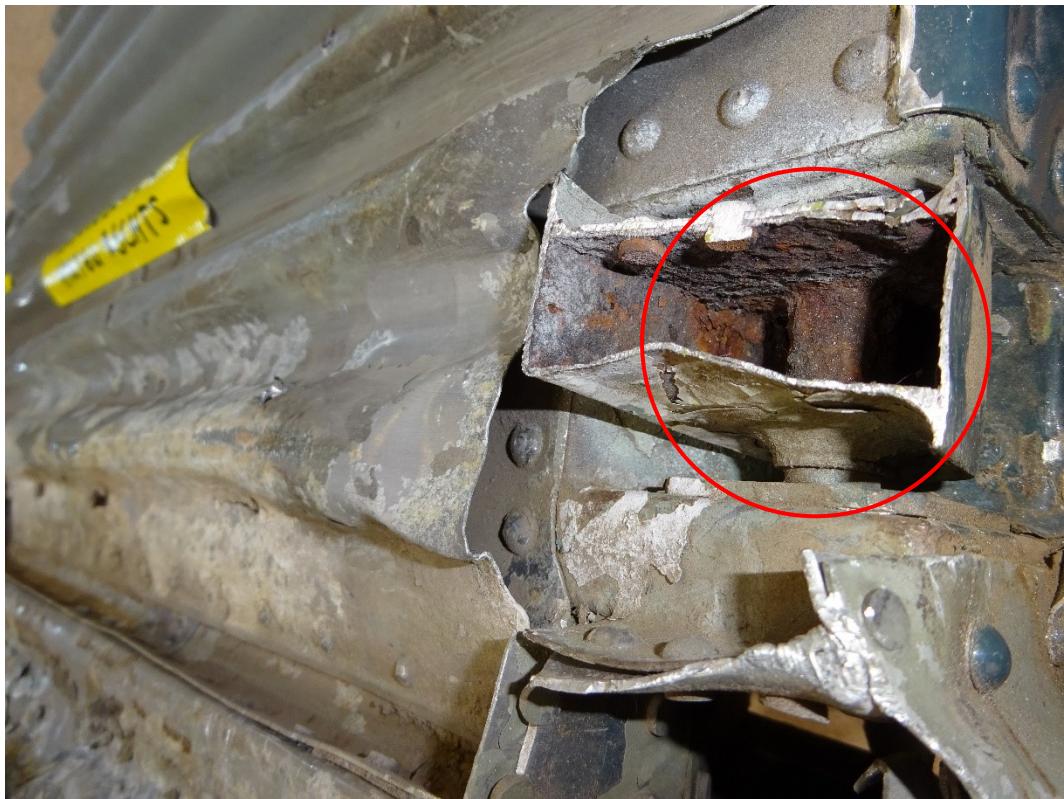
Figure 7: Close-up of figure 5 – severely corroded hinge of the cargo door (red circle).

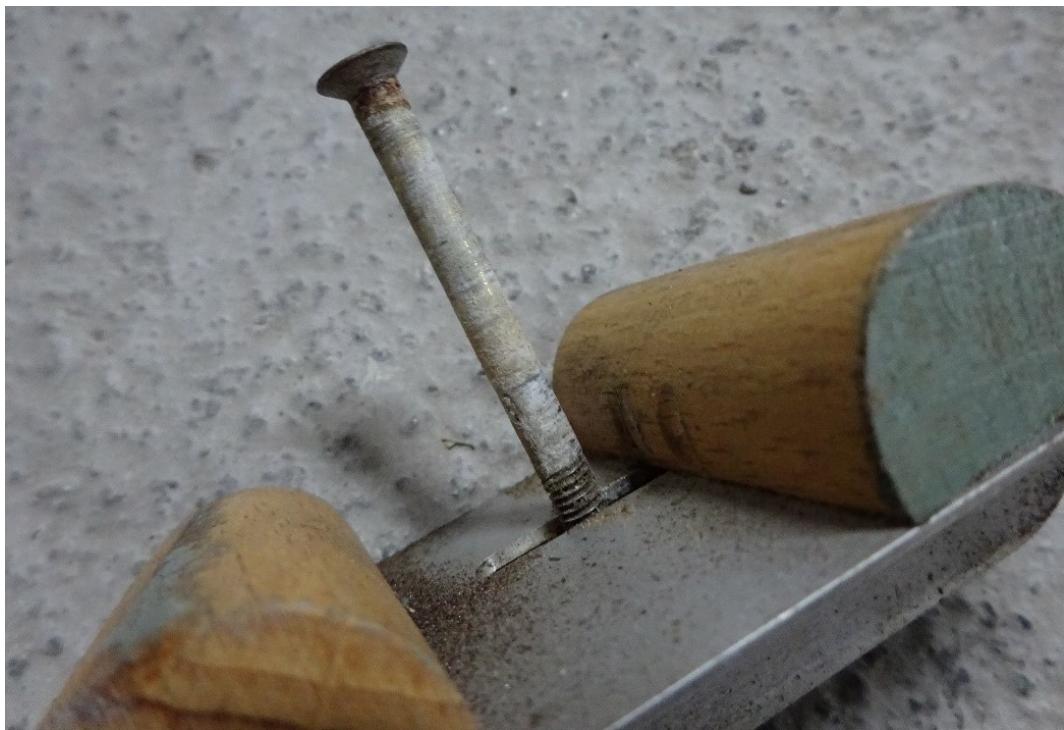
Figure 8: Severely corroded bolt for mounting a seat rail.

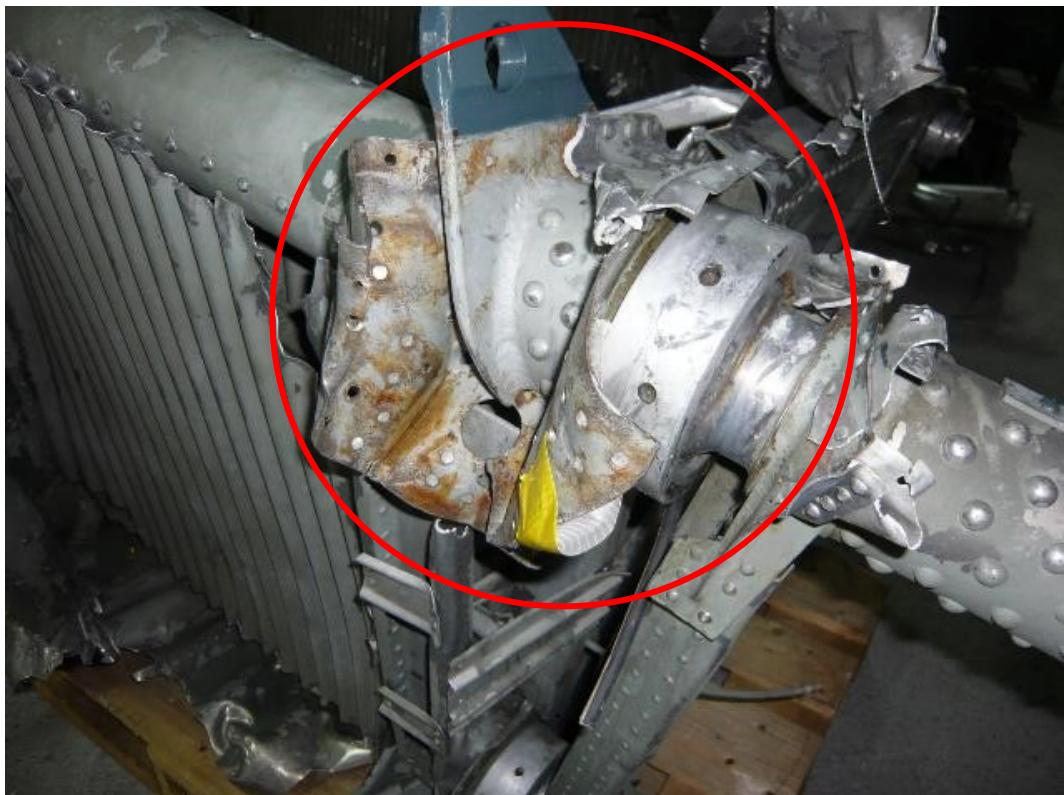
Figure 9: Corrosion over the entire area connecting the outer wing to the centre wing (red circle).

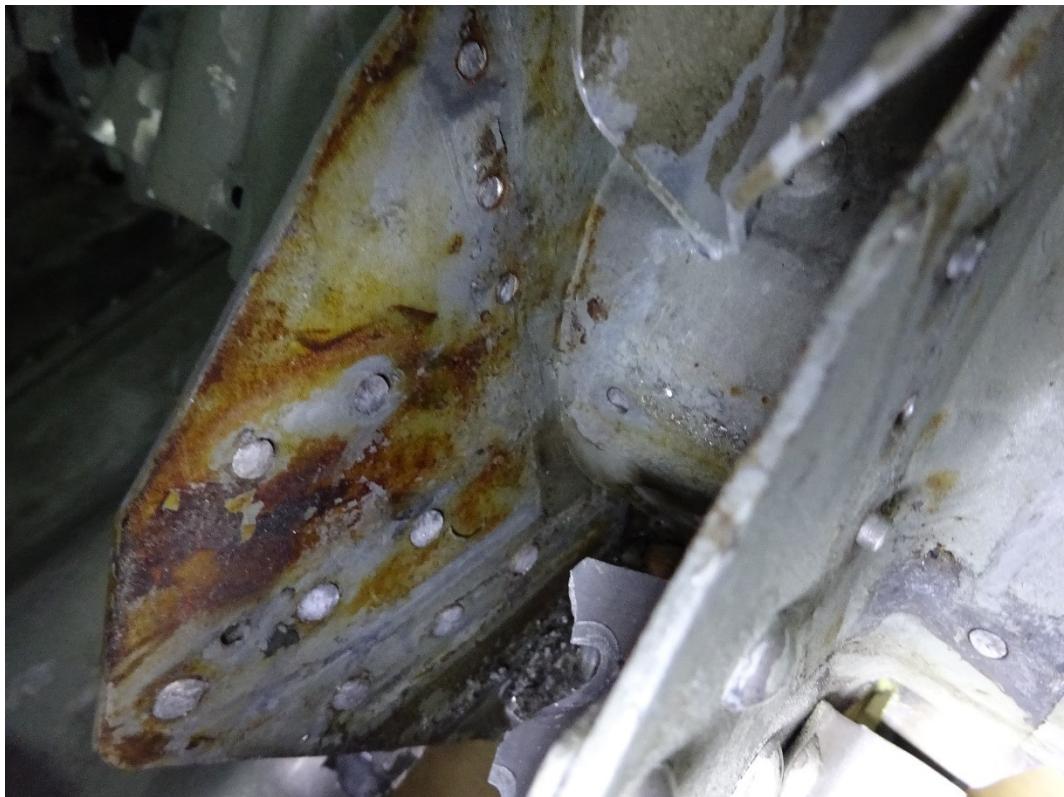
Figure 10: Corrosion in an area connecting the outer wing to the centre wing.
