A1. Factual information

A1.1 Background and course of the accident flight

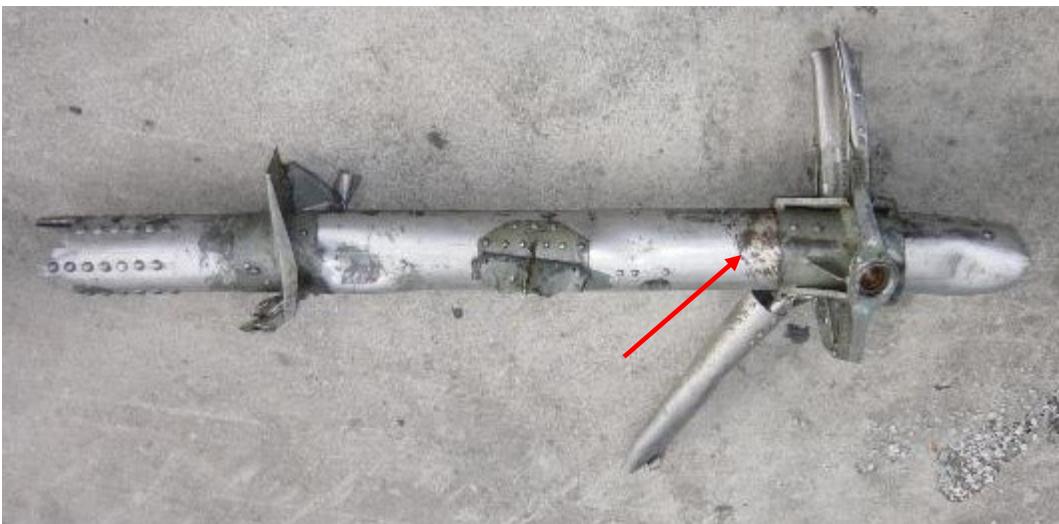
Figure 12: Lower spar tube of spar I on the left outer wing. The arrow points to the area of the spar tube with fractures. The outer diameter of the spar tube is 90 mm.

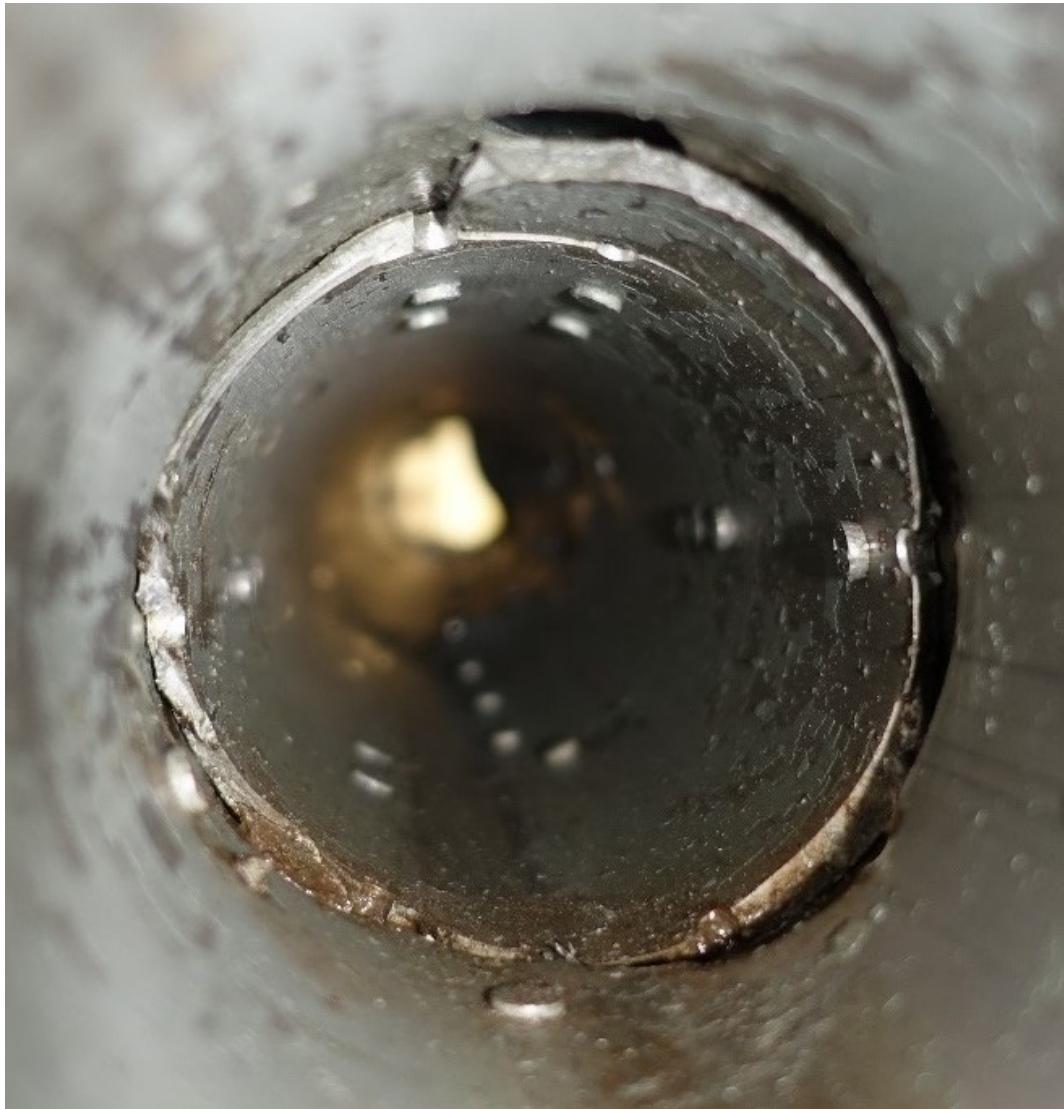
Figure 13: Close-up of the inside of the spar tube where fractures were found.

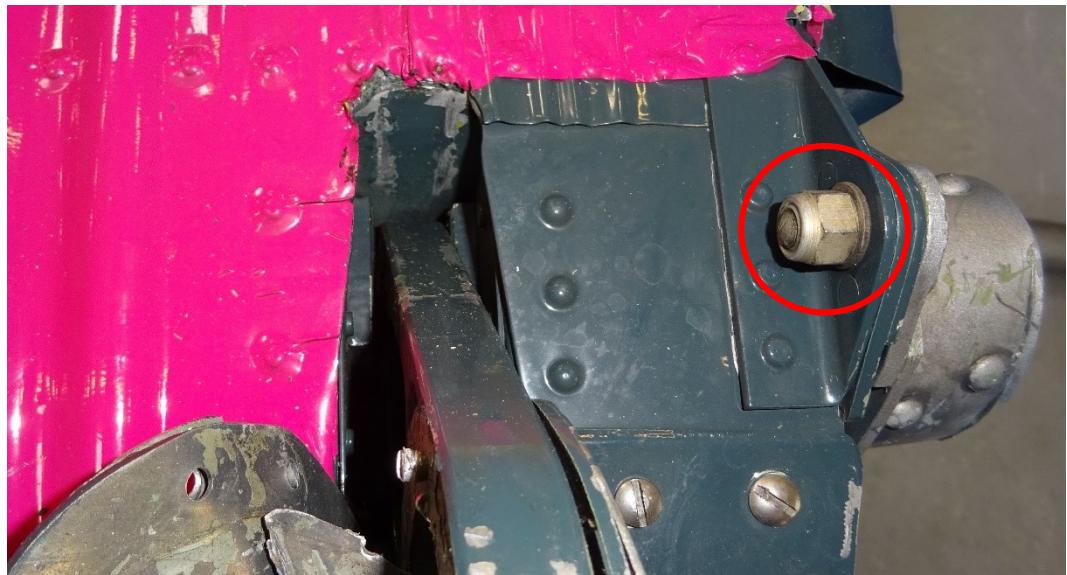
Figure 14: Right-side elevator with connecting flange of its actuating element, which was mounted using a nylon locknut on a thread that was too short for this purpose (red circle).

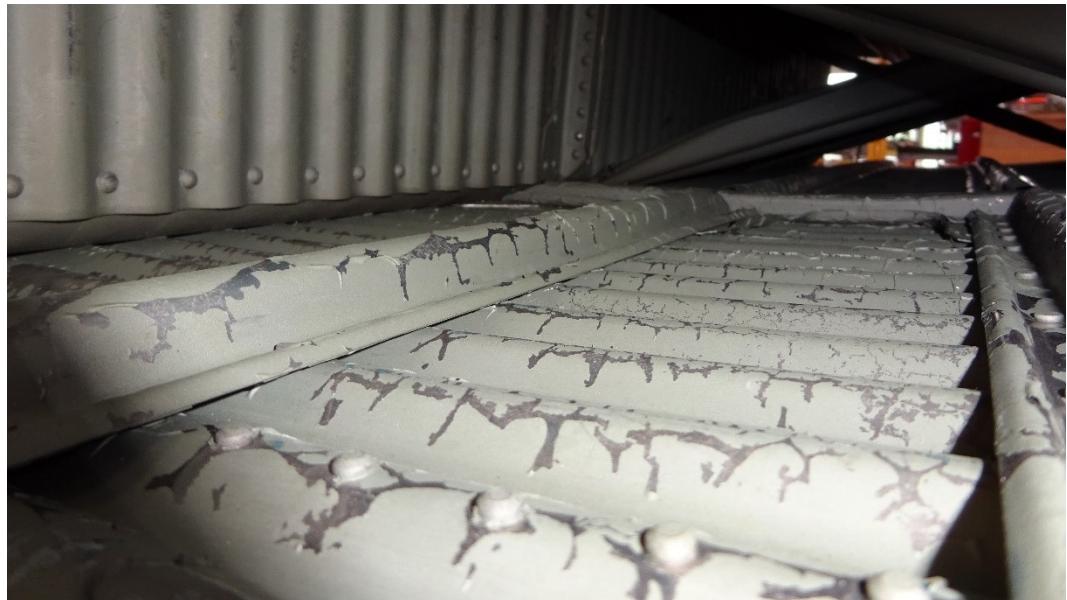
Figure 15: Inside of the horizontal stabiliser – areas where the anti-corrosion paint had partially flaked off.

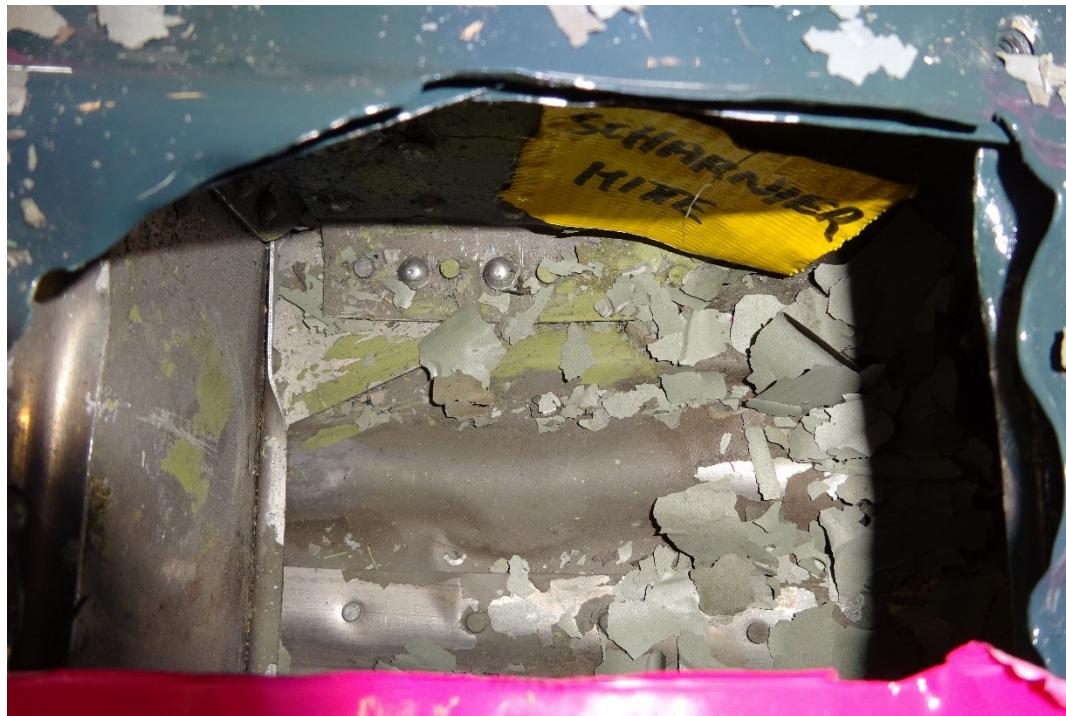
Figure 16: Flaked off anti-corrosion paint on the inside of the left elevator.

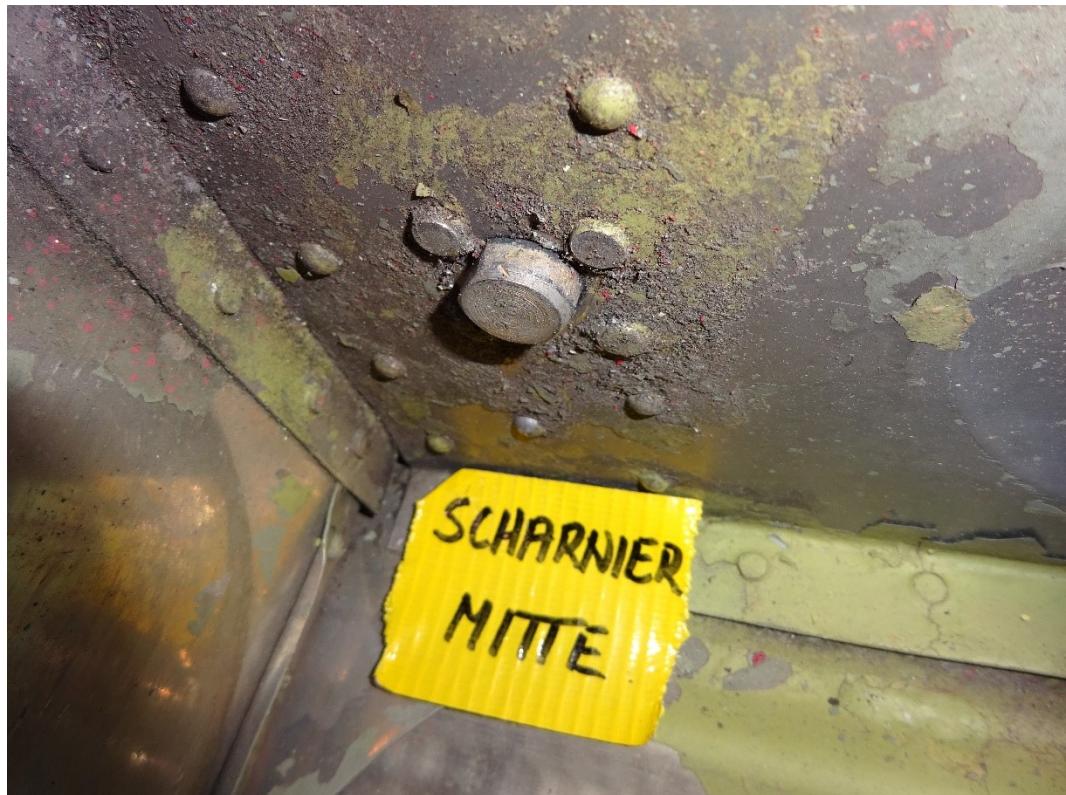
Figure 17: Inside of the rudder – head of the bolt for attaching the central hinge; lack of anti-corrosion paint; corrosion on sheet metal, rivets and bolt (label text reads central hinge).

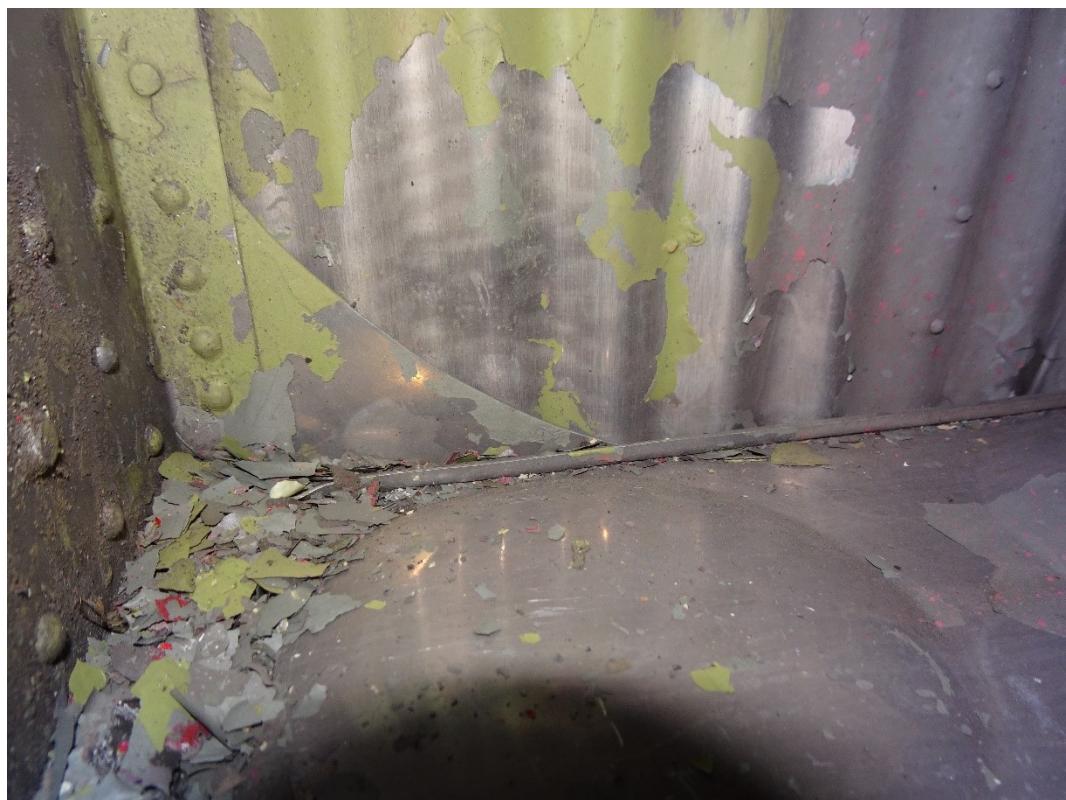
Figure 18: Flaked off anti-corrosion paint on the inside of the rudder.

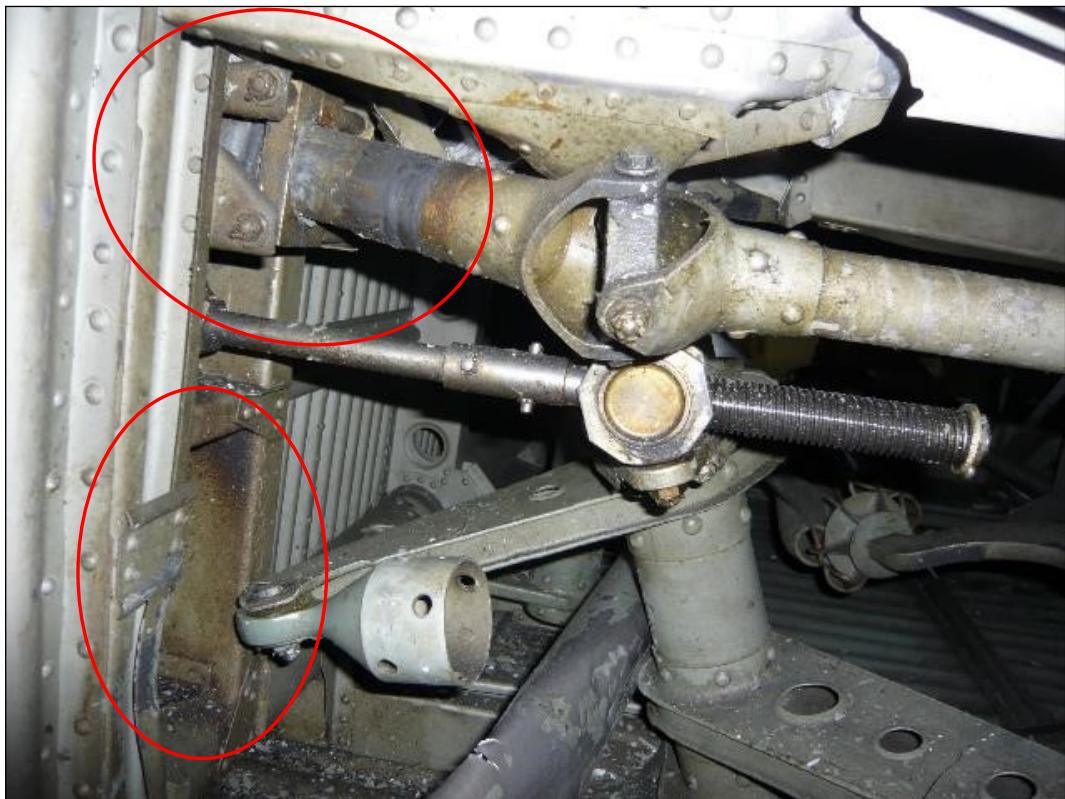
Figure 19: Corrosion (circled in red) in the centre wing and the control elements.

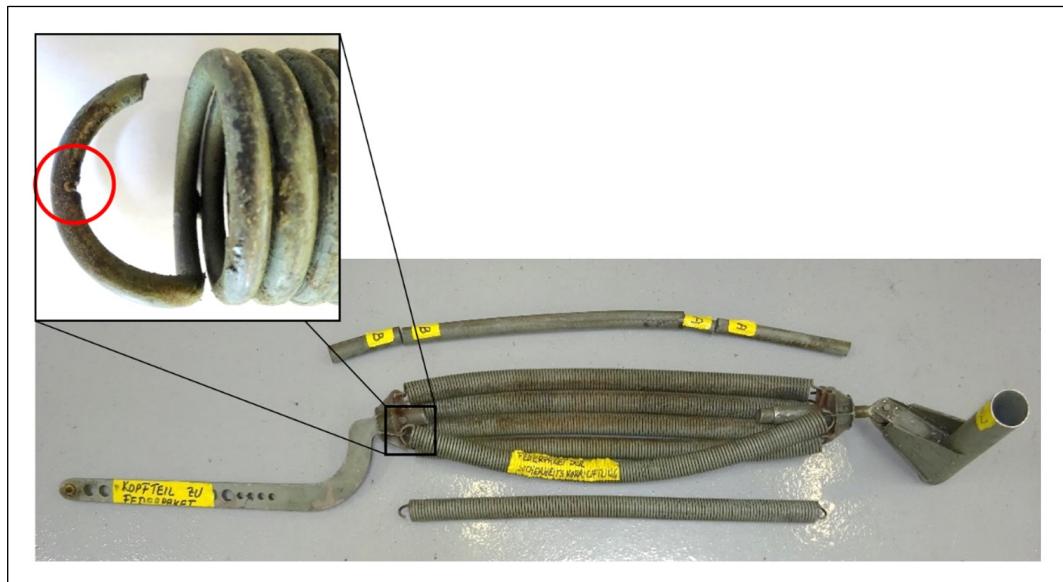
Figure 21: Spring assembly (auxiliary-wing adjustment safety device); spring hooks weakened by wear and tear.

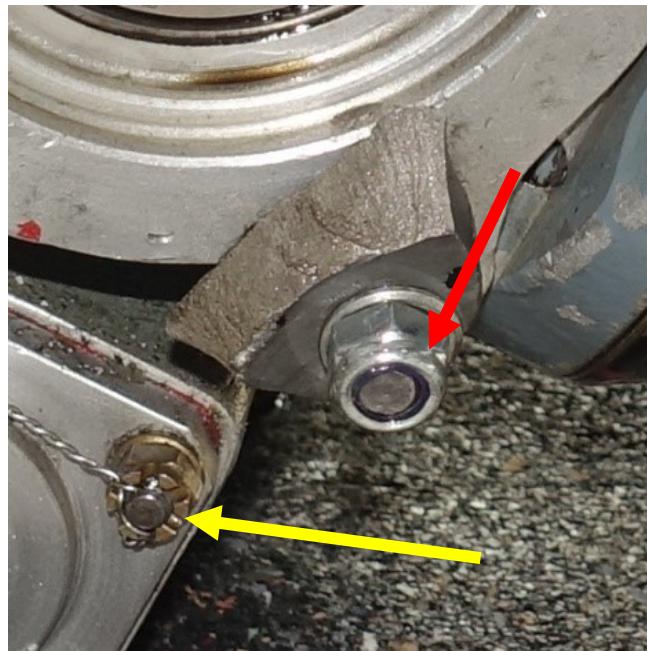
Figure 25: Engine housing – a nylon locknut (red arrow) on a bolt with a thread that is too short, and a castellated nut secured by wire (yellow arrow).

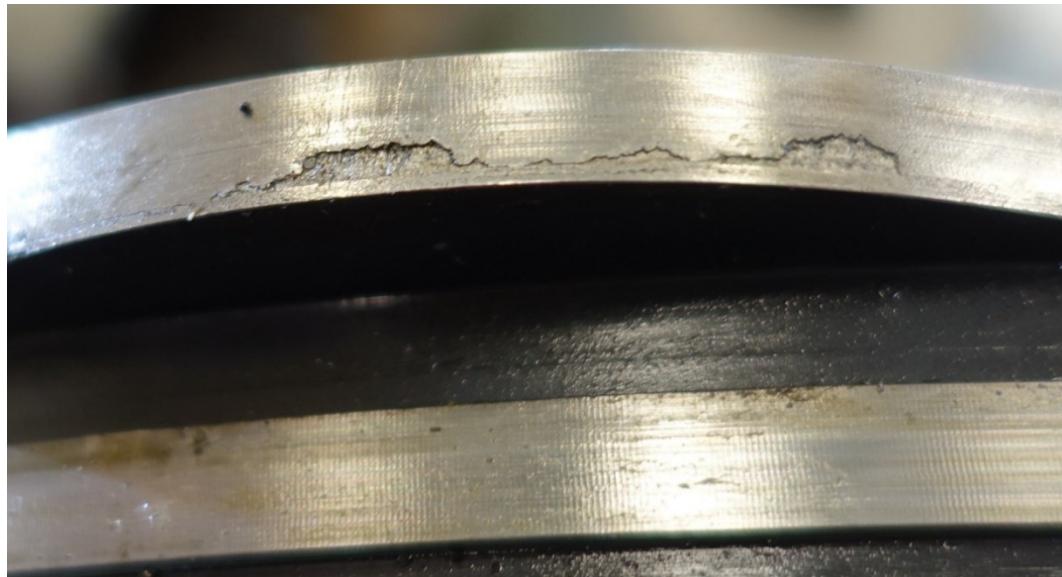
Figure 27: Cam discs from the centre engine – the machining marks (regular, finely grooved surface) and the chipping on the upper running surface are clearly visible.

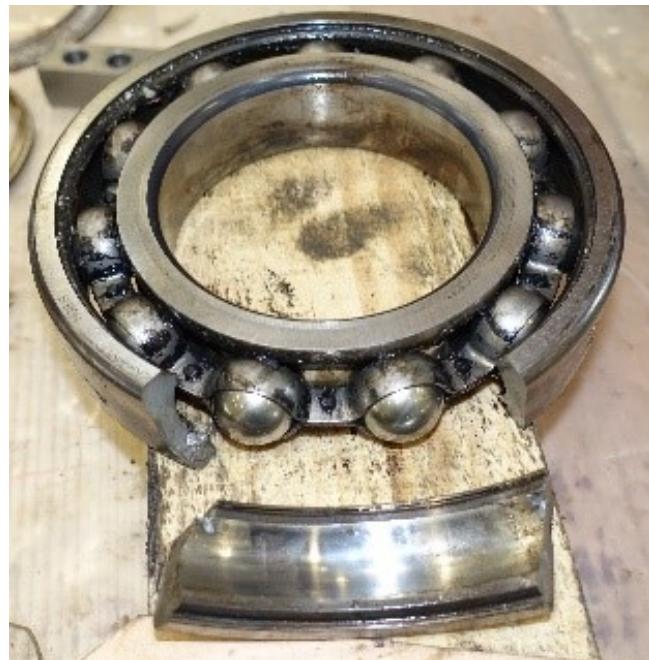
Figure 28: Broken outer race of the propeller bearing from the centre engine.

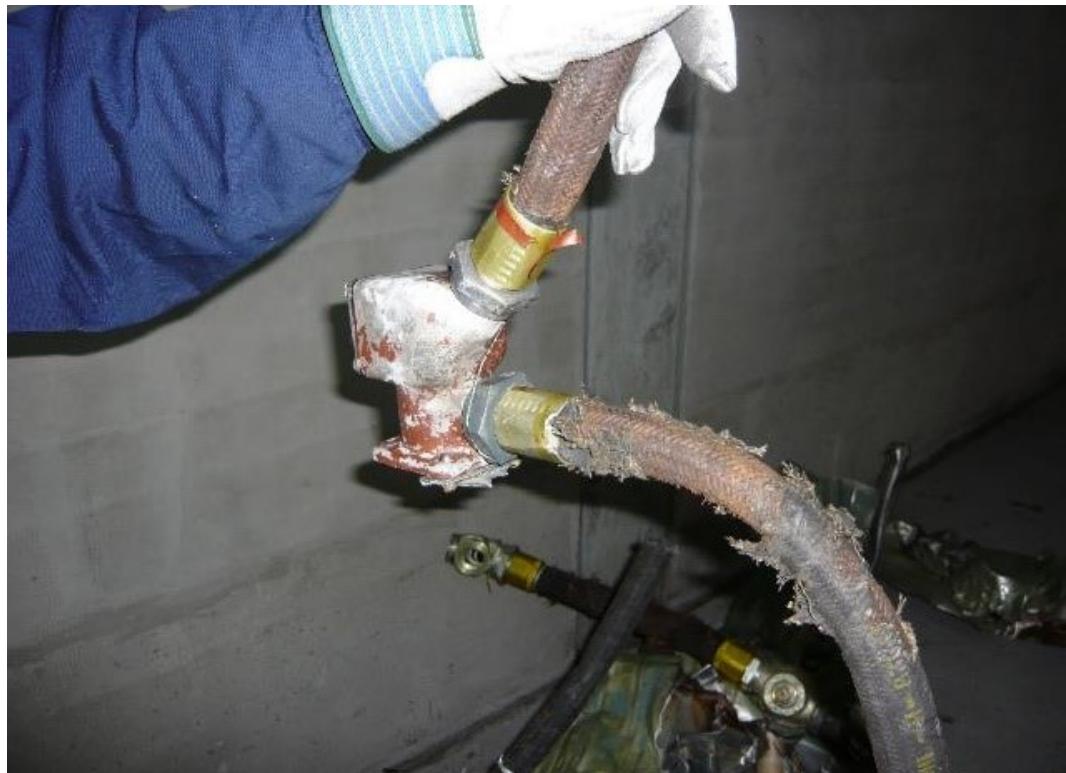
Figure 30: Lines show obvious signs of decay due to age.

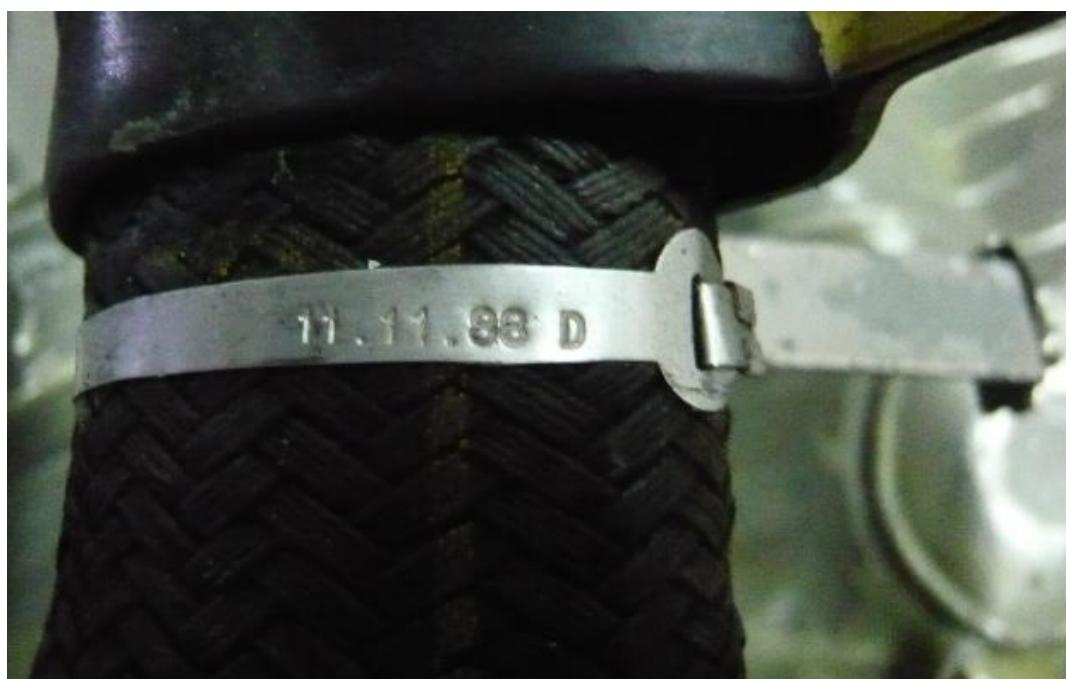
Figure 31: Hardened fuel line dated 11 November 1988.

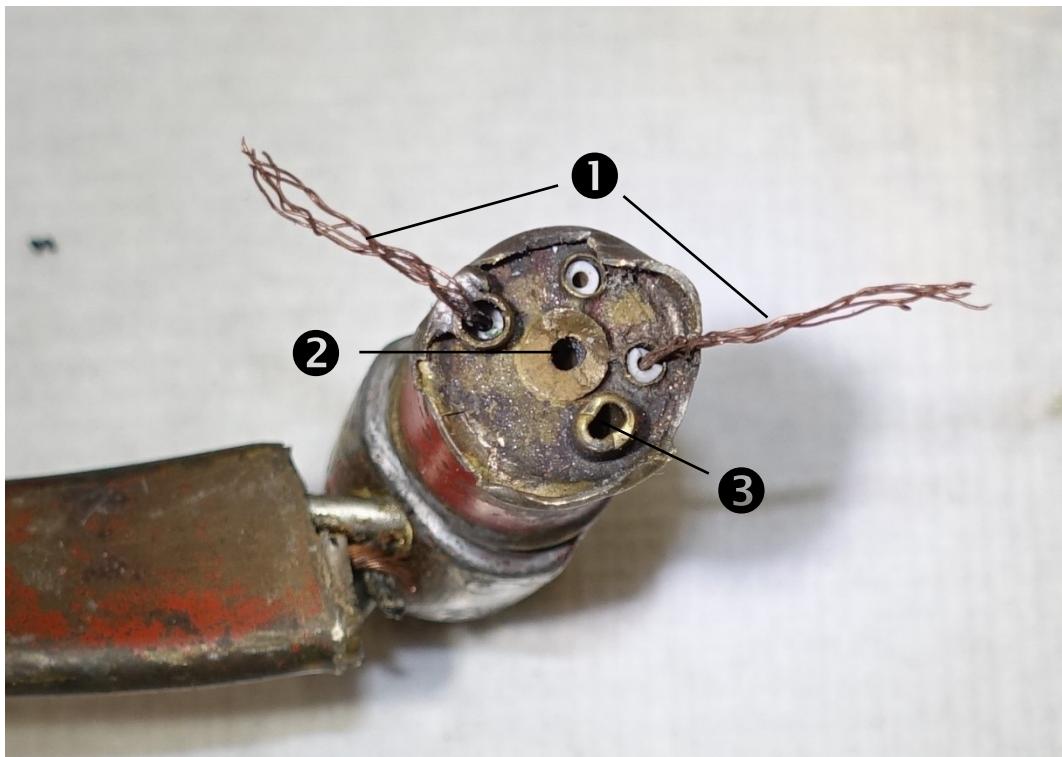
Figure 39: Severely damaged pitot tube. (1) Pitot tube heating element wires; (2) borehole for dynamic and static pressure; (3) borehole for static pressure.
