## A1. Factual information

### A1.16 Tests and research results

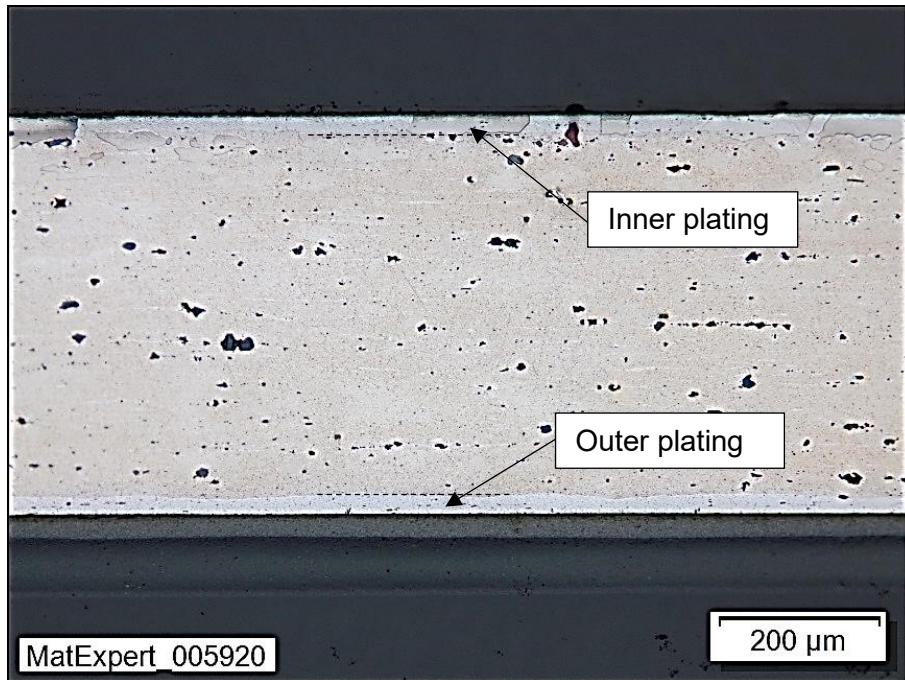
Parts of the cabin floor, stringer sections and structural parts from the aft section of the fuselage were examined. According to the OES analysis, the majority of the examined parts consist of an AlCuMg alloy and correspond chemically and materially to the aircraft manufacturer's specification. Individual parts are made of steel and were riveted to parts made of Duralumin. Sheets were found with plating on both sides (see figure 2).

**Figure 2:** Microsection of sheet with inner and outer plating.

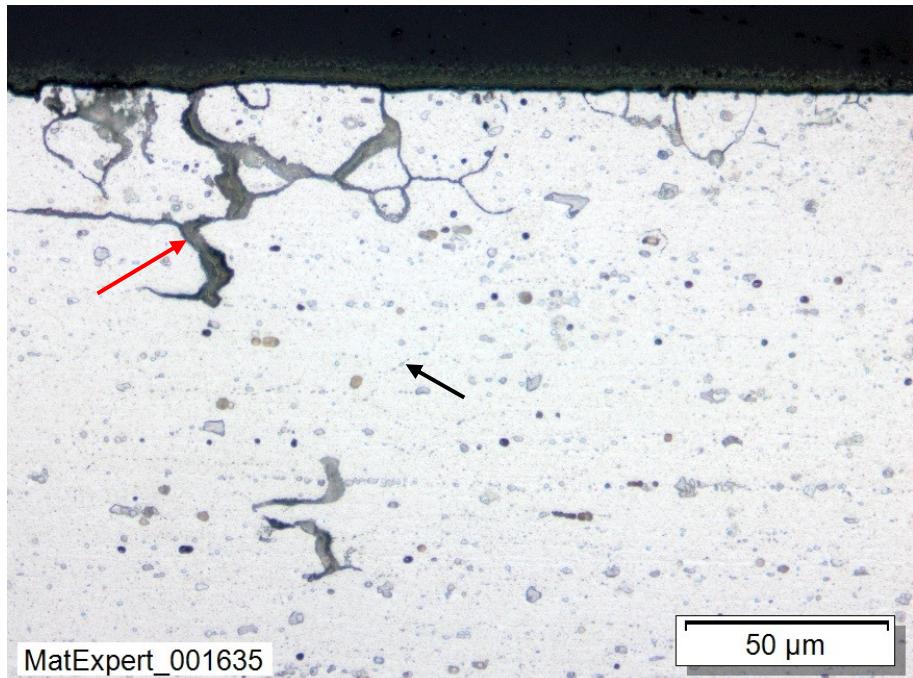
Spar section L1 (see figure 4) exhibited grain boundary precipitations (see figure 6). These precipitates were formed either by artificial ageing after solution heat treatment or by a secondary, longer exposure to a temperature of more than 120 °C. This makes the material in question susceptible to intergranular corrosion. Intergranular corrosion can develop along the detected grain boundary precipitates.

**Figure 6:** Microsection of spar section L1 – intergranular corrosion attack (red arrow) and grain boundary precipitation (black arrow).

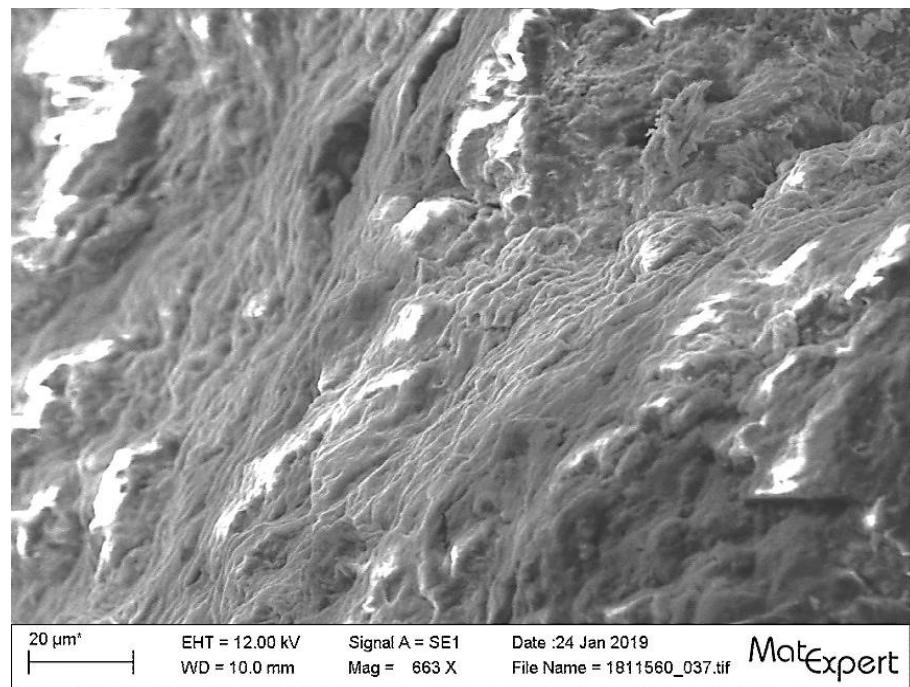
The spar tube below joint 89 was broken (see figure 7). The analysis of this fracture surface using SEM showed a ductile spontaneous fracture and a fatigue fracture with typical striations (see figure 8). The fatigue fracture accounted for approximately 10 % of the total fracture surface. Extensive corrosion damage and further cracks were uncovered in the contact area between joint 89 and the spar tube. This corrosion was intergranular corrosion resulting in a loss of wall thickness (see figures 9 and 10). One of the cracks was exposed and fractographically analysed (see figure 11). This crack was an intergranular fracture with striations, i.e. a fatigue crack (see figures 12 and 13).

**Figure 8:** Fatigue fracture with typical striations.

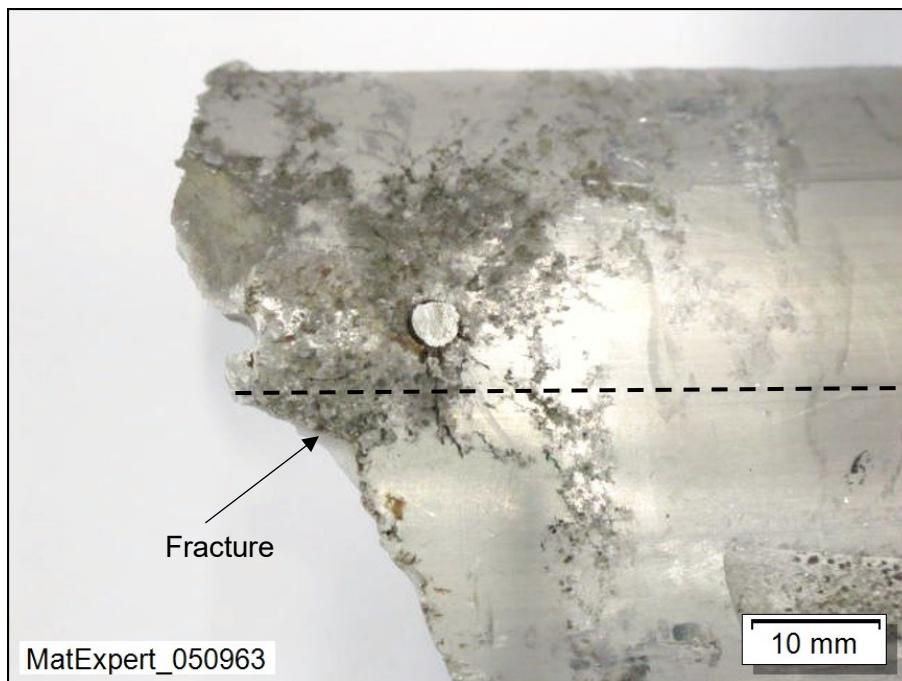
**Figure 9:** Point of corrosion with broken rivet. The black, dashed line indicates the position of the microsection.

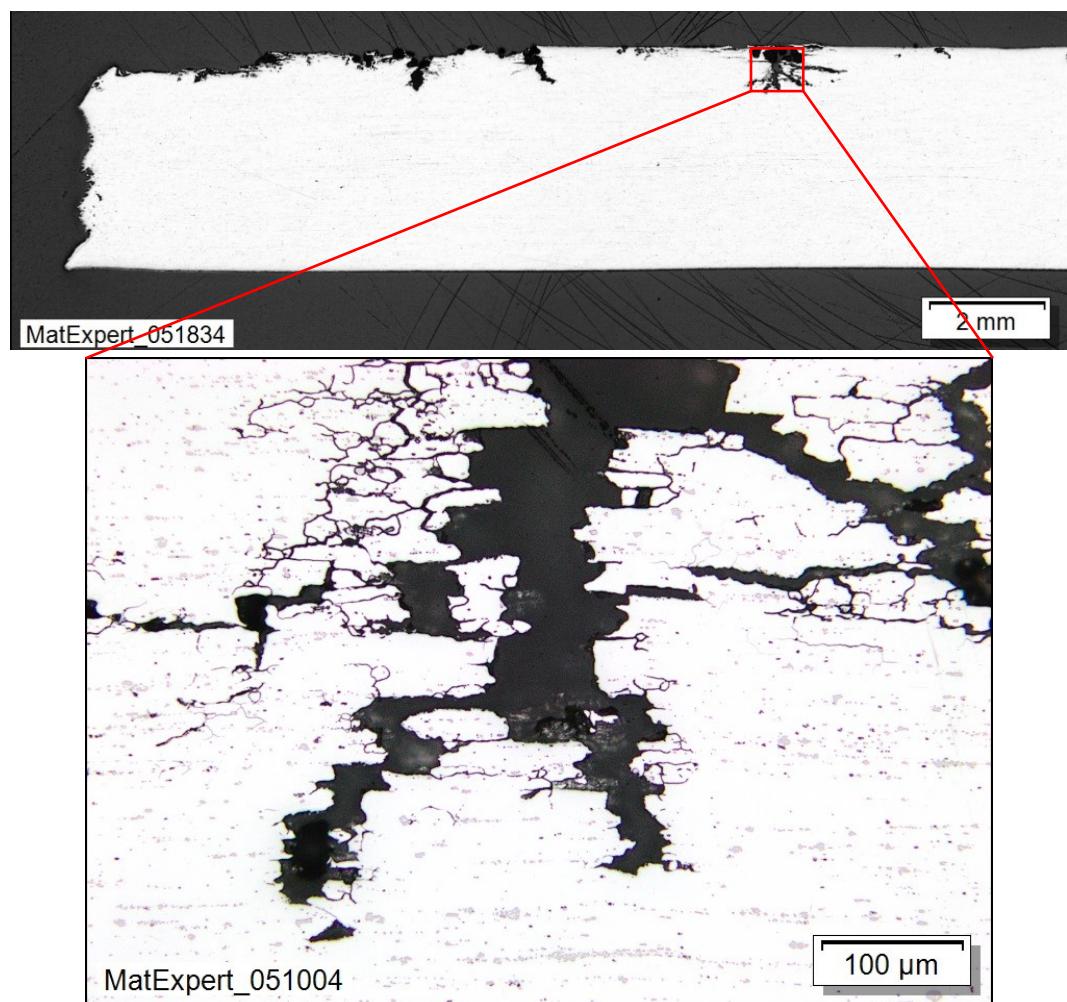
**Figure 10:** Wall thickness loss due to corrosion and intergranular corrosion.

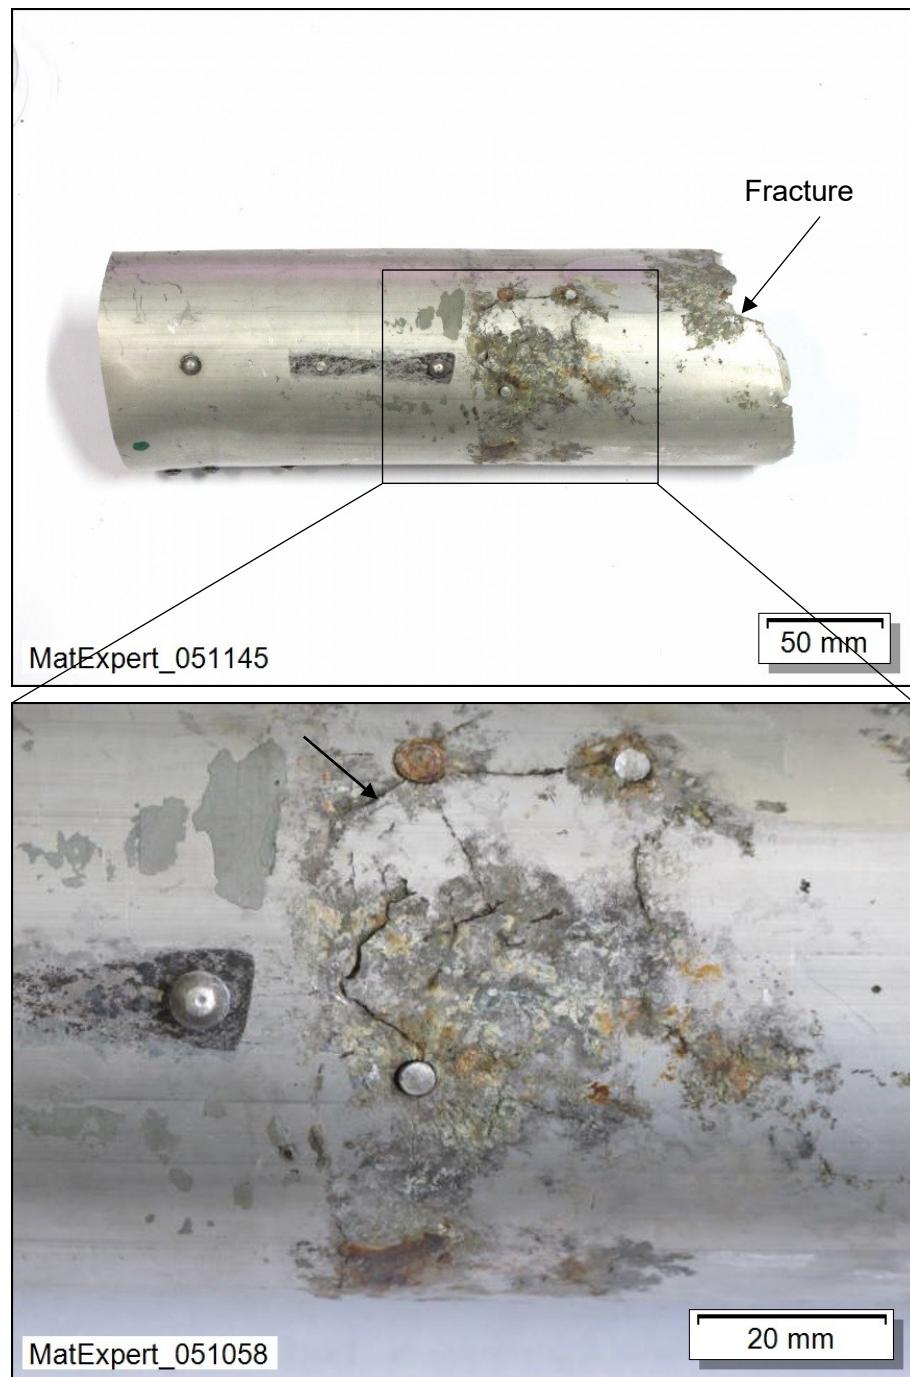
**Figure 11:** Exposed crack (arrow) under joint 89 on the lower spar section L1.

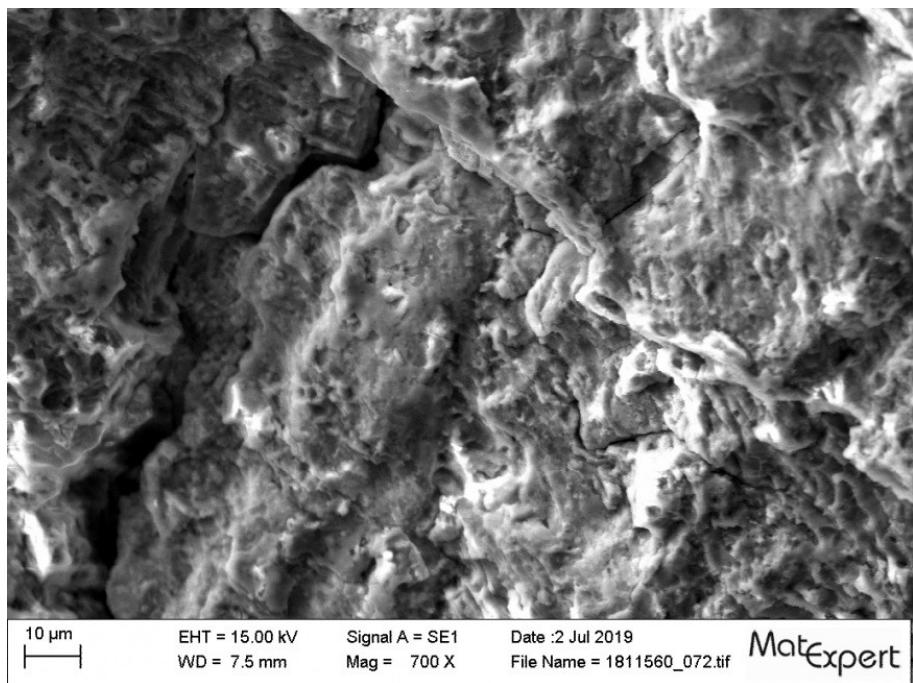
**Figure 13:** Magnified version of figure 12.

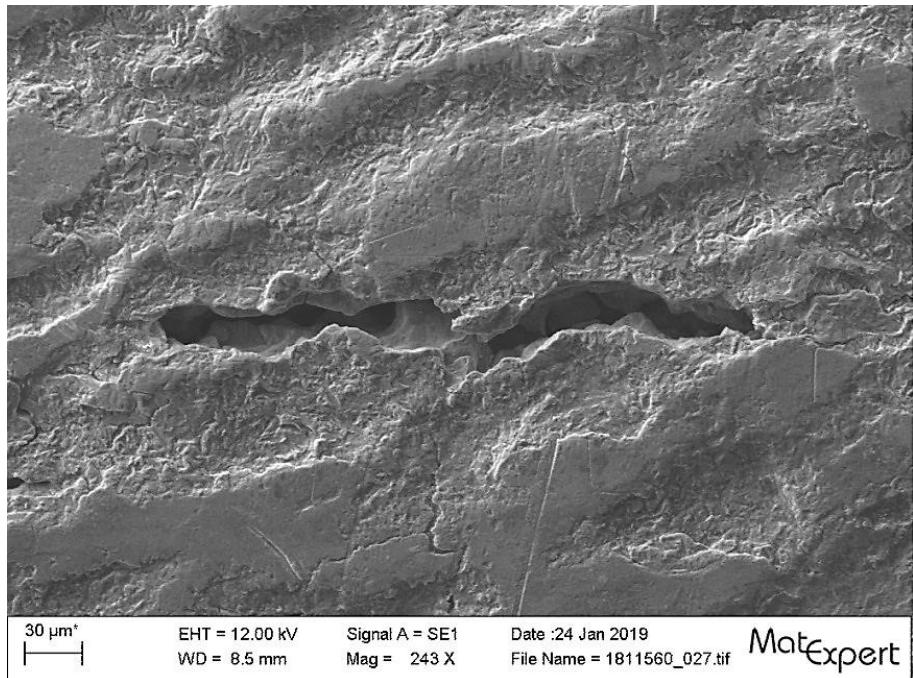
In the area where the panelling was riveted to the spars, damage similar to chafing can be seen (see figure 14). This type of wear attests that the panelling was no longer firmly attached to the spar and that the surface was severely damaged by the panelling's movement and by penetrating liquid (see figure 15). Besides general loss of material, intergranular cracks were also discovered (see figure 16). These cracks were mainly found near the rivet holes, and they can initiate fatigue cracks (see figure 17).

**Figure 16:** Incipient crack and wear due to erosion and cavitation (close-up of number (2) in figure 14).

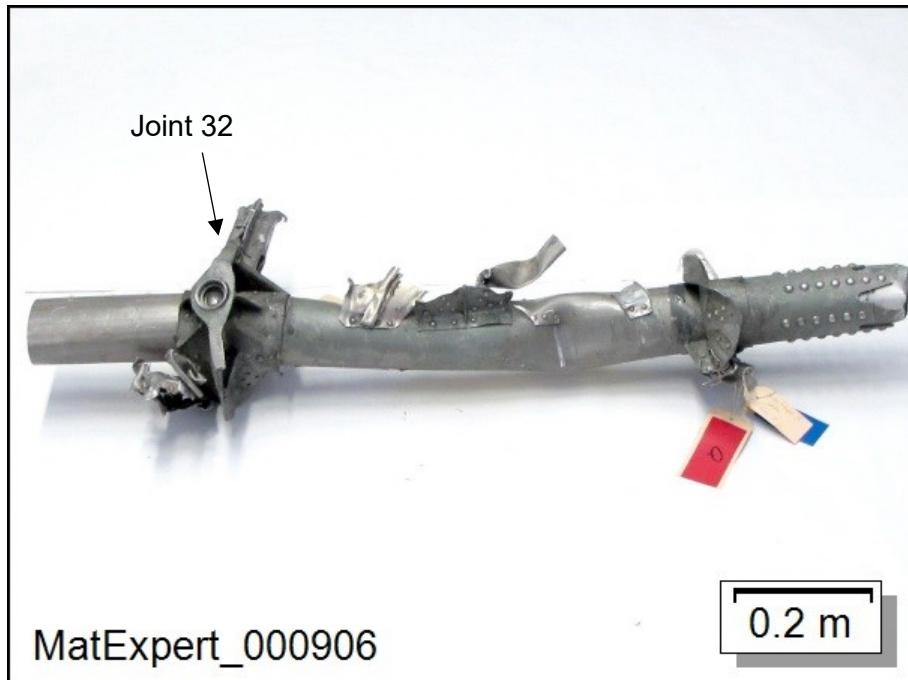
The lower spar section 1Ru (see figure 18), cut from spar I near the right engine, exhibits pitting (see figure 19). This is the typical type of corrosion for a naturally aged structure. This type of corrosion also leads, among other things, to a localised loss of wall thickness. Wear caused by the panelling is also present on this spar section.

Figure 18: Lower spar section 1Ru.

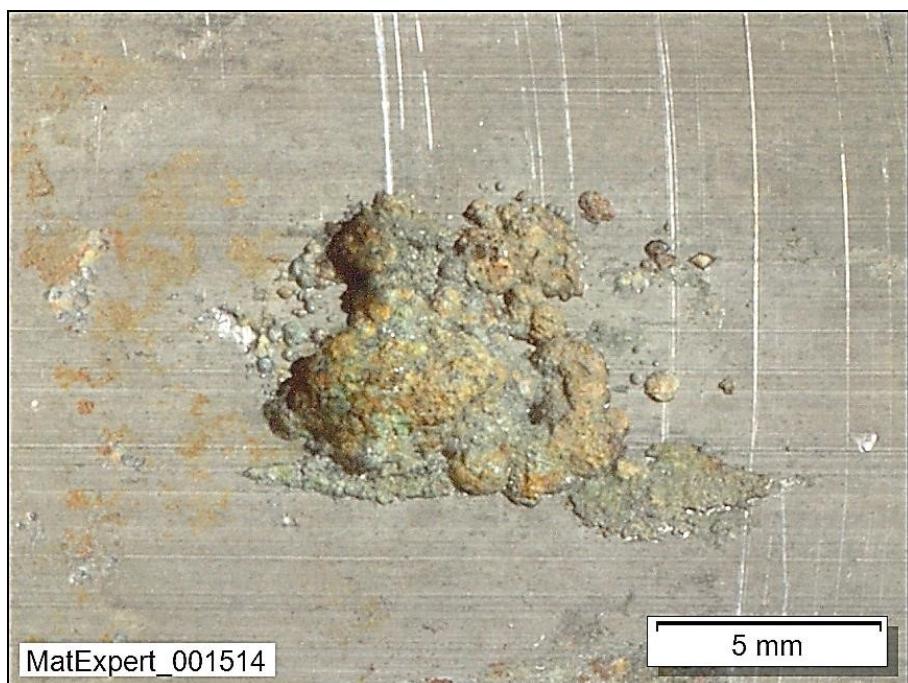
Figure 19: Close-up – pitting on the lower spar section 1Ru.

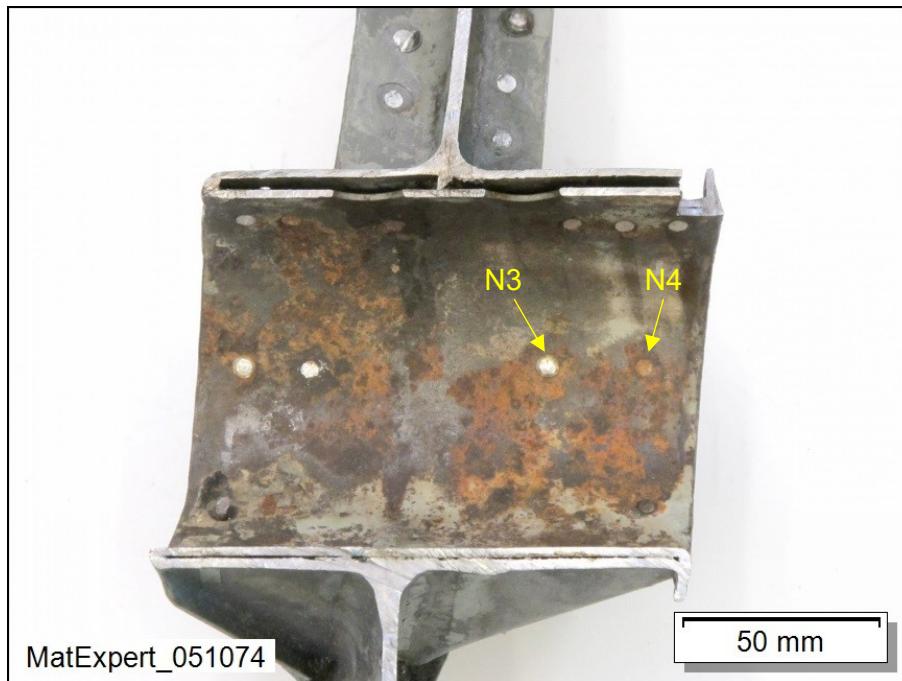
The inner tubing of the analysed joint exhibited corrosion with surface corrosion around the rivets (see figure 20).

**Figure 20:** Cut open joint 89 with rivets N3 and N4.

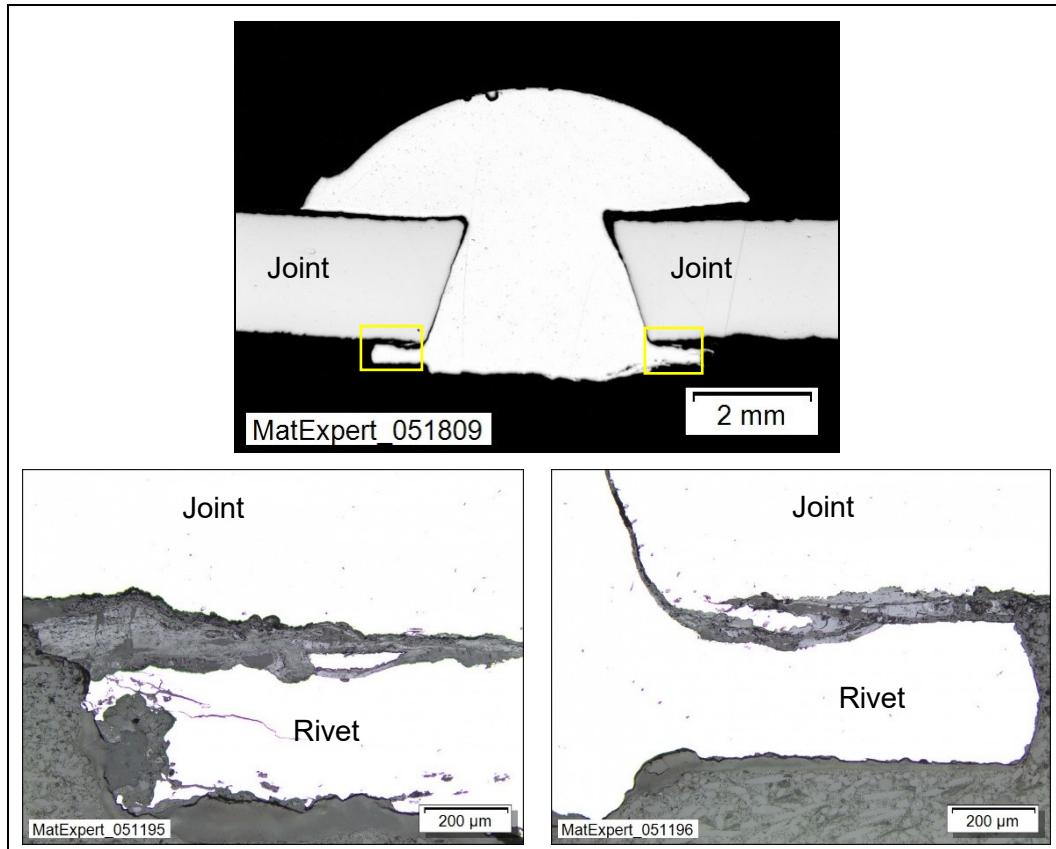
Pitting and surface corrosion can be identified in the contact area between the rivets and both the joint and spar tube (see figure 22).

**Figure 22:** Cross section of rivet N3 – pitting and surface corrosion of sheet steel and aluminium rivets.

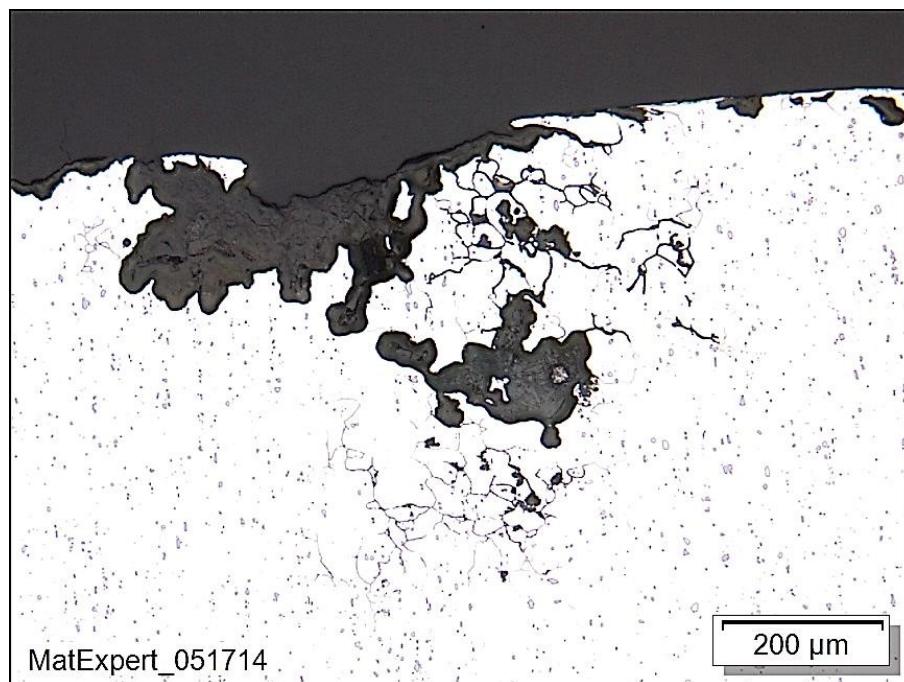
Fractures were found in the rivets which clearly occurred before the accident (see figures 23 to 25). Furthermore, intergranular corrosion was discovered (see figure 26). Fatigue and intergranular fractures were also discovered in some rivets. They can be easily distinguished from the shear fractures caused by the collision.

**Figure 26:** Close-up – intergranular corrosion on rivet N5.

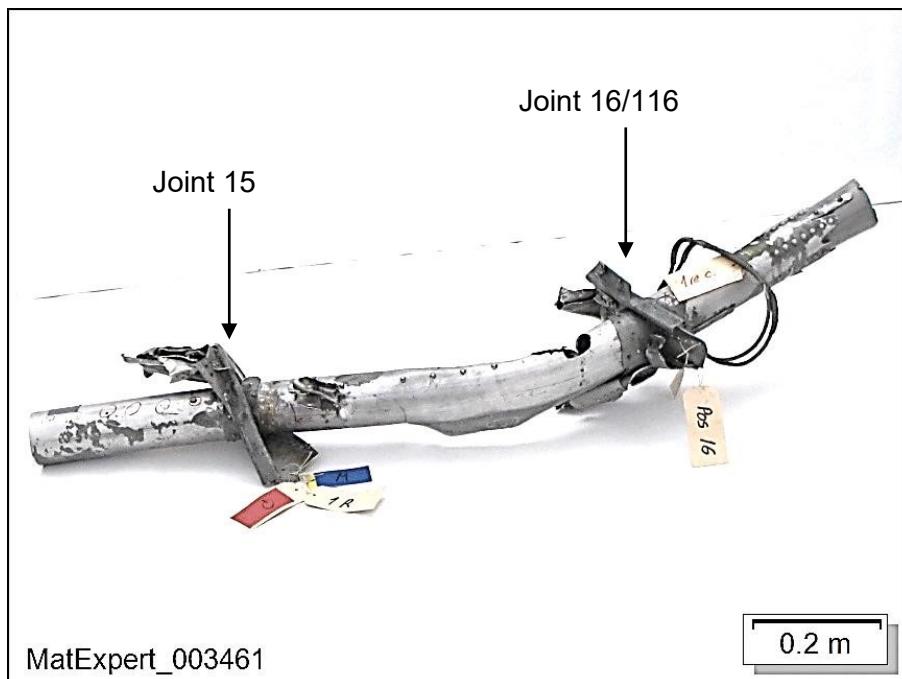
Examination of spar section A (see figure 27) shows a similar condition for the joints as those on spar section L1. In the contact areas between the joints and the spar tube, severe corrosion and cracks, old rivet fractures, impact wear, erosion and cavitation were also found on the surface of the aluminium spar tube (see figures 28 to 32).

**Figure 27:** Spar section A.

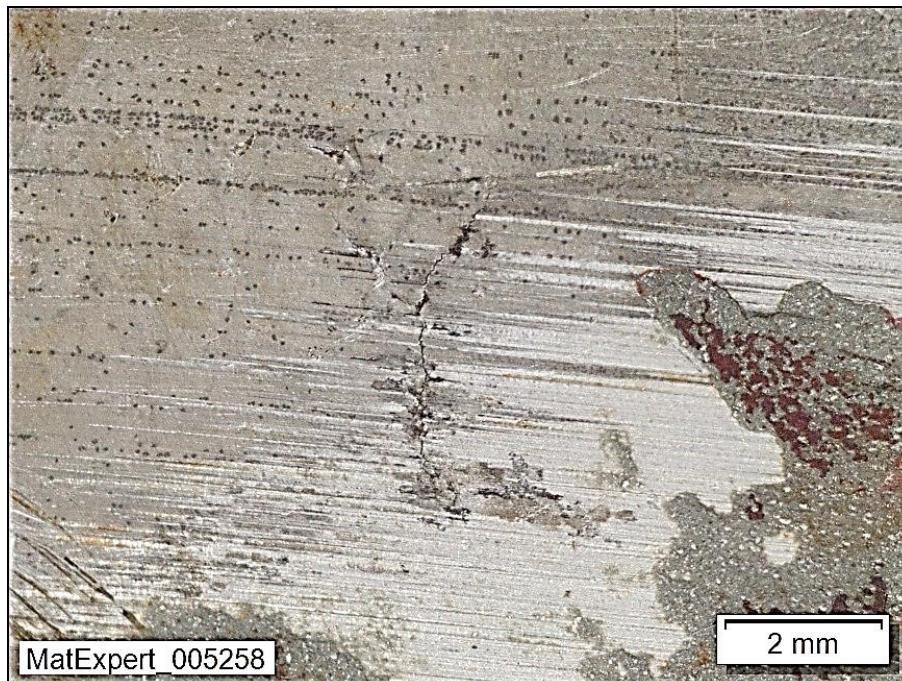
**Figure 28:** Area around joint 15 – brittle cracking, partially intergranular.

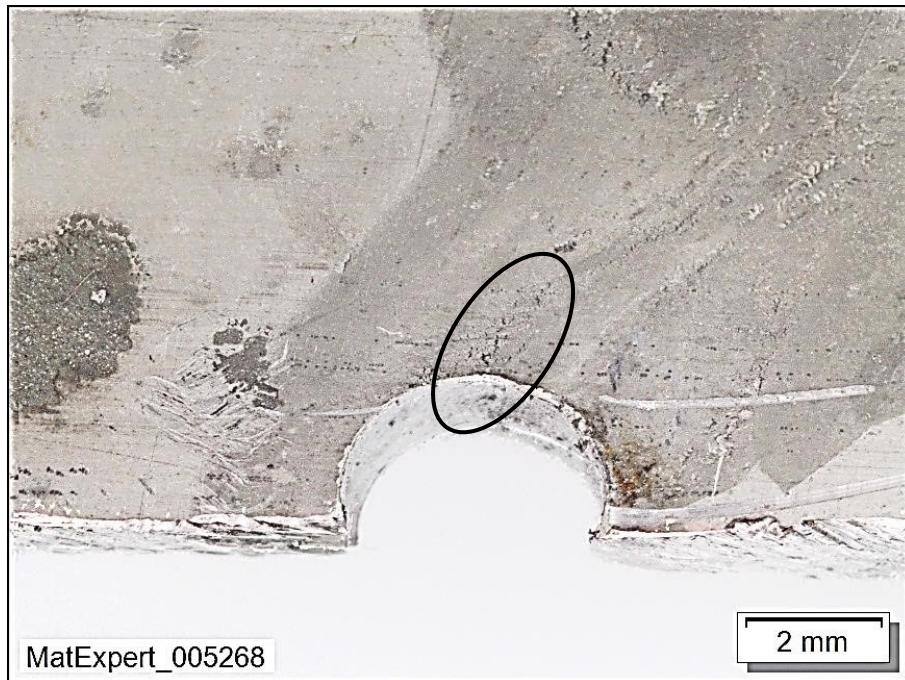
**Figure 31:** Close-up of figure 30 – start of a crack at the rivet hole (circled).

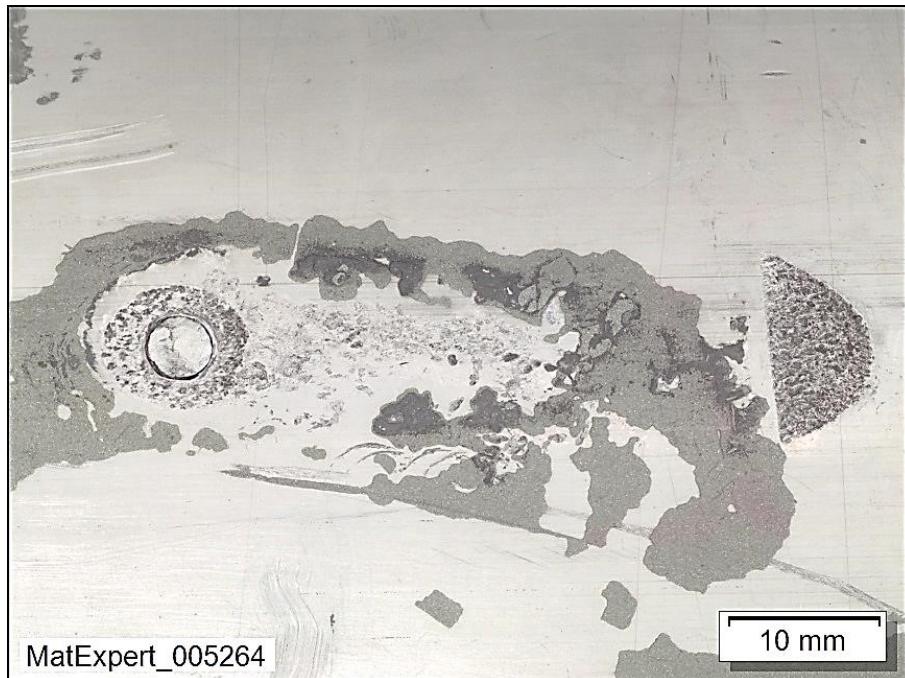
**Figure 32:** Area around joint 16/116 – pre-existing broken rivet and impact wear, erosion and cavitation on the spar tube.

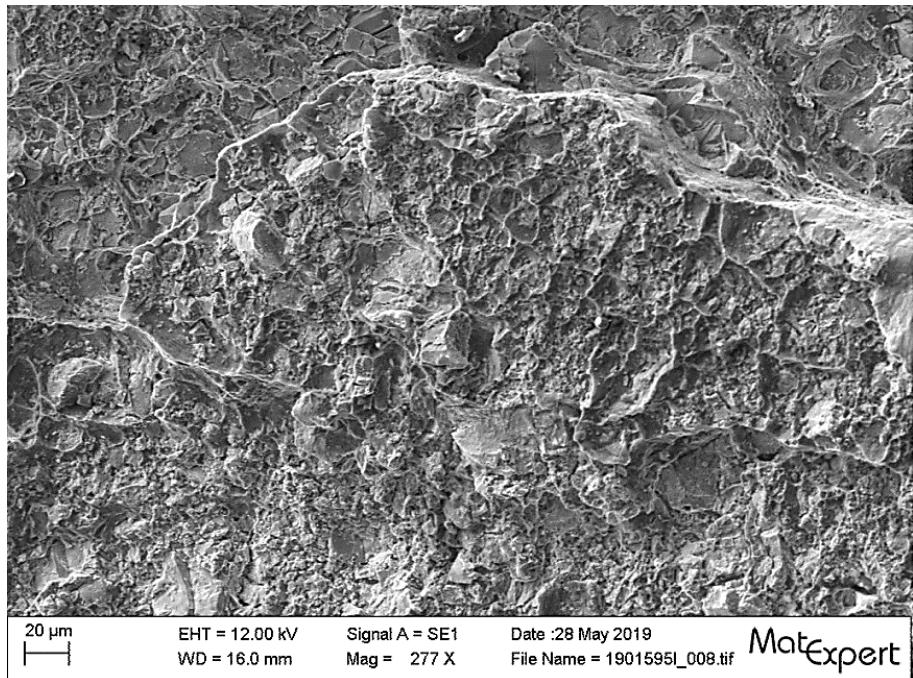
A fracture surface from the centre engine mount (see figure 33) was microfractographically analysed using SEM (see figure 34). The fracture was identified as a brittle, spontaneous fracture exhibiting a mixed fracture pattern of honeycomb, quasi-cleavage and intergranular fractures across a wide area (see figure 35). The intermetallic phases are clearly visible in the fracture pattern and are partially surrounded by roundish cavities. The localised 'terracing', which is a defect, is striking (see figure 36). On the fracture surface, a localised fatigue fracture-like formation can be seen (see figure 37).

**Figure 35:** Mixed fracture featuring honeycomb and quasi-cleavage fractures.

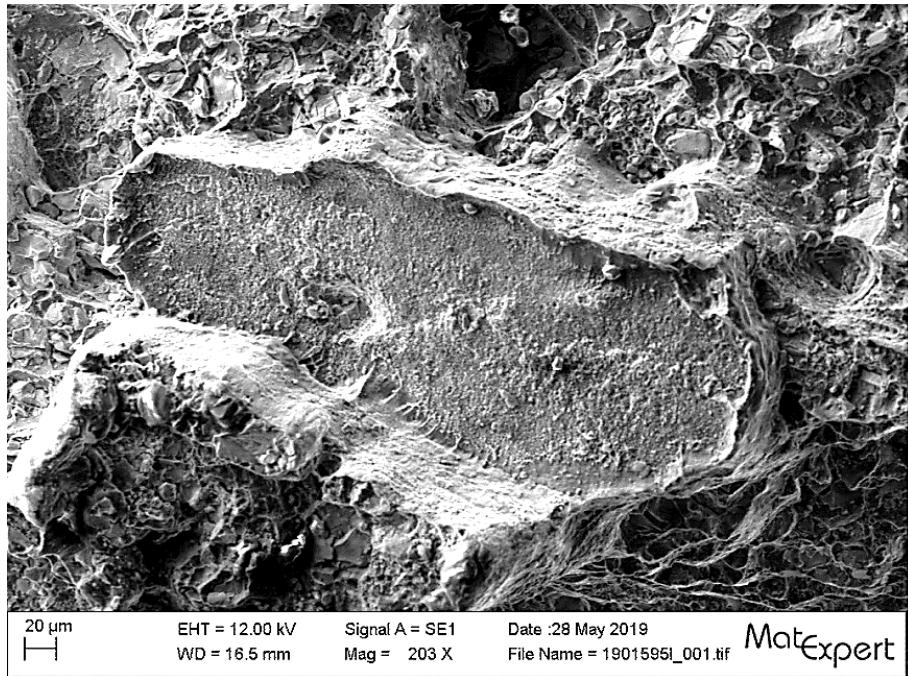
**Figure 36:** Defect in the form of a terrace, with oxide skin.

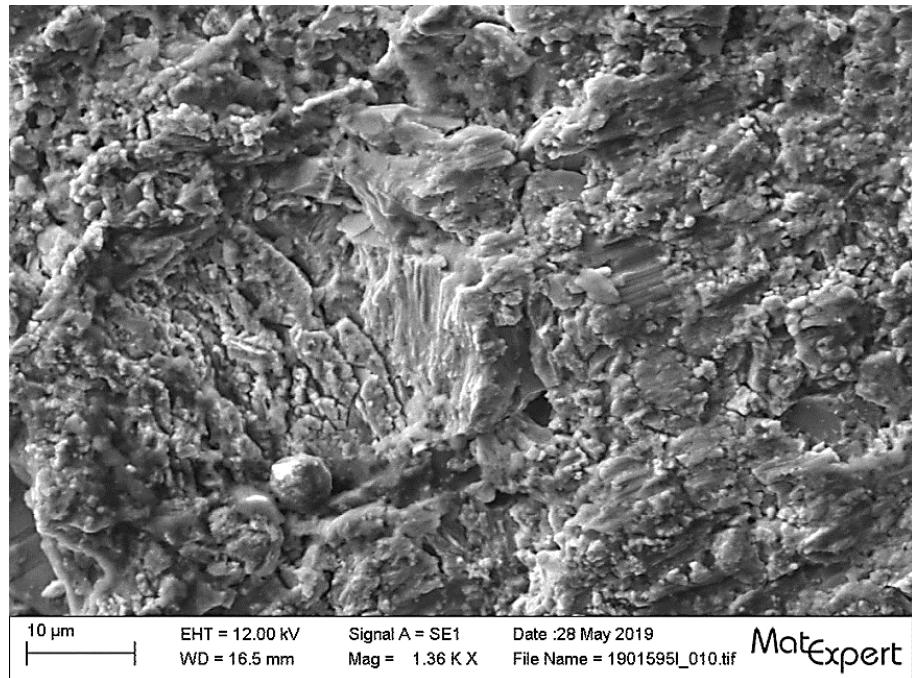
**Figure 37:** Fine, fatigue crack-like secondary cracks.

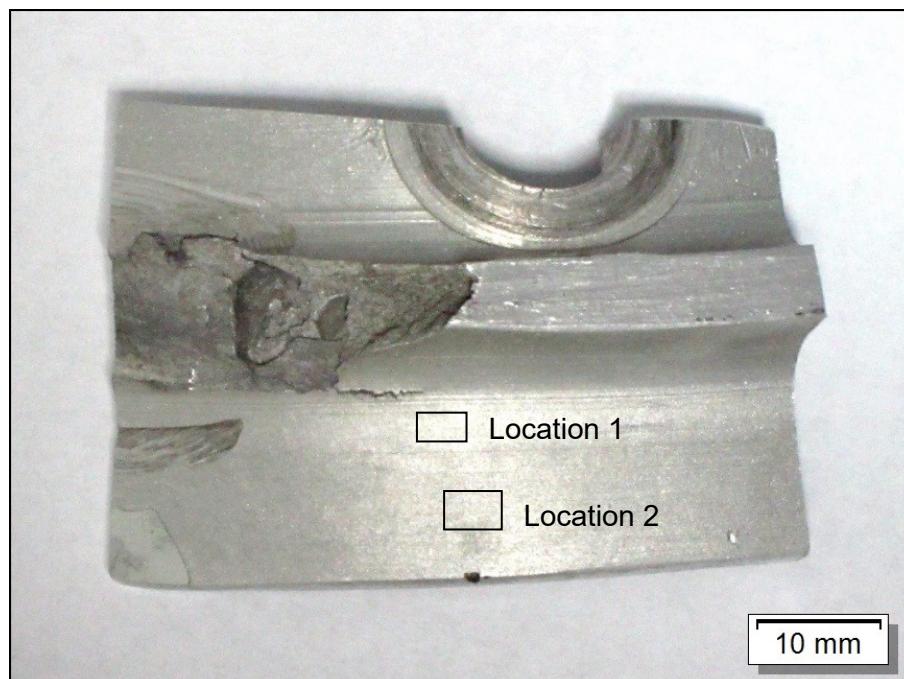
The centre engine mount is assumed to have been shot-peened. In addition, many small cracks can be seen on the surface (see figures 38 to 42). It is not possible to determine when these cracks were formed. The crack depth was not measured.

**Figure 38:** Segment of the centre engine mount – locations of the examined surfaces.

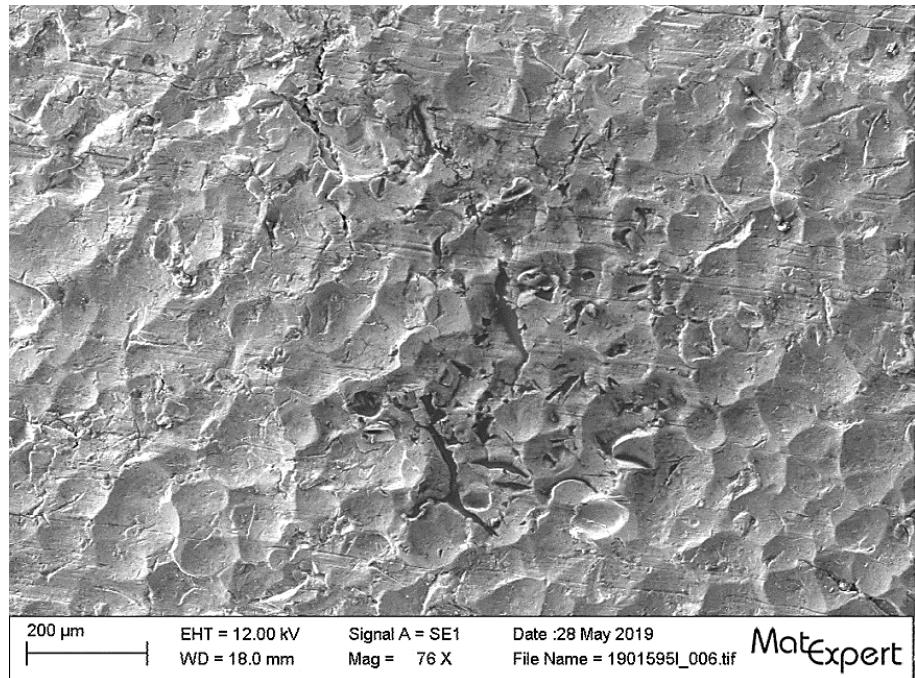
**Figure 39:** Close-up of location 1 – shot-peened surface with cracks.

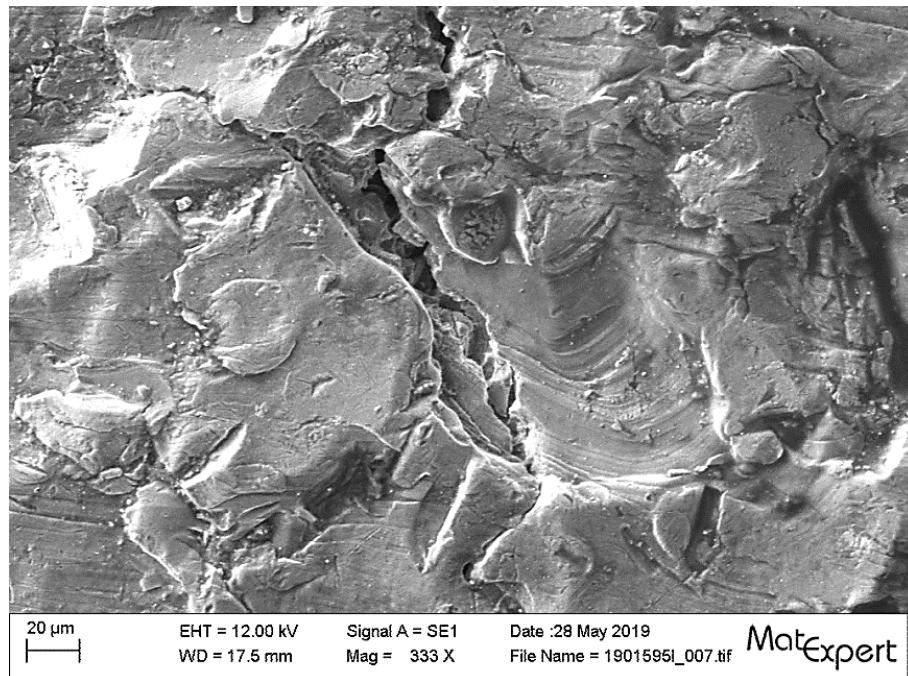
**Figure 40:** Magnified version of figure 39.

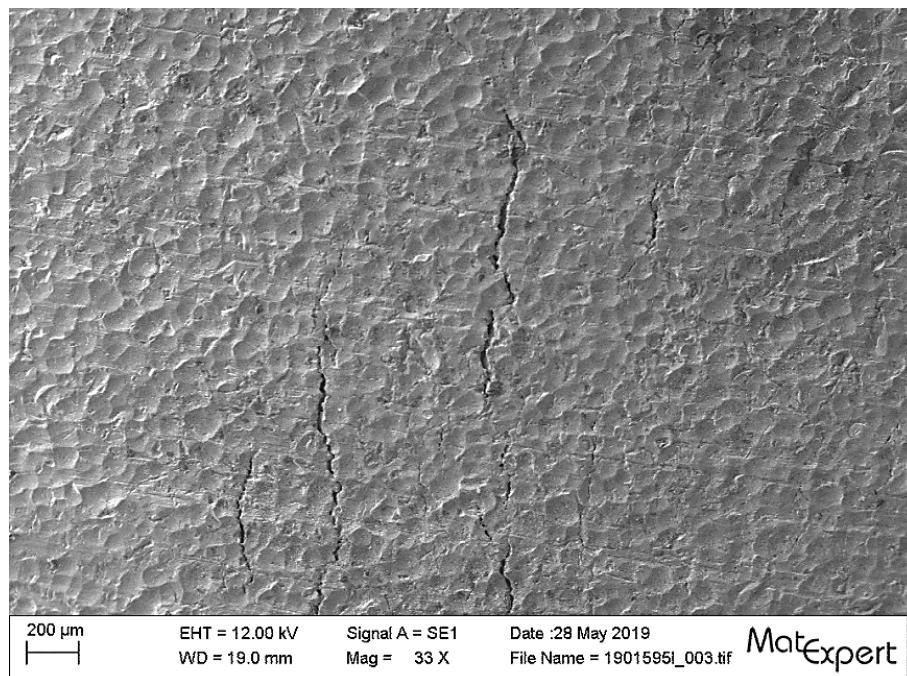
**Figure 41:** Centre engine mount, location 2 – shot-peened surface with cracks.

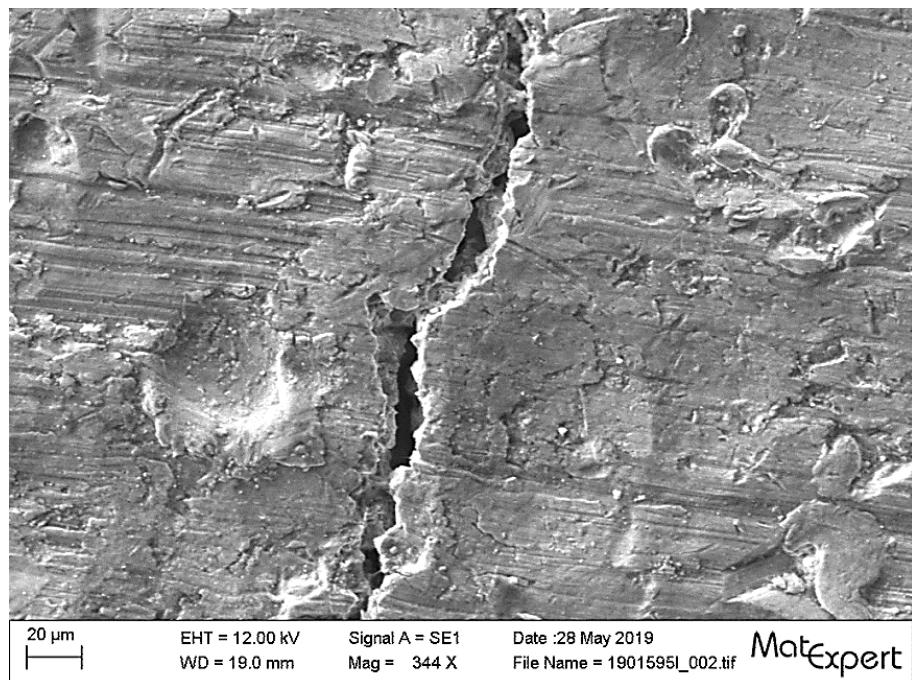
**Figure 42:** Magnified version of figure 41.

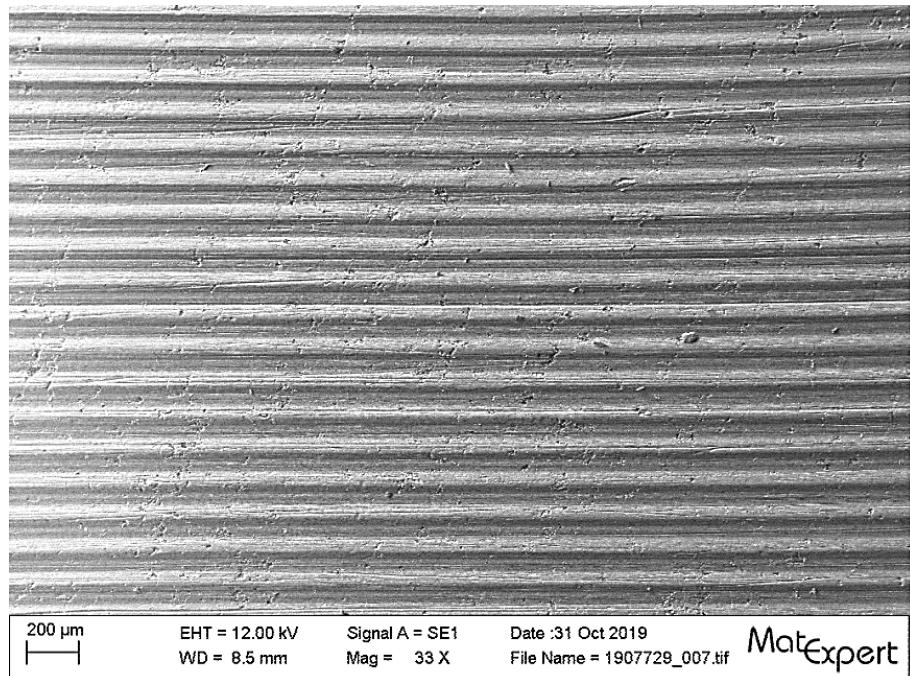
The distinct marks found on the surface of the right engine mount indicate that it was machined (see figure 43). No signs of shot peening and no surface cracks were found.

**Figure 43:** Right engine mount – existing, distinct machining marks (from turned surface).

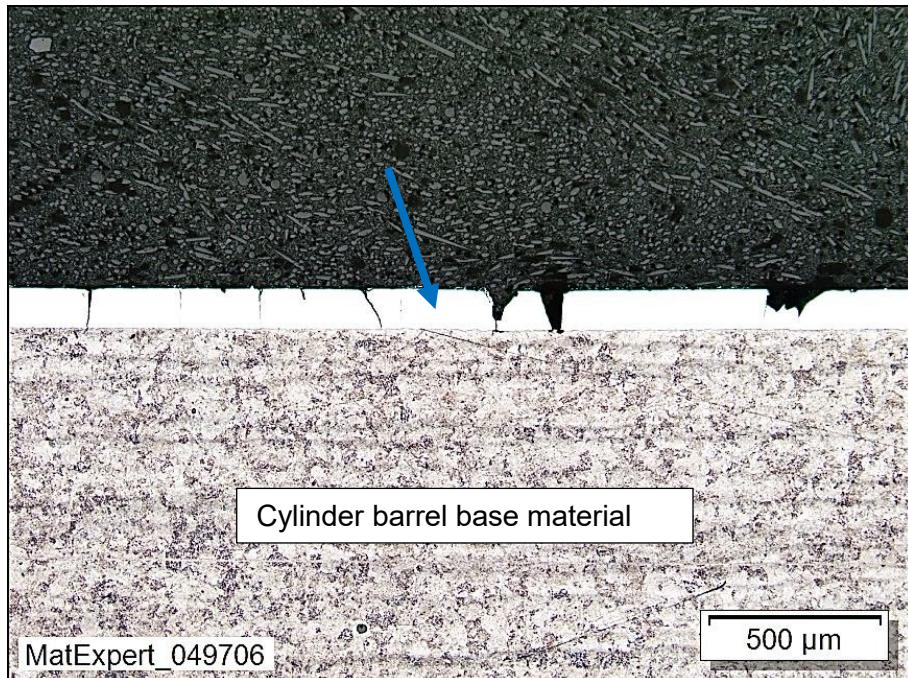
The examined cylinder from the left engine as well as that from the centre engine has been hard-chrome plated (see figure 44). The thickness of this plated surface is 0.121 and 0.123 mm respectively. It features peeling and has cracks covering the surface like a net, which can be seen with the naked eye. The cracks detected are typical for these kinds of coating and are a result of the process used. The chrome plating is extremely hard, the measured value HV0.3 is between 775 and 820.

**Figure 44:** Microsection of the cylinder wall (left engine, cylinder 5) including hard-chrome plating (blue arrow), network of cracks and peeling.

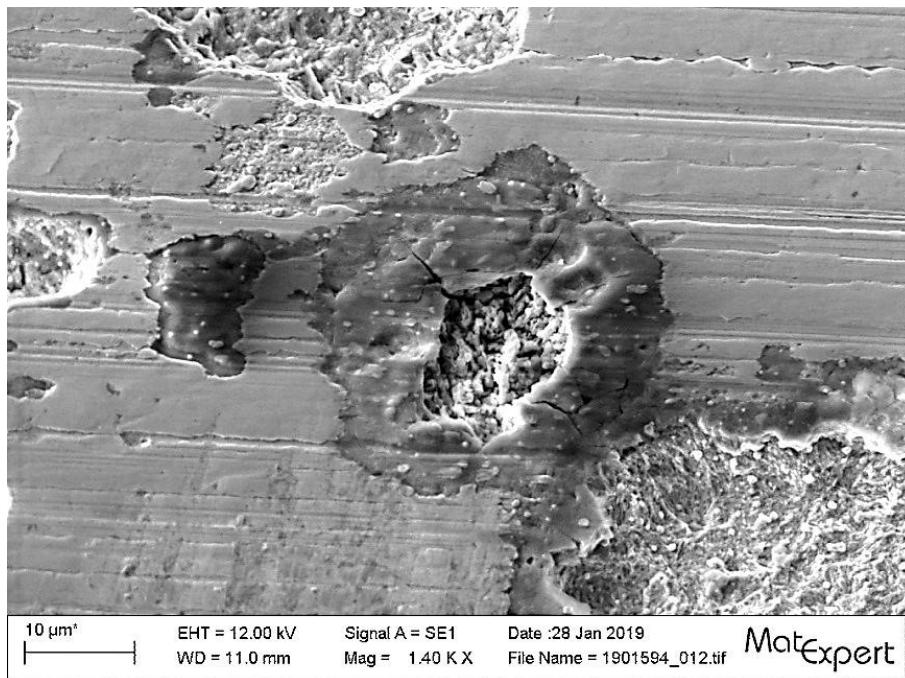
**Figure 49:** Ball bearing from the right engine, inner-race bearing track – material chipping and corrosive damage.

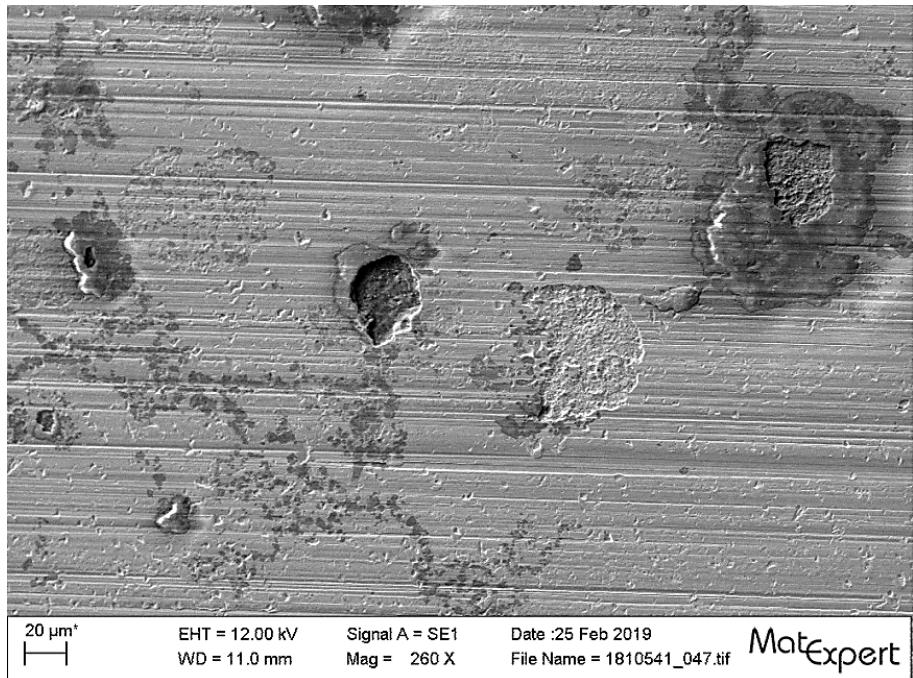
**Figure 50:** Ball bearing from the left engine, inner-race bearing track – material chipping, corrosion and minor pitting.

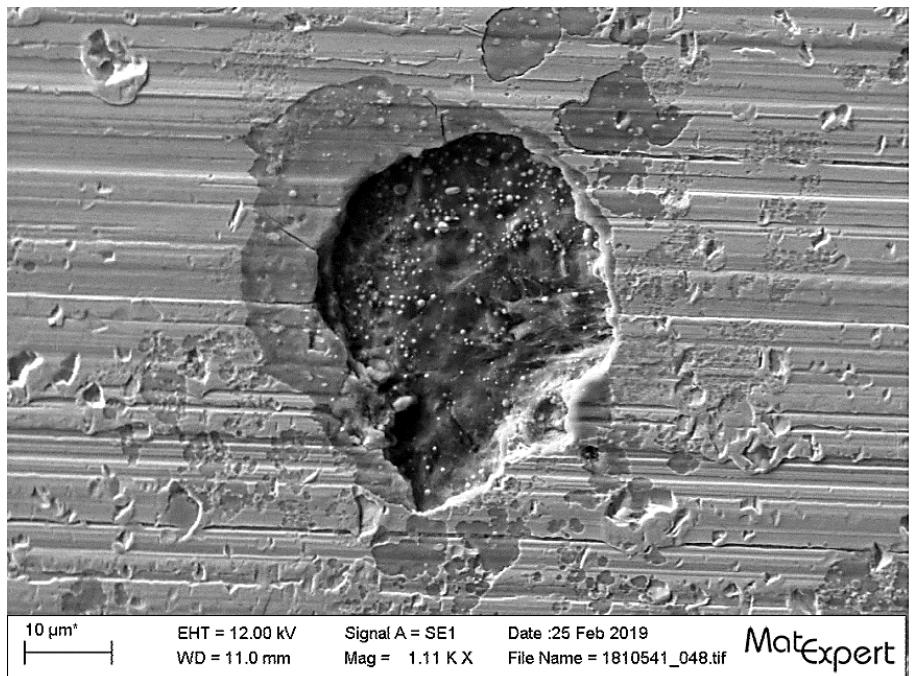
**Figure 51:** Close-up of figure 50.

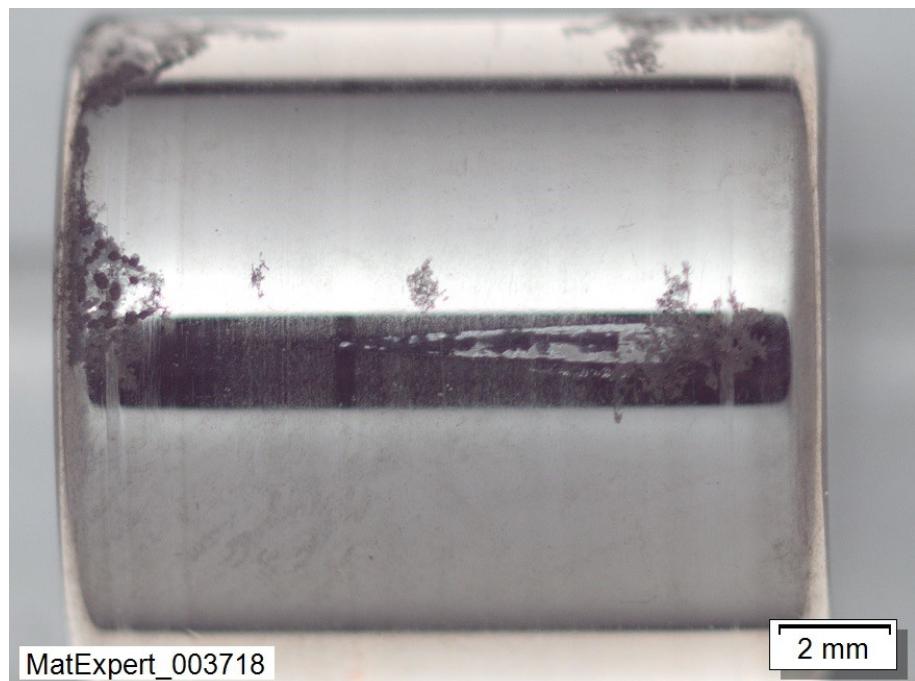
**Figure 54:** Bearing no. 3 – cylindrical roller with wear.

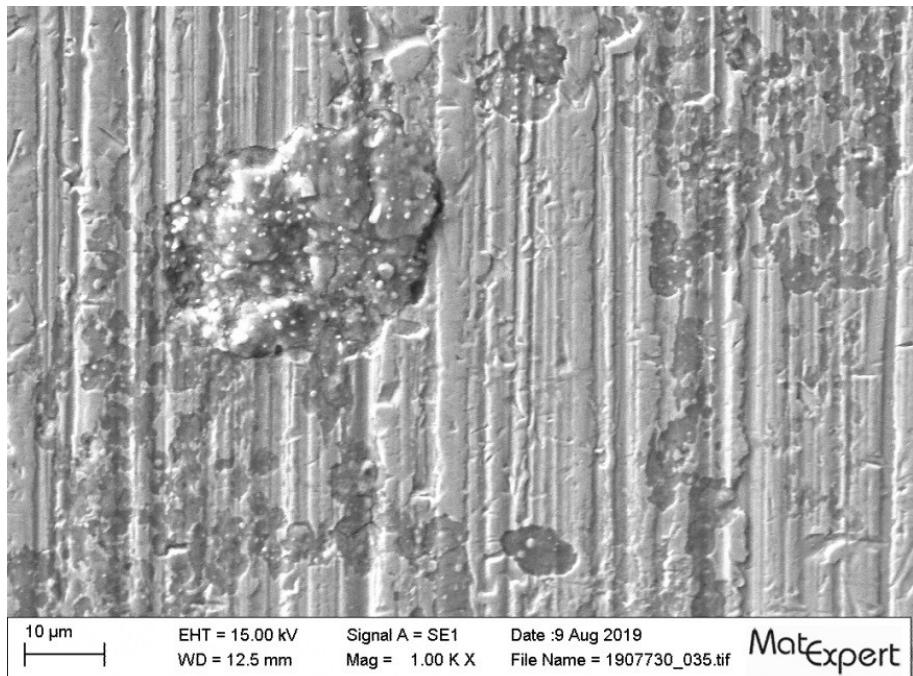
**Figure 58:** Bearing no. 3, outer-race bearing track – flat-rolled corrosion and abrasive wear.
