## A1. Factual information

### A1.16 Tests and research results

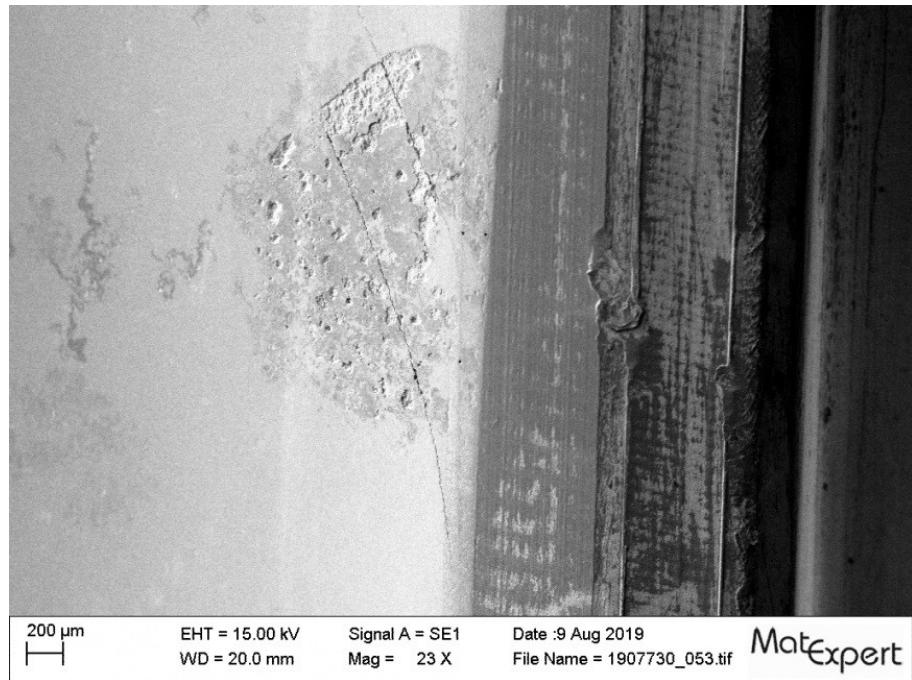
**Figure 59:** Bearing no. 4, outer-race bearing track – damage due to material chipping and cracks.

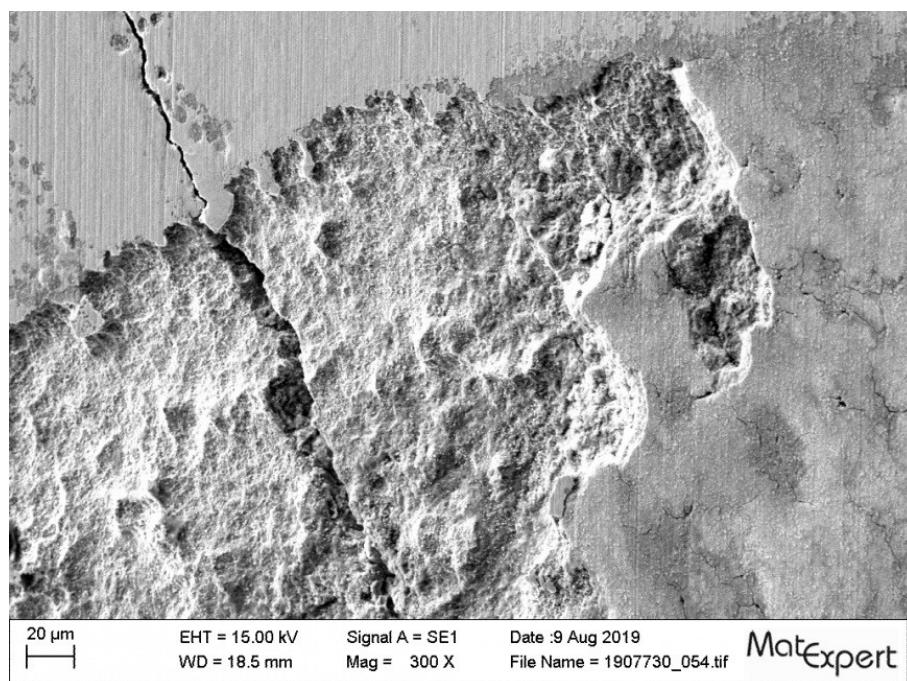
**Figure 60:** Close-up of figure 59.

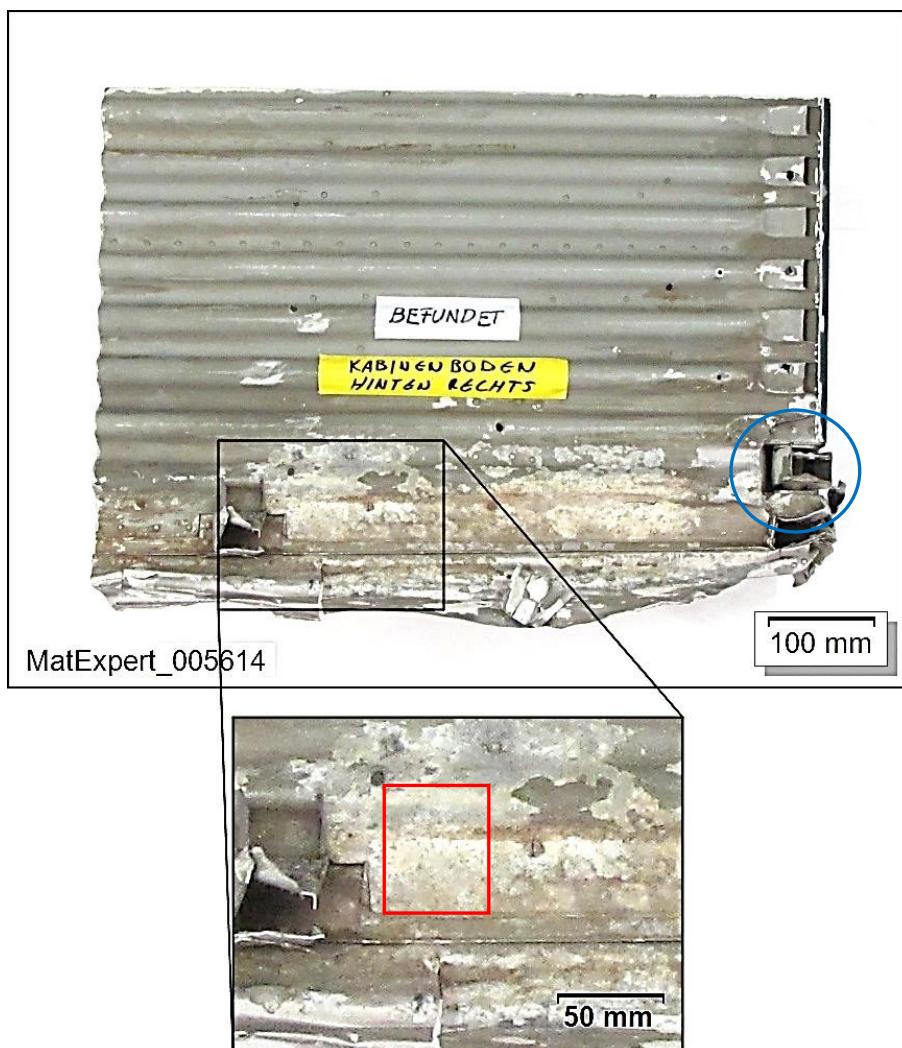
The sheet metal of the cabin floor near the aft hinge of the cargo door exhibited cracks, pronounced intergranular corrosion and pitting. In parts, the sheet was affected all the way through (see figures 62 to 64).

**Figure 62:** Corroded cabin floor from the aft right area (label text reads cabin floor, aft right). Samples were taken from the zone marked in red for the subsequent microsections. The blue circle marks the cargo door's aft hinge.

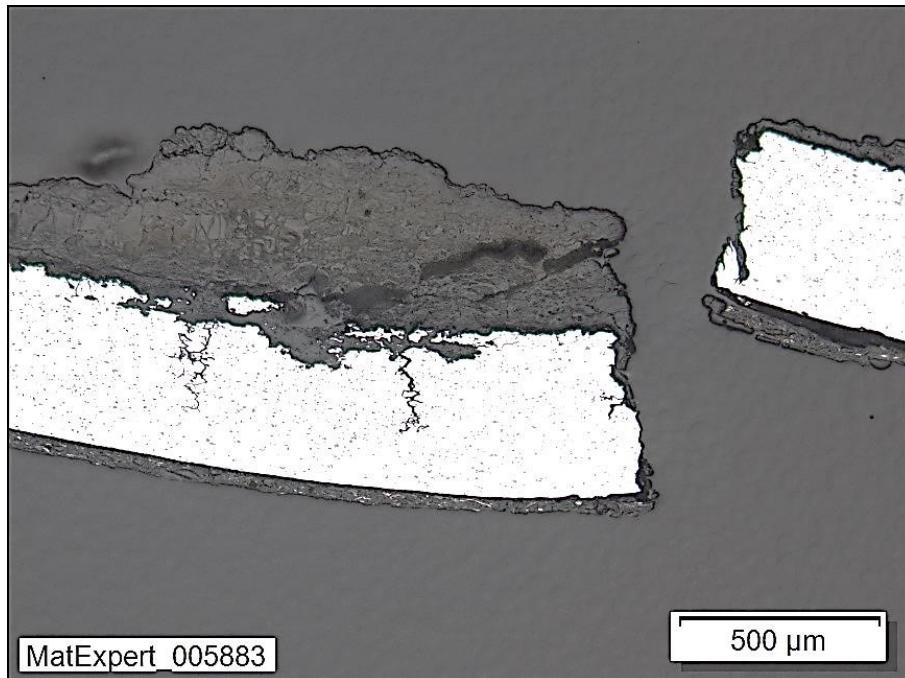
**Figure 63:** Microsection of the corroded sheet. Cracks with intergranular corrosion.

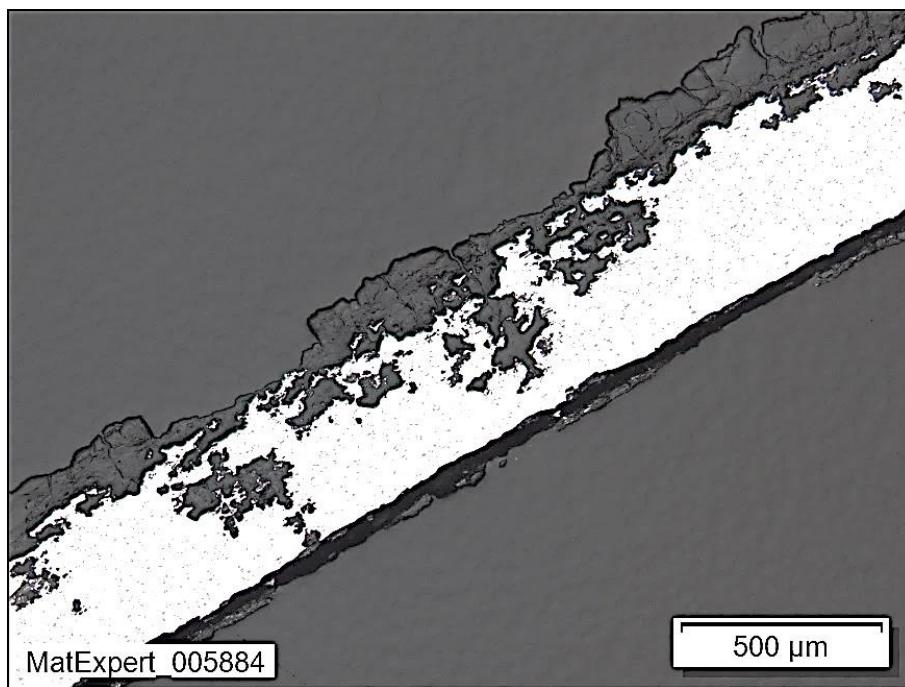
**Figure 64:** Microsection of the corroded zone; intergranular corrosion and pitting.

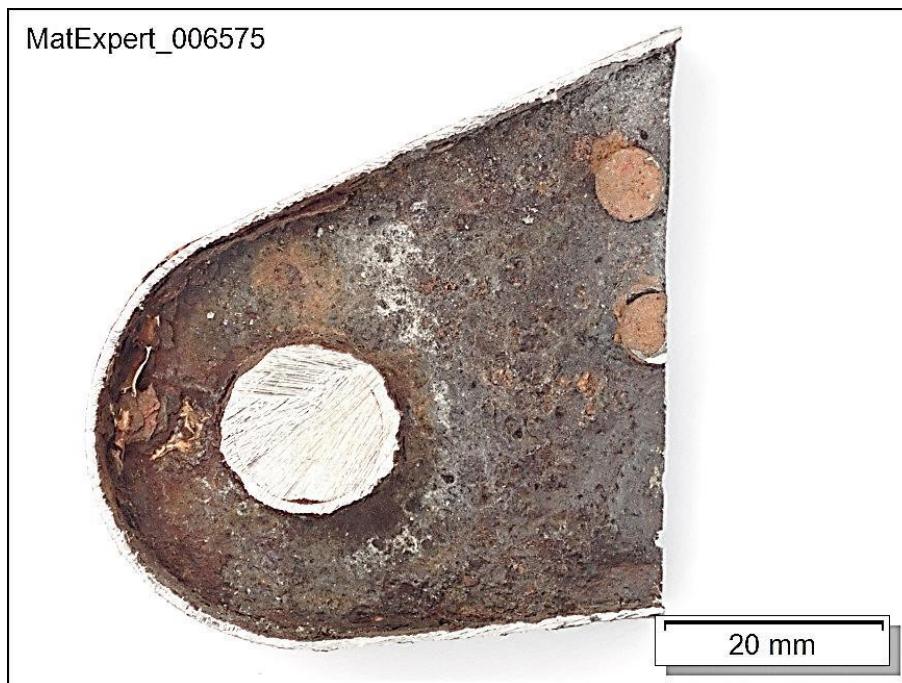
The hinge of the cargo door made of steel was severely corroded. Some of this corrosion was very advanced (see figure 65).

**Figure 65:** Severely corroded inner side of the cargo door hinge.

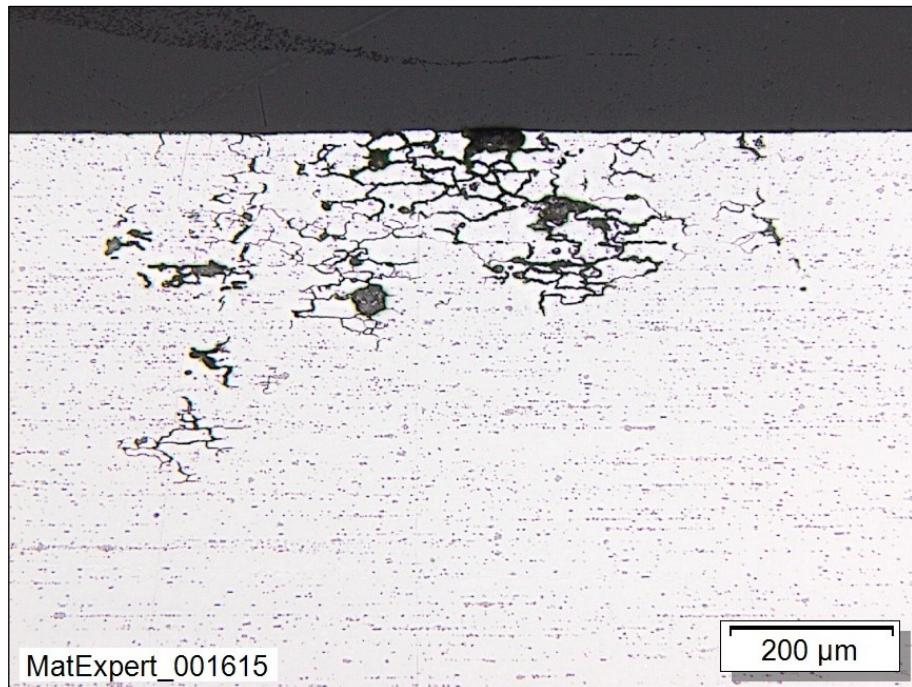
Intergranular corrosion was found in lower spar section L1 (see figure 66), while on section 1Ru, pitting, as is common for this material, was found (see figures 67 and 68). The former only occurs when the material does not conform with the specifications and is the result of artificial ageing or thermal stress and grain boundary precipitation.

**Figure 66:** Microsection of lower spar L1 with intergranular corrosion.

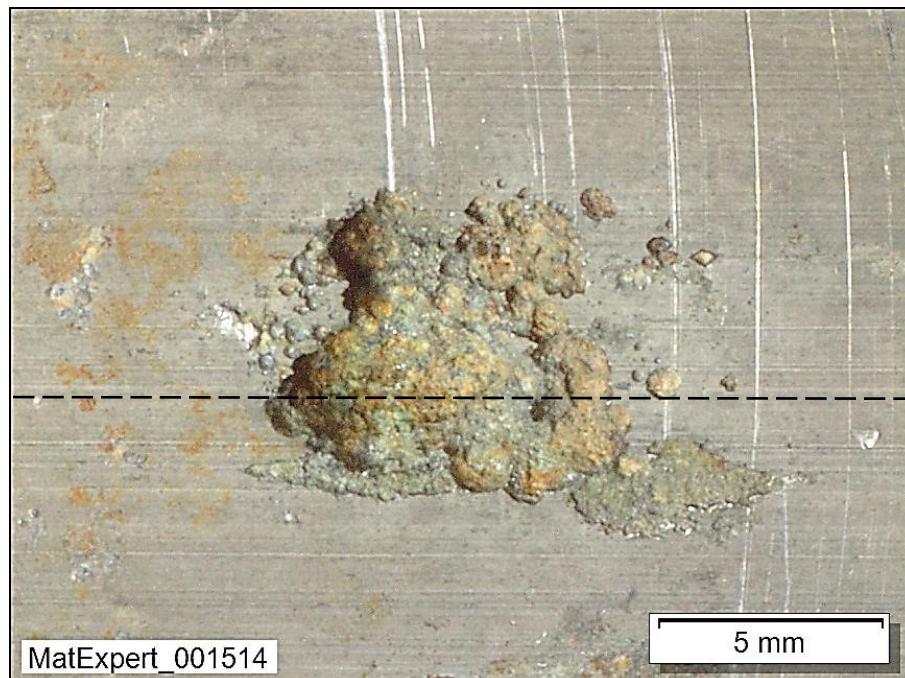
**Figure 67:** Pitting on spar section 1Ru (line of cross section, see figure 68).

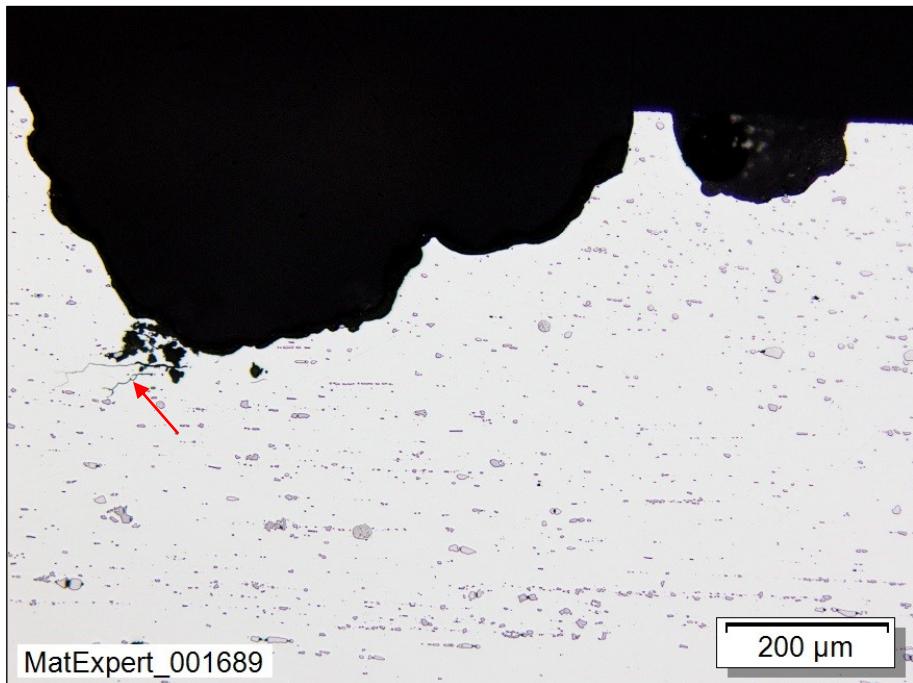
**Figure 68:** Microsection along the line as indicated in figure 67 with severe pitting and individual stress cracks (arrow).

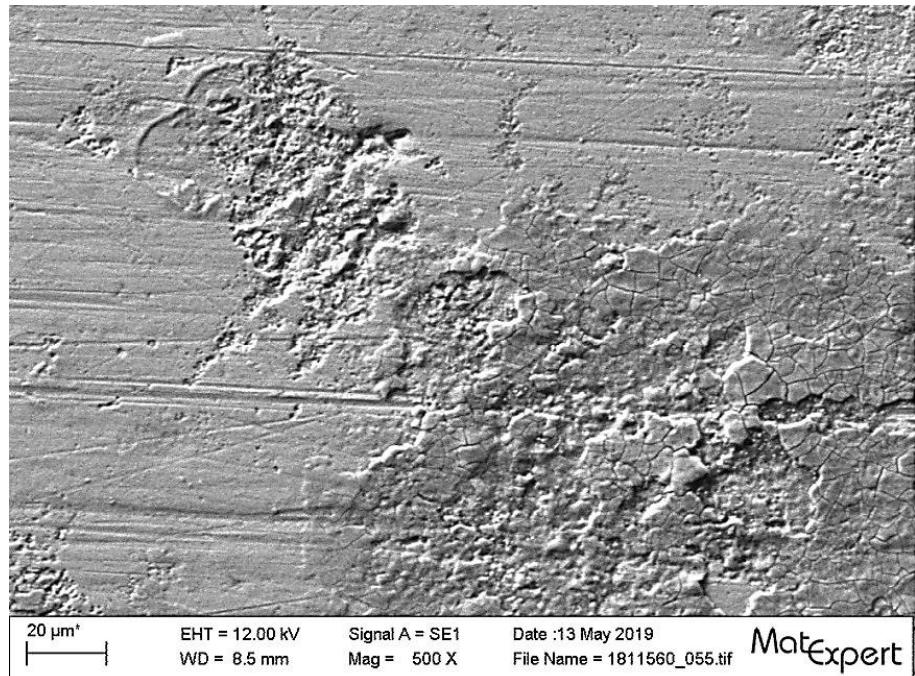
The panelling was also examined in the laboratory for corrosion. Analyses using scanning electron microscopy show that the surface was partially covered with corrosion and exhibited corrosive damage (see figure 69). Metallographically, corrosion spots can be detected in some areas on the surface of the plating, underneath the coat of paint (see figure 70).

**Figure 69:** Outer surface with corrosion and corrosive damage.

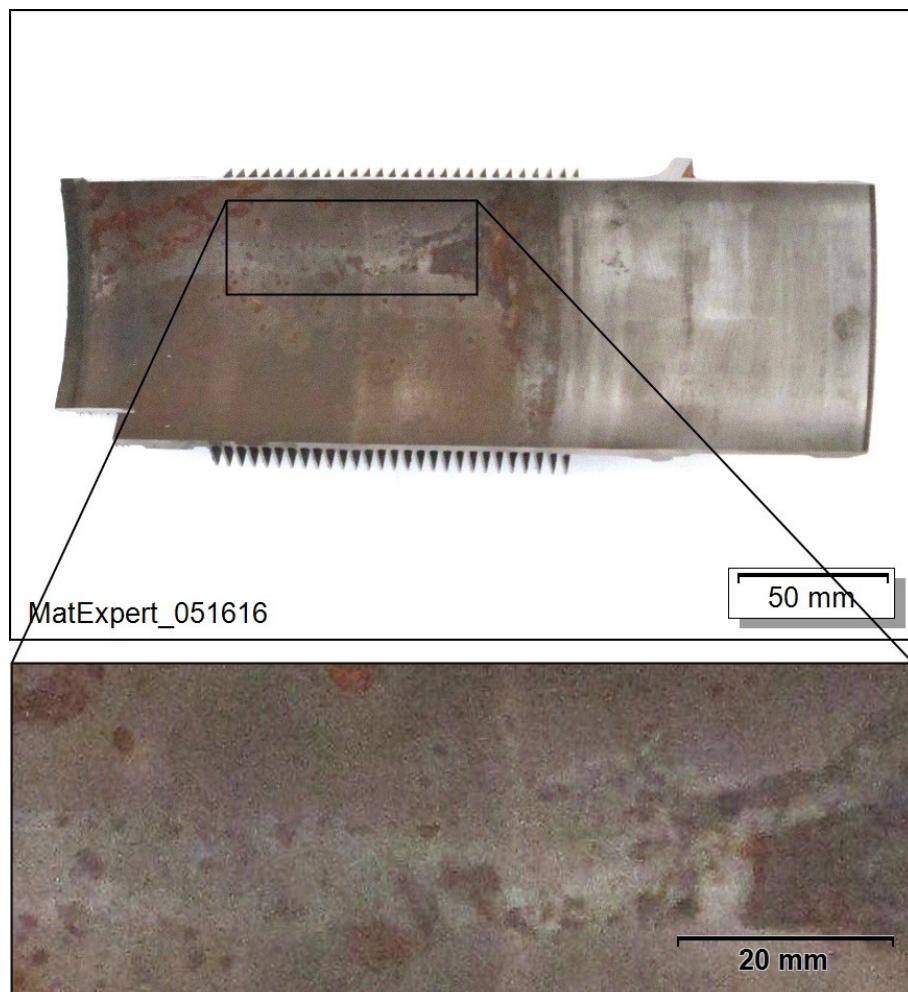
This corrosion was identified as rust, which explains the red discolouration of the bore. The cause of the bond coat's detachment from the cylinder barrel (see figure 72) is indication of pre-existing corrosion damage.

**Figure 71:** Right engine, bore of cylinder 1 – rusty surface.

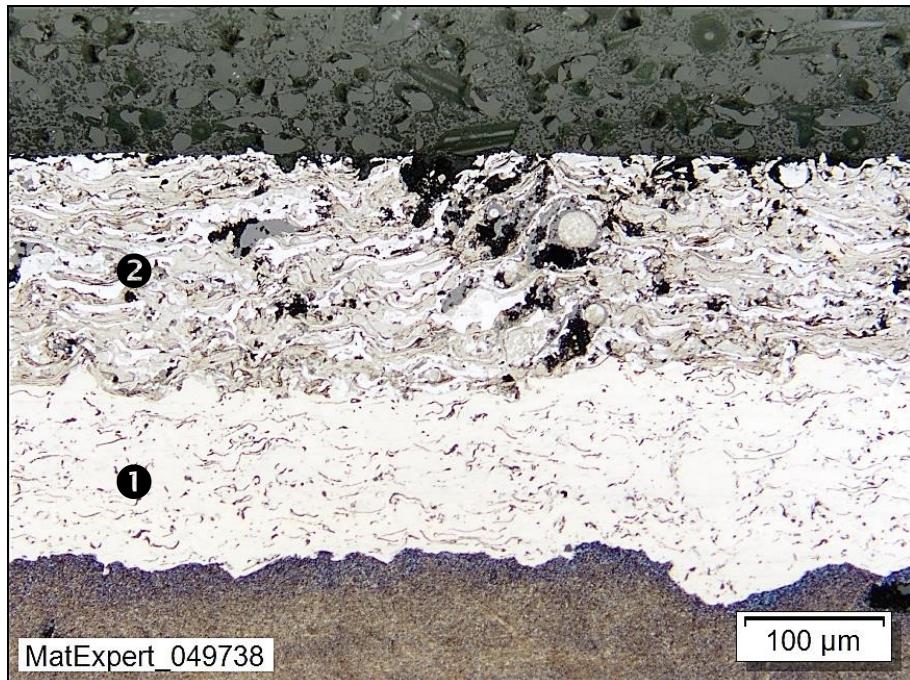
**Figure 72:** Close-up of the bore of cylinder 1 with two-layer thermal spray coating. Number (1) is the bond coat. Number (2) is the top coat, which is partially open-pored.

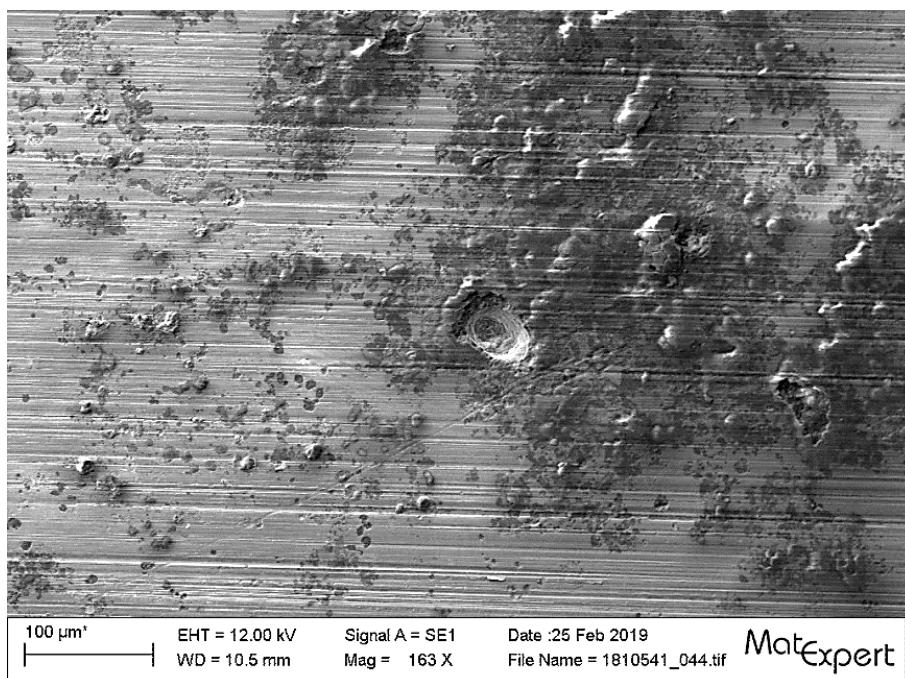
**Figure 73:** Ball bearing from the left engine, inner-race bearing track – corrosion.

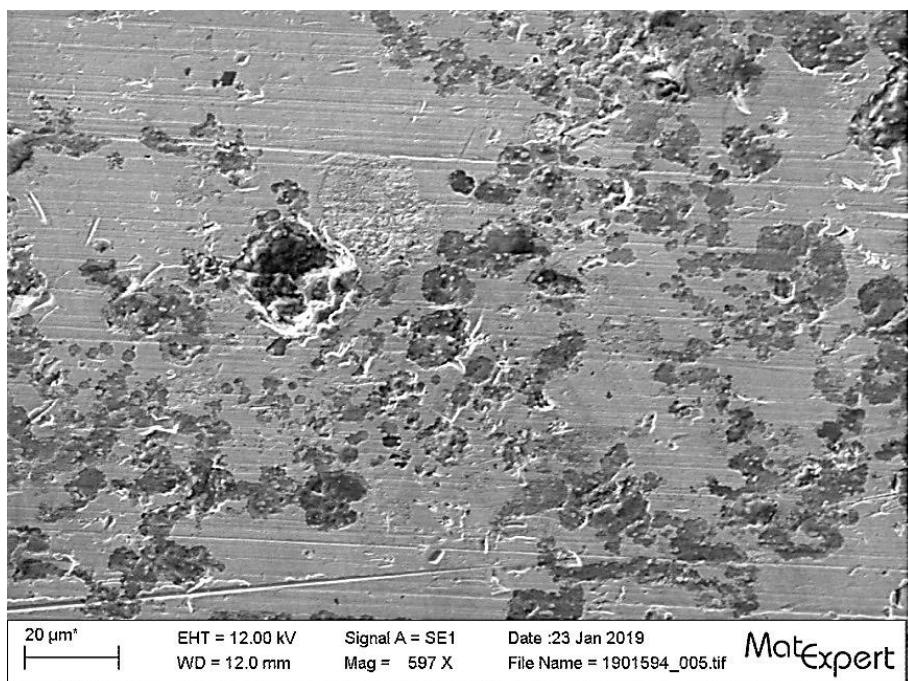
**Figure 75:** Ball bearing from the centre engine, inner-race bearing track – corrosion.

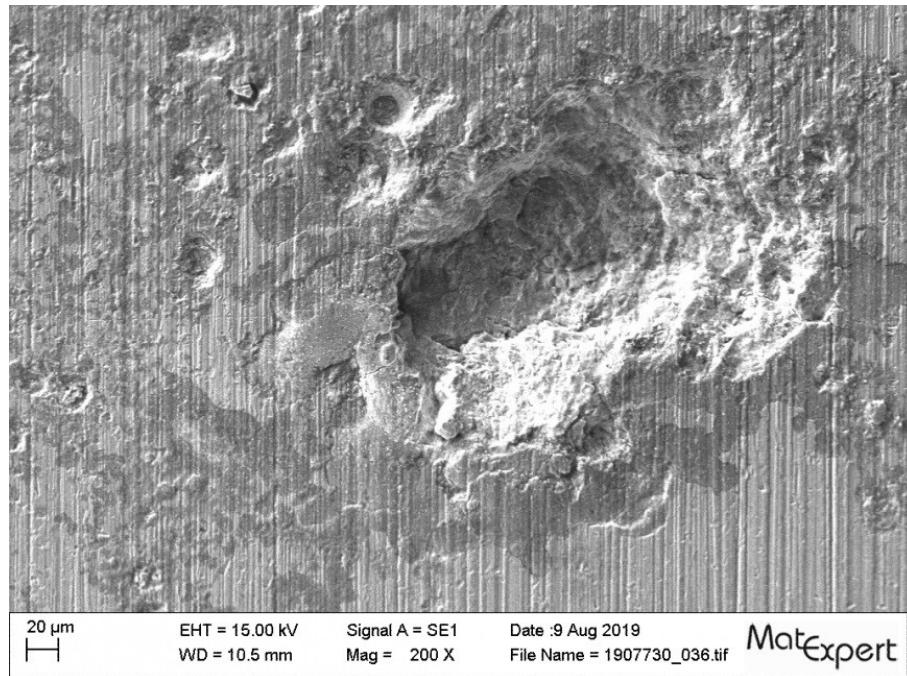
**Figure 76:** Bearing no. 3, outer-race bearing track – pitting.

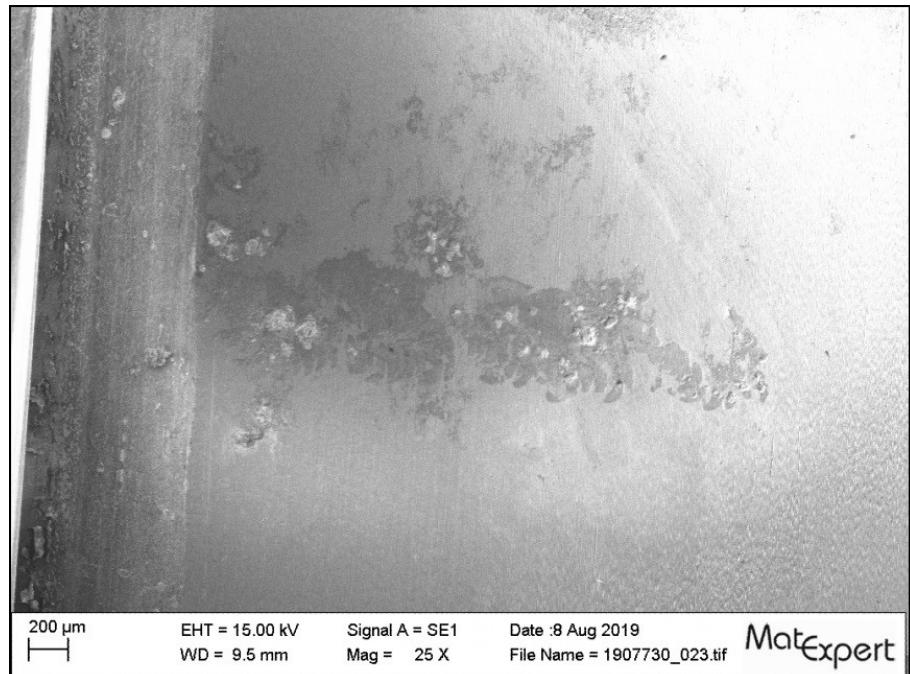
**Figure 79:** Bearing no. 3, inner-race bearing track – pitting and filiform corrosion.

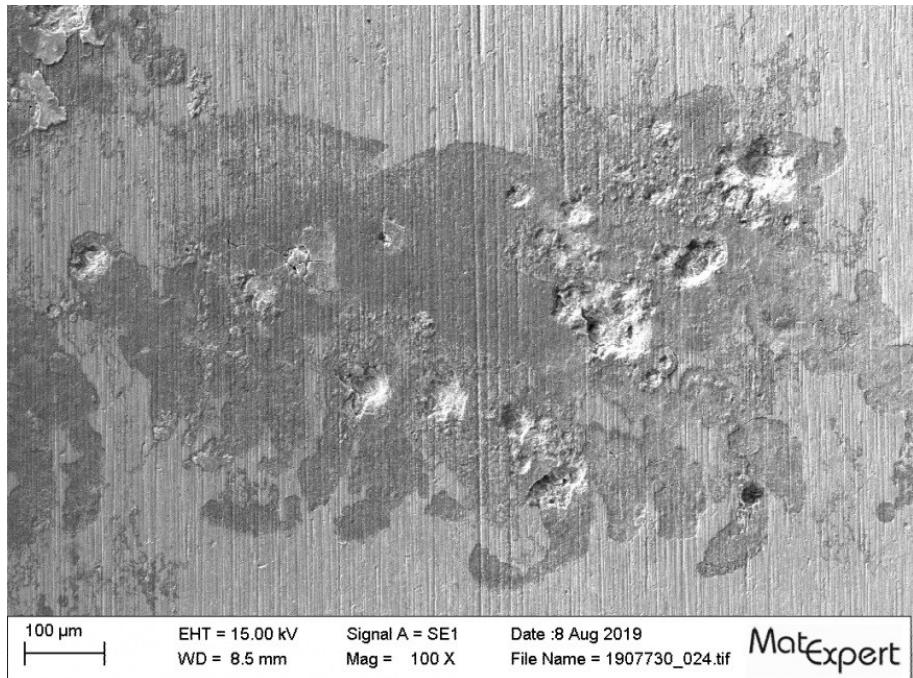
**Figure 80:** Close-up of figure 79.

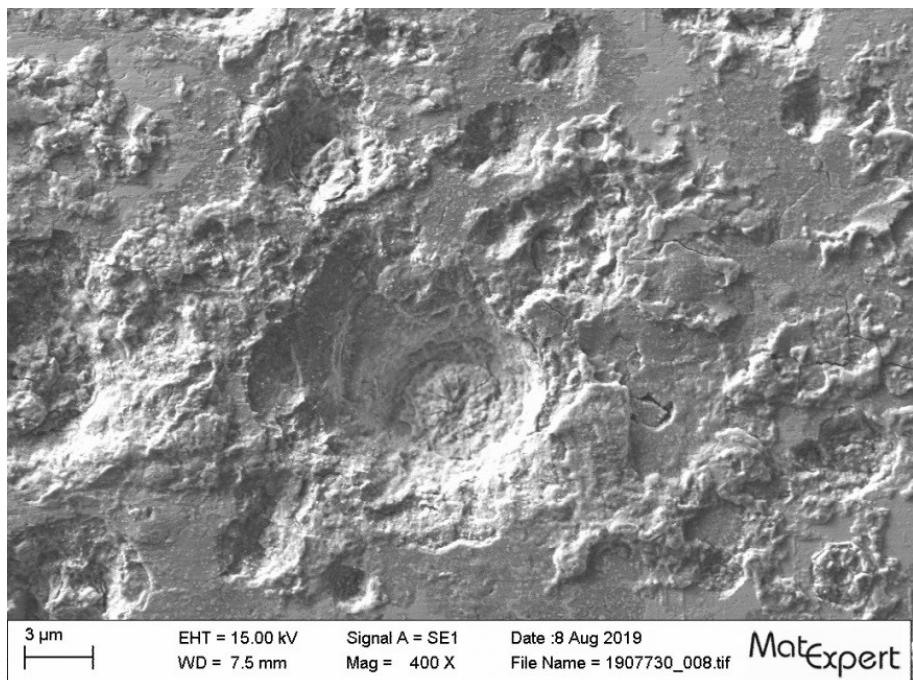
**Figure 83:** Close-up of figure 82.

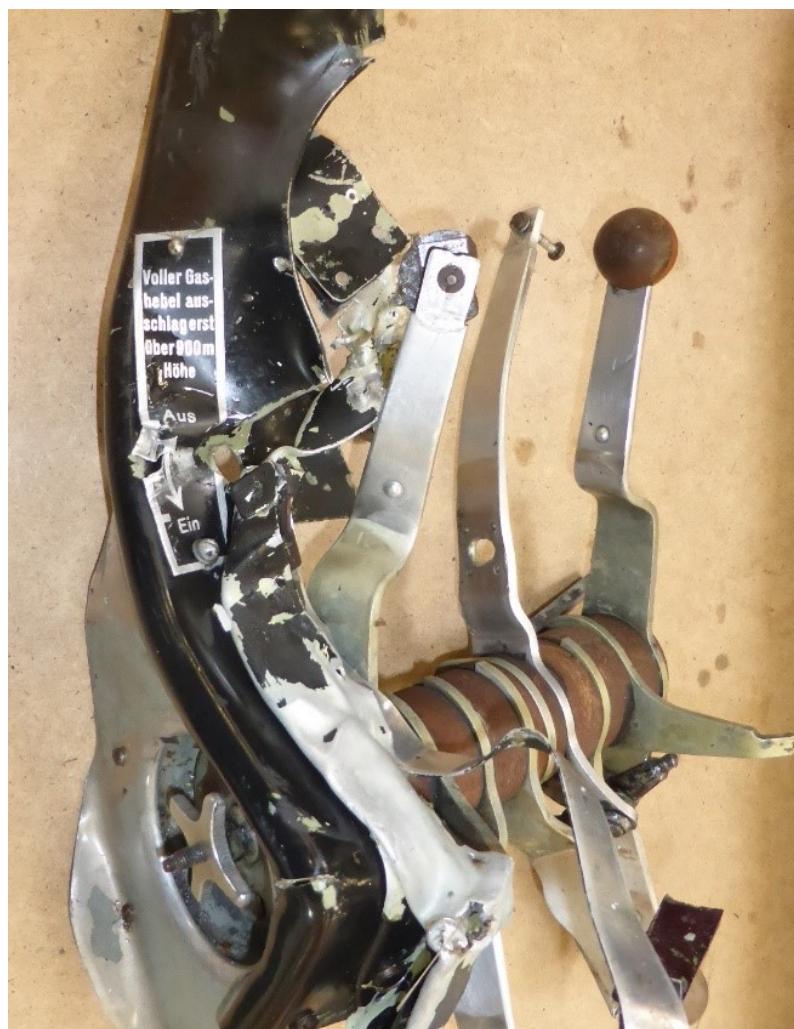
**Figure 86:** Deformed main throttle levers.

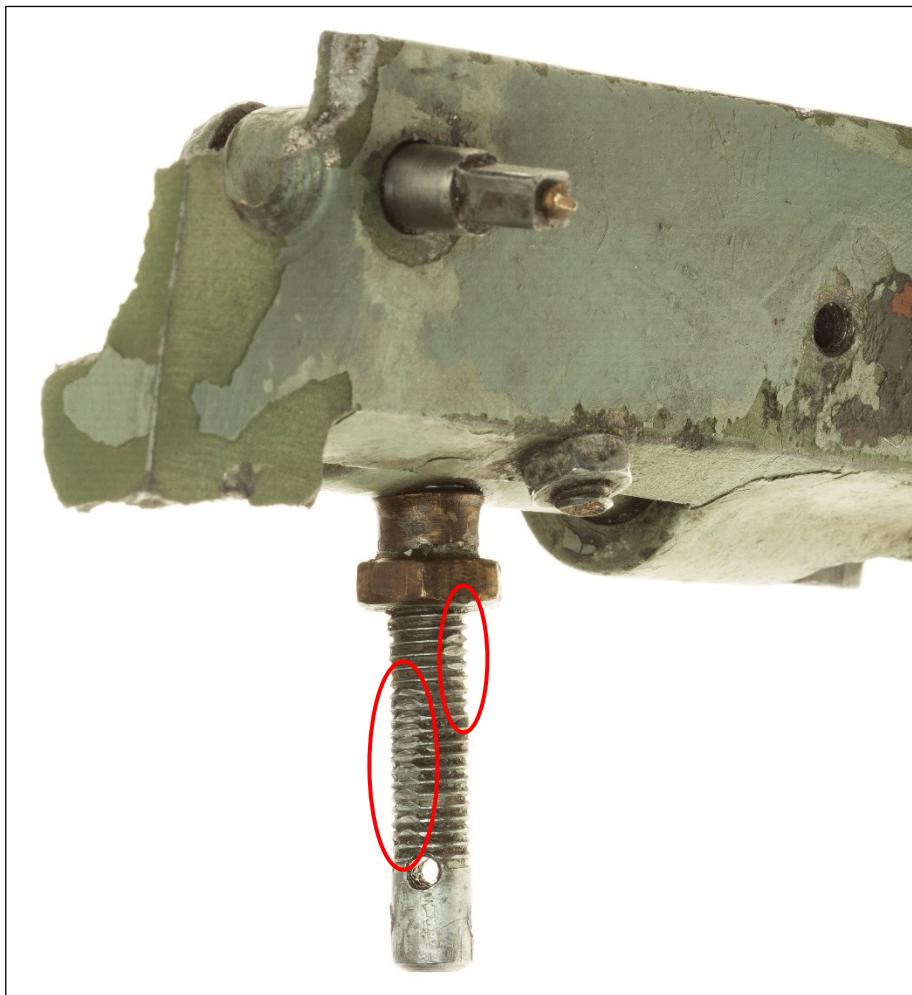
**Figure 90:** Limiting stop bolt for the left engine with damaged thread.

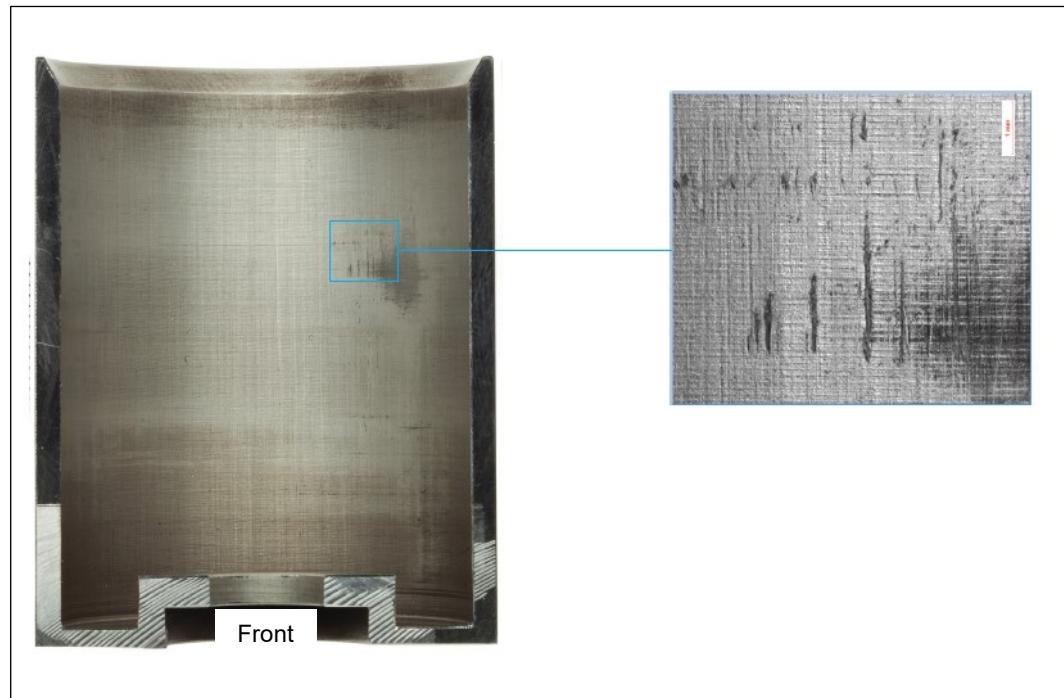
**Figure 93:** Abrasions in the pump cylinder from the carburettor for the left engine.

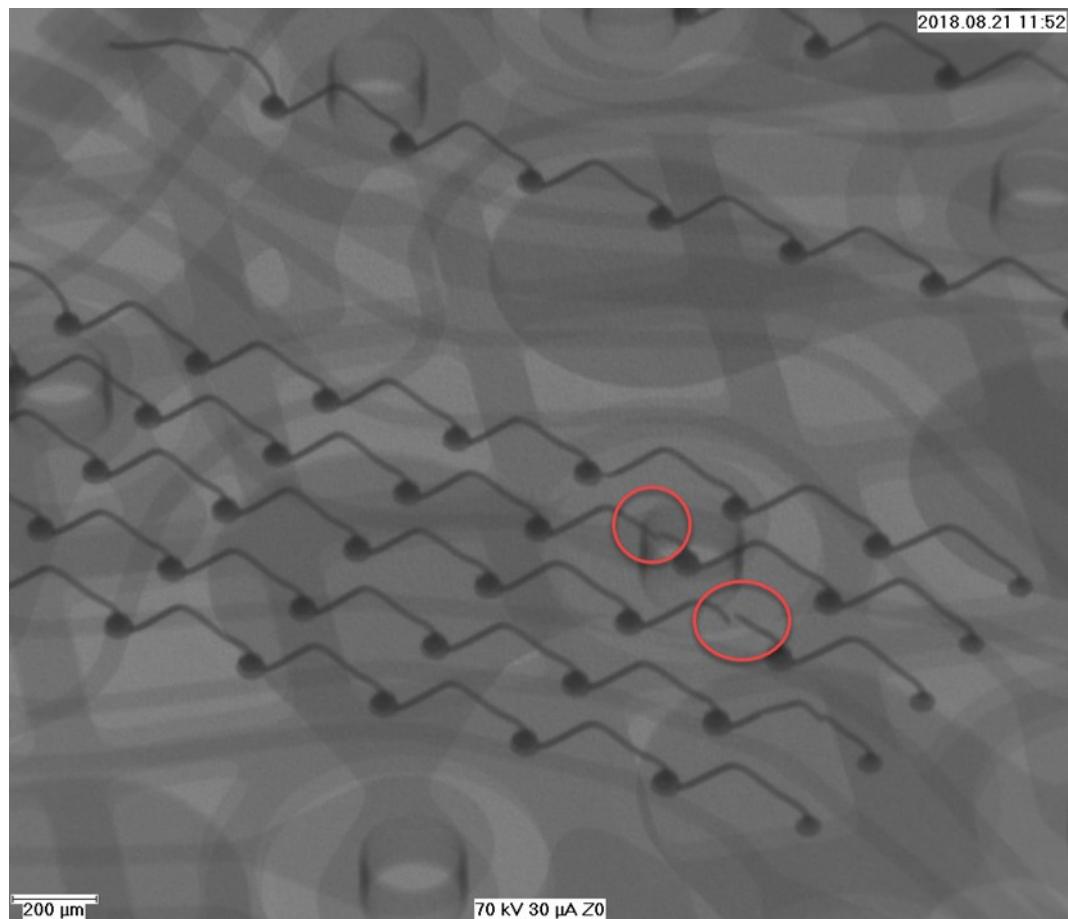
**Figure 2:** Heavily magnified CT scan of an SD card. Damage to the circuitry within is circled in red. Source: BEA.
