# AAIB Bulletin S1/2009

## SPECIAL

### INCIDENT

<b>Aircraft Type and Registration:</b>	Embraer 190-200, G-FBEH	
<b>No &amp; Type of Engines:</b>	2 General Electric CF34-10E7 turbofan engines	
<b>Year of Manufacture:</b>	2007	
<b>Date &amp; Time (UTC):</b>	15 January 2009 at about 0740 hrs	
<b>Location:</b>	Overhead Edinburgh	
<b>Type of Flight:</b>	Commercial Air Transport (Passenger)	
<b>Persons on Board:</b>	Crew - 5	Passengers - 40
<b>Injuries:</b>	Crew - None	Passengers - None
<b>Nature of Damage:</b>	None	
<b>Commander's Licence:</b>	Airline Transport Pilot's Licence	
<b>Commander's Age:</b>	40 years	
<b>Commander's Flying Experience:</b>	6,250 hours (of which approximately 100 were on type) Last 90 days - 137 hours Last 28 days - 33 hours	
<b>Information Source:</b>	AAIB Field Investigation

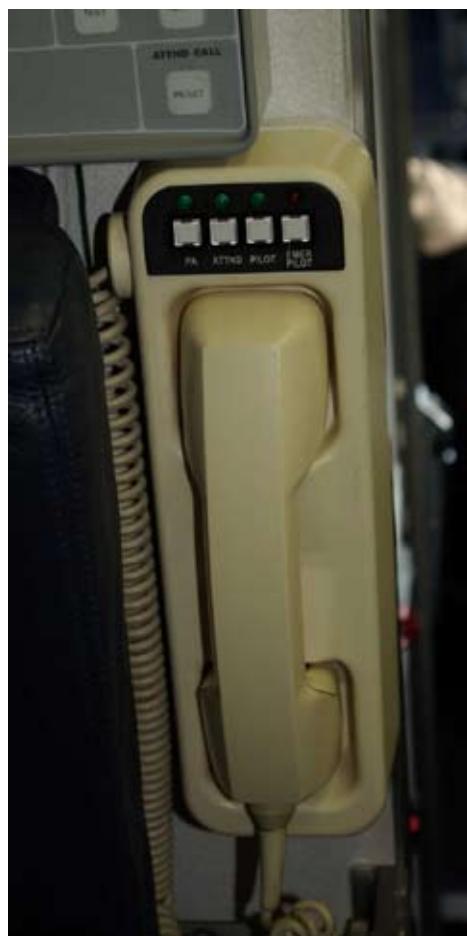
The SCCM attempted to call the flight crew on the cabin interphone system, by pressing the PILOT call button. The green light above the button (Figure 1) illuminated, but the flight crew did not answer. Despite repeated attempts, using handsets in both the forward and rear galleys, the SCCM could not establish communication with the pilots in this way.

**Figure 1**  
Cabin interphone handset at front galley

With emergency power (from the RAT and batteries) applied to the aircraft, the EMER system functions normally. However, if a PILOT call is initiated from either handset in the cabin, the green light above the pushbutton illuminates and a single chime is heard in the flight deck, but the pushbuttons on the pilots’ audio panels do not illuminate, and voice communication cannot be established.

The PILOT function of the interphone system seemed, to the cabin crew, to indicate that it was functioning normally. However, the CAB pushbutton in the flight deck did not illuminate, and no voice contact was possible. The cabin crew did not attempt to use the EMER PILOT function, as this would involve an emergency call, which differed (in the cabin crewmembers’ perception) from the normal call only in the number of chimes.

The ‘false positive’ indication of the PILOT call was crucial to the incident; had the PILOT call not appeared to function correctly, it is probable that the cabin crew, instead of contemplating incapacitation of the flight crew or serious emergency on the flight deck, would have attempted to establish communication using the EMER PILOT call.

It is recommended that Embraer (Empresa Brasiliera de Aeronautica SA) immediately notify all operators, of the Embraer 190 family of aircraft, to inform their flight and cabin crew of the functioning of the interphone system when the aircraft is supplied only with emergency electrical power.

It is recommended that Embraer (Empresa Brasiliera de Aeronautica SA) modify the functioning of the interphone systems of Embraer 190 family aircraft to provide crew with the facility to make both normal and emergency calls when the aircraft is supplied only with emergency electrical power.

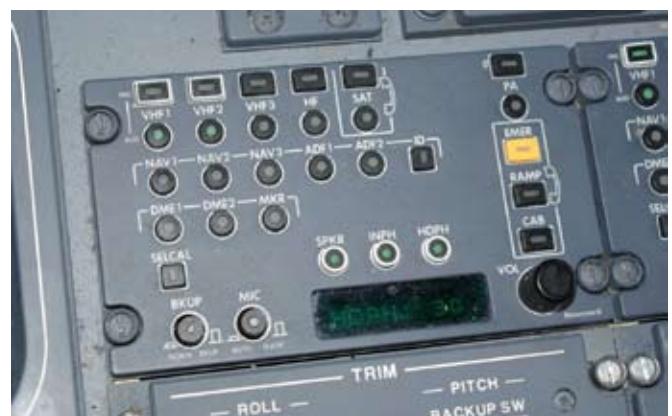
**Figure 2**

The interphone system includes handsets with illuminated pushbuttons at the forward and aft galleys (Figure 1) and illuminated push-buttons on audio panels in the flight deck (Figure 2). With normal power applied to the aircraft, removing the handset from its cradle and then pressing the PILOT call pushbutton above the handset causes a single chime to sound in the flight deck, and the CAB pushbuttons on the pilots’ audio panels illuminate to show an incoming communication. Pressing the pushbutton

Pilot’s audio panel in flight deck
