## **APPENDIX A: FLIGHT DATA RECORDER TECHNICAL ANALYSIS REPORT**

# **Flight Data Recorder Readout and Analysis**

## **SA227-DC VH-TFU**

**ATSB TECHNICAL ANALYSIS REPORT 21/06**

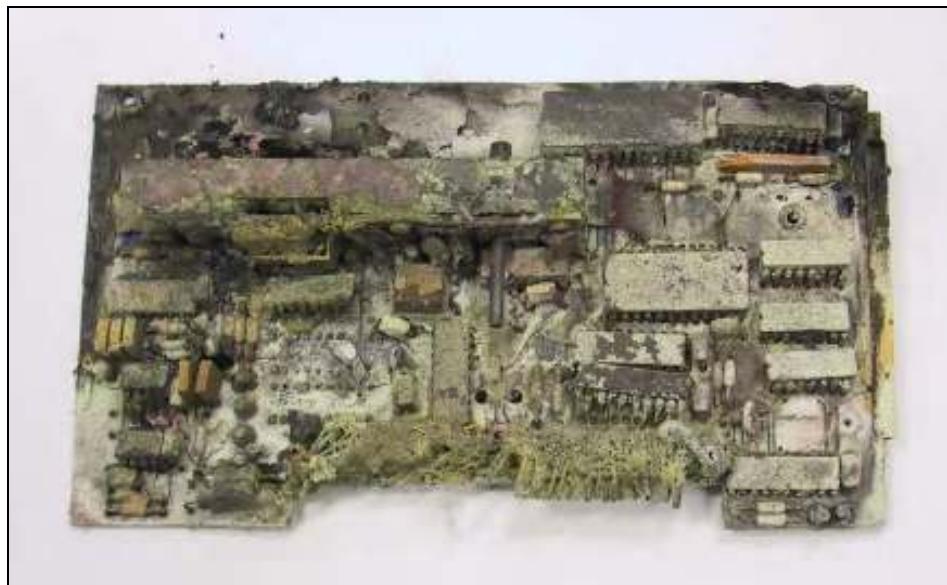
**Figure A-16: Pneumatic printed circuit board from VH-TFU**

The recorded IAS data was initially processed using the manufacturer's standard polynomial conversion equation. Examination of the results showed that the IAS values were unreasonable i.e. cruise speeds did not agree with the cruise speeds documented in the operator's trip records. The damage to the pneumatic PCB from VH-TFU precluded any direct testing/calibration.

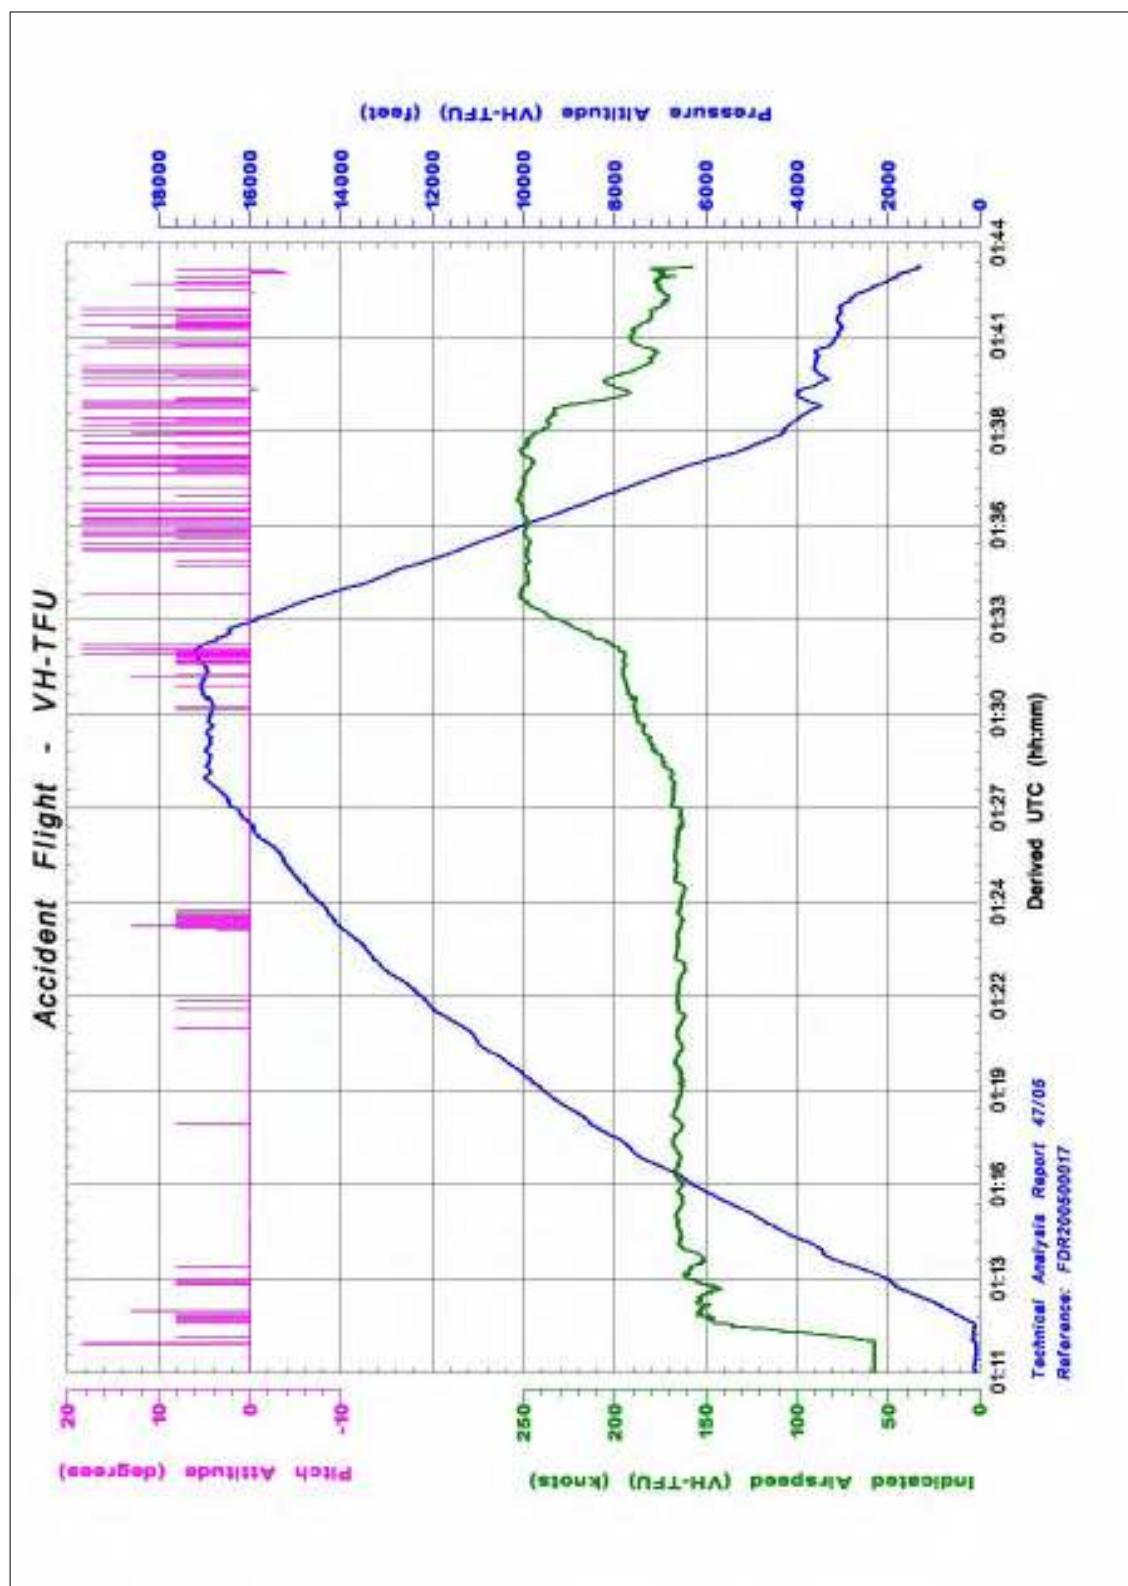
Figure A-38: Pitch attitude data

1. The aircraft was shown in clear weather conditions and not the actual lighting, visibility and weather conditions that existed at the time of the accident.
2. Due to an FDR recording system unserviceability, the aircraft pitch attitude was always shown as zero i.e. nose level. In reality, the aircraft pitch attitude would have varied and not been constant at zero degrees.

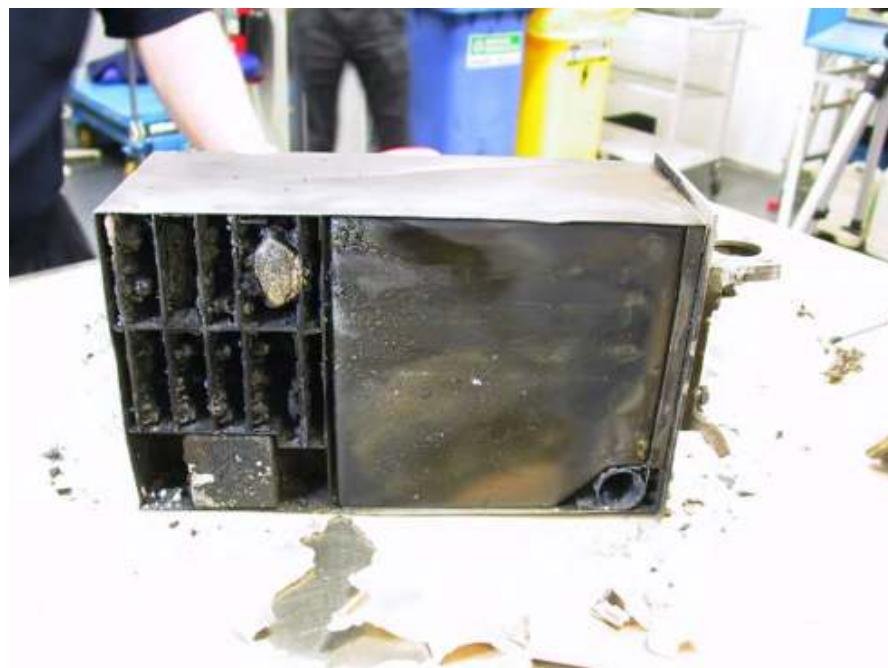
**Figure B-3: CVR with casing removed**

The CVR appeared structurally intact. The casing and front panel had not been subjected to high impact forces. The cockpit voice recorder was identified from the manufacturer's data plate shown in Figure B-2. The CVR was a Fairchild Model A100A, part number 93-A100-83, serial number 60652, manufactured in May 1992. The CVR was manufactured by Loral Data Systems, Fairchild Aviation Recorders, Sarasota Florida, USA. Fairchild Aviation Recorders is now known as L-3 Communications Aviation Recorders.

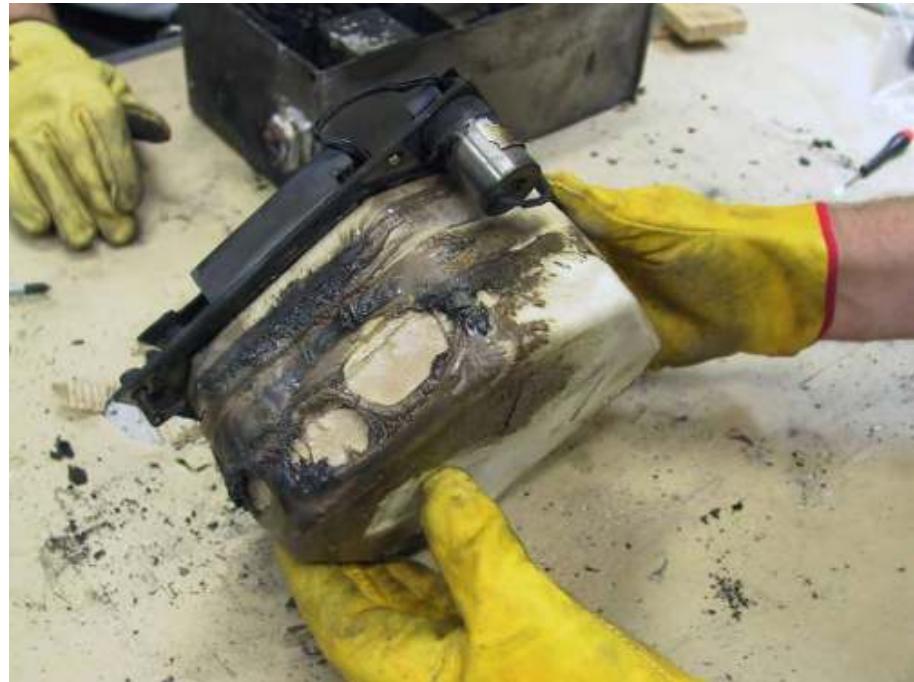
electrical connections to the crash-protected module were significantly heat affected with molten insulation and damaged connectors. To remove the crash-protected module, the electrical wires were cut a short distance from the connector.

**Figure B-4: Crash protected module with armouring removed. Heat damage to the fire protection can be seen.**

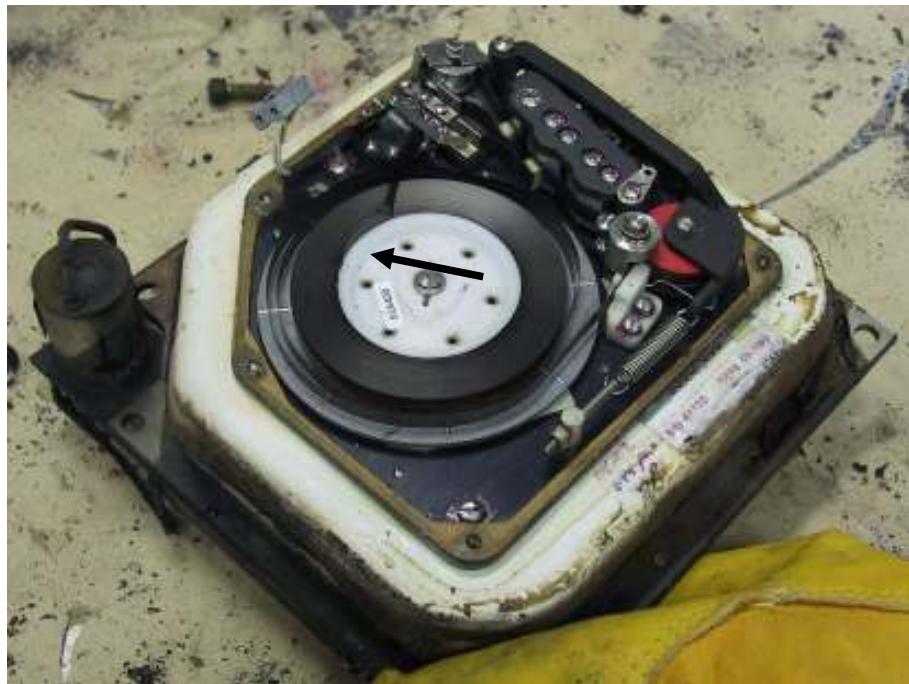
**Figure B-5: Recording tape in tape transport; note slight damage to tape at centre of spool.**

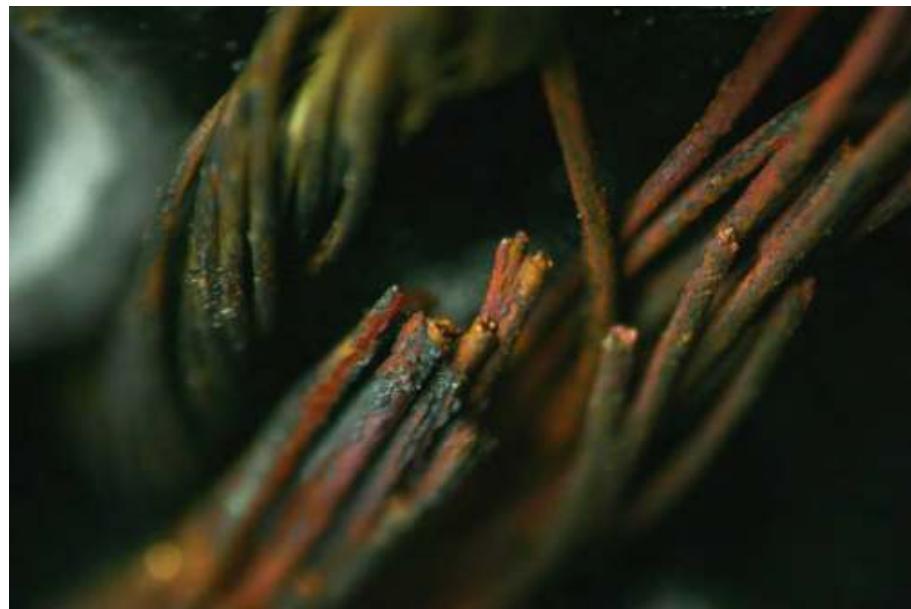
Examination of the wire strands showed they had failed in overload and exhibited ductile 'necking' and a crystalline fracture surface, as shown in Figure B-17. A similar characteristic was exhibited by the broken strands of the wire connecting to pin 9, the connection to the aircraft 27.5 V d.c. power supply. A close up photograph is shown in figure 18.

**Figure B-17: Photograph of aircraft interface connector wire strand ductile unpowered fracture**
