Air Accidents Investigation Branch

**Report on the accident to
Gates Learjet 25B, EC-CKR
at RAF Northolt, Middlesex
on 13 August 1996**

Aircraft Accident Report No: 3/97

(EW/C96/8/6)

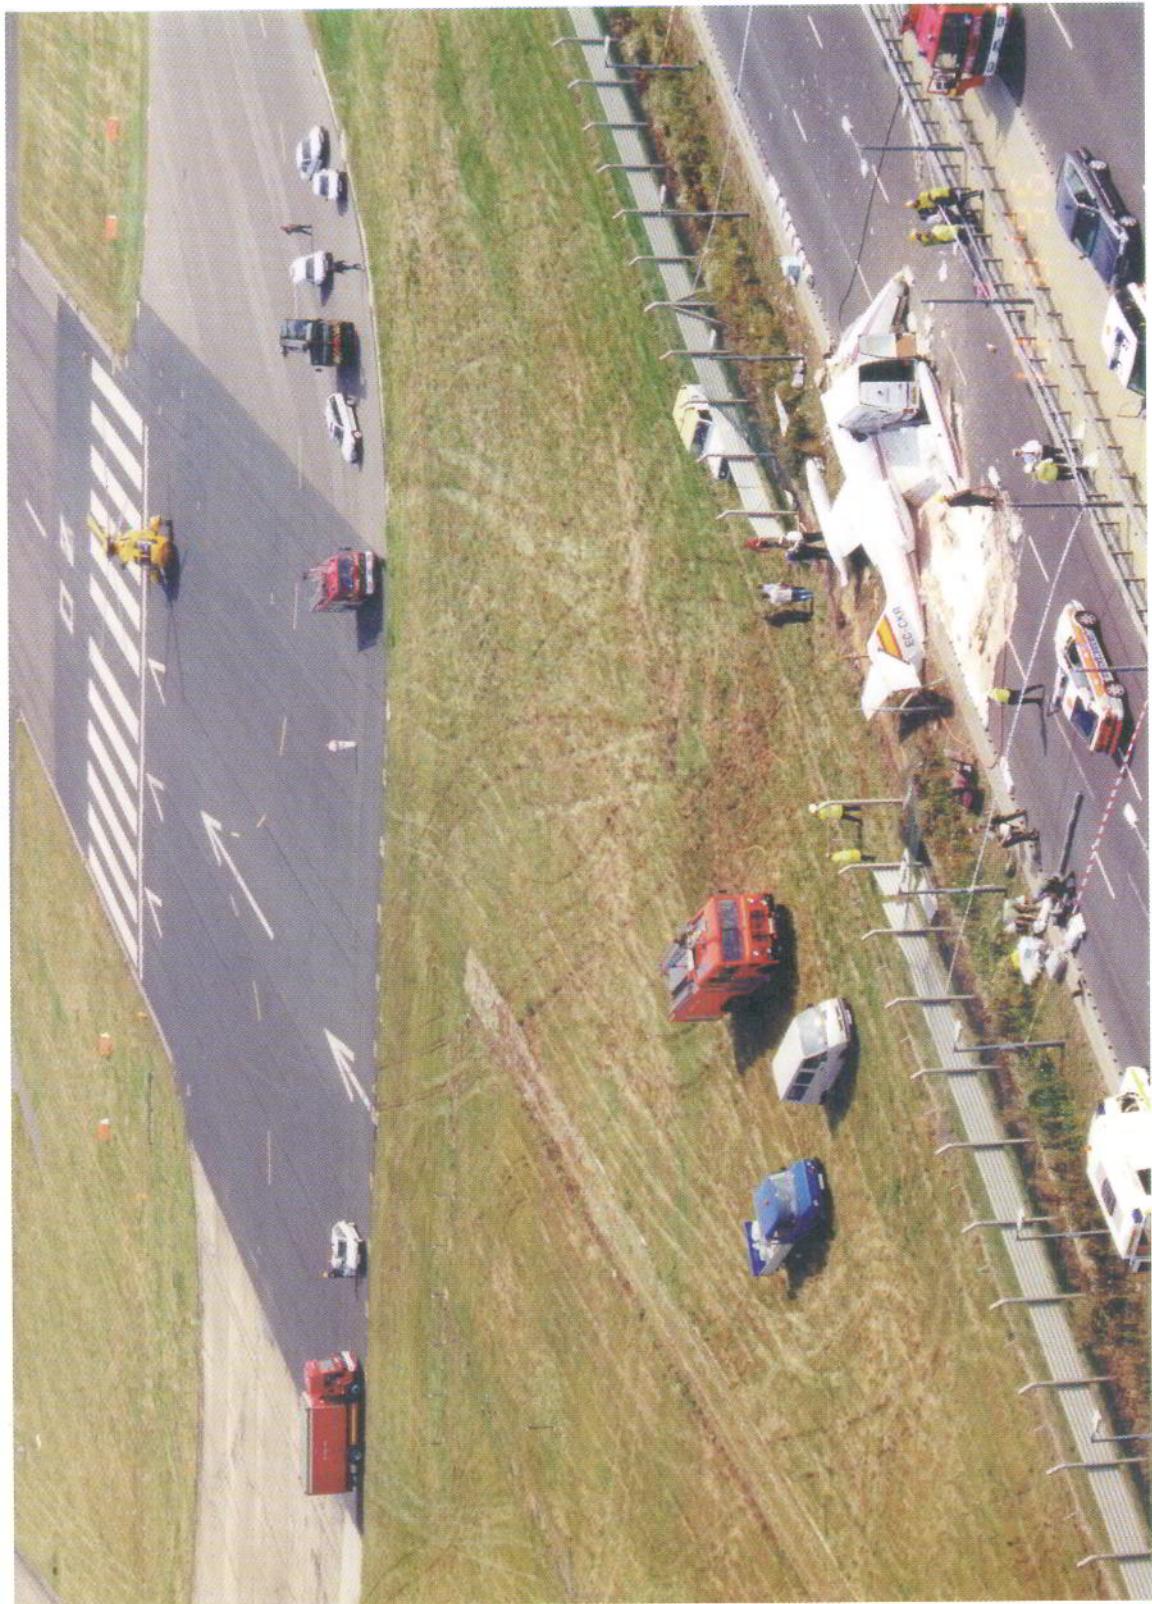
LEARJET ON THE A40 DURING RESCUE
