# Protecting Aircraft and Passengers from Cargo Fires

Cargo compartment linings are designed to provide an air-tight space, and are essential in protecting the aircraft and its occupants from fire and smoke.

This article looks at how these composite components have come to play such an important role in Safety, and what can be done to make sure they stay in good condition.

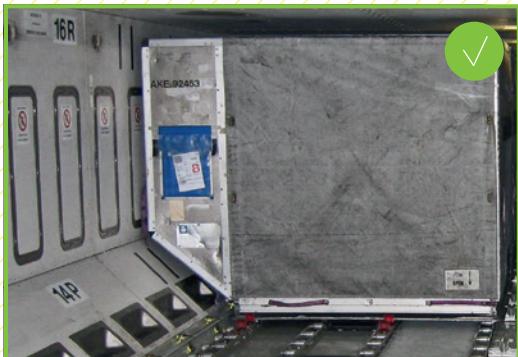
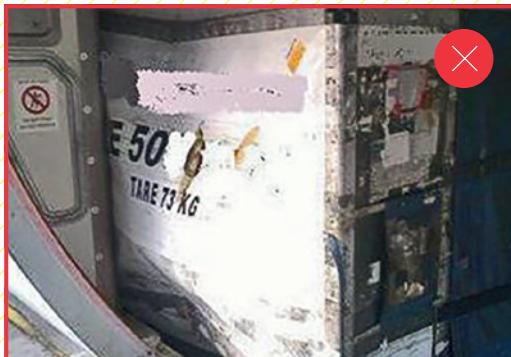
Typical damage identified on widebody aircraft types are related to out of contour cargo containers or pallets impacting and/or scratching the sidewalls, with ceilings being damaged less frequently. Damage to the cargo door linings are also typically caused by impact with out-of-contour containers, and often result in cracking of the panel around fixation holes upon door closure.

**Don't load out of contour ULDs (containers or pallets)**

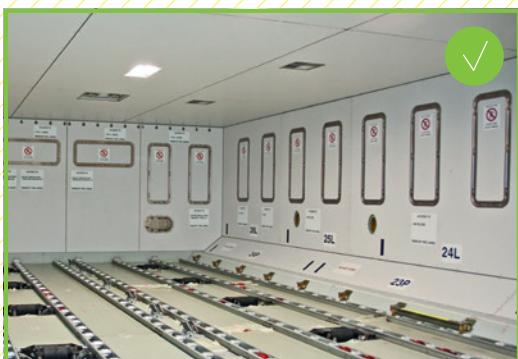
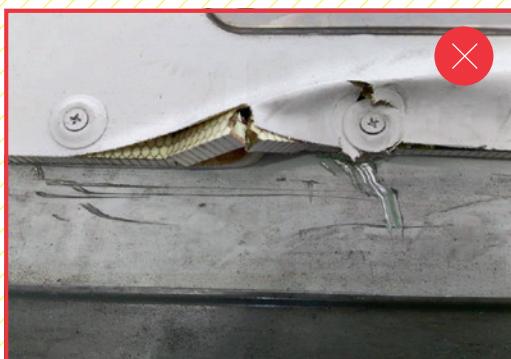
**Report any damage to the lining**

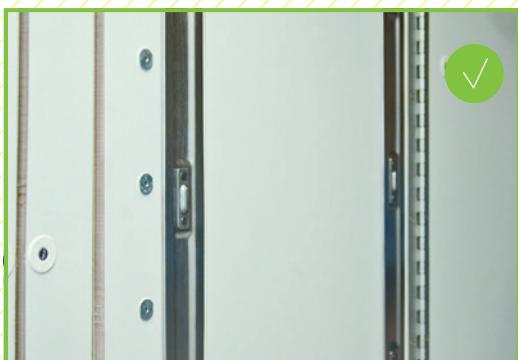
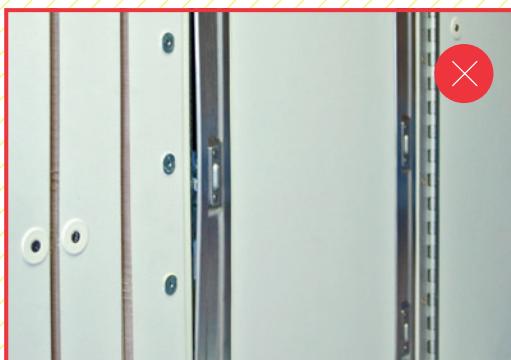
**Check decompression panels and catches are in the correct position**

Decompression panels are clearly identified with placards mentioning 'DO NOT PUSH' and 'DO NOT REMOVE'. In case any panel is found partially or totally dislodged, it must be reinstalled as per AMM procedures in order to avoid additional damage. These require removal of the sidewall panel upper assembly for proper completion.

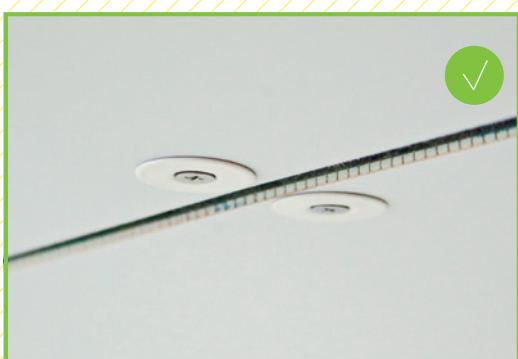
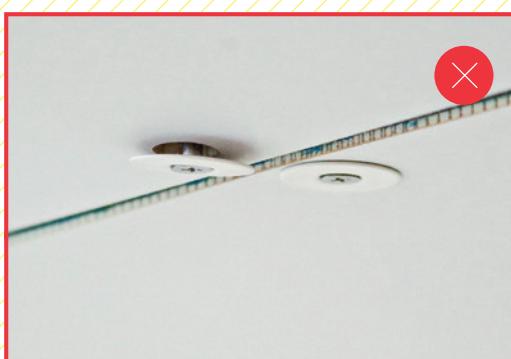
**Ensure fasteners are present, tightened, and flat on the panel**

All lower deck cargo compartment lining panels are attached to the structure and/or systems by a quick release fastening system (fasteners). About 10% of reports of damages to the cargo hold are related to either missing, or incorrectly installed fasteners. The reports principally impact the ceiling panels.

Investigations into these reports allowed Airbus to identify clear recommendations for fastener tightening and cargo lining installation. The appropriate torque value to be applied when tightening a fastener is between 0.055 and 0.060 m.daN (4.87 and 5.31 lbf.in).

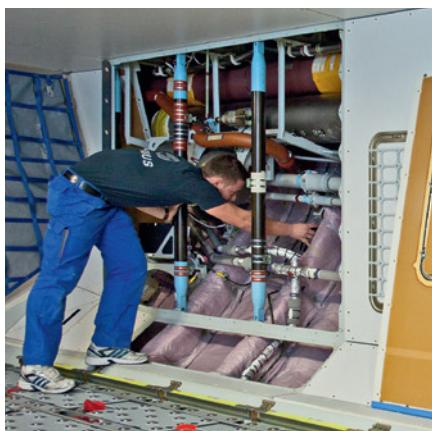
### Correct

Access by removal of sidewall panel assembly to perform maintenance

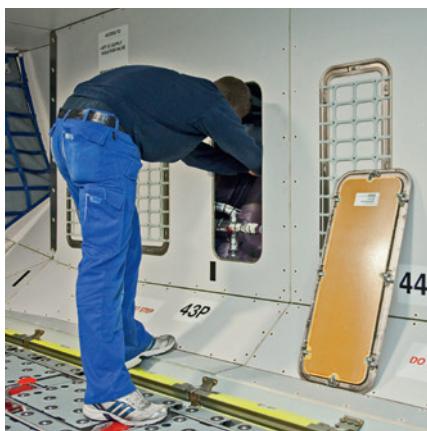
### Incorrect

Typical damage is found around at the edge of the cut-out for the decompression panel (e.g. on the upper assembly, where the decompression panels attaches to the vertical sidewall). These reports are often due to a removal and installation of the decompression panel by pushing on it, without properly unlocking the catch. Other findings include missing or dislodged panels, or incorrectly latched panels.

Access by removal decompression panel to perform maintenance
