AERAZUR

PRELIMINARY STUDY on AIRCRAFT EVACUATION SYSTEMS AGING

**DGAC / SFACT Contract
N° 00/07/SFACT/AEF dated 03.02.2000**

NOTE ACI: 00-611

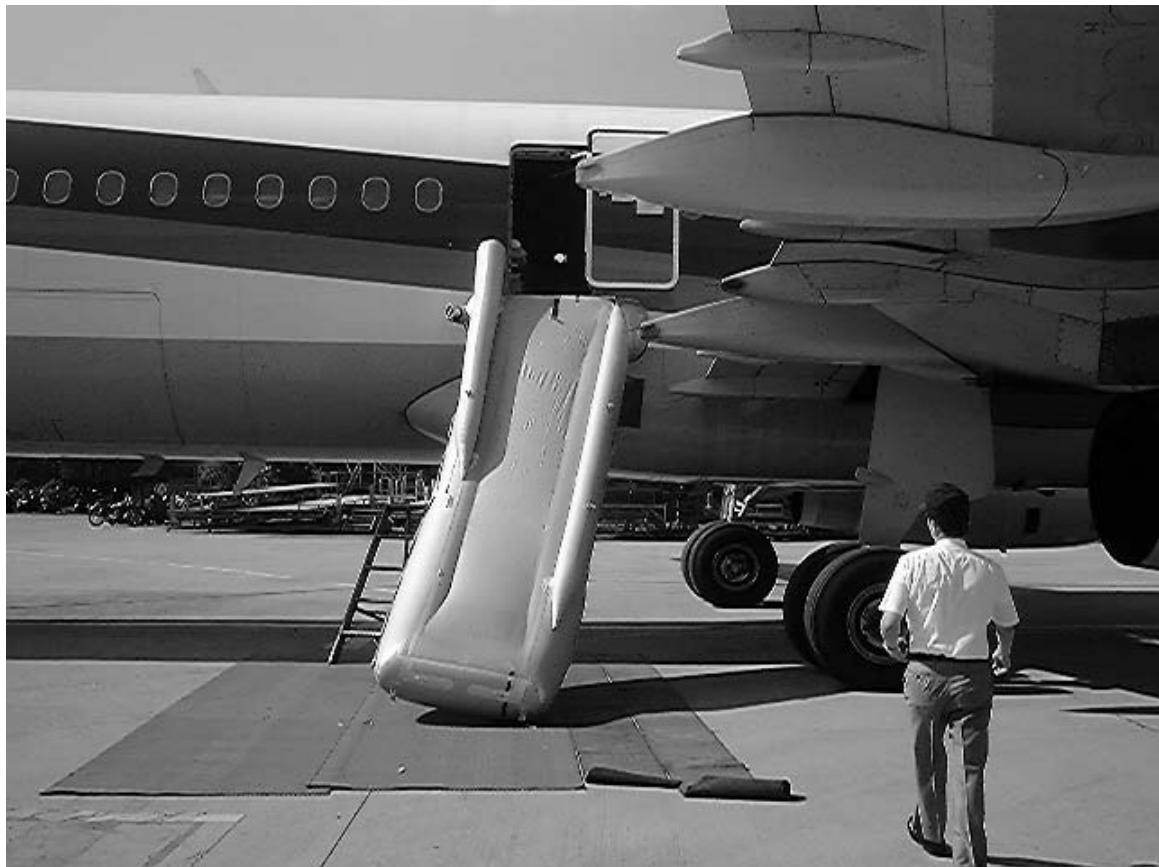
A321 Evacuation Slide

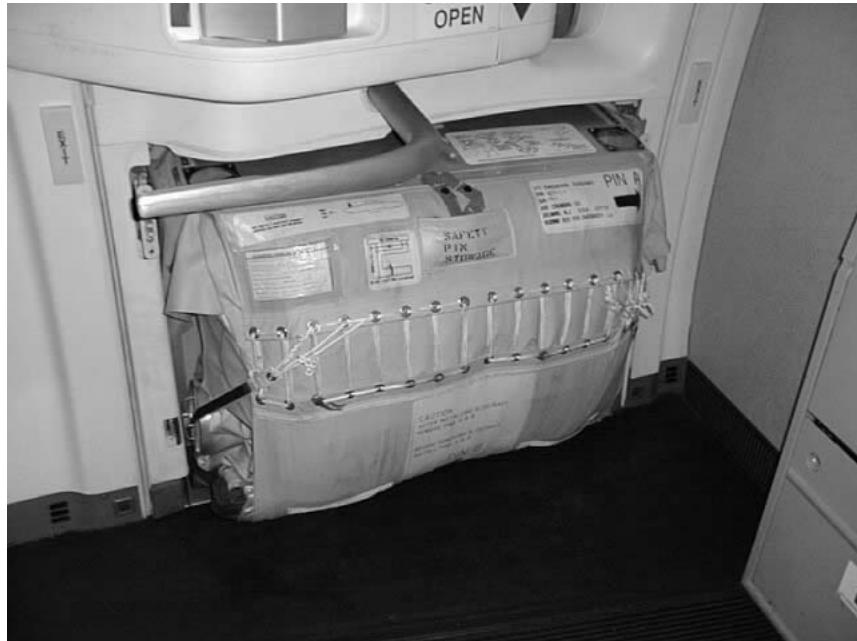
B777 Slide Raft fitted on a door.

“Bustle” or “decorative cover” is removed to show the evacuation system

For door exits, the evacuation system can be mounted on the lower part of the door.

This is the case of most evacuation systems in service.

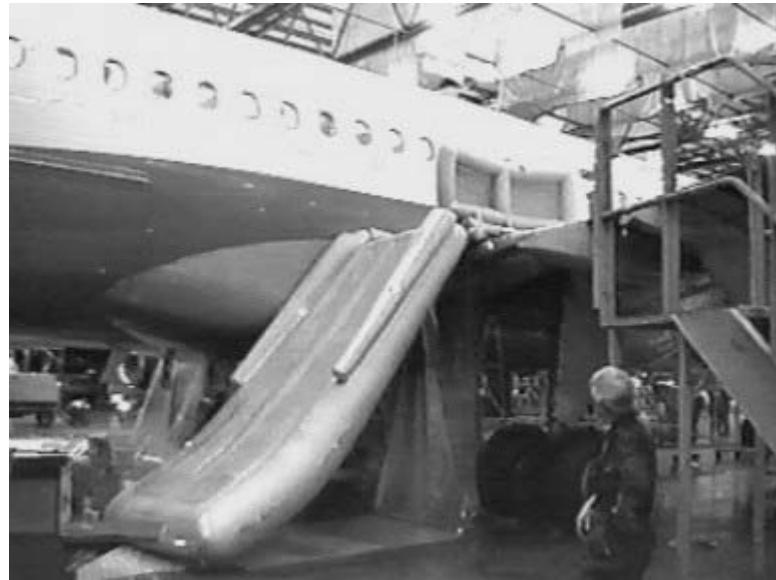
A320 Off Wing Slide

- from the trailing edge near the fuselage (flaps down) (ex: A320)
- from the leading edge, usually after the inboard engine (ex: MD11).

The slide or slide raft has to be combined with a ramp that guides the evacuees from the overwing exit onto the wing towards the sliding lane(s).
