# Some Thoughts on Reducing the Risk of Aircraft Loss of Control

Don Bateman<sup>1</sup>

*Advanced Technology --Honeywell International, Redmond WA\**

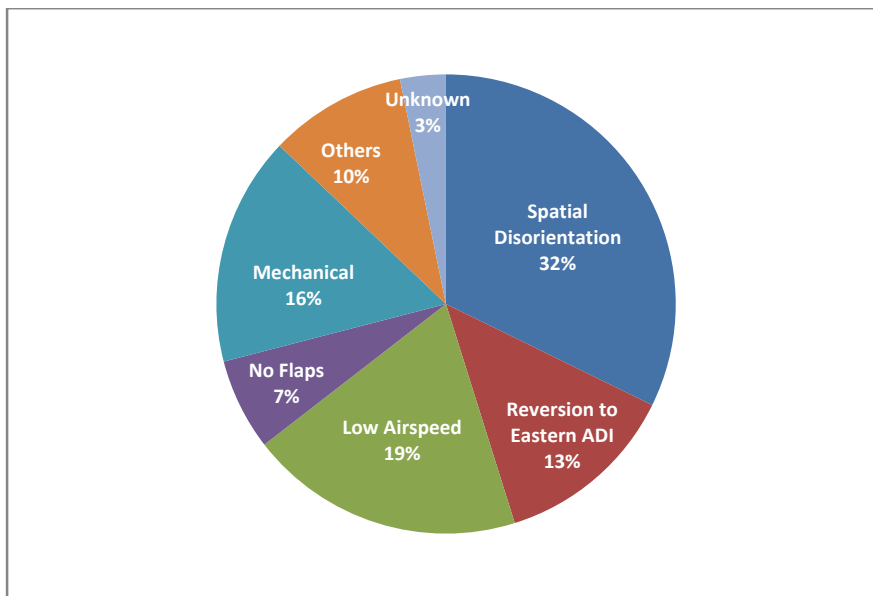
Spatial Disorientation (SD) and suspected Reversion or confusion of Western to Eastern (Soviet era) Attitude formatted displays are about 45 % of the losses. Undetected loss of Airspeed leading to Stick Shaker and into Stall accidents are about 20% of the losses. Take-off accidents attempted with No Flaps continue to occur. Mechanical-Failures leading to LOC are also significant and the pilot can do very little if the controls are not useable. LOC from Wake Vortex upsets (“others”) is a risk growing as RNP procedures confine aircraft tracks during departures and initial approach.

**Figure 1—Loss of Control Classification**

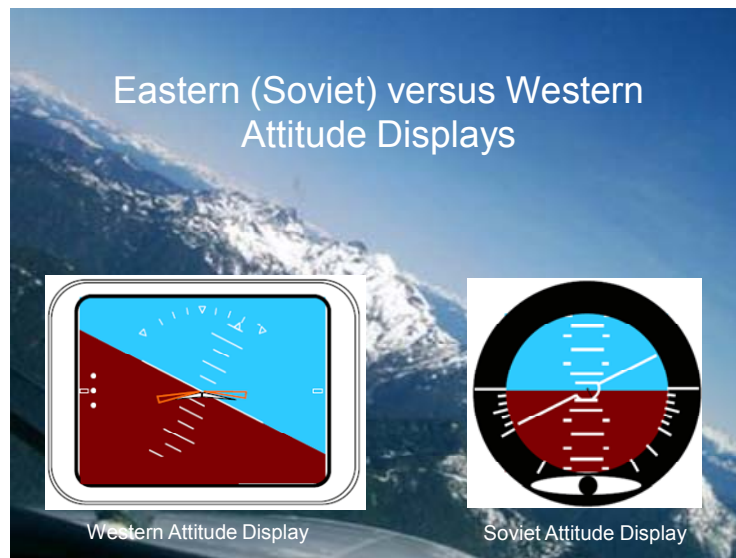
**Figure 2---- Western versus Eastern (Soviet Era) Attitude Display Indicators**

Note that the Western Attitude Display horizon symbol-line is aligned to the outside horizon and the airplane symbol stays fixed. The Eastern (Soviet) Display horizon symbol-line stays fixed and is aligned to the airplane while the airplane symbol moves with roll and pitch attitude. Many Turn and Bank instruments used in Western general aviation aircraft use a format similar to the Eastern format.

When a pilot is attempting to recover from an unusual attitude, the type of aircraft ADI (EADI / EFIS) display can contribute confusion, time delay, 'bobble' (back and forth uncertainty) especially when the pilot has been exposed to thousands of hours of prior experience Eastern (Soviet era) ADIs or conversely Western ADIs (see Figure 2) . Also see References 9 and 13.

The Soviet era ADI was conceived in the early 1920s for instrument flight and was designed for a beginning pilot and was simpler to build mechanically. Many pilots had difficulty in adapting quickly in abnormal/unusual attitude situations, after Russia and Federated Republic Russian operators began to purchase used Western built aircraft that came equipped with Western ADI, EADI or EFIS cockpit displays and introduced them into operations in the 1990's. This has resulted in LOC incidents and accidents. Re-training has proved very difficult to transition with a pilot's life time flying experience with either type of display.

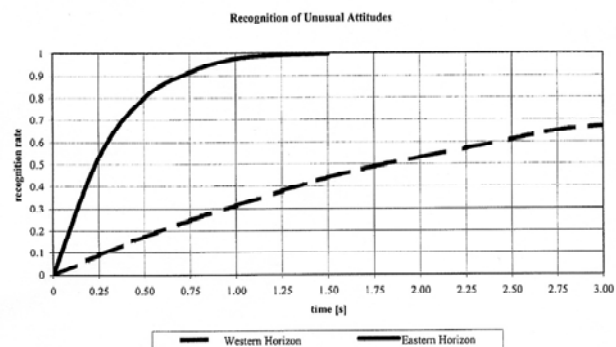
The diagram below shows the results of a study which registered the time needed by pilots trained on eastern horizons to detect an attitude with certainty. The rigid curve represents the situation in which eastern horizons were used, the dotted curve represents the one, when artificial horizons of western make were used.

For instance after one second, 98% of pilots were able to interpret the attitude, if it was represented by eastern horizons. But only 32% of the same pilots could reliably determine attitude after one second on western instruments.

**Figure 3---The Time Recognition Response for a pilot skilled in the Eastern (Soviet) Era ADI to interpret the Western Display\*** *this chart is apparently taken from Russian Research*

The Swiss investigative accident report CRX498 (page 70, and 71 of the report) for a SAAB 340 LOC accident at Zurich (Reference 9) provided some interesting data comparing pilot response time for pilots trained on Eastern (Soviet) ADIs while using a Western ADI format. A similar pilot response would probably occur for a pilot trained and experienced for Western ADIs when using an Eastern formatted display. See Figure 3.

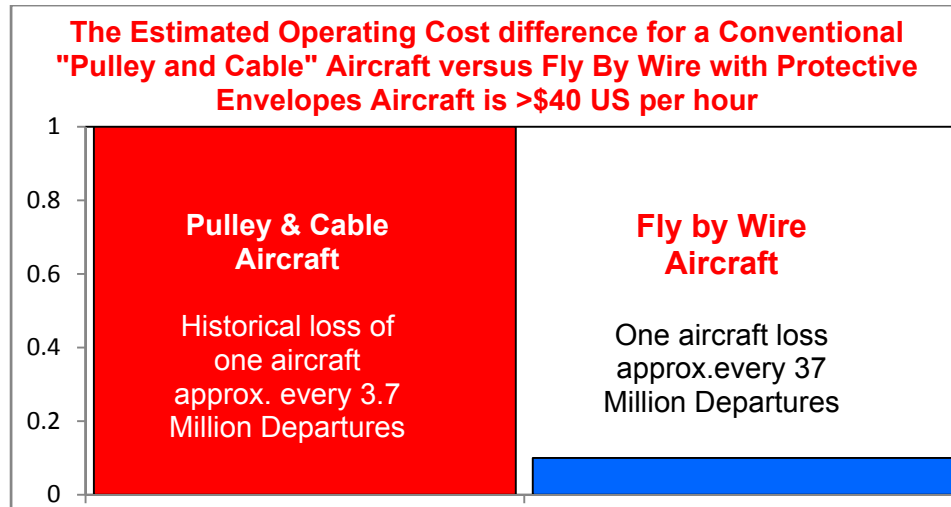
As mentioned earlier, the LOC accident losses (Table 1 in the Appendix) for conventional control system aircraft are approximately \$36 US per flight departure, while FBW aircraft are about \$4 per flight. See Figure 5.

Figure 5--Inferred Operating Risk Cost Difference Between Conventional Versus Fly-By Wire Aircraft

LOC risks are approximately 70 times worse for the Conventional "Pulley and Cable" control aircraft as compared to the "Fly by Wire" aircraft with hard or soft protective envelopes.

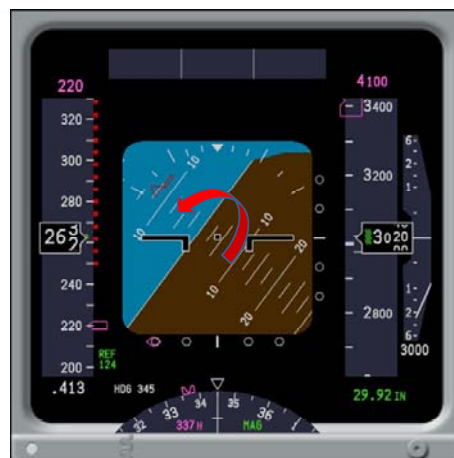
See Figure 7 for one example of a corrective roll attitude Arrow.

Figure 7— Example ADI / EFIS with a Corrective Arrow for an Excessive Bank Angle Situation

In their papers, Gary Gerhzohn of Boeing, William J. Bramble Jr. of the NTSB and Dennis Beringer of the FAA and others (Reference papers 2, 8 and 21), have discussed and looked at the possible use of an roll and pitch recovery “Arrows” on the ADI / EFIS to help the pilot recover from unusual attitudes. In a simulation study, Gerhzohn was able to show that such an Arrow helped reduce errors by 90%, recognition and hesitation time were reduced, helped remove ‘bobble’ (roll reversions) and confusion for the pilot. The pilots could quickly and correctly determine which way to correct the bank angle. For many ADI / EFIS existing displays this could be a modification with minimum investment.

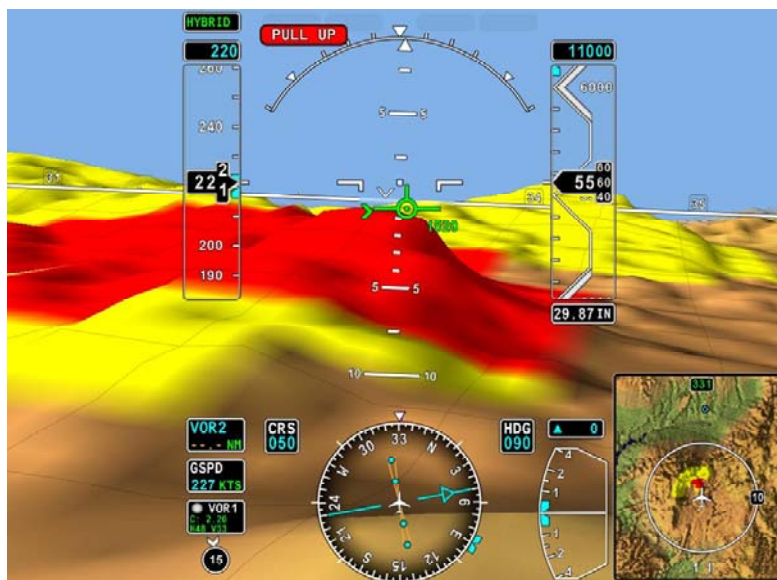
If the pilot can see the horizon clearly outside the aircraft, the probability of loss of control is probably very low. The Synthetic Vision System (SVS) Display does just that by bringing a “daytime clear visibility” synthetic outside view into the cockpit “Heads Down” into an overlay of primary flight instruments similar to those found on a Heads-Up Display (HUD). Both SVS and HUD are very valuable tools for the pilot. Honeywell has a long history in the successful development of both SVS and HUD displays and their application to business aircraft. There have been several SVI papers ---see References 23, 24 and 25. Adding virtual Terrain, Obstacles and the runways can be almost awesome. The databases for terrain, obstacles need to be of high integrity and complete. The pilot in good visual metrological conditions can spot and report any differences to help improve the databases. A typical SVS format is shown in Figure 9.

Figure 9-- Synthetic Vision—bringing the outside world inside to the cockpit.

During a recovery from an unusual attitude, the SVS display can automatically remove non-essential information from the display to help the pilot focus on the recovery.

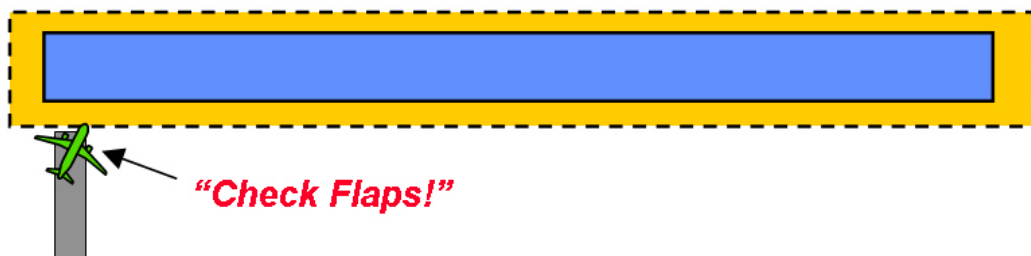
One simple risk reducing function is to provide an aural “CHECK FLAPS!” when entering a runway for Take-Off without Take-Off flaps set. This is currently a function in the E-GPWS requiring **NO** wiring or hardware change where flap position was interfaced to E-GPWS for enabling reactive Windshear functions. A table of acceptable take-off flaps is all that is required as the aircraft enters a “virtual box” around the runway. E-GPWS has the runway data used for the TAWS functions and to create a “virtual box” and with other flight safety functions hosted in E-GPWS. The hosted Take-Off function is **completely independent** of the Configuration Warning System and can also provide a Visual text message “FLAPS” on the existing Navigation-Terrain Display. See Figure 13.

Figure 13---No Take-Off Flap Aural and Visual Advisory

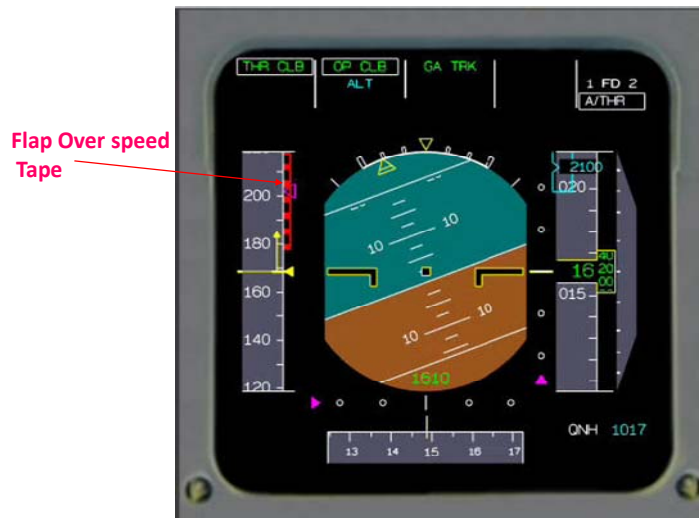
The speed tape typically uses a red stripped area for flap or aircraft overspeed. The natural reaction for a pilot is to push away (nose down) for an aural flap over speed warning and with an airspeed indication akin to a thermometer this will increase the airspeed. For many aircraft types, this red stripped area is also physically close to the normal operating speed when on approach. See Figure 12.

**Figure 12----Airspeed Tape with a Flap Overspeed Stripped Tape**

The author’s opinion is that the EFIS airspeed tape used on most commercial transport aircraft which read zero airspeed at the lower part of the tape similar to a vertical temperature thermometer should be reversed.

In the 1980's, there was considerable debate as to how the airspeed scale should be shown as a typical thermometer or reversed. Honeywell has built and helped certify formatted airspeed tapes for some aircraft (Gulfstream) that could be easily reversed by a program pin and wire. Unfortunately, in the 80's as more glass attitude displays were selected for new aircraft types, the industry gravitated to a vertical scale akin to the temperature thermometer. Now, because of the thousands of aircraft flying this format, it would be difficult to make a change. This could be a concern to some of whether this could introduce a training problem for the pilots, converting from an increasing Airspeed Vertical Speed Tape to that of a reversed scale. Some operators have experienced no such problem for pilots flying either vertical tape presentations for the same business aircraft type.
