**Emergency landing after bird strike**

Boeing 737-4B6, Amsterdam Schiphol Airport,  
6 June 2010

The Hague, November 2011 (project number 2010034)

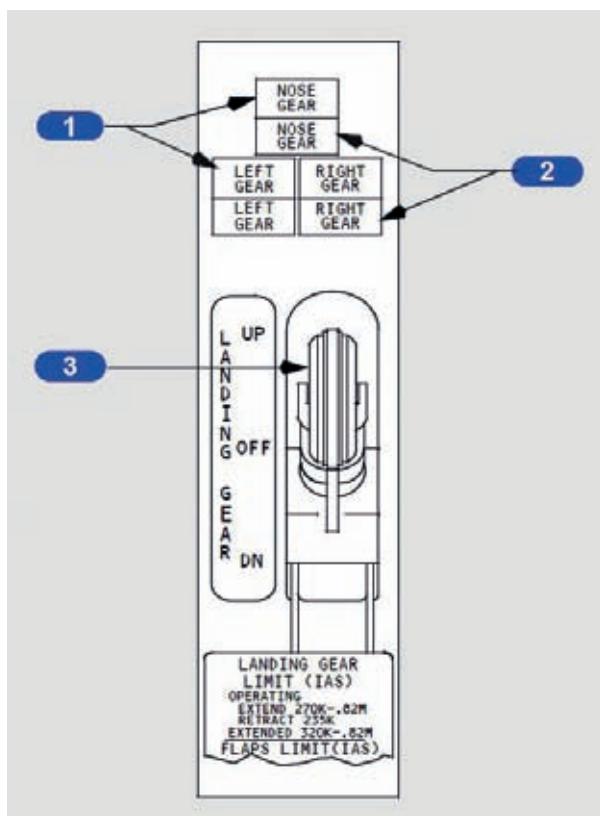
*Illustration 1: landing gear panel*

### *Legend for illustration 1*

1. Illuminated red lights indicate that the landing gear is not down and locked or the related landing gear is in disagreement with the landing gear lever position (in transit or unsafe).
2. Illuminated green lights indicate that the related gear is down and locked.
3. Landing gear lever. The landing gear is retracted in the up position (UP) and extended in the down (DN) position.

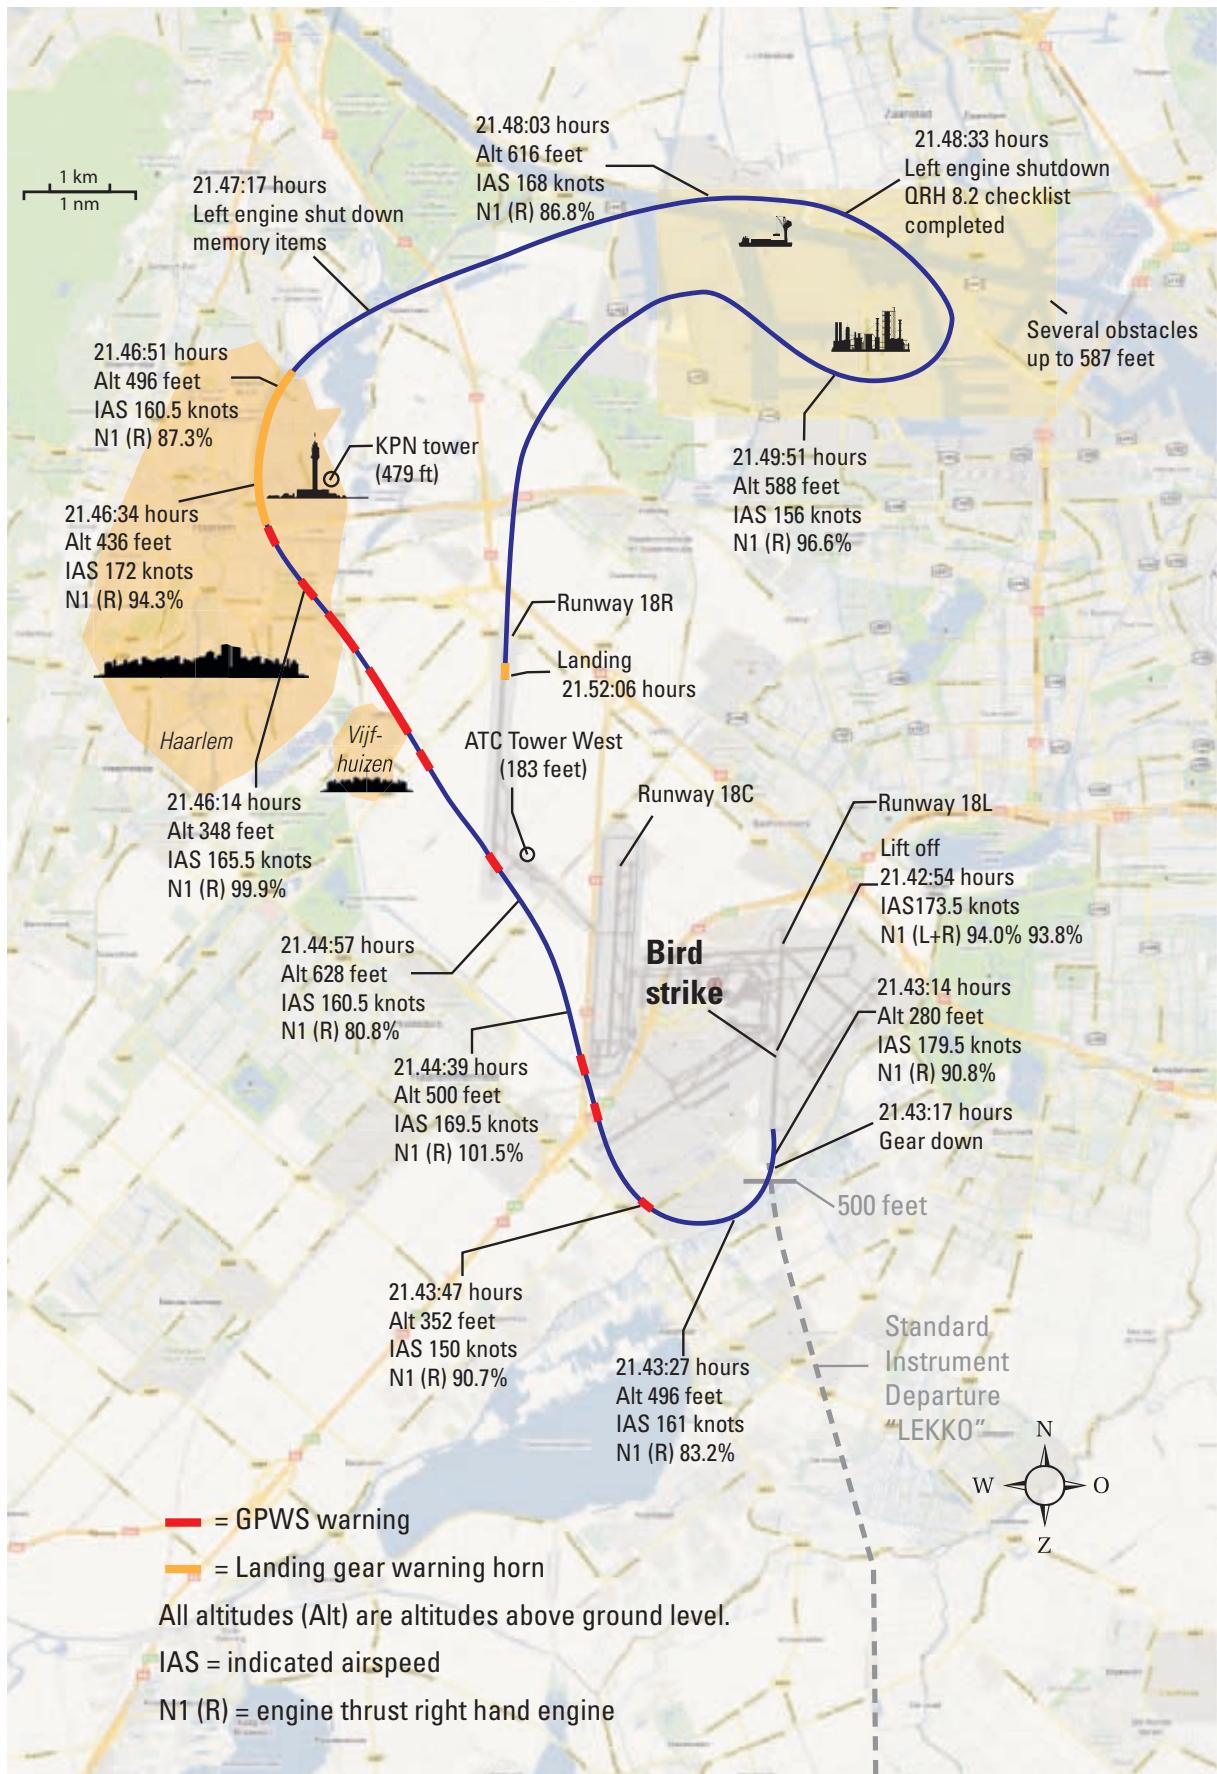
Illustration 2: flown route with the location of the bird strike and part of the standard instrument departure LEKKO

At 21.42:58 hours, at a height of 16 feet the gear retraction was initiated. At this moment with a speed of approximately 175 knots the aircraft encountered a bird strike with multiple geese. This resulted in an immediate loss of almost all thrust on the left engine. The landing gear indication system displayed an unsafe nose gear indication.

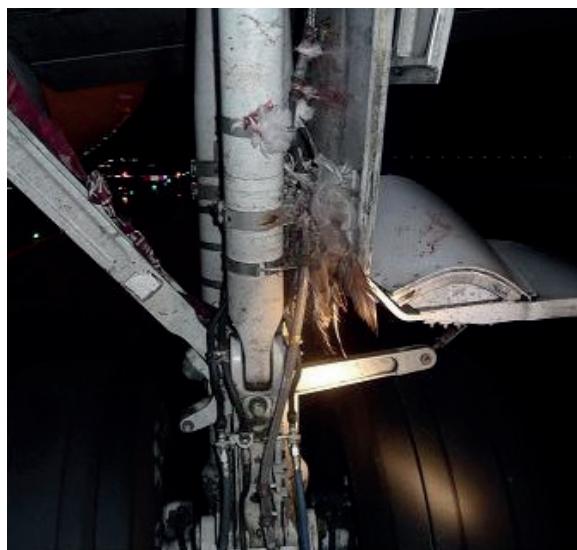
*Illustration 3: bird remains found in the left main landing gear*

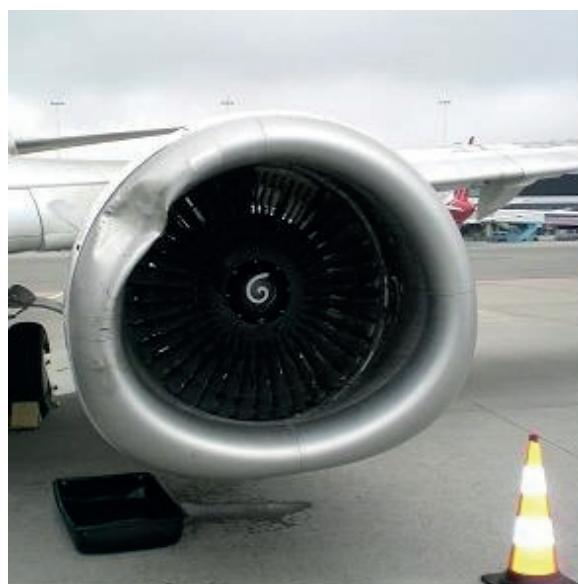
*Illustration 4: damaged left engine cowling*

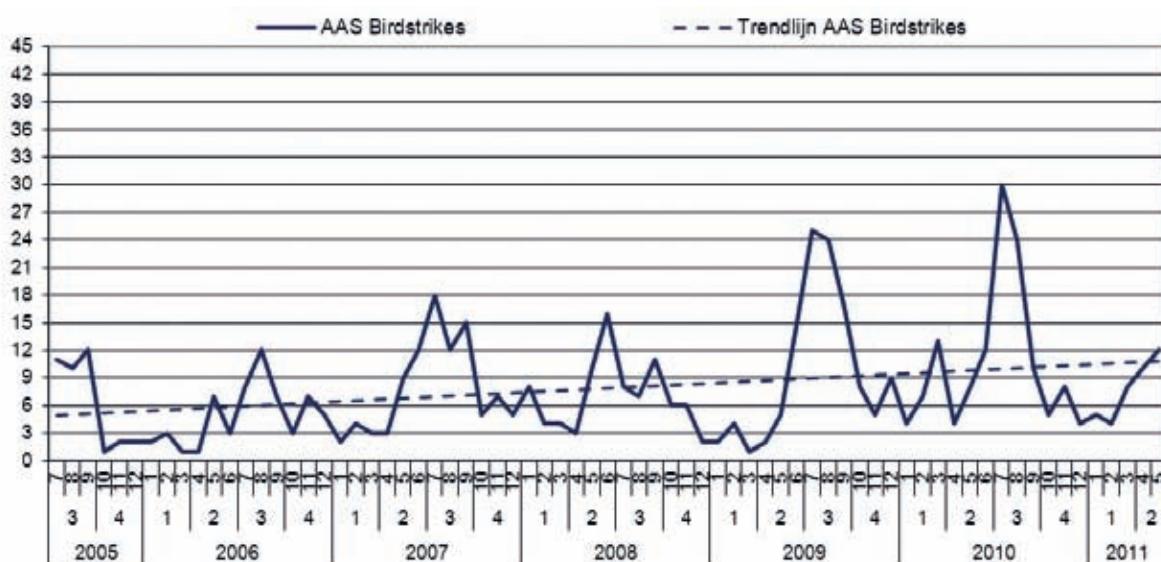
The illustration below shows the number of bird strikes per month and trend in the period medio 2005 till medio 2011 at Schiphol airport (all sorts of birds).

Illustration 5: number of bird strikes per month over the period medio 2005 till medio 2011 at Schiphol airport (all sorts of birds) during landing below 200 feet and during start up to 500 feet [Source: Amsterdam Airport Schiphol]

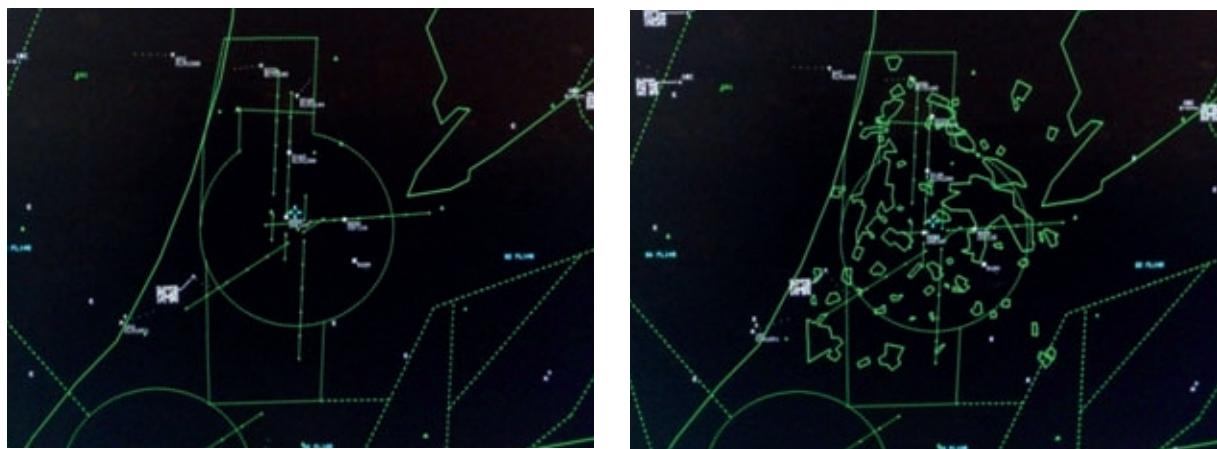
Illustrations 6 and 7: radar screen with Schiphol airport in the middle, normal (on the left), radar screen with built-up areas in 2000 (on the right)

The outcome of the 3PR investigation was that although it may be technically possible to show populated areas on radar screens, neither pilots nor air traffic controllers believe it is effective or practical to do so.

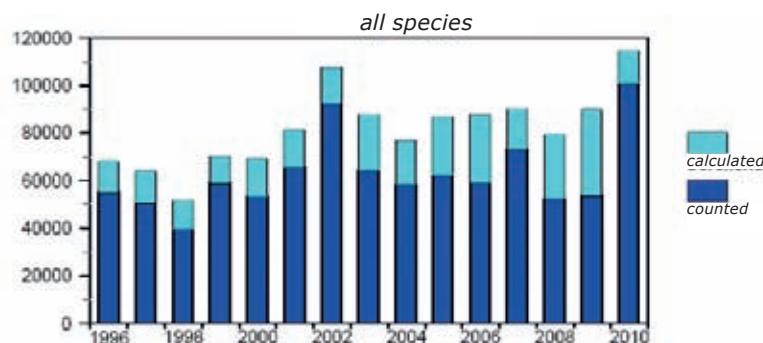
The numbers of birds that can constitute a risk for bird strikes in the 10-kilometre area around Schiphol airport have been recorded. Illustration 8 shows that the number of waterfowl representing a risk to flight safety has almost doubled over a ten-year-plus period. This increase is almost entirely attributable to the rapidly rising number of geese in the area around Schiphol airport. See illustrations 9 and 10. Observations have also established that the number of migrating geese flying over Schiphol airport is on the rise. If efforts to control the bird population are not intensified, these numbers can be expected to rise further still.

Illustration 8: numbers of water fowl (all species) representing a risk to flight safety within the 10-kilometre zone around Schiphol airport in the 1996-2010 period [source: SOVON]

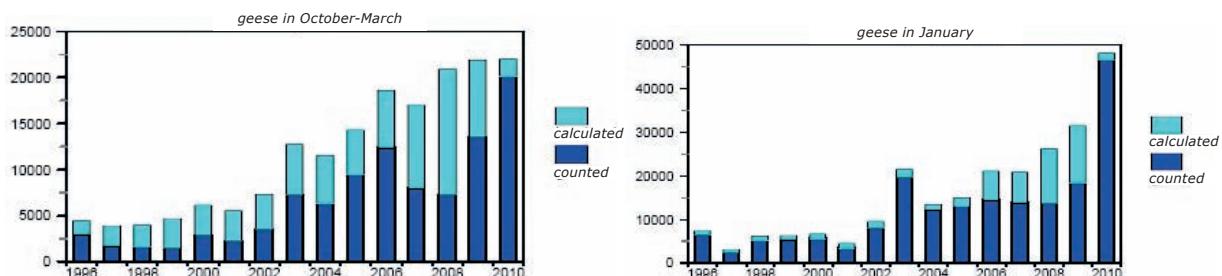
Illustrations 9 and 10: numbers of geese in 10-kilometre zone at Schiphol airport in the period 1996-2010. [source: SOVON]

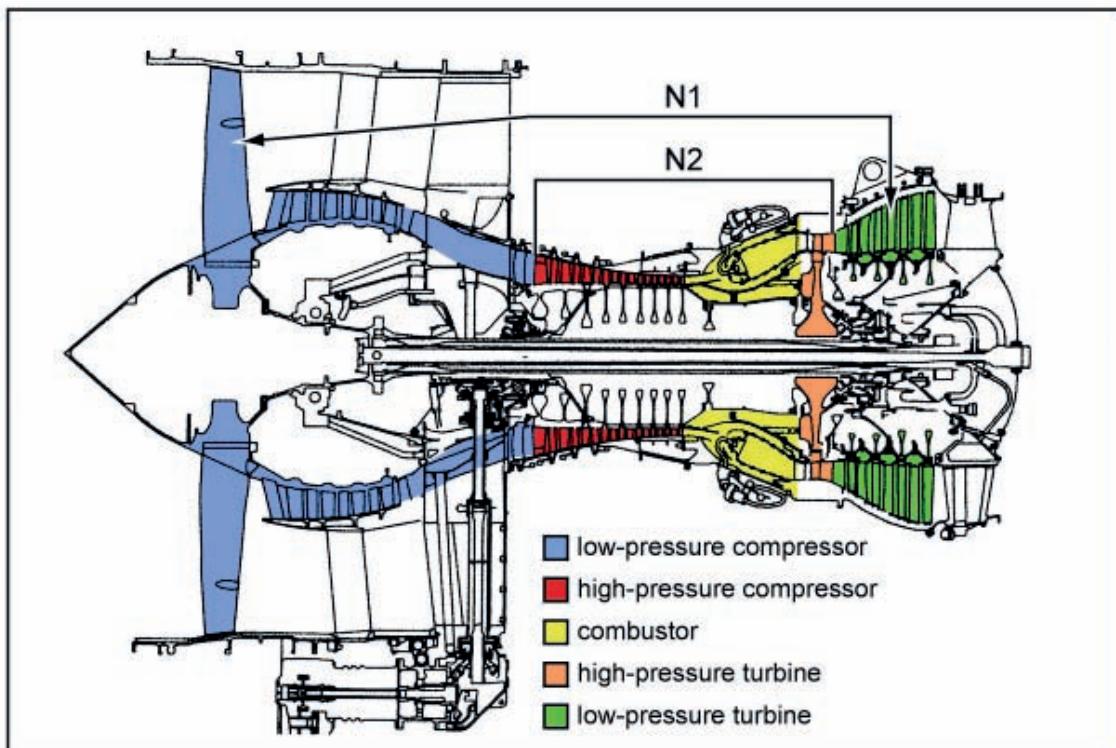
The CFM56-3C-1 engine comprises an inlet area, which contains a gas-turbine-driven ducted fan, a 3-stage<sup>74</sup> low-pressure compressor (LPC), a 9-stage high-pressure compressor (HPC), a combustor, a single-stage high-pressure turbine (HPT), a 4-stage low-pressure turbine (LPT) and an exit exhaust nozzle. Illustration 11 shows a cutaway of a turbofan engine.

Illustration 11: cutaway of a turbofan engine (not a CFM56-3 engine) showing the LPC, HPC, combustor, HPT, and LPT (source: Aviation Accident Report NTSB/AAR-10/03)

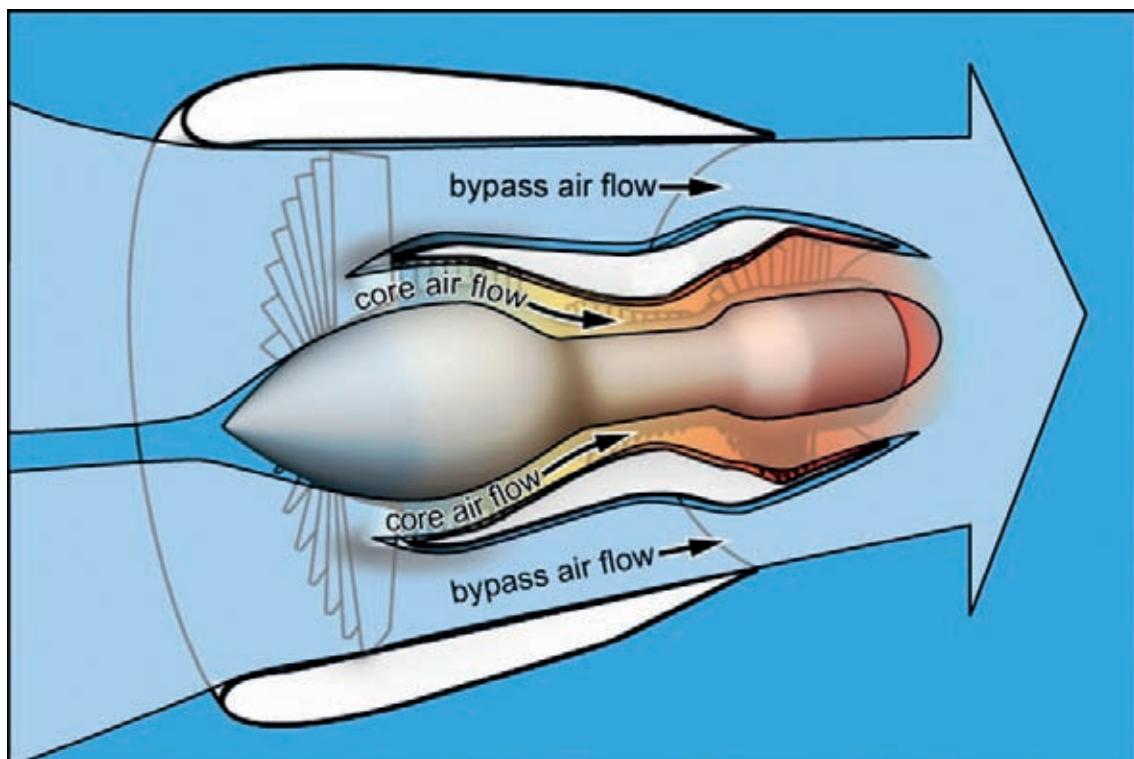
Air enters the engine inlet area, passes through the ducted fan, and is then channeled to two distinct flow paths. Most of the air bypasses the engine core and is directed through the bypass duct, providing about 70 percent of the engine's overall thrust. The remaining air enters the engine core, where it is compressed; mixed with fuel; combusted; expanded through the LPT, providing rotational power to the fan; and then exhausted, supplying about 30 percent of the engine's overall thrust. Illustration 12 shows the two airflow paths through the turbofan engine.

Illustration 12: a diagram showing the two airflow paths through the turbofan engine (source: Aviation Accident Report NTSB/AAR-10/03)

A bird may strike any part of the engine inlet area. If a bird enters the inlet near the outer radius, it will most likely strike only the fan blades, continue along the bypass duct, and be ejected at the rear of the engine. In this case, the fan blades may exhibit some form of leading edge impact damage and may bend and fracture. Debris continuing downstream can damage the bypass duct and fan outlet guide vanes. All of this damage negatively affects thrust production; however, typically, the engine will still be able to operate at a lower thrust level.

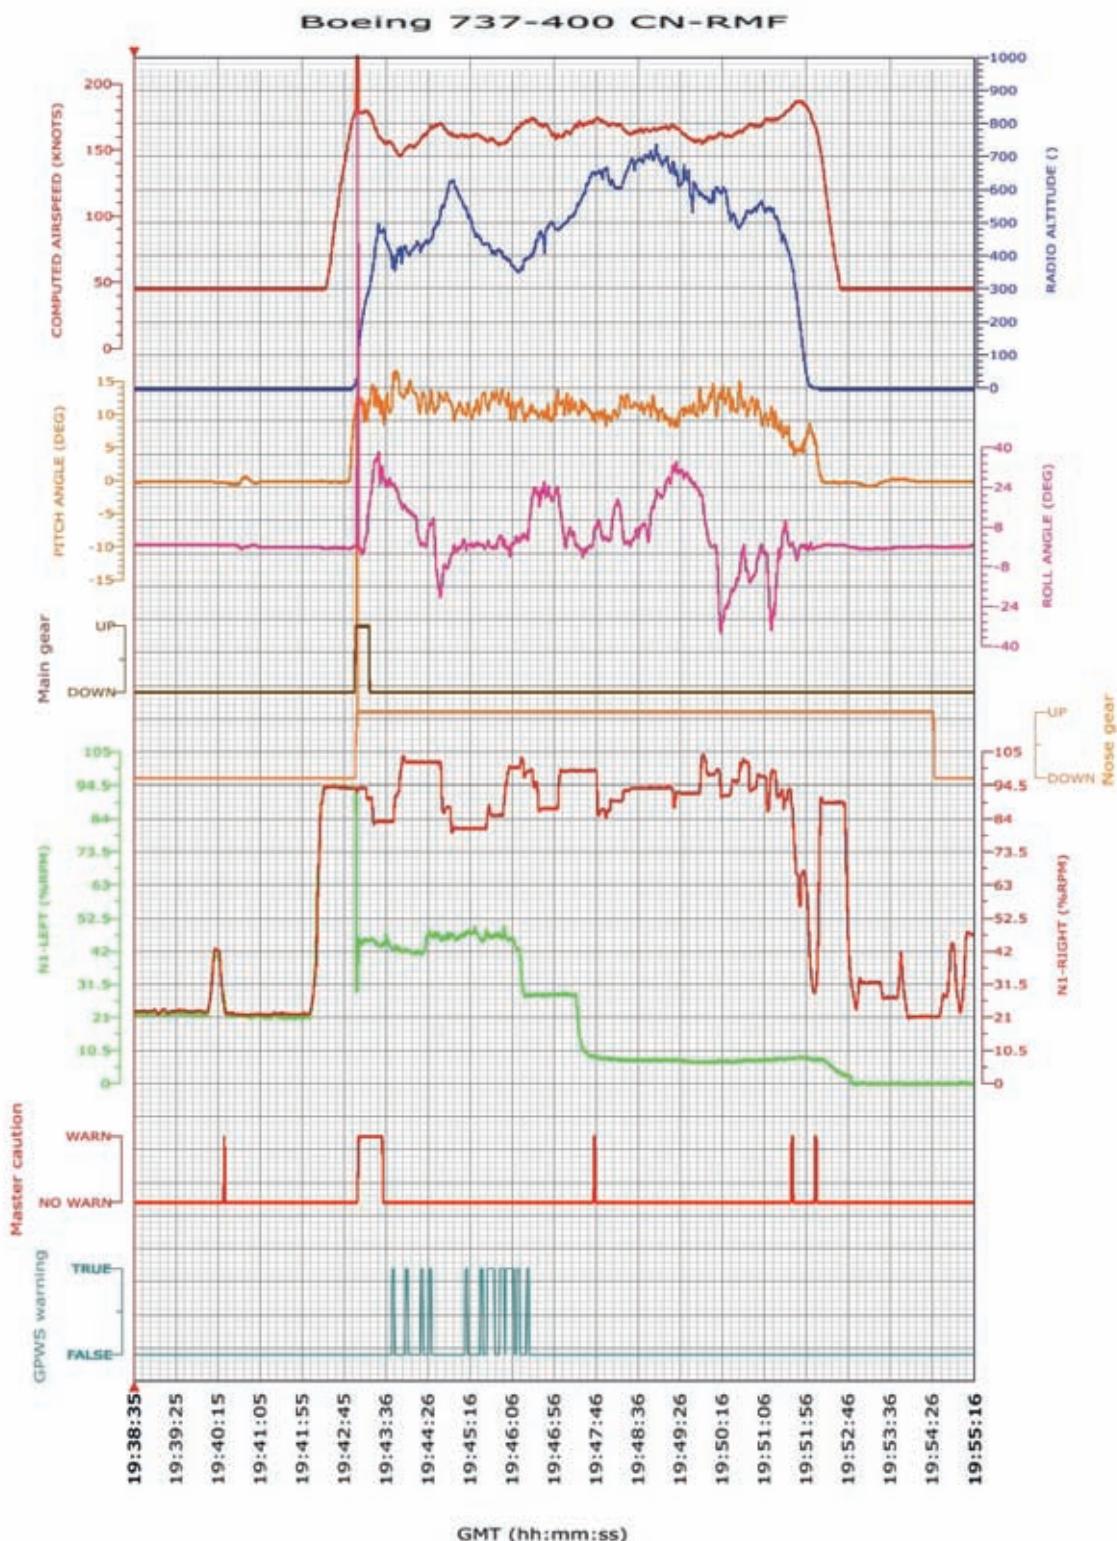
A plot has been created showing relevant data from the flight RAM685R data recorder. The horizontal axis shows the time in GMT (Greenwich Mean Time) in [hours.minutes:seconds]. GMT is local time minus two hours.

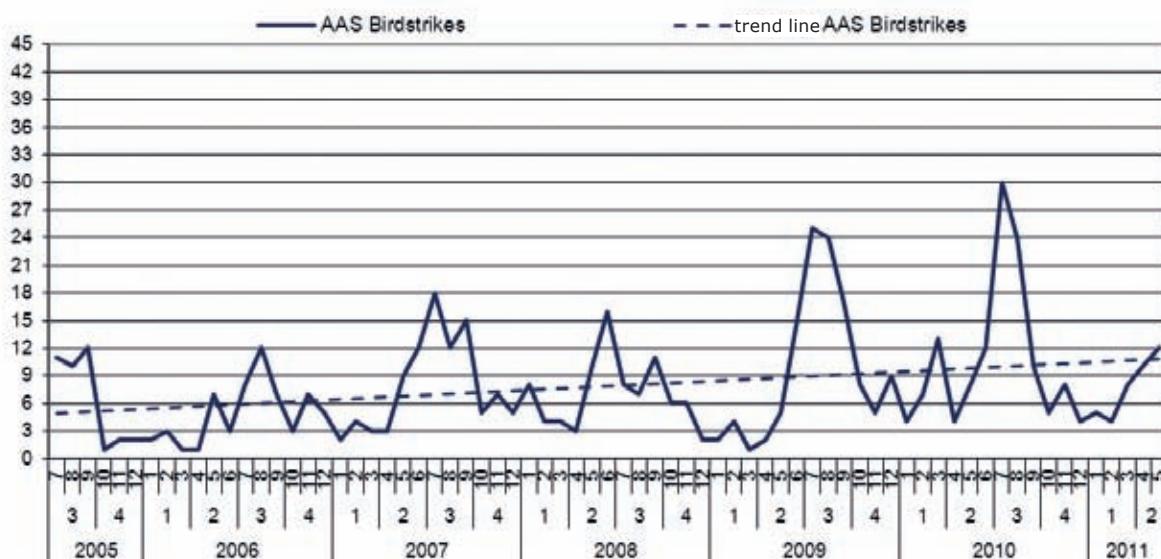
The graph below shows the trend in the number of bird strikes per month over the period from mid-2005 to mid-2011 (all species of bird).

Figure 13: number of bird strikes (all species of bird) per month over the period mid-2005 to mid-2011 [Source: Amsterdam Airport Schiphol].

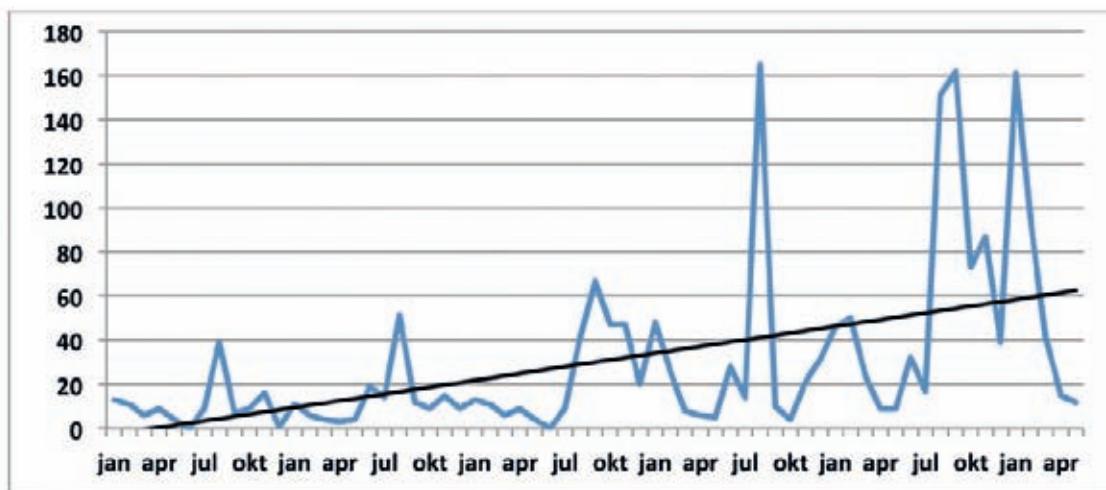
Figure 14: number of sightings of geese flying over Amsterdam Airport Schiphol from January 2006 to April 2011 inclusive and trend line [source: Amsterdam Airport Schiphol]

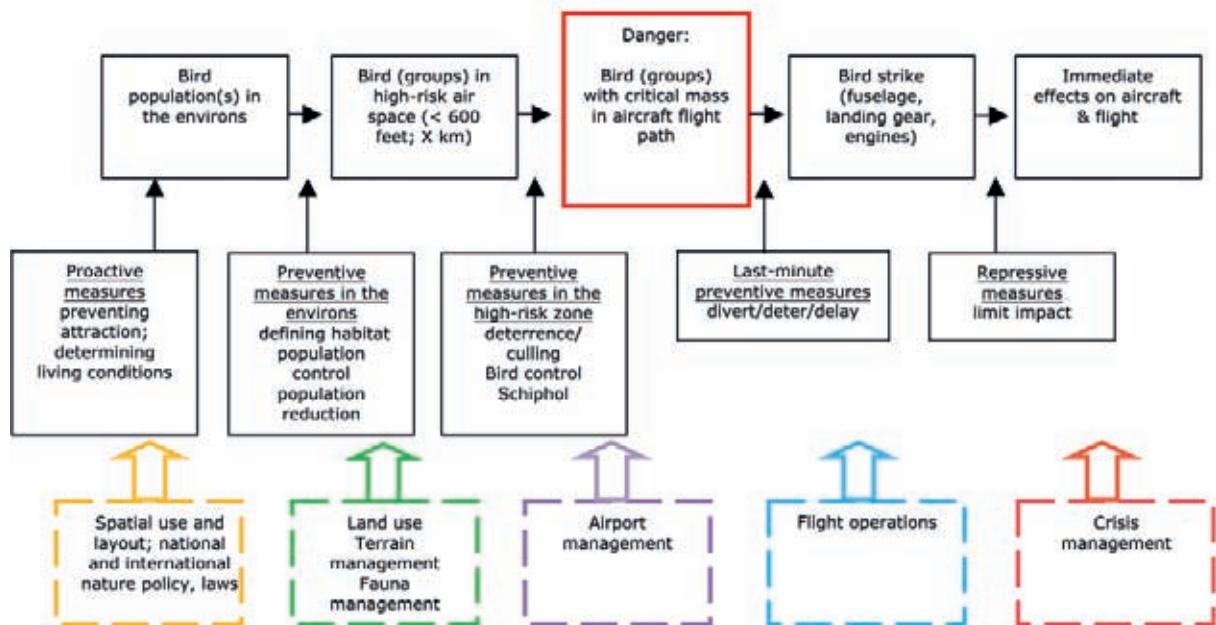
Figure 15: bird strike risk chain and intervention chain

Figure 15 illustrates the two key aspects of the bird strike issue:

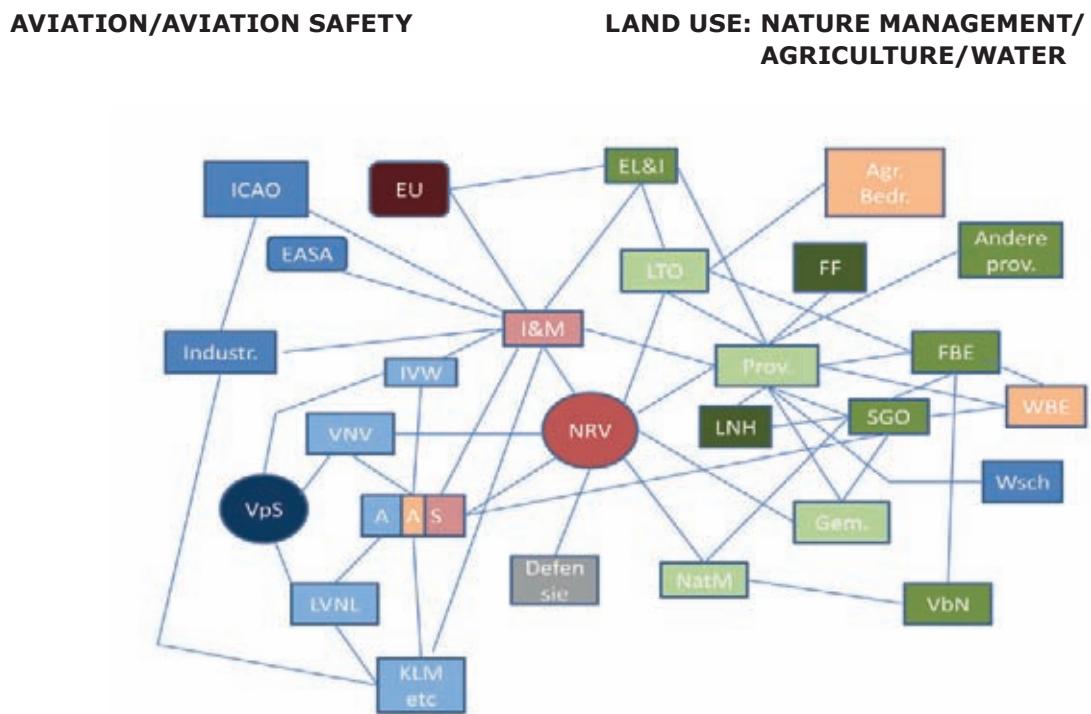
The authorities coloured orange are authorities that can perform actual management activities. The other authorities are involved in a regulatory or policy-related capacity and/or as dialogue partners.

Figure 16: authorities involved in bird control at and around Amsterdam Schiphol Airport

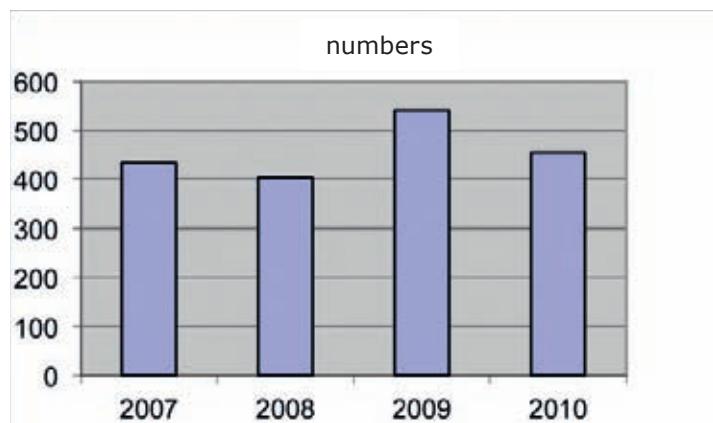
The graph below shows the total number of bird strikes reported in the Schiphol control zone and Schiphol terminal control area and the airspace around Schiphol, for all species of bird, including suspected bird strikes and near collisions in the years 2007 -2010 [source: Occurrence Analysis Bureau, IVW].

*Figure 17: number of bird strikes reported in the Schiphol control zone and terminal control area in years 2007 - 2010*

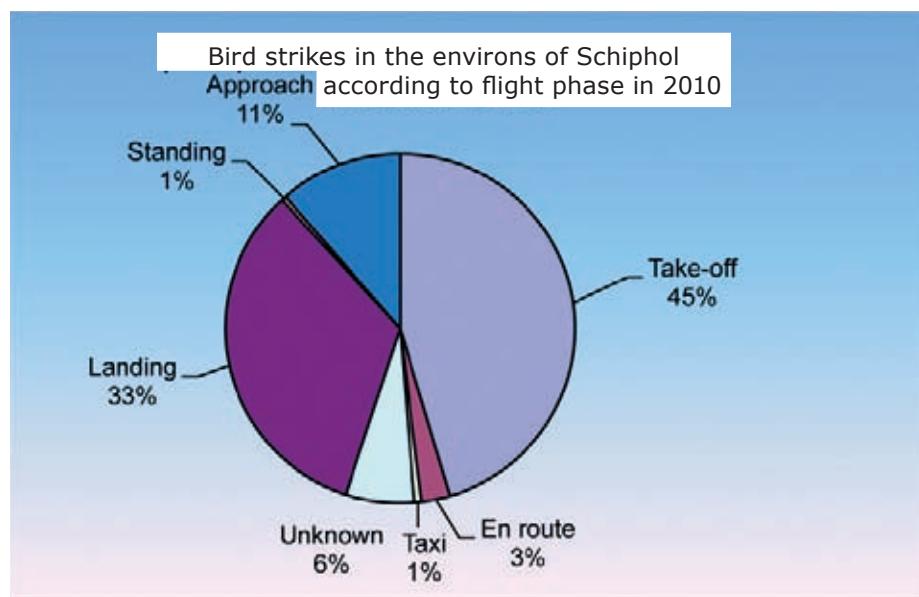
The figure below shows the statistics according to flight phase for bird strikes in the Schiphol control zone and Schiphol terminal control area [Source: Occurrence Analysis Bureau, IVW]

*Figure 18: statistics according to flight phase for bird strikes in the Schiphol control zone and terminal control area in 2010*

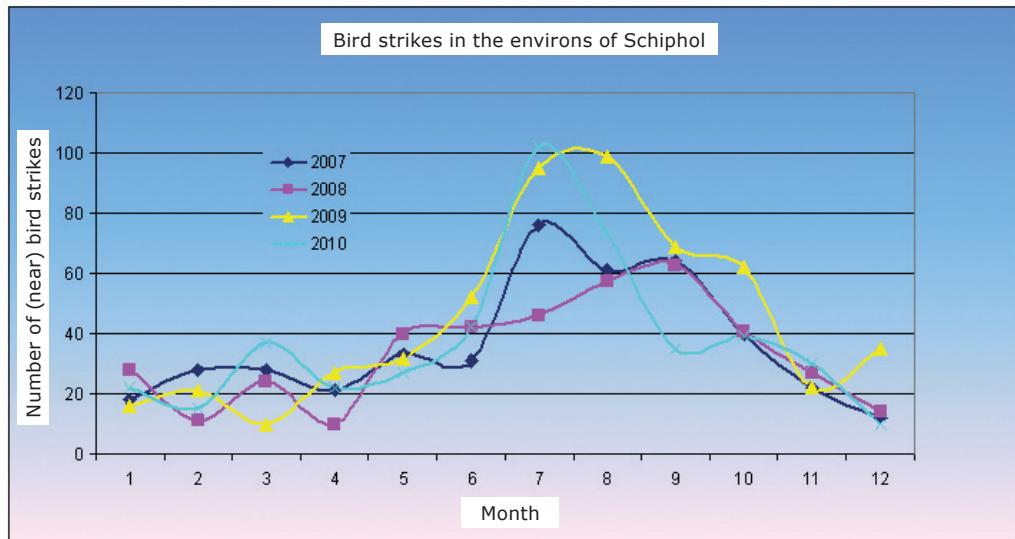
The figure below shows the trend in the number of bird strikes in the Schiphol control zone and Schiphol terminal control area (all birds) and distribution across the months (years 2007-2010). [Source: Occurrence Analysis Bureau, IVW]

Figure 19: trend in the number of bird strikes in the Schiphol control zone and terminal control area (all birds) and distribution across the months (years 2007-2010)

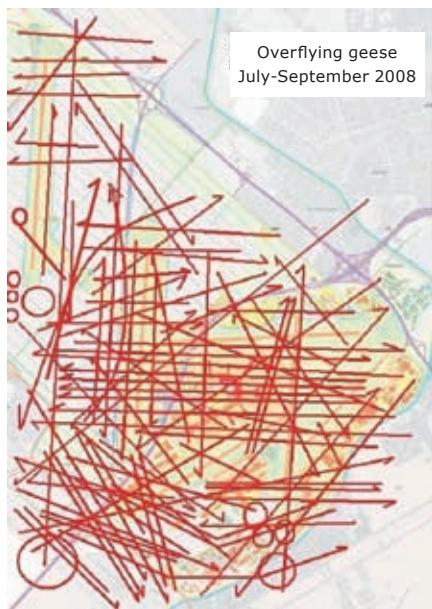
The figures below show sightings of overflying greylag geese in 2008 and 2010. Each line represents a group of overflying greylag geese, with the arrow indicating the direction of flight [source: Schiphol Safety Platform].

Figure 20: sightings of overflying greylag geese in the third quarter of 2008

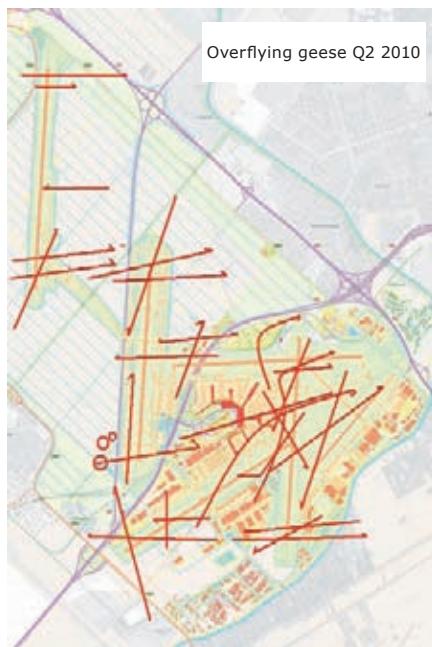
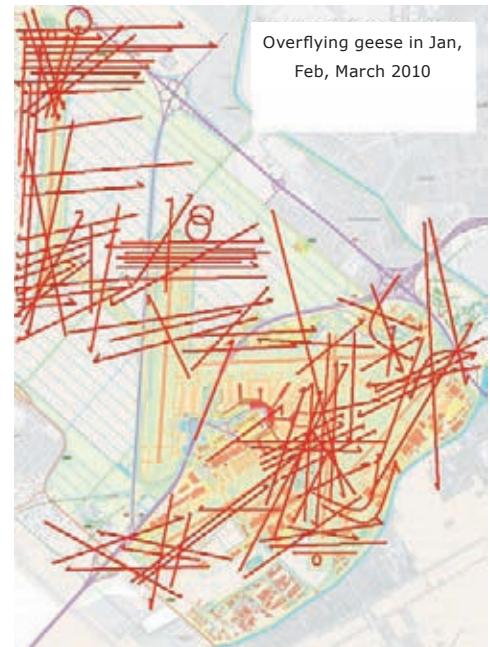
Figures 21 and 22: sightings of overflying greylag geese in the first and second quarters of 2010

The number of goose flyovers observed in 2010 is shown in figures 21 to 24 inclusive, Attachment 1.

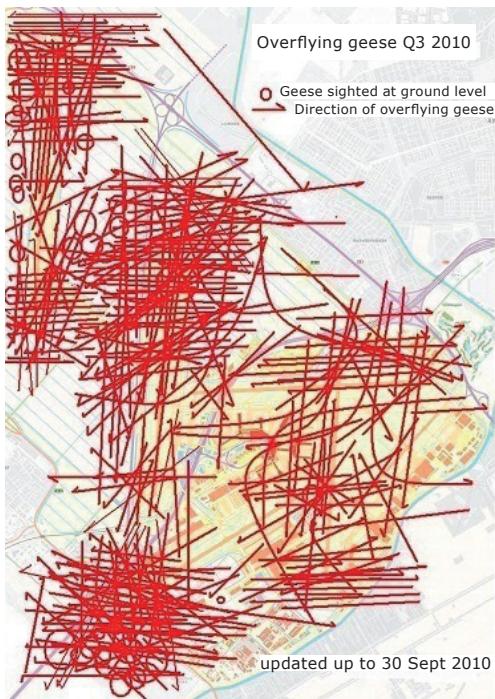
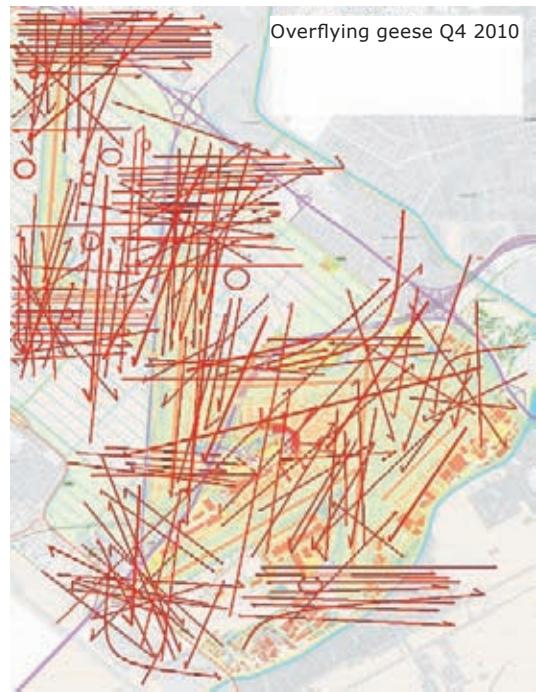
Figures 23 and 24: sightings of overflying greylag geese in the third and fourth quarters of 2010

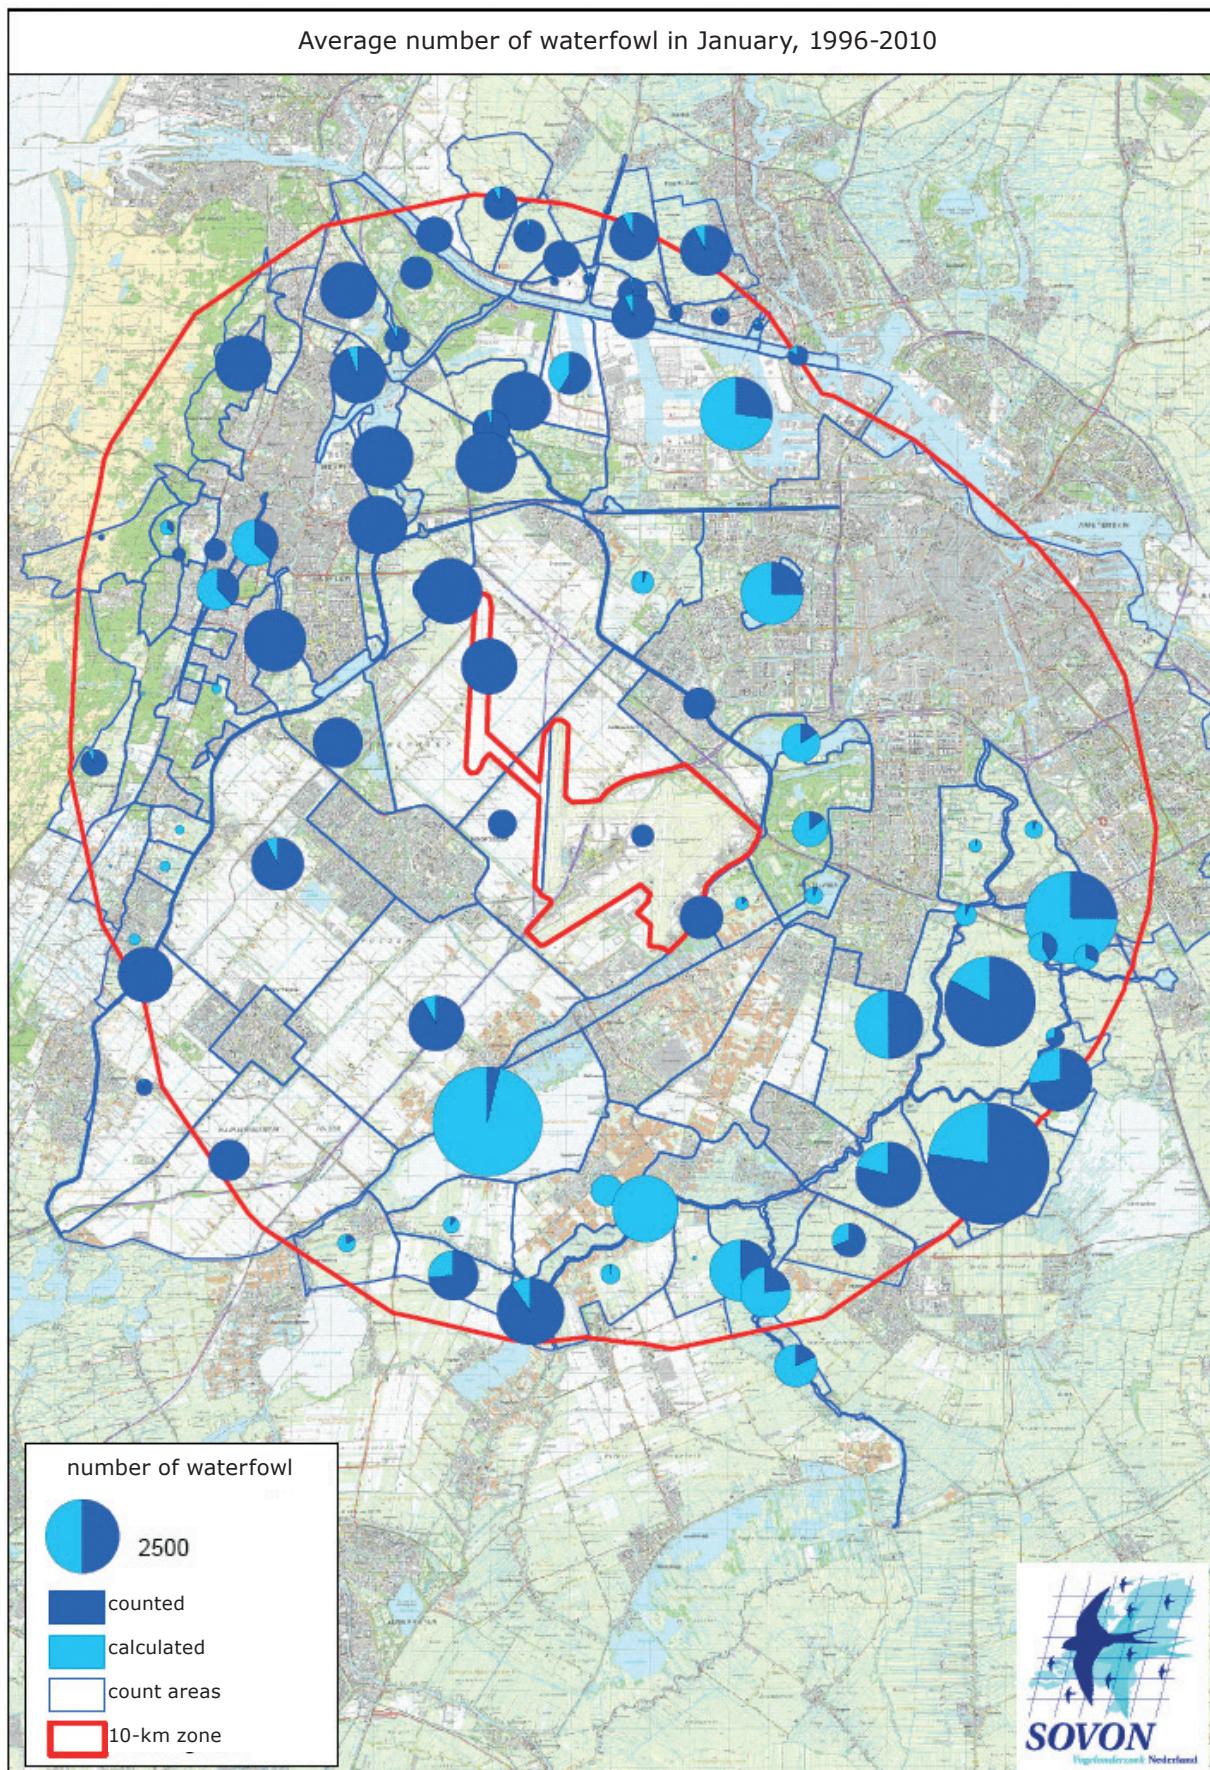
Two figures have been produced that show the average number of waterfowl in January in 1996-2010 and the average number of summer birds in 2008-2010. To place the statistics within a long-term context, a number of bar charts have been produced that show the winter averages for each year. Both the winter average for geese based on the January count and a winter average over the months October to March are also included. The effect of the harsh winter in 2010 was very noticeable during the January count, however the numbers over the winter season as a whole bear a greater resemblance to those in the previous year. This shows that the distribution of geese during the winter months is reasonably flexible.

Figure 25: location and average number of waterfowl in the 10-kilometre zone around Schiphol airport in January 1996-2010 [Source: SOVON]

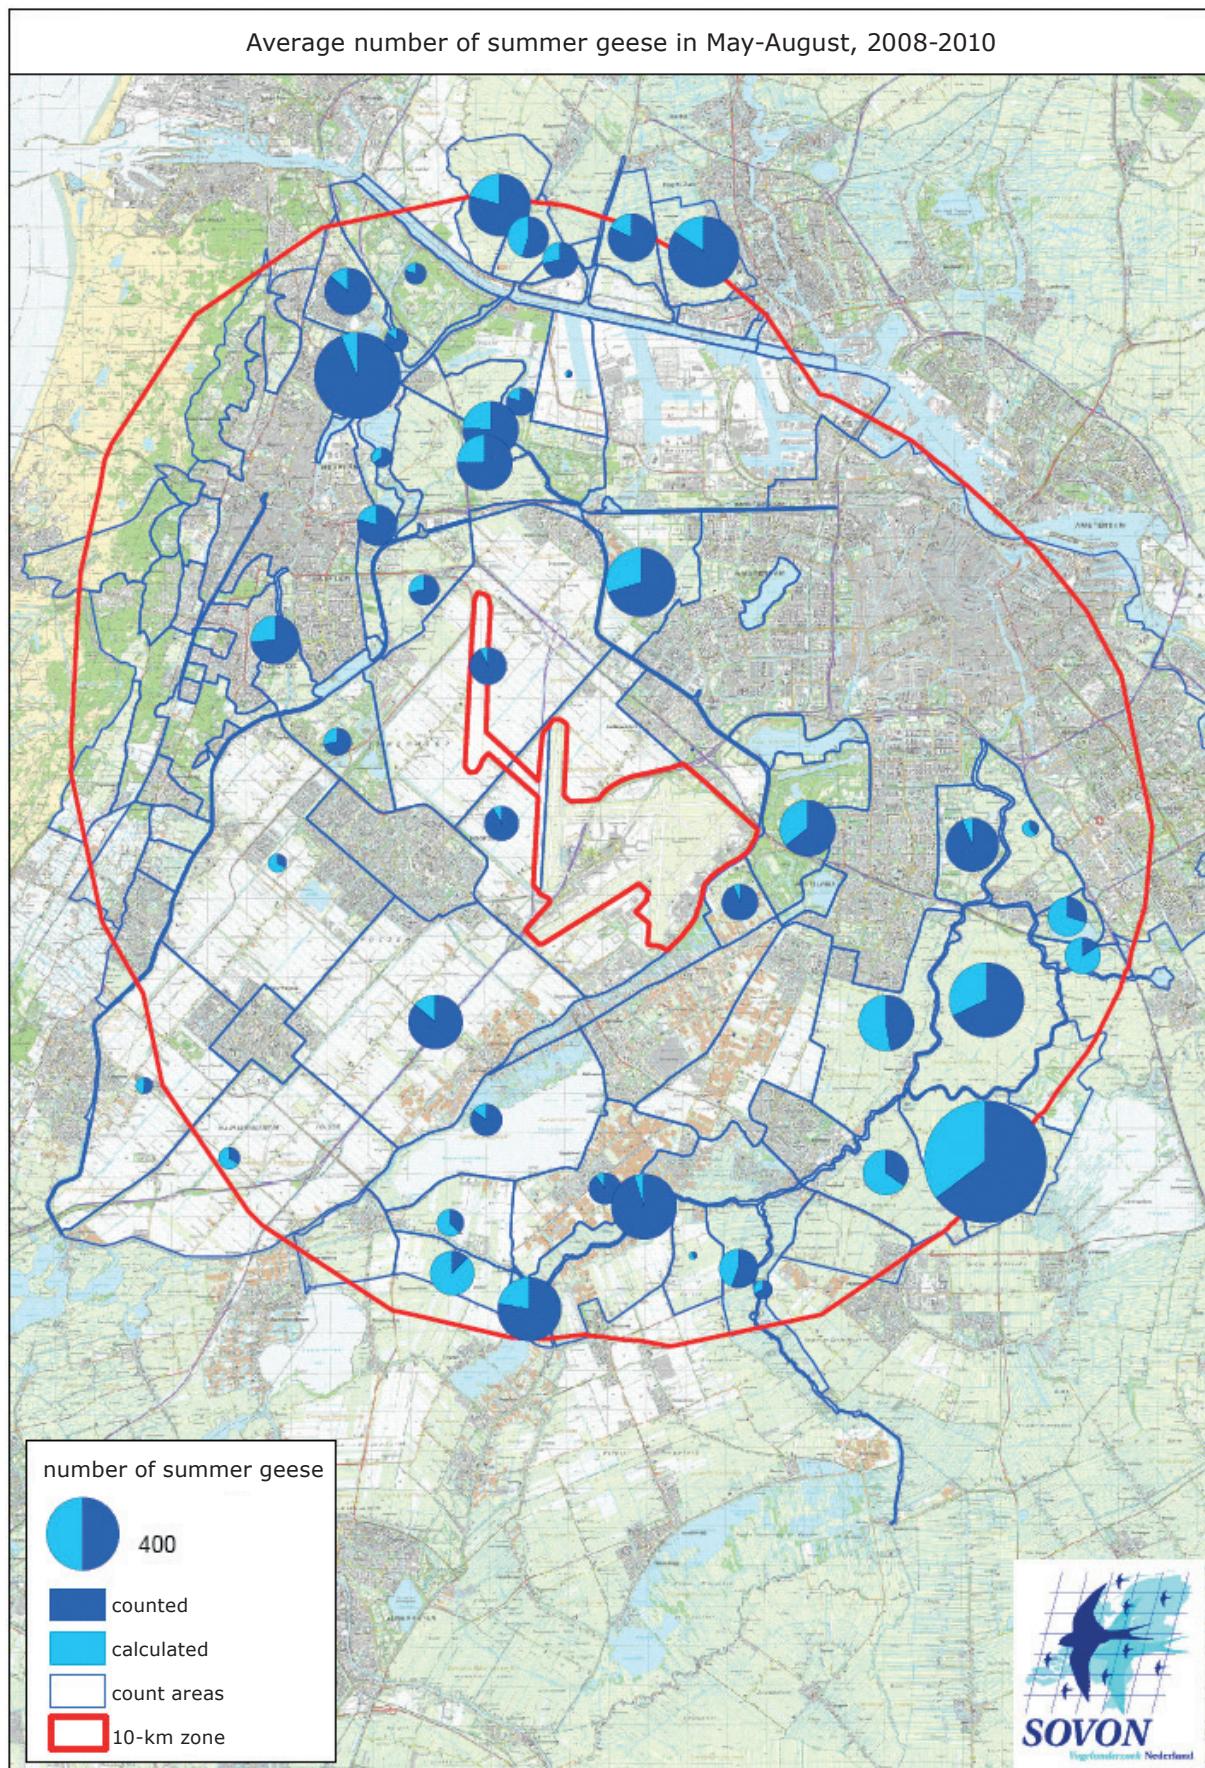
Figure 26: location and average number of summer geese in the 10-kilometre zone around Schiphol airport in May-August 2008-2010 [Source: SOVON]

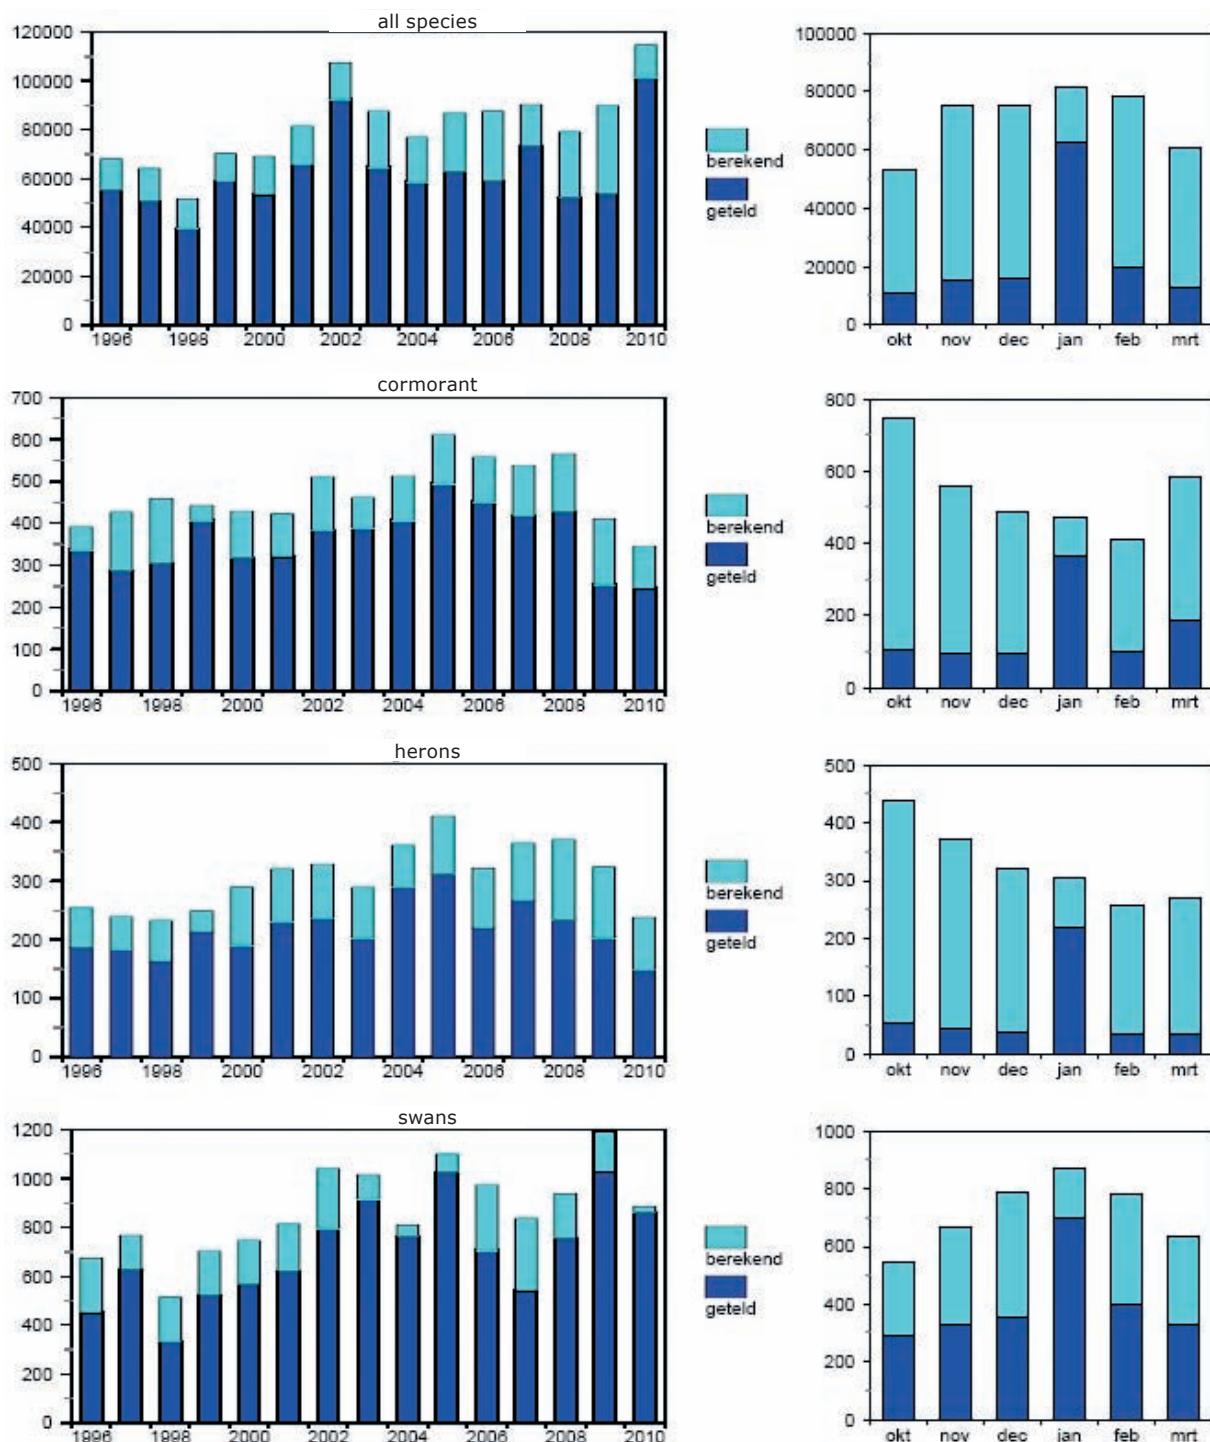
The figures below show the counted (geteld) and calculated (berekend) waterfowl in the 10-kilometre zone around Schiphol airport from 1996-2010 [Source: SOVON].
