SMCG – Second Industry day
19.04.2013

Lufthansa Technik Group
“Measurement and driving of Safety Performance”

Measurement and driving of safety performance

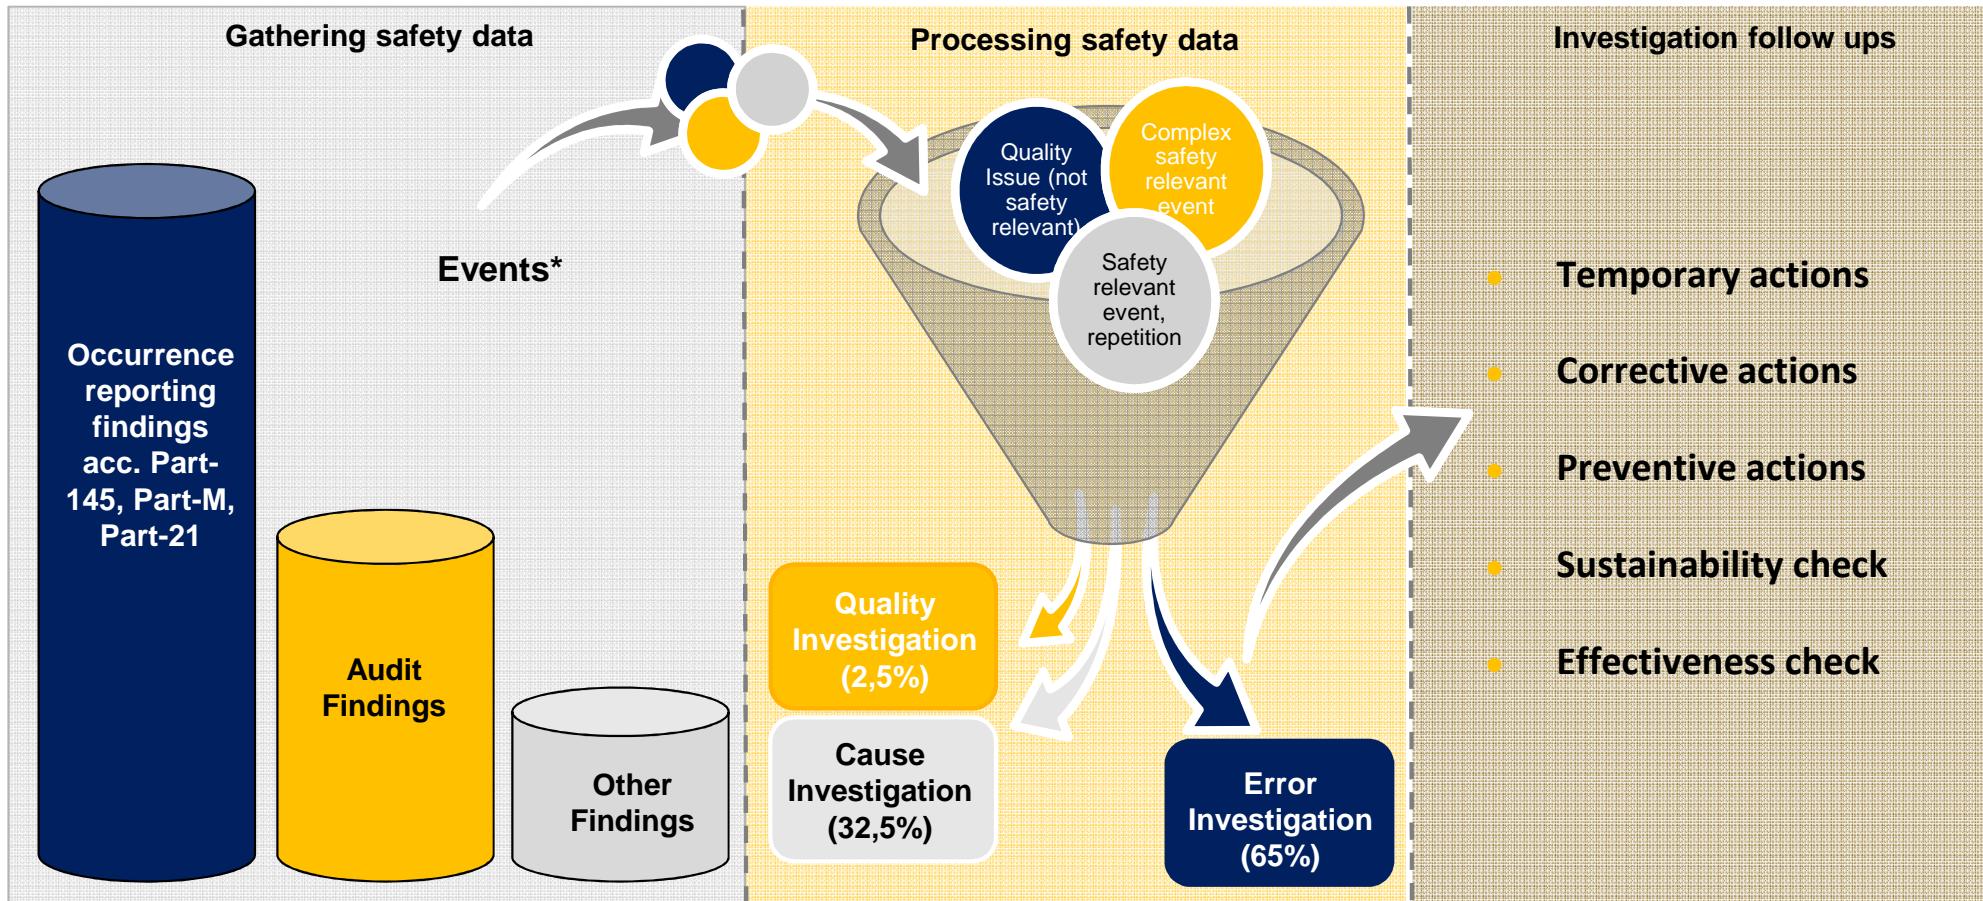
Gathering and processing of safety data

* 2012: 2500 events

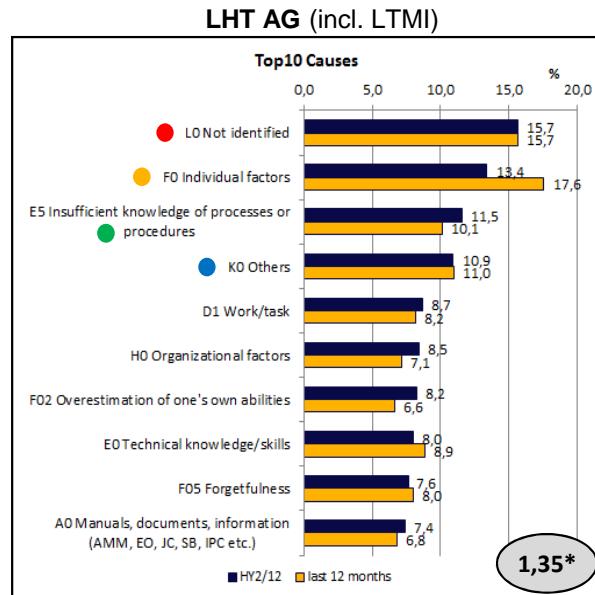
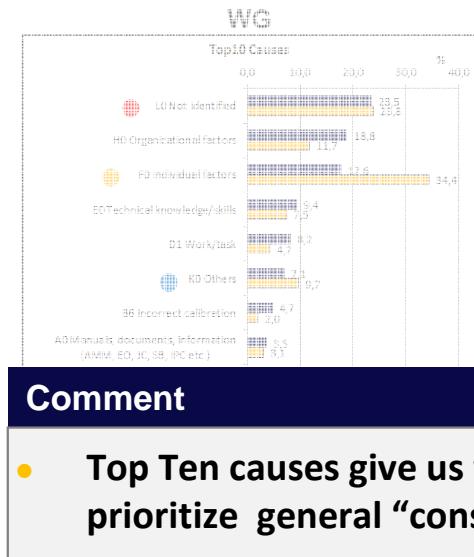
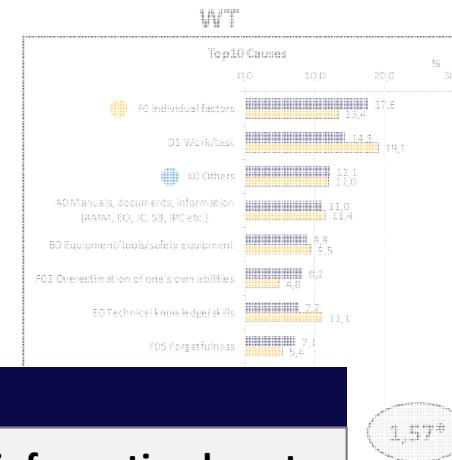
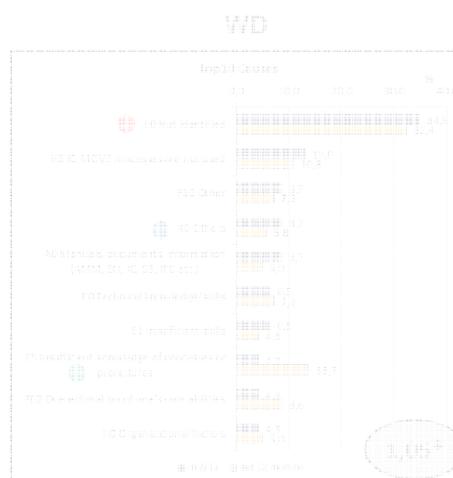
Measurement and driving of safety performance – Top Ten causes

- Top Ten causes give us well information how to prioritize general “construction sites”
