FROM THE BRIEFING ROOM

Runway safety at Amsterdam Schiphol

by Job Brüggen and Jan Smeitink

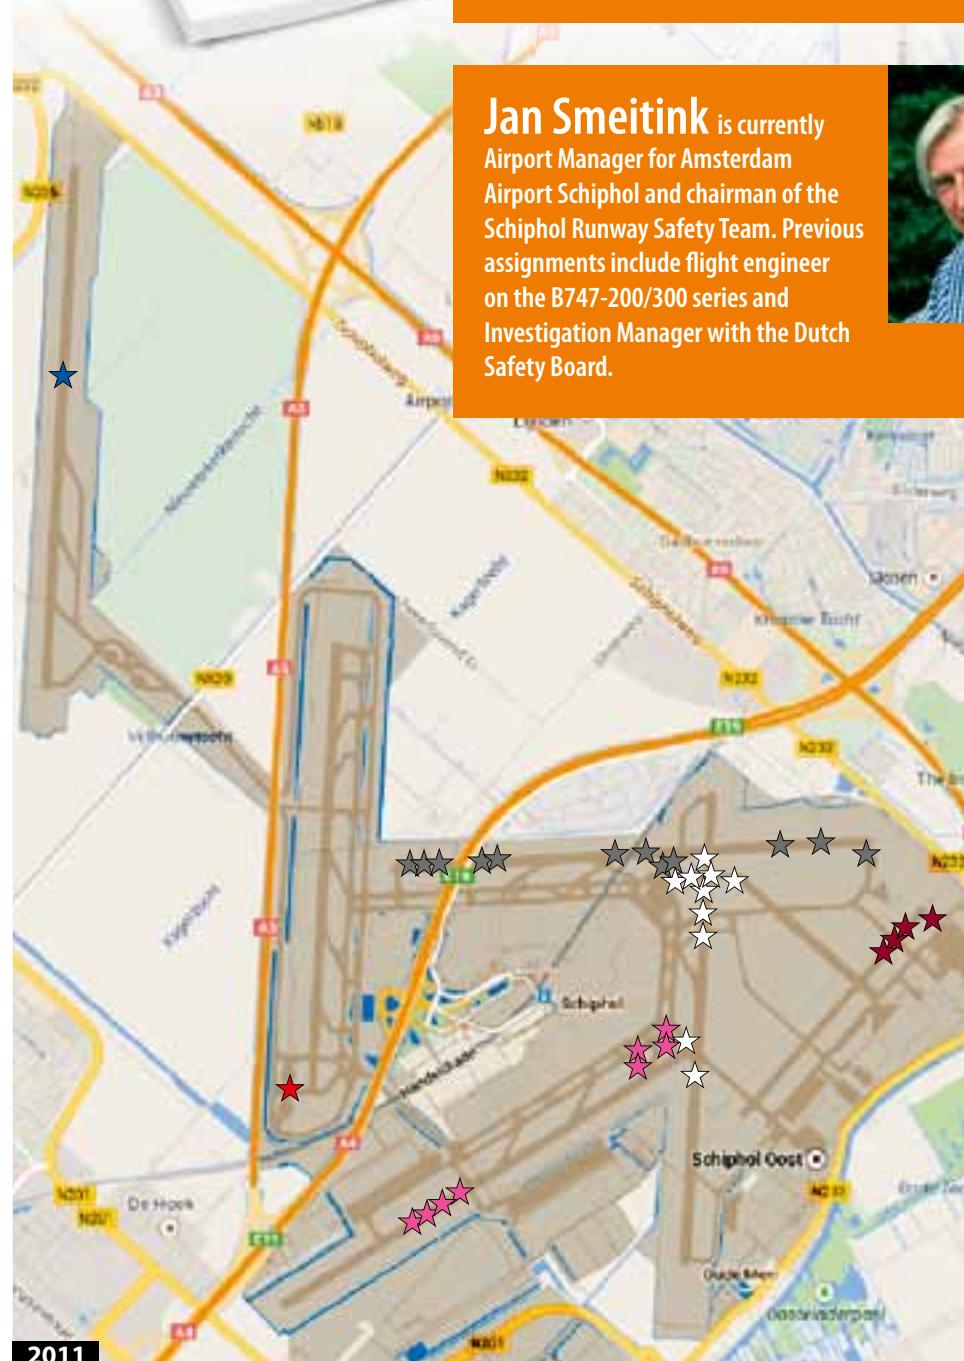
On an annual basis all runway incursions are plotted in a map, showing the runway system at Schiphol. The use of such a map as part of a comprehensive annual report on runway safety, is a great help in objectively identifying hotspots and it provides a strangely powerful means to convince management of the need for necessary changes and their cost.

While the map itself depicts events in absolute numbers, more detailed analyses can relate the number of incursion events on each runway to the traffic density on the runway involved. Would you guess that the incursion rate of the most vulnerable runway 04-22 is about six times higher than the best performing runway 18R-36L? Given the geography and usage, perhaps this is not a big surprise, but clearly there is room for improvement.

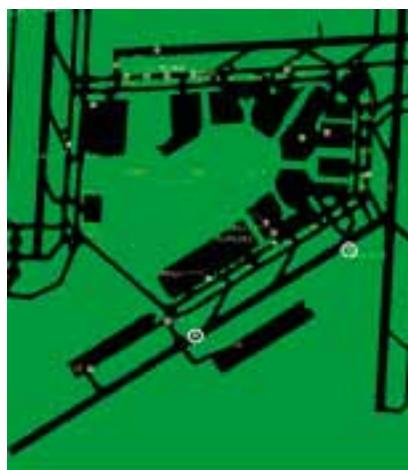
An especially valuable addition was the introduction of an alerting tool to warn tower controllers verbally and visually of potential collision risks. The words "Incursion, zero six! Incursion, zero six!" are sure to get the controller's attention and swift action will follow to mitigate the severity. Have a look at the radar screen of the tower controller, showing an alert (the two white circles around the labels).

Introduction of the tool was only possible after the installation of a full multi-lateration system at the airport and the introduction of a requirement for all vehicles with access to the manoeuvring area to be equipped with a transponder. The system became fully operational for all six runways on 20 December 2010 and has become one of the best trusted friends in the tower

cab. It works day and night, independent of lighting, visibility, stop bar status or runway usage.

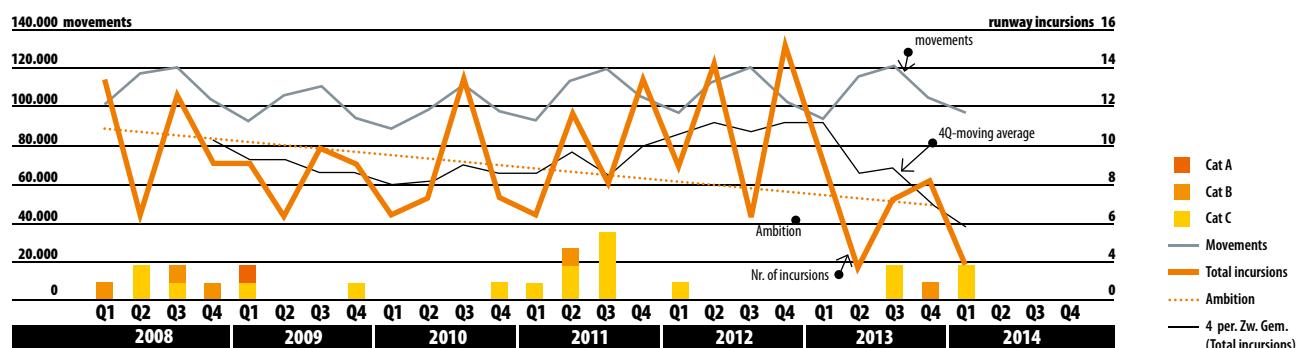
Have a look at the chart below. The blue line shows the absolute numbers of runway incursions, including even the most futile incidents. You may notice that the severity of the incursions has dropped, which for us is far more important than their total number. Nevertheless, the total number is now also beginning to fall.
