EMAS - A PASSIVE SAFETY NET FOR RUNWAY OVERRUNS

by Stan Koczkodaj

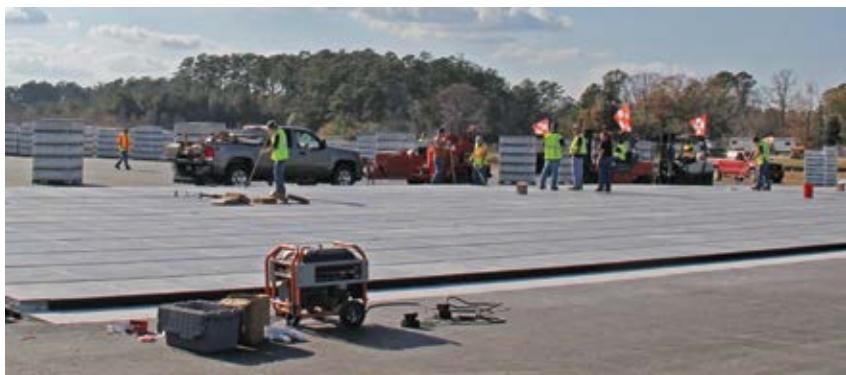
January 19, 2010 at Yeager Airport, Charleston, West Virginia USA, at 4:20 PM, when US Airways Express Flight 2495, a Bombardier CRJ-200 regional jet carrying 34 passengers and crew onboard, rejected take off 4 seconds after V1 due to an incorrect flap setting and was safely stopped by an EMAS arrestor bed. This save was unique due to the circumstance of the aborted takeoff, as the five previous successful EMAS aircraft arrests had all taken place during aircraft landings.

The aircraft had reached a speed of 143 knots before braking aggressively, leaving skid marks on the runway before entering a substantial distance into the length of the EMAS bed, safely and dramatically stopping short of a steep 136m (446 ft) drop at the end of the airport runway, which overlooks a valley near the Kanawha River and the city of Charleston. Thanks to the EMAS, the passengers and crew walked away unharmed. After a brief shutdown, the runway was reopened by 10:15 PM, less than six hours after the arrestment.
