# Incidents in Air Transport

## Wildlife Hazards

n° 11

October 2009

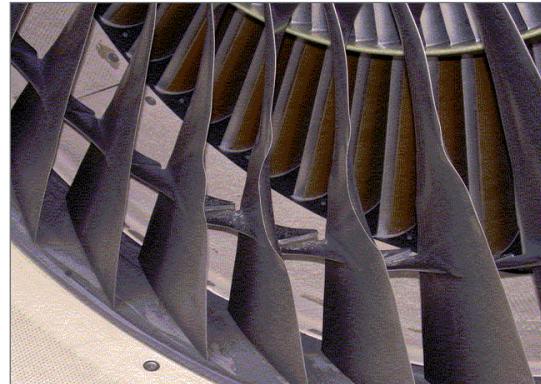
A gull was ingested by the right engine. Several fan blades were damaged and had to be replaced. Analysis of the recorded parameters showed that the gull ingestion did not lead to the loss of thrust on this engine.

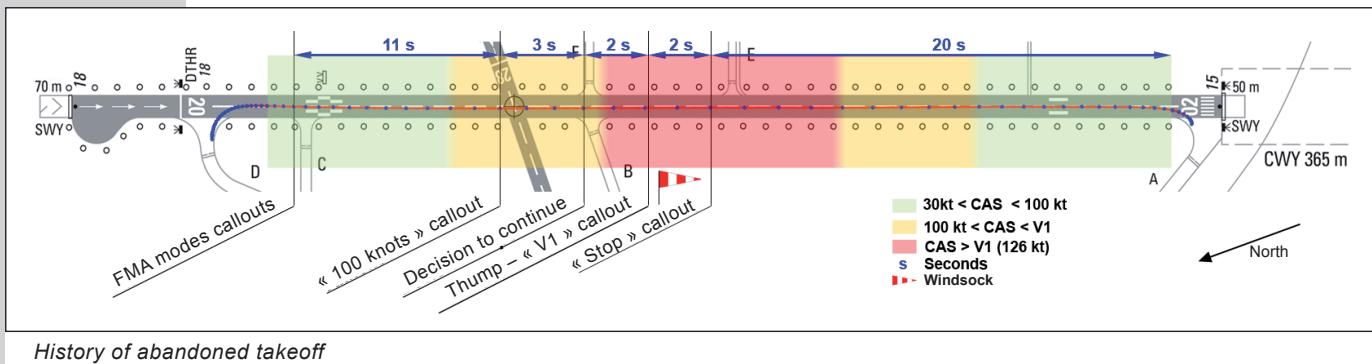
History of abandoned takeoff

Shortly after the "100 knots" callout, the Captain caught sight of a flock of gulls on the right of the runway, in front of the aeroplane. He decided to continue the take-off run. Two seconds later, a heavy thud and significant vibrations were noticed in the cockpit. The Captain called out "V1" and decided to abandon the take-off. He reduced the thrust and realized that the indicated airspeed was above V1. Despite maximum manual braking, the use of thrust reversers and automatic spoiler extension, the crew was afraid of not being able to stop the aeroplane before the runway end and the sea. They decided to take exit taxiway A at the runway end. The crew stopped the aeroplane on the taxiway. After a visual examination of the aeroplane by the rescue and fire fighting services, the crew taxied to the ramp and the passengers disembarked as usual.

The first braking action was recorded at 14 knots above V1, two or three seconds after the V1 callout.

On the date of the event, these measures had not been put in place. In particular, the pool near the wind sock (zone V1 Vr in red on the diagram on page 1) had not been drained.

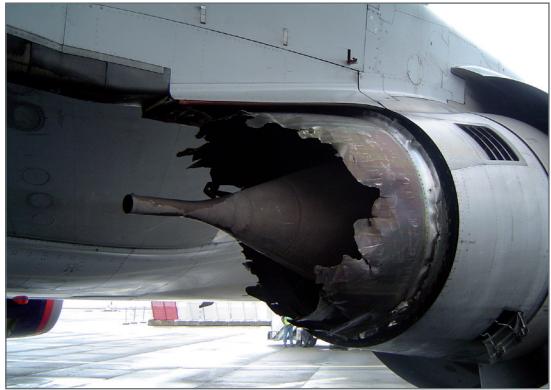
Numerous pieces of debris from the right engine were found on the runway over a length of 1,200 metres. The external part of the exhaust nozzle was 300 metres from runway 22L threshold.

Three gulls had struck two of the right engine's fan blades. The blade hit by two of the birds had broken. The blade fragments then severely damaged the leading edges of the other blades. Debris had gone through the inlet nozzle and pierced it in five places. One of the pieces of debris had pierced the engine cowling and been propelled outside but without enough force to damage the fuselage.

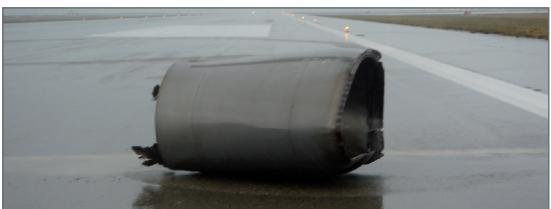
The separation of the exhaust nozzle was due to the vibrations following the fracture of the blades. The duct between the oil filter and the scavenge pump had been severed. The oil tank had emptied and the bearings that had not been lubricated had been damaged or had melted. The engine showed no signs of fire.
