Lightning Direct Effects Handbook

Report Reference Number: AGATE-WP3.1-031027-043-Design Guideline
Work Package Title: WBS3.0 Integrated Design and Manufacturing
Date of General Release: March 1, 2002

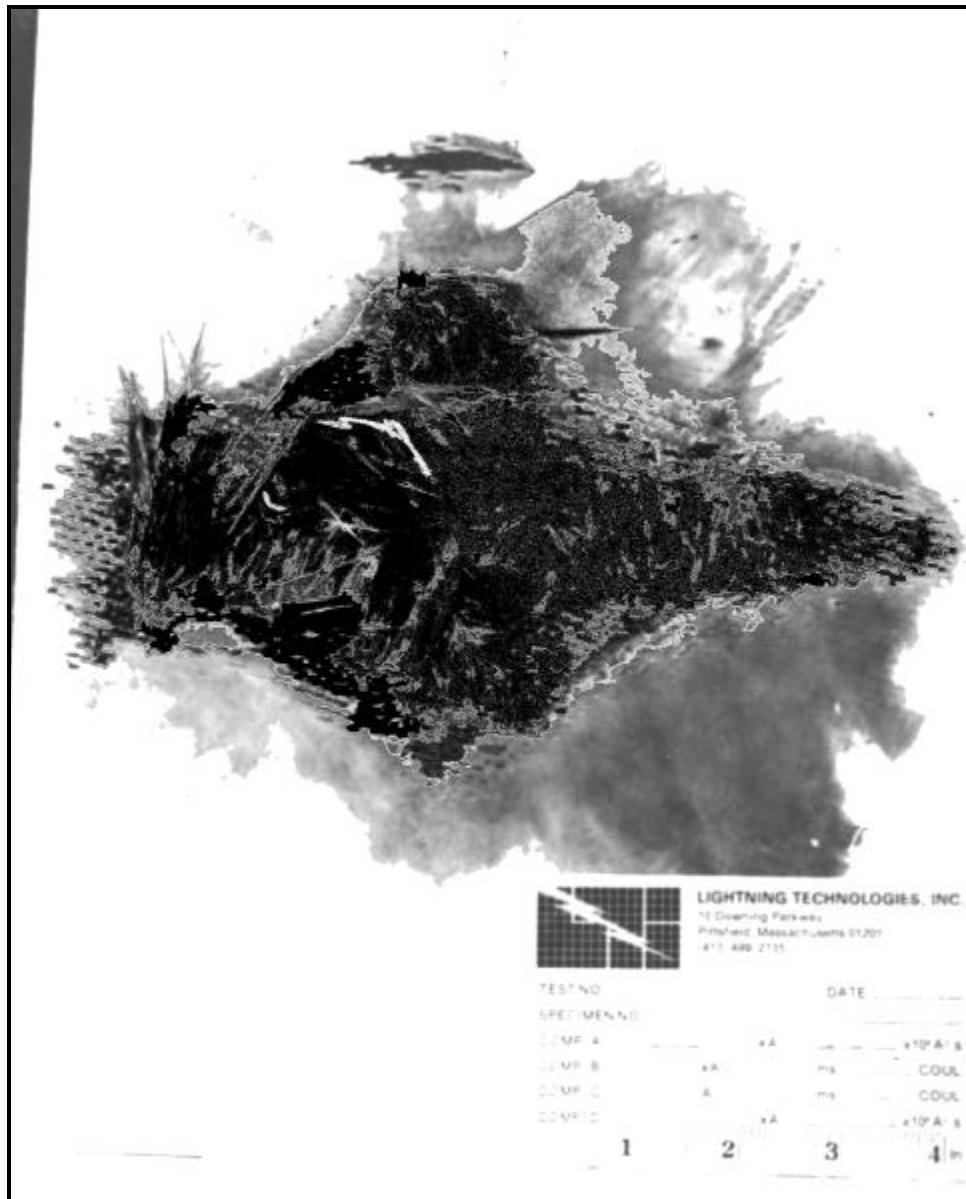
Figure 6.2.1-2 : Zone 1A stirke to a painted exterior surface of unprotected 4 ply 0.052 in. CFC laminate of woven cloth plies.

Zone 1A - Painted: Figure 6.2.1-2 shows the results of a Zone 1A lightning strike to a 0.040 in. thick painted CFC panel. The laminate was damaged over a regions of 30 to 40 square inches of the laminate. The laminate was also punctured on the back side of the panel.

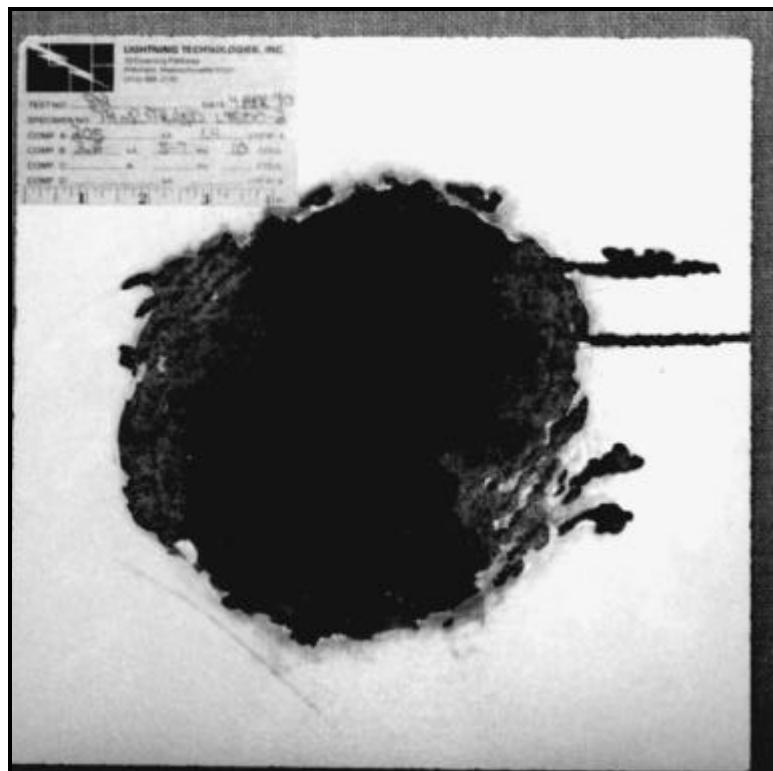
Figure 6.3-1 : Thorstrand protected fiberglass panel

Analysis: None of the fiberglass non-conductive panels showed puncture when protected by expanded foils of either copper or aluminum.

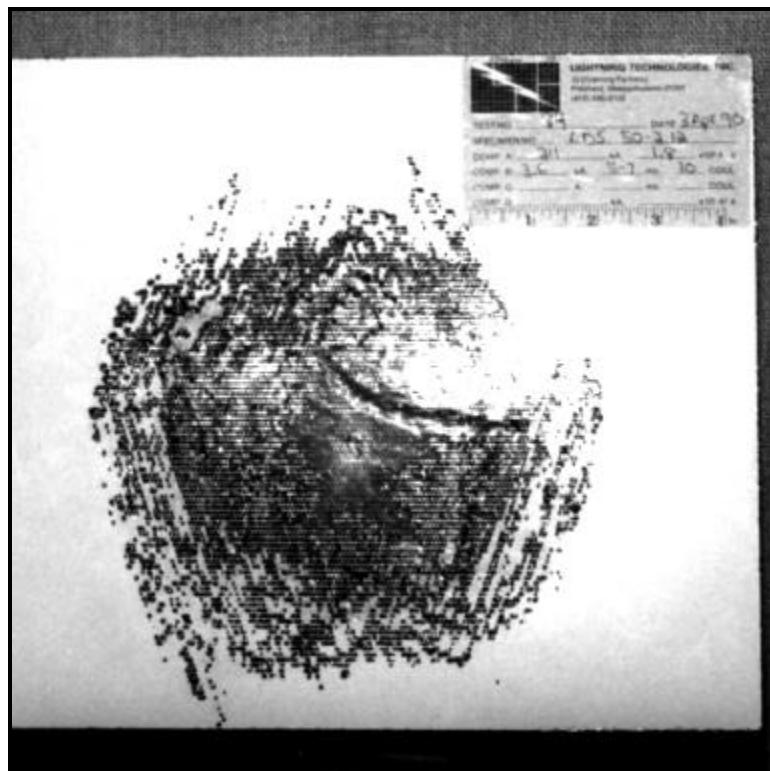
Figure 6.3-3 : LDS 50-120 Alum. Foil
protected fiberglass panel

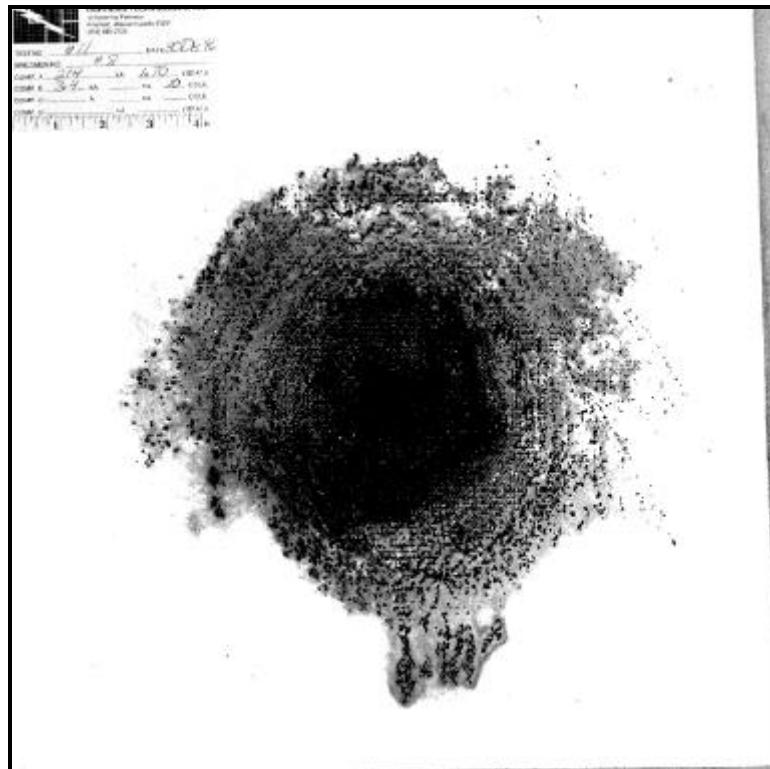
Figure 6.3-5 : 0.029 ECF protected panel, Zone 1A

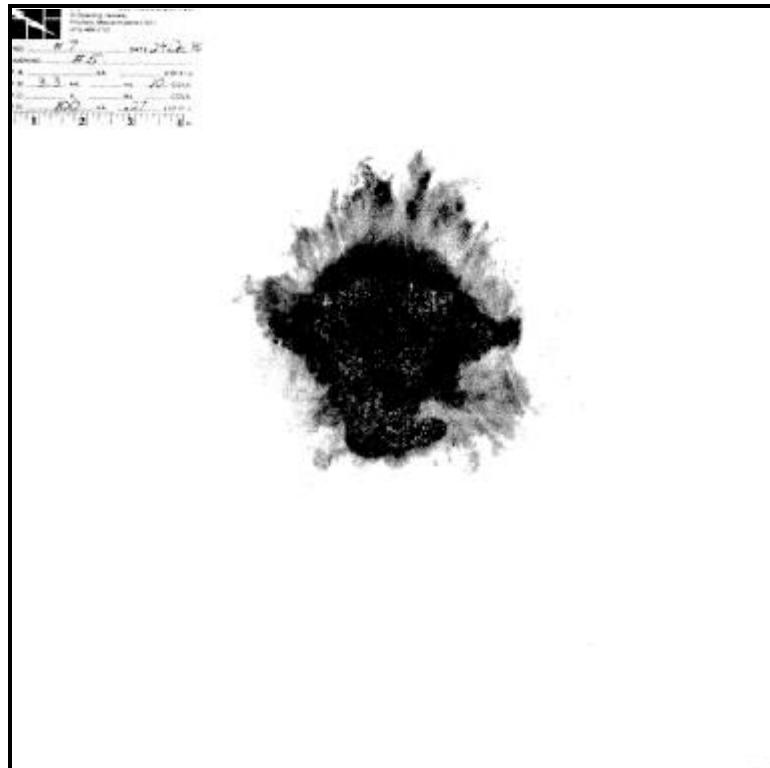
Figure 6.3-6 : 0.029 ECF protected panel, Zone 2A

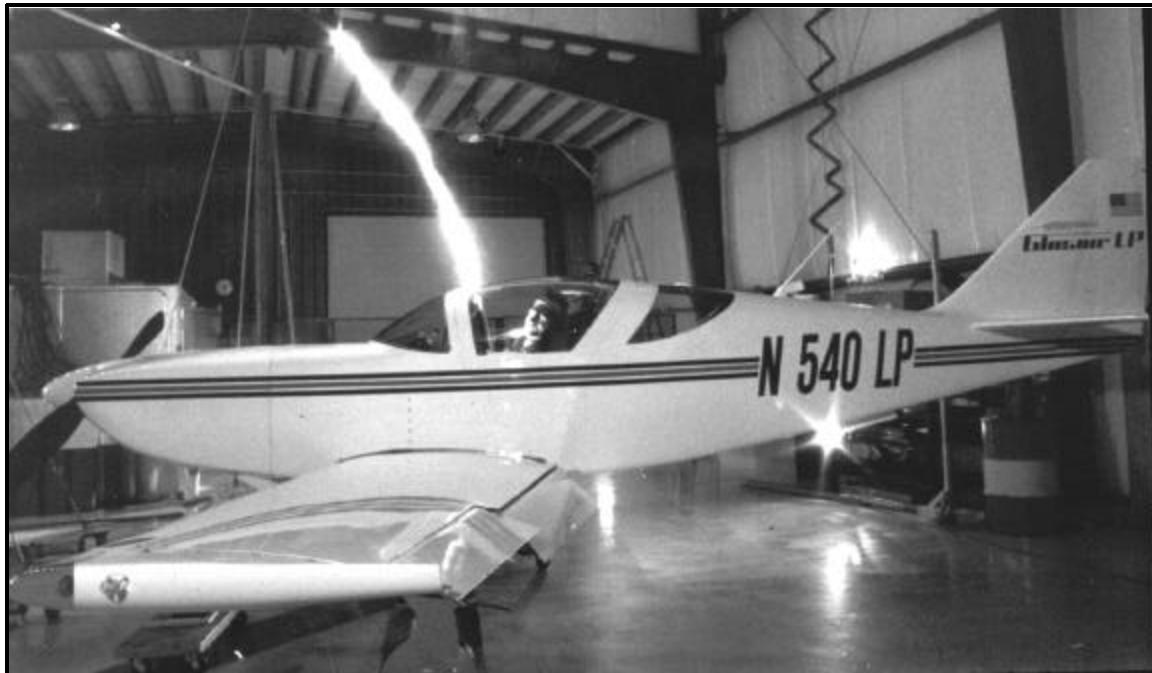
Figure 7.0-3 : High voltage attachment testing to windshield and canopy

and canopy side windows. A mannequin was placed in the front seat of the aircraft to simulate a passenger or pilot. Cameras were placed behind the mannequin to witness streamers or arcing to the head region. Figure 7.0-3 shows a typical high voltage discharge to the windshield and canopy region. In all cases the lightning channel attached to adjacent airframe structure with no evidence of dielectric breakdown or punctures of the windshield or canopy. Figure 7.0-4 shows a photograph of the mannequin's head during a high voltage test.

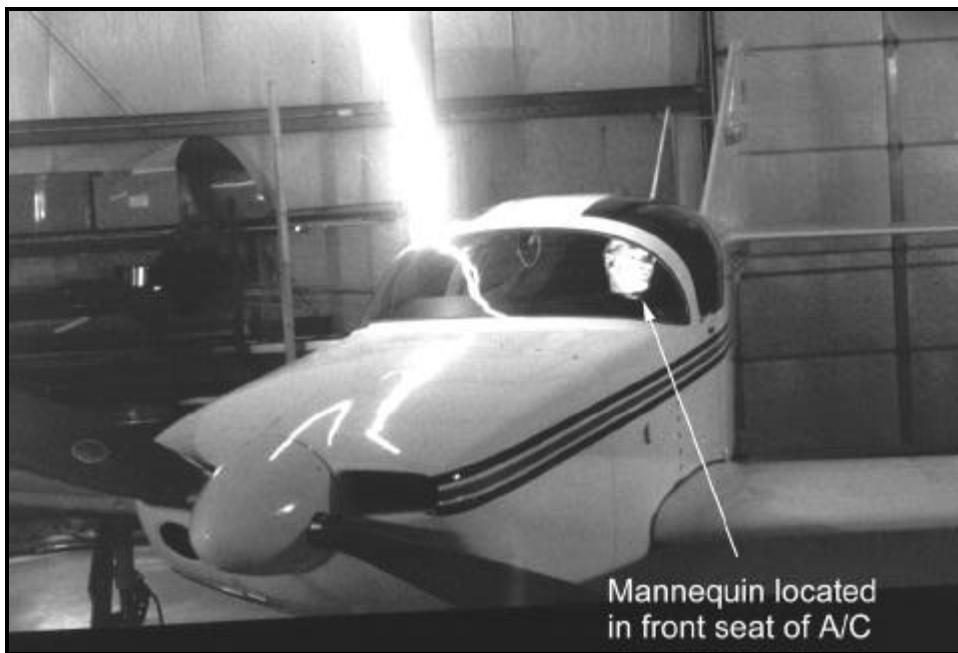
Figure 7.0-4 : Photograph of mannequin during testing.

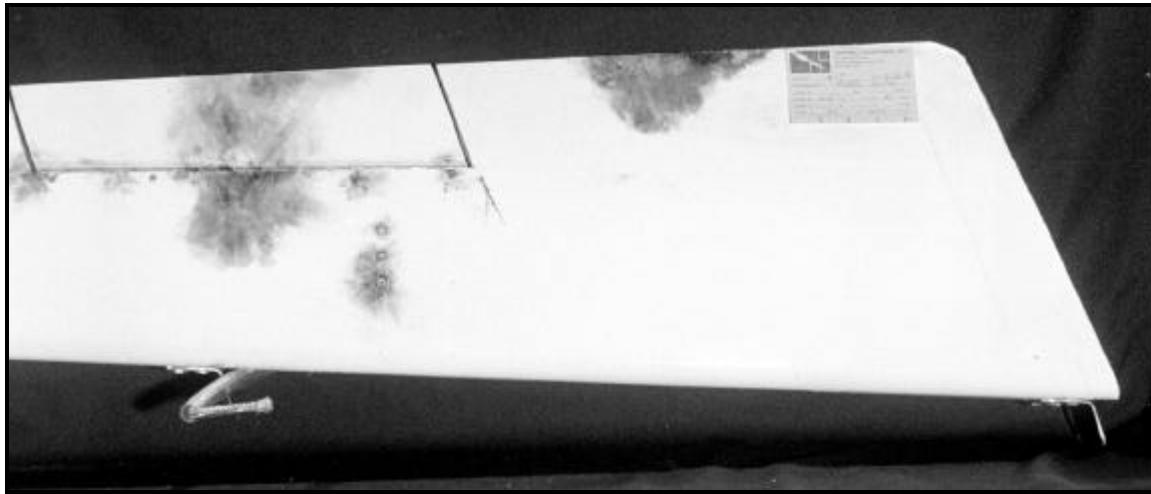
Figure 8.2.3-1 - Post test photograph of rudder test article

Figure 8.2.3-1 shows the post test photograph of the rudder.

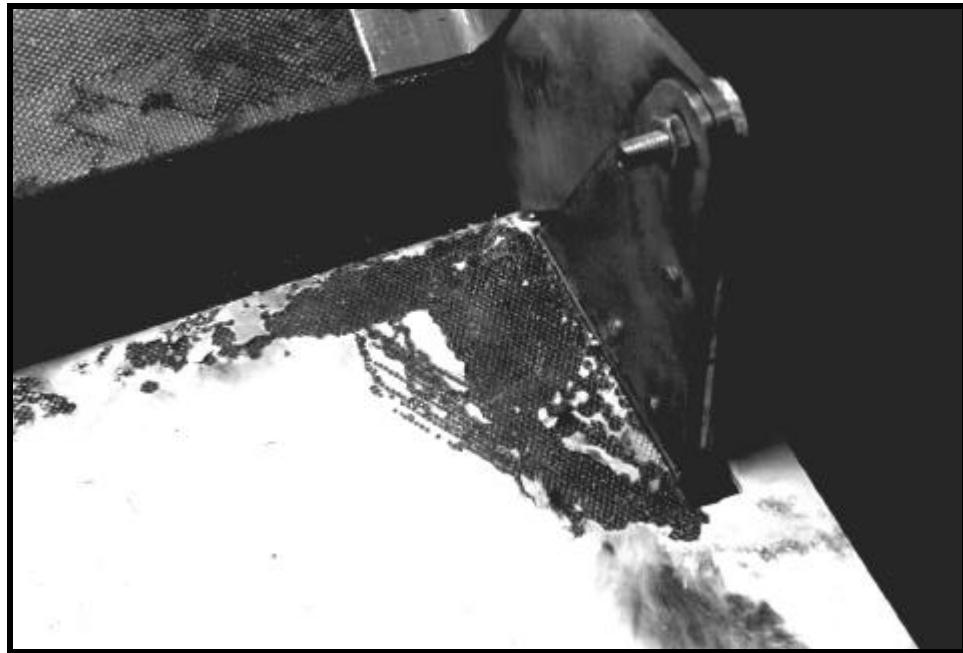
b) close-up of hinge damage area

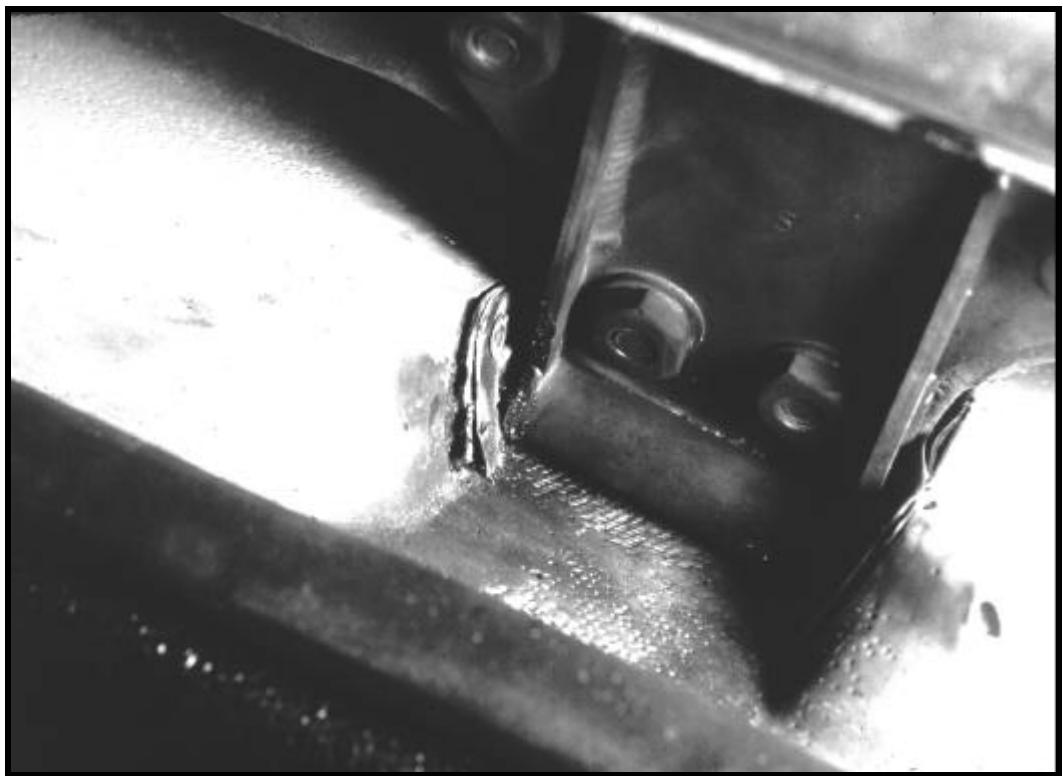
Figure 9.3-2 : Closeup photograph of canopy hinge after the test

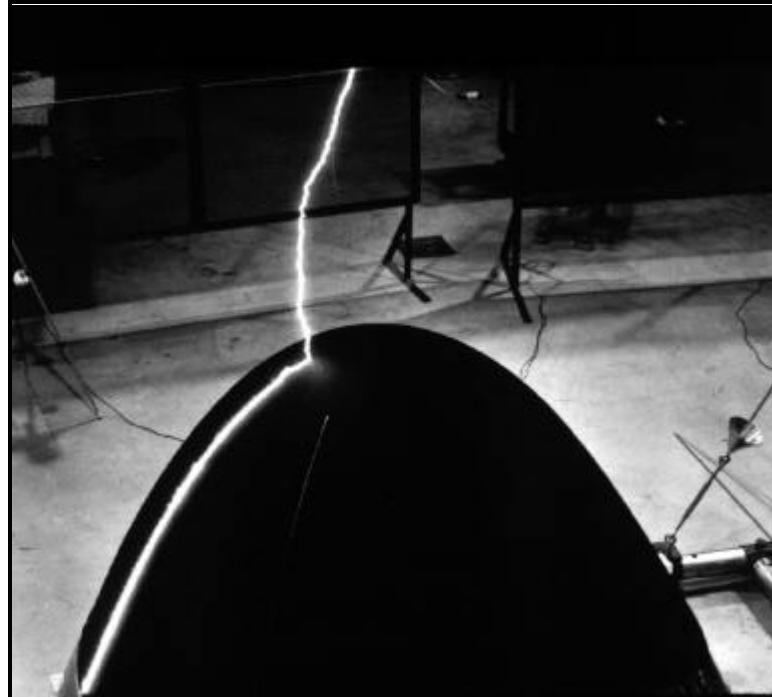
Figure 12.2-1 : Typical high voltage test
