Operational Safety Study: Controller Detection of Potential Runway and Manoeuvring Area Conflicts

Edition 1.0

Edition date: 01/12/2015

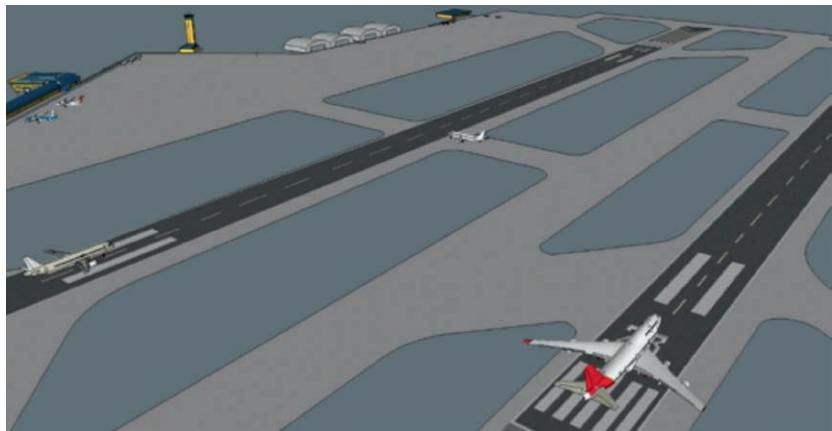
The controller is also increasingly monitoring on a tight landing or go-around situation on 28R. When the second aircraft lands, the previous lander is just clear of the runway and being asked to expedite clear.

The A320 is cleared take-off while E190 begins to cross 28L. The controller has forgotten that he has cleared the E190 to cross. The pilot of the A320 saw the E190 and announced immediately to the controller that he does not roll.

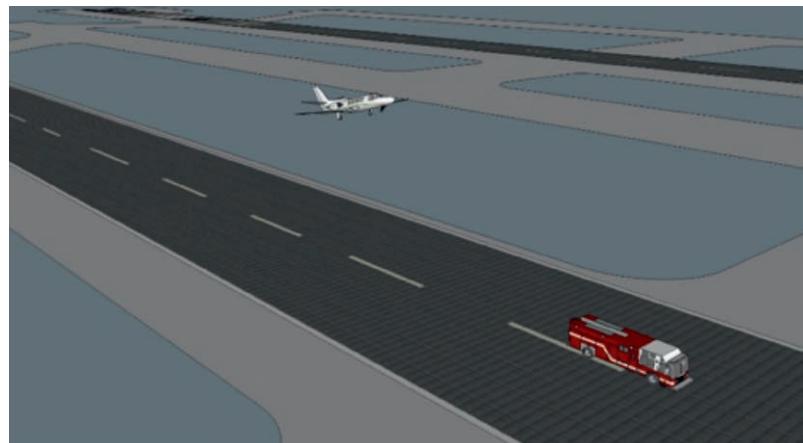
The aircraft involved in this incident is a C510, a MEDEVAC flight. The C510 requests taxi and is cleared to taxi and cross runway 17R for runway 17L departure. There is an airport vehicle on runway 17R just south of the runway crossing point leading to runway 17L.

An illuminated white cross lies on the threshold of runway 17R to show it is closed. In order to avoid aircraft lining up runway 17R from the crossing point the procedure specified red lighting to be installed across the runway. However, to facilitate a quicker change of runway between 17 and 35 the red lighting had been replaced by "a mini cross" attached to a vehicle. The controller involved in the incident knew the existence of this vehicle.

ATC wanted to help the MEDEVAC flight by optimizing its departure route. The controller offers the C510 a runway 35L departure, giving the shortest taxi and direct flight routing. ATC gave the surface wind and the distances available. The C510 responded that the distance was sufficient. ATC cleared the C510 for take-off runway 35L.

The C510 takes off and then informs TWR that he just avoided collision with a truck on the runway. ATC then remembers it had not been removed. Because all controllers "know" the temporary procedure, there was no specific strip used for showing the vehicle blocking 17R/35L.

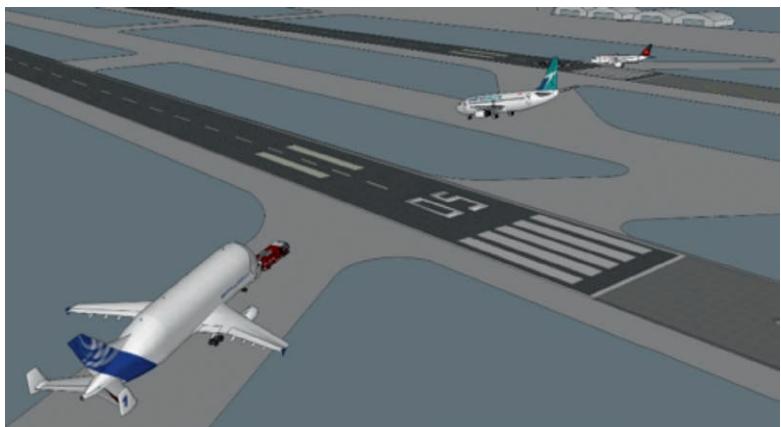
ATC ask the Beluga tug driver if he is in sight of the traffic on final, the driver answers he is seeing an aircraft about to land. ATC clears the Beluga tug to "cross runway 05L behind the traffic on final and then maintain holding point Lima (between 05L and 05R). The tug driver replies "Roger for crossing rwy 05L and maintaining holding point 05R"

The departing A319, on hearing this conversation asks for confirmation of its line-up and take-off clearance and to check the runway of the landing aircraft.

The aircraft on final rwy 05L is cleared to land. Some 20 seconds later, ATC instruct the Beluga tug to hold position and then asks him if he is on the runway, to which the tug driver replies that he is. ATC cancel the A319 take-off clearance and instruct the aircraft on short final for 05L to go-around.

The driver did not understand the situation and made his own interpretation of the clearance he was given, which was that the landing aircraft some 4nm out was landing on 05R not 05L.

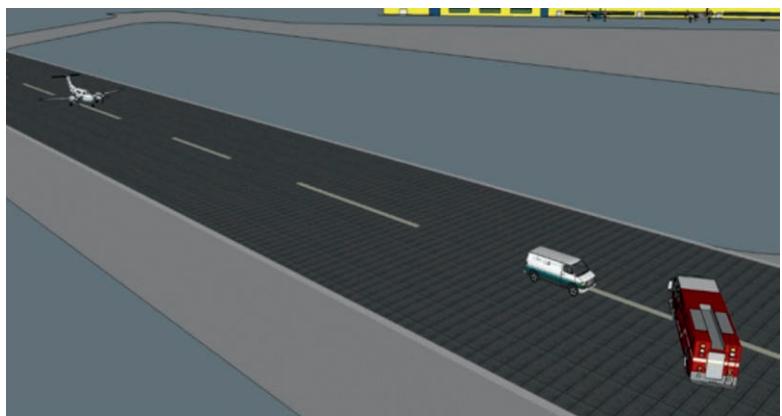
ATC1 clears the airport Ops vehicle and the maintenance vehicle to enter the runway. Six minutes later ATC2 (TWR Supervisor) relieves ATC1.

10 minutes after that ATC3 relieves ATC2. ATC2 informs ATC3 that a PC12 is about to taxi for departure but does not include the runway works in the handover. ATC3 tells the PC12 to taxi for the holding point of the runway and 5 minutes later ATC3 clears the PC12 to line up and take-off.

The Airport Ops vehicle driver hears the increase of the engines and calls back ATC to signal his presence on the runway. ATC3 immediately stops the take-off of the PC12. The aircraft is already moving but stops quickly. The pilot of the PC12 did not see vehicles.

The driver of the airport Ops vehicle did not immediately react to the take-off clearance given on the frequency. It was given in English so there is a possibility that the driver of the airport Ops vehicle, a native speaker, did not understand it. He heard the increase engine noise.

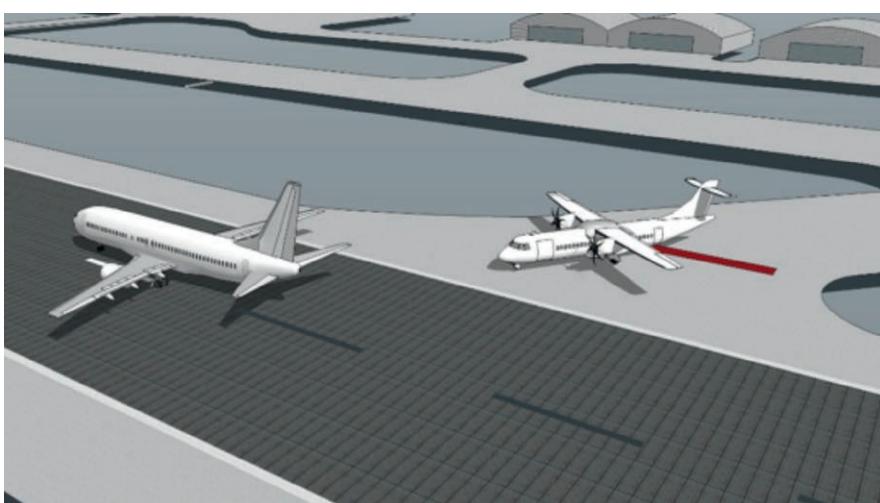
A conditional clearance is given to the ATR42 "Behind next landing short final, line up 07 behind" The readback is correct. No reference, however, to the fact that an A321 will take-off before the next landing.

The A321 takes off. B737 is given clearance to land and ATR42 begins to move onto rwy. When the B737 landed, the ATR42 is 40m from rwy c/l. The B737 crew saw the ATR42 and deviated to right as soon as possible.

ATC did not see the ATR42 until the pass was taking place. ATR42 crew said they saw the A321 pass them and assumed that was the landing aircraft in the conditional clearance. The holding point for 07 that the ATR42 was using was a RET for rwy 25 and therefore the view from the flight deck of the ATR42 towards the 07 approach was restricted.

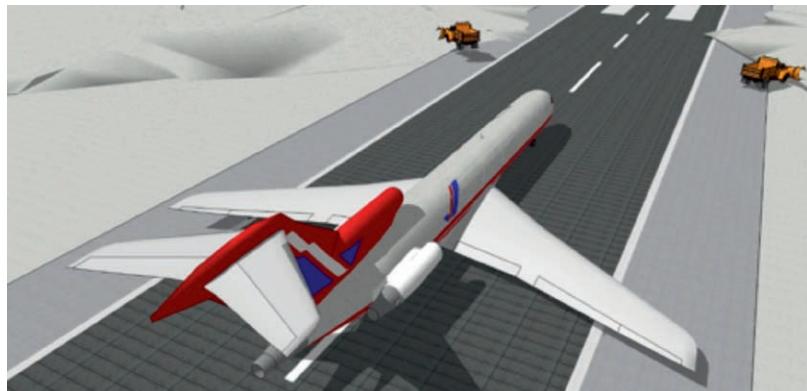
The B727 First Officer acting as PM had begun to acknowledge the clearance as soon as the controller had finished giving it and as a result, only the very end of the readback - the aircraft callsign - was heard by the controller who assumed that the intended «cancellation» of the take off clearance had been understood.

He issued an instruction for the snow clearance vehicles to clear the runway and then looked away from it whilst giving taxi instructions to another departing aircraft still on the apron and, by the time he returned his attention to the runway, was surprised to see the B727 on the take-off roll. The take-off roll had gone unnoticed by the controller for more than 20 seconds».

Upon seeing the aircraft approximately 350 metres down the runway and accelerating, he instructed the B727 to "abort take off". There was no response or acknowledgement from the crew. The aircraft was just passing 80 kts and the required SOP check was being called and acknowledged. The first third of the runway has an incline from the threshold before flattening out. At that time of the instruction to abort the take-off, the crew were unable to see any obstruction ahead due to still being on the upslope. Shortly afterwards, as the aircraft approached the mid-section of the runway at 122 Kts, they saw the lights of the snow clearance vehicles ahead and immediately initiated a rejected take off. The B727 was brought to a stop approximately 365m from the snow sweepers. The vehicles had moved to the side of the runway in case the aircraft was unable to stop in time.

In respect of the overlooked 'Blocked Runway' indication on the controllers display, a review of 4 hours of recording around the time of the occurrence showed that aircraft had departed on runways that had a 'blocked runway' depiction at least three other times, although in all three cases, the runway was not in fact physically occupied».

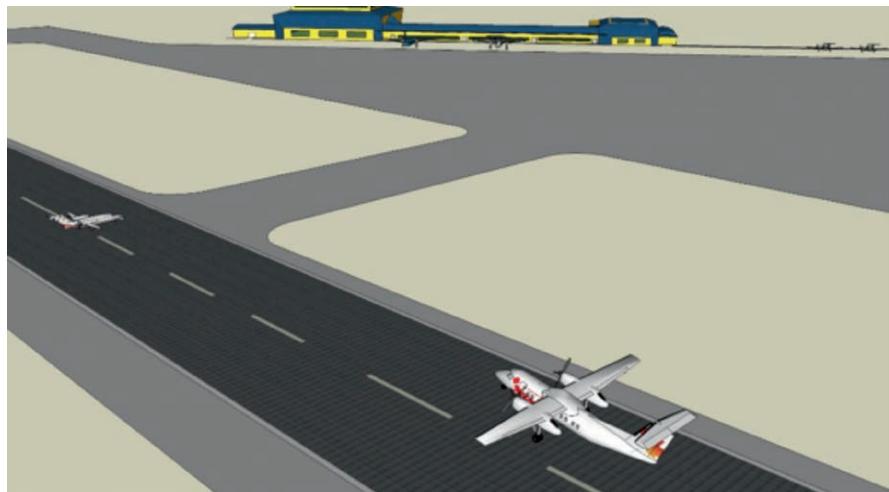
Runway 06 was in use for arrivals and departures, and Runway 13 was being used for departures of aircraft leaving the de-icing pad. As a consequence, the GMC and TWR controllers frequently exchanged responsibility for the control of Runway 13. Under these circumstances, best practices for issuing taxi instructions to any aircraft taxiing to Runway 06 would include a restriction to hold short of Runway 13. Nonetheless, the ground controller issued a Piaggio P180 a taxi clearance to cross runway 13 without restriction for departure on Runway 06.

The GMC controller issued instructions to a DHC8 to taxi from the de-icing pad to Runway 13. It was instructed to contact TWR once holding short of Runway 13. Coordination between the GMC and TWR was completed for the exchange of responsibility for Runway 13 to allow its use by the DHC8, at which point the airport controller took over responsibility for Runway 13.

The TWR controller completed a scan of the airport Manoeuvring Area and the Electronic Flight Display System. The TWR controller saw an aircraft (the P180) on the taxiway; however, as there was no indication on the airport controller's display screen that the aircraft was taxiing for a runway, it was assumed that the aircraft would turn right towards the de-icing pad.

The DHC8 was cleared for takeoff on Runway 13. Some 30 seconds later the P180 entered Runway 13. When the P180 was in the middle of Runway 13, the horizontal distance between the two aircraft was approximately 1000m. The GMC controller noticed the runway incursion and estimated that P180 would be clear of the runway by the time DHC8 reached the same point, if not airborne. Thus, no call was made for DHC8 to abort the takeoff. Neither P180 nor DHC8 was aware of the runway incursion.

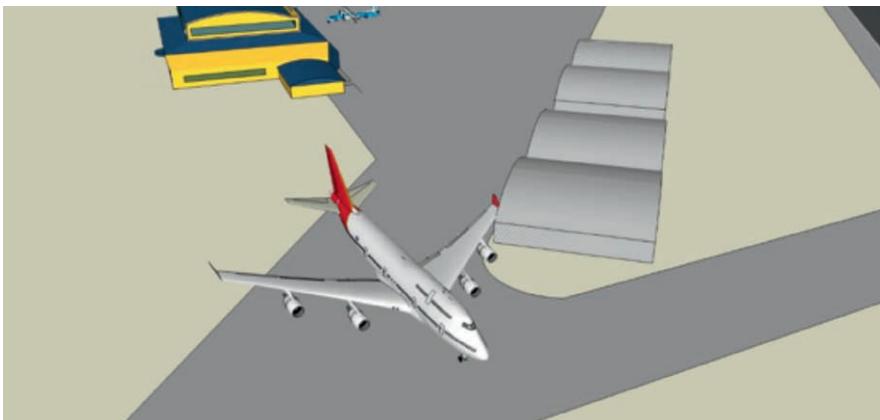
All flight crew members were familiar with the airport through multiple previous visits and all had significant experience on the B747. A preflight brief was conducted prior to push back which included the expectation that the taxi routing they would get for departure runway would be via taxiway 'B'.

When the clearance came it was not the one briefed but the alternative of proceeding via taxiway 'A'. No revision to the earlier crew brief took place. Initially, the clearance as correctly read back was followed but, when taxiway 'A' turned to the left as it approached the runway Cat 2 holding point which was the clearance limit, the aircraft wrongly continued straight ahead on a narrower taxiway 'L' which unlike 'A' had no centreline lighting, just blue edge lights.. As soon as the aircraft entered 'L', the FO, who was PF, expressed his doubts about the apparent narrowness of the taxiway but there was no response from either of his colleagues and he continued ahead.

A further remark by the FO when the aircraft was about 10 metres from the building to the right of the taxiway that the wing was not very far from the building, was followed almost immediately by impact of the right wing with the building. Just prior to the collision, when he was unable to see the aircraft on taxiway 'A' the TWR controller checked the A-SMGCS display and discovered that the aircraft was on 'L'. He immediately transmitted to the aircraft to hold position but by this time, the collision had already occurred.

The Captain reported that as the junction between the 'A' and 'L' taxiways approached, the crew has just completed the "before take-off checks" so that his mind was focused on the objective of getting to the runway. He did not react adequately to concerns raised by the FO before the ground collision.

Some of the centreline lights on A were unserviceable. It was also noted that over a distance of approximately 300 metres up to the holding point, no centreline lights were installed. The direction information sign on the left side of taxiway 'A' ahead of the intersection of 'A' and 'L' which consisted of a black inscription on a yellow background was not lit.

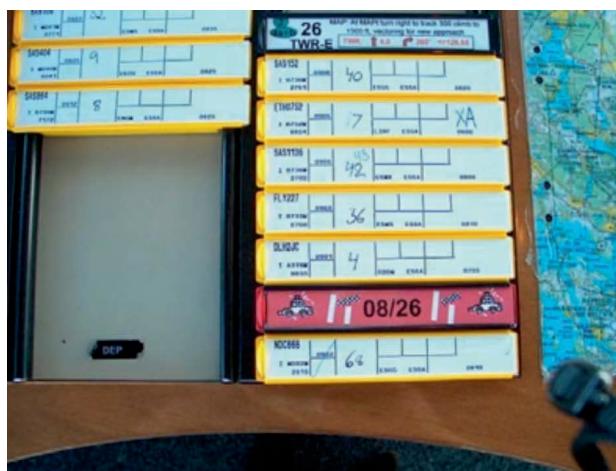
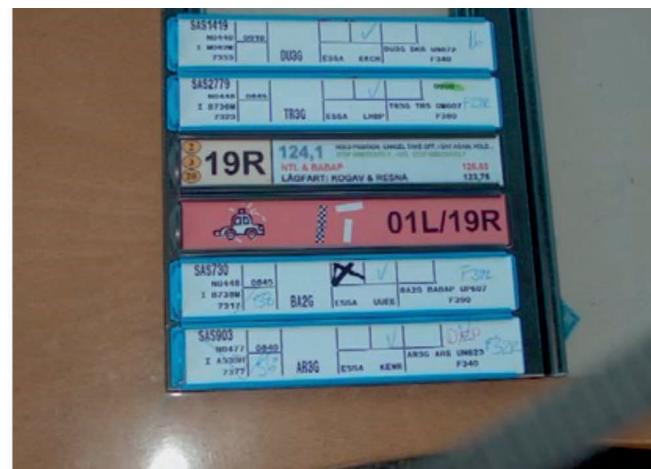
Fig 1 Dedicated flight strip for runway inspection (one per runway)

This may be placed in a dedicated Strip holder of a different colour, usually red, to make it more noticeable.

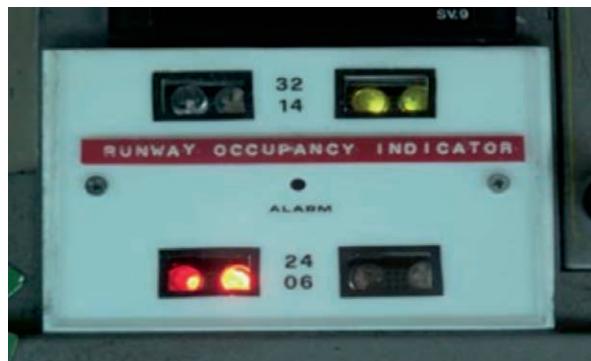
Figure 3. Runway occupancy indicator

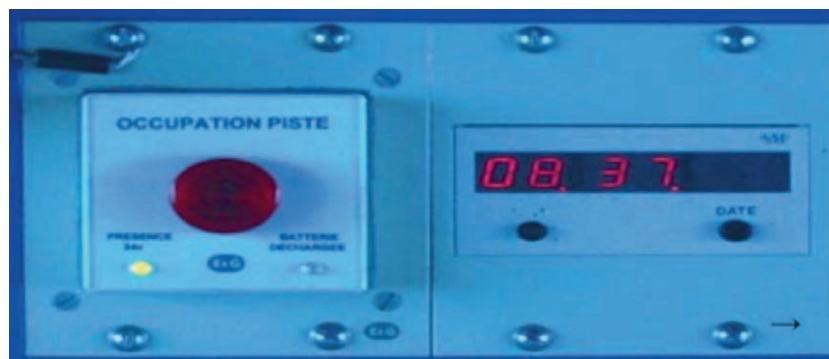
Figure 4. «A runway occupied box» display panel - Flashing red light

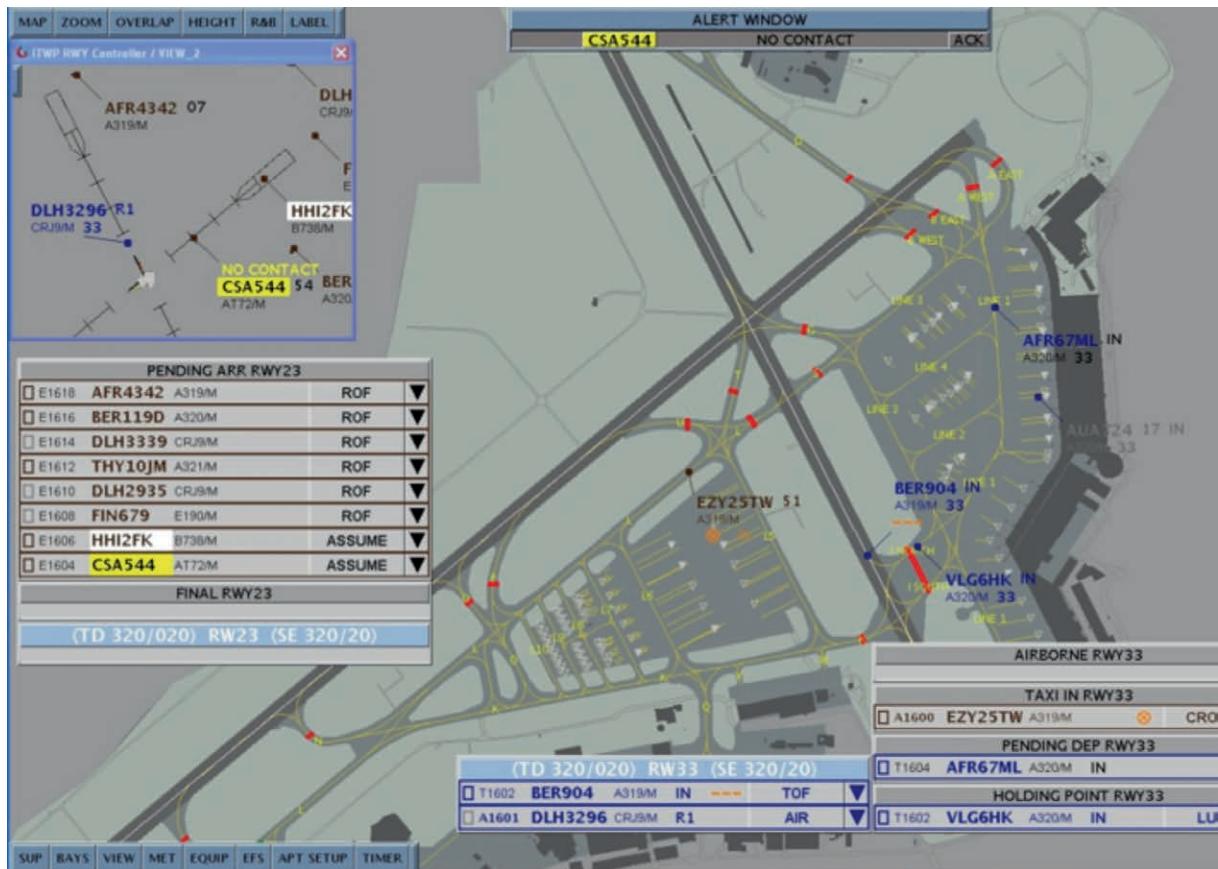
Figure 10. Yellow Highlight appears in Alert Window at top of display and yellow highlight on ATM element for no TWR frequency contact with an aircraft within 4 miles.

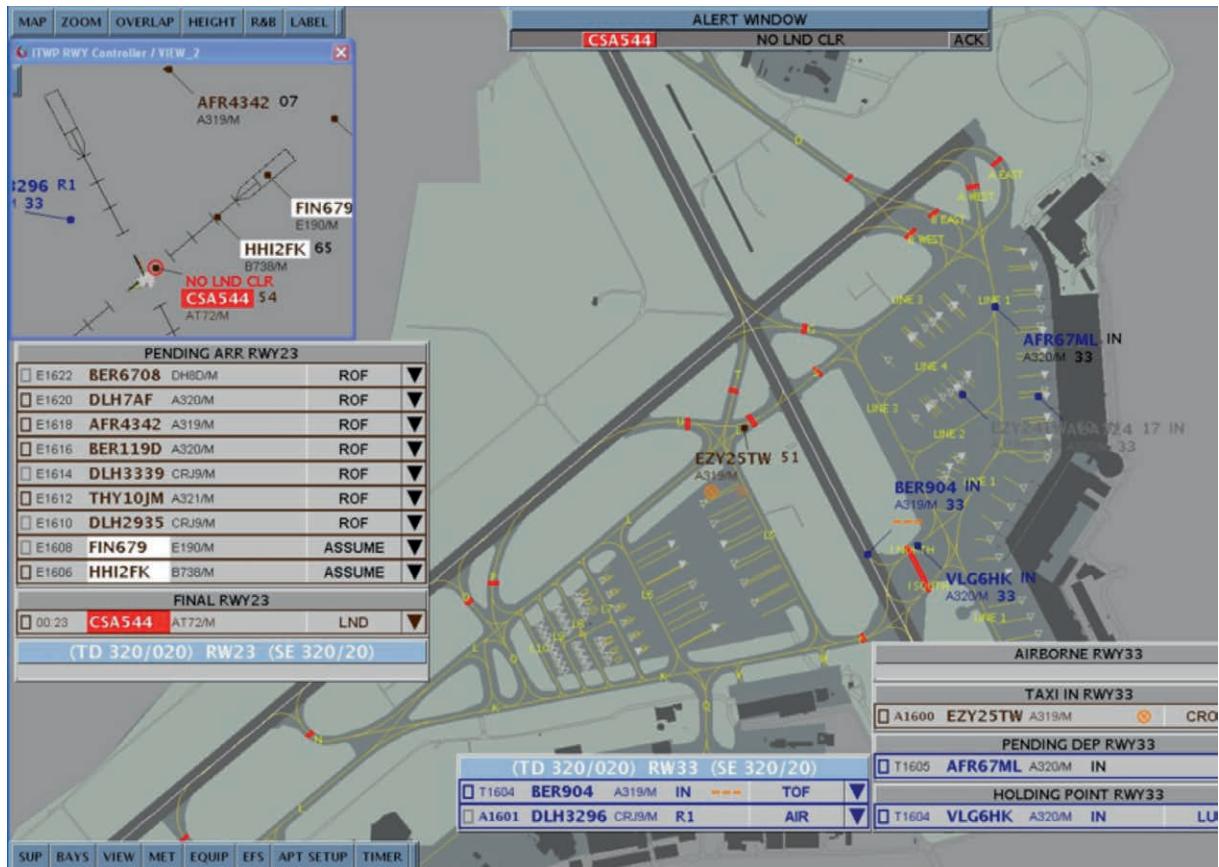
Figure 11. Red highlight appears in Alert Window at top of display and red highlight on ATM element and Arrivals elements for aircraft with no landing clearance within 1 mile.

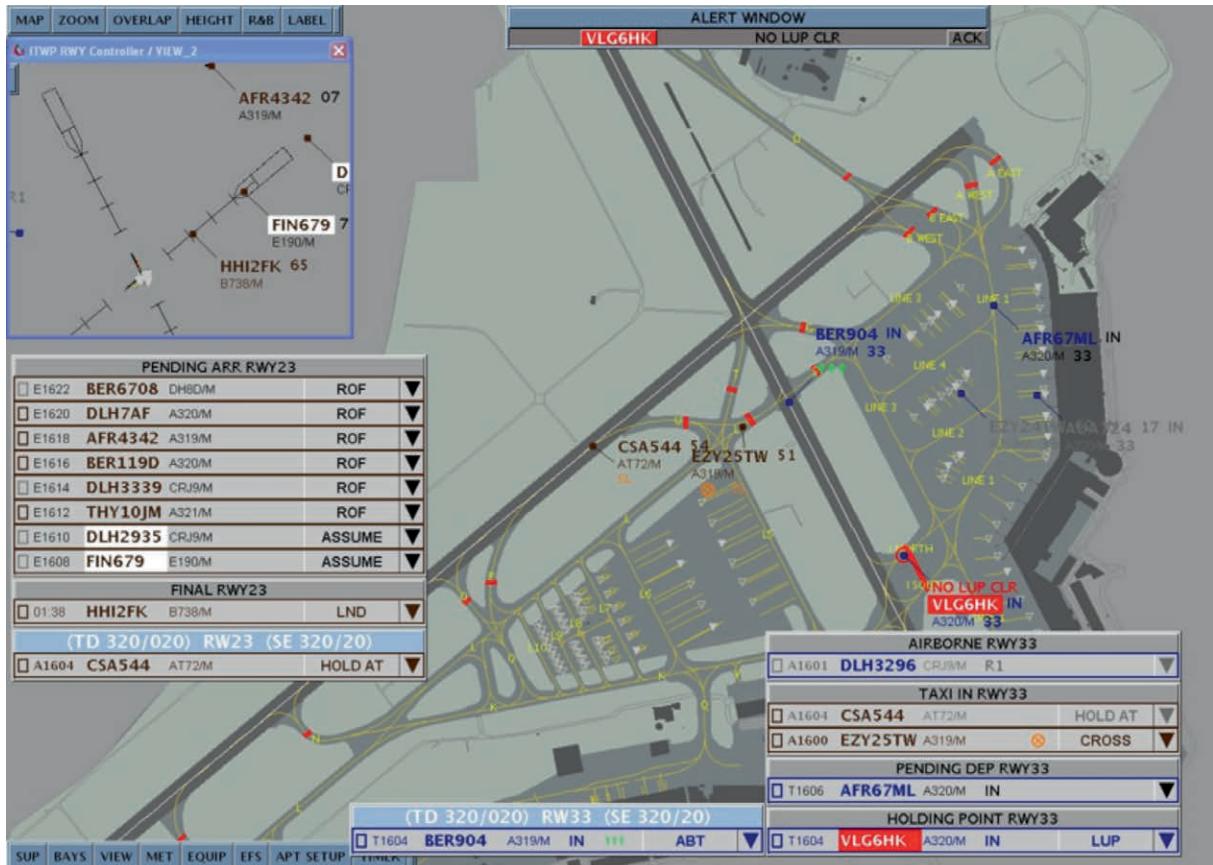
Figure 12. Red Highlight appears in Alert window at top of display and red highlight in Holding point bay and runway entry point for an aircraft that is entering the runway without a clearance.

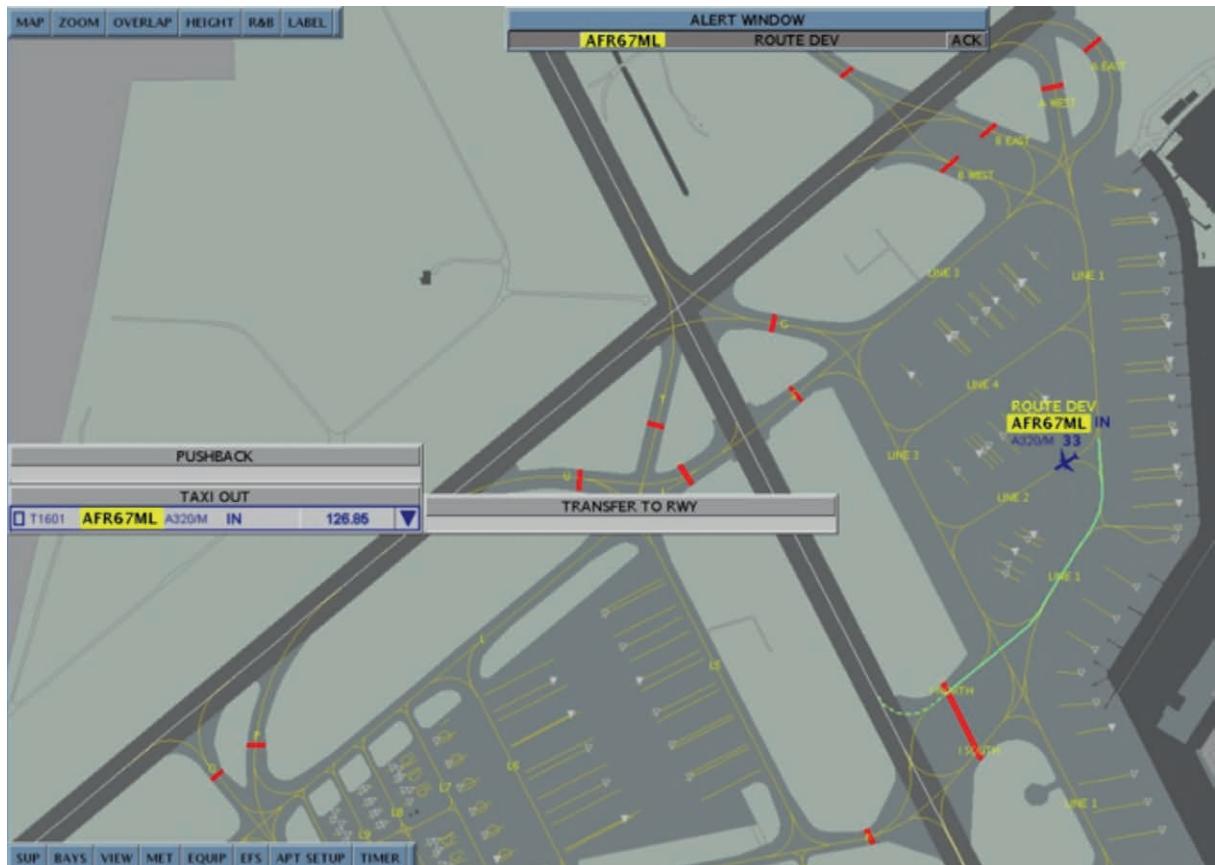
Figure 14. Yellow Highlight appears in Alert Window at top of display and yellow highlight on aircraft symbol and in Taxi bay for an aircraft that has deviated from the cleared routing.
