Havarikommisjonen
Accident Investigation Board Denmark

BULLETIN

Serious incident

CESSNA 172

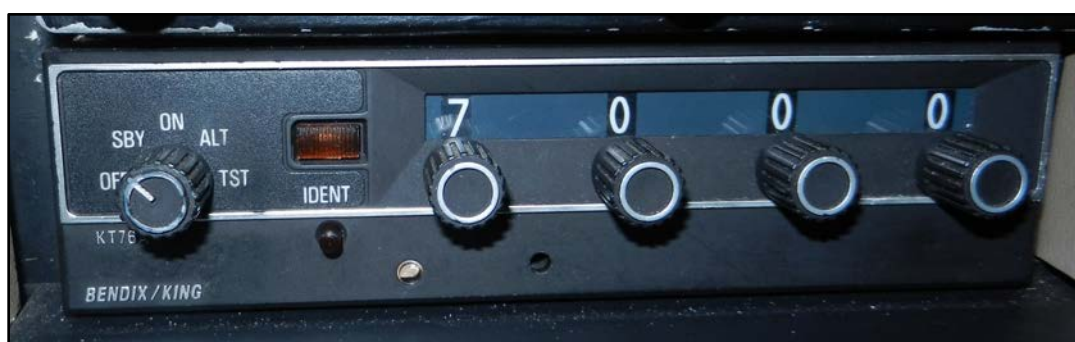
Aircraft A was equipped with a Bendix/King KT76A altitude encoding (Mode C) transponder. See picture below.

When the mode selector switch was set to “ON” (Mode A), the transponder code information was transmitted. If the mode selector switch was set to “ALT” (Mode C), the transponder transmitted both transponder code and aircraft altitude information.

The pilot of aircraft A explained to the AIB that the transponder transmitted altitude information to the air traffic services system (ATS) during the previous flight from EKRK to EKRN.

During the serious incident flight, the pilot stated that he operated the transponder according to normal procedure (and in the same way as during the previous flight) and before take-off set the transponder mode control to “ALT” (Mode C activated). The pilot stated that he did not change the setting of the mode control knob throughout the serious incident flight.

In the time period from departure from EKRN until the serious incident had happened, the transponder of aircraft A did not transmit altitude information (Mode C) to the ATS system or to the TCAS system

It was not possible for the AIB to establish whether or not the transponder of aircraft A, for a part of the flight was set to Mode A only, or if the transponder was affected by a periodic failure.

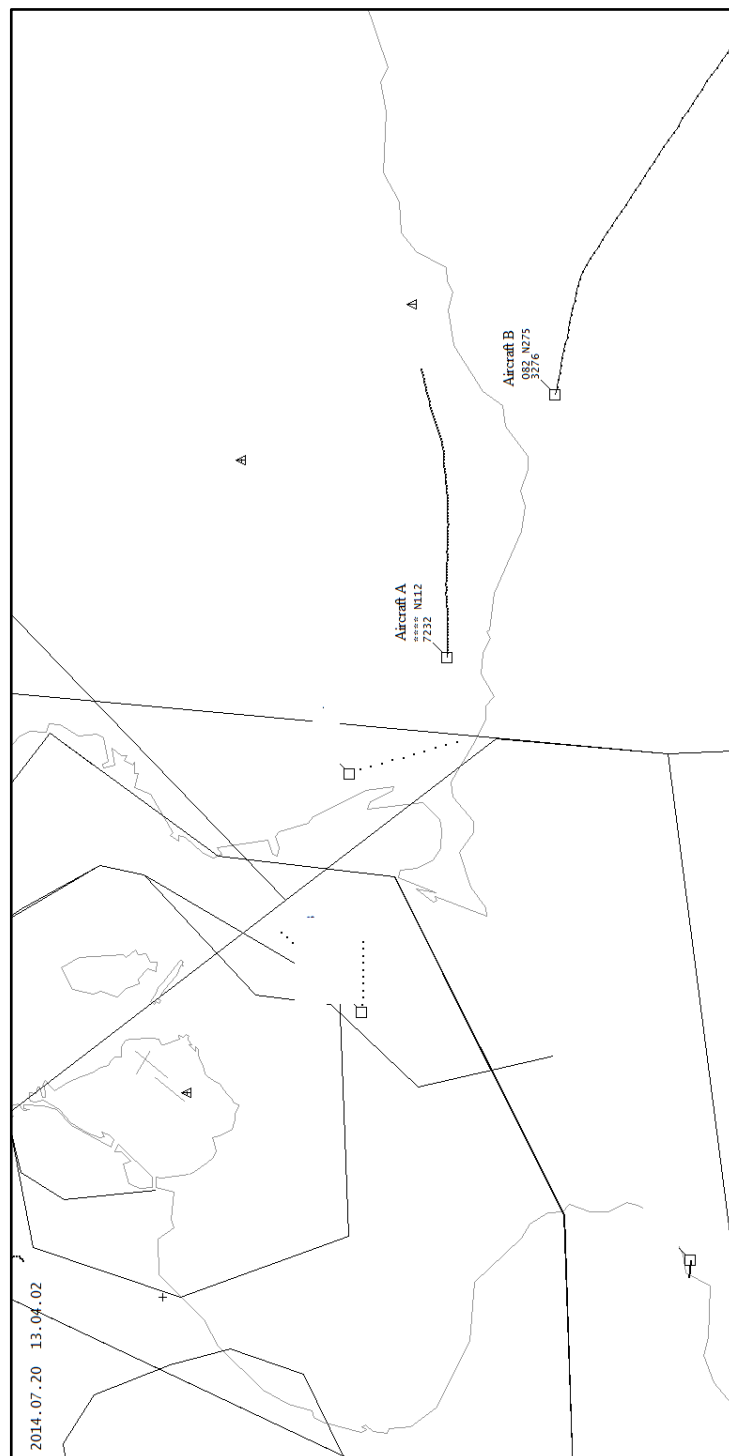
Appendix 1

Radar presentation 13:04:02 UTC (AIB software generated presentation).

Without further radio communication with Sweden Control, aircraft A continued westbound into and through Malmoe TMA at 4,000 feet msl, and passed just north of the city of Trelleborg at 13:04:02 hours.

At the same time, aircraft B was approaching the southern coastline of Sweden on a west-northwesterly course descending through Flight Level (FL) 082.

See appendix 1.

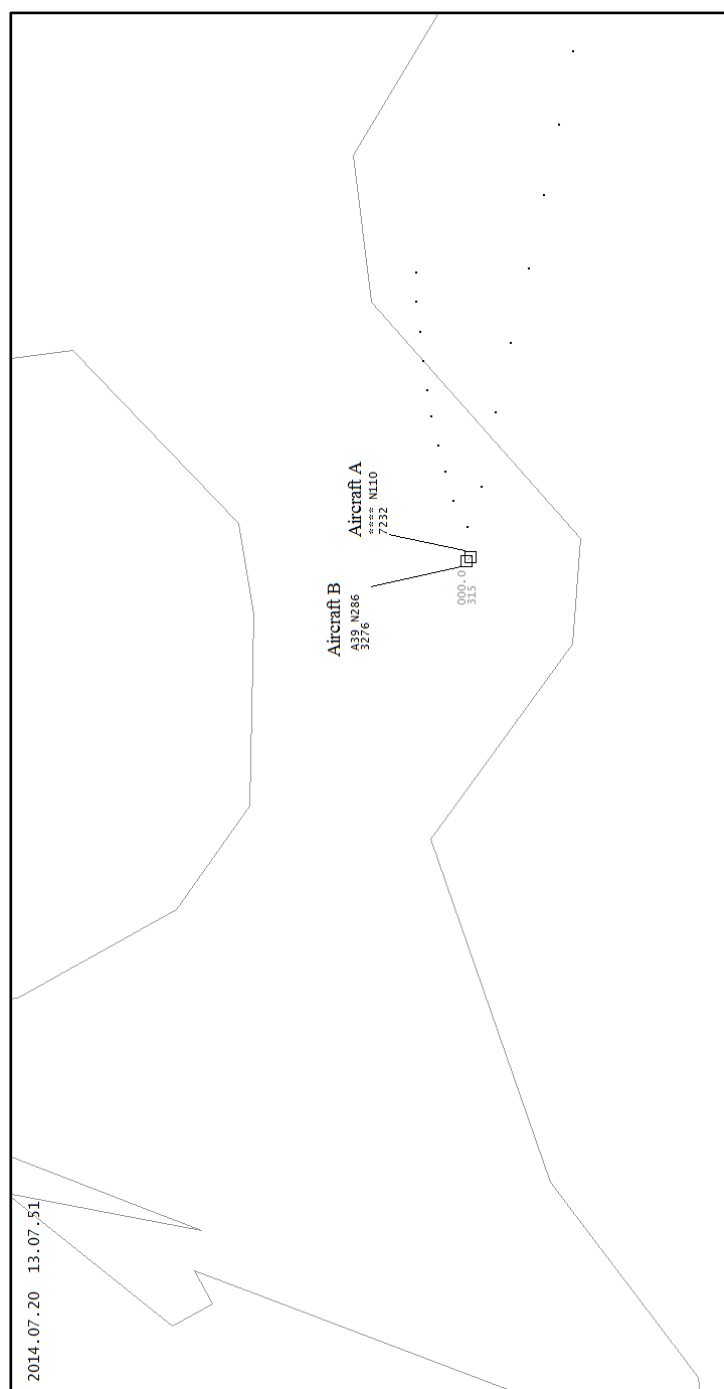
Appendix 2

Radar presentation 13:07:51 UTC “Horizontal separation” (AIB software generated presentation).

The radar presented horizontal separation and position of aircraft A and B were valid.

However, due to a technical feature of the software used by the AIB for the presentation, the altitude of Aircraft B is indicated as A39 and not A40.

At 13:07:51 hours, aircraft B passed aircraft A at a radar presented horizontal distance of 0.0 nm and seemingly at the same altitude. The position of the serious incident was just west of the Falsterbo canal, on the outskirts of Hoellviken in Sweden.

See appendix 2 and 3.

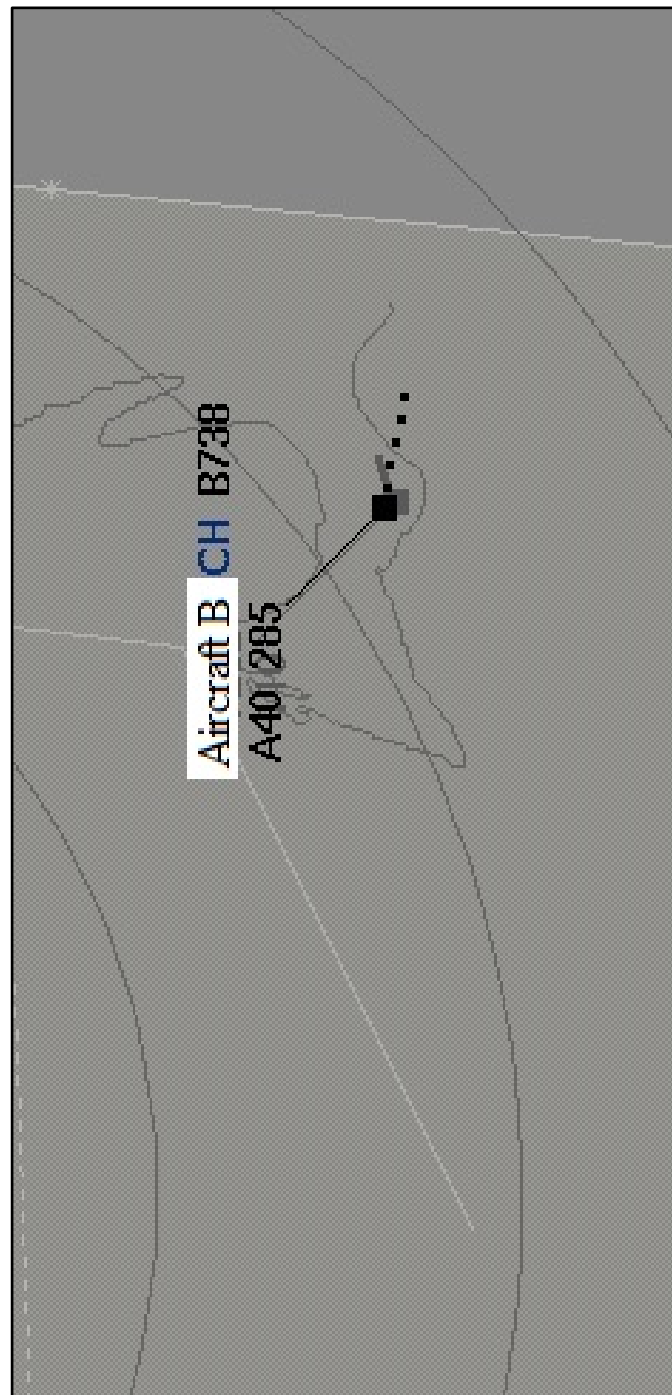
Appendix 3

Radar presentation 13:07:50 UTC “Altitude of Aircraft B”.

The radar presentation is identical to the actual ATCO radar presentation at Copenhagen approach.
The altitude of Aircraft B was presented as A40.

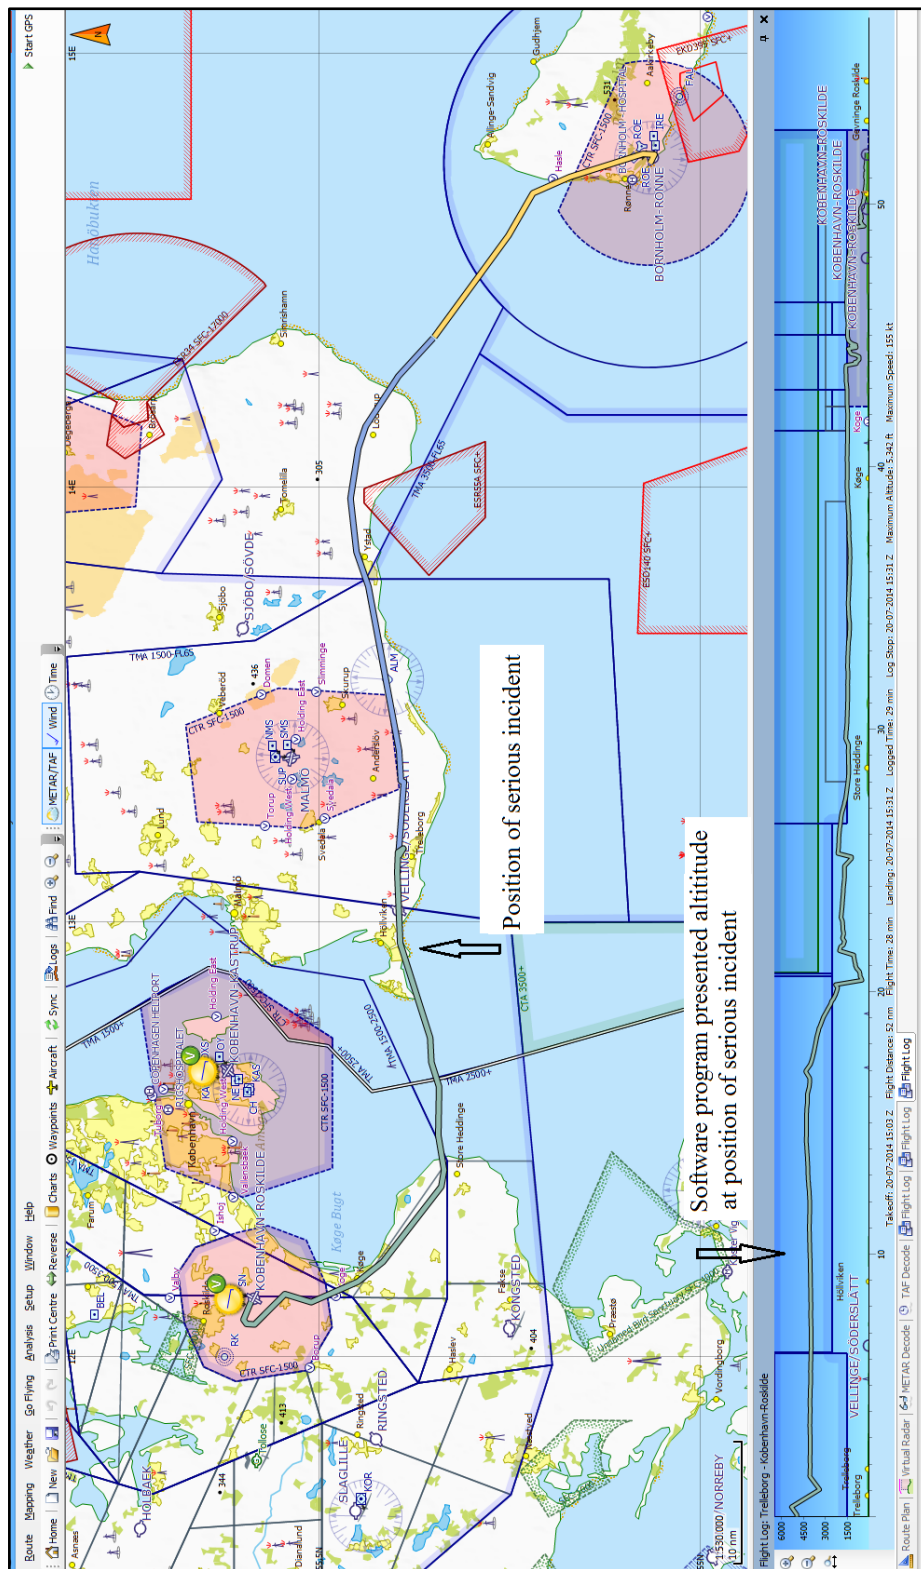
Appendix 4

Flight planning software program presentation of track and altitude of Aircraft A

On the basis of the recorded flight planning software program data log files a presentation of the flight of aircraft A was produced.

See appendix 4.

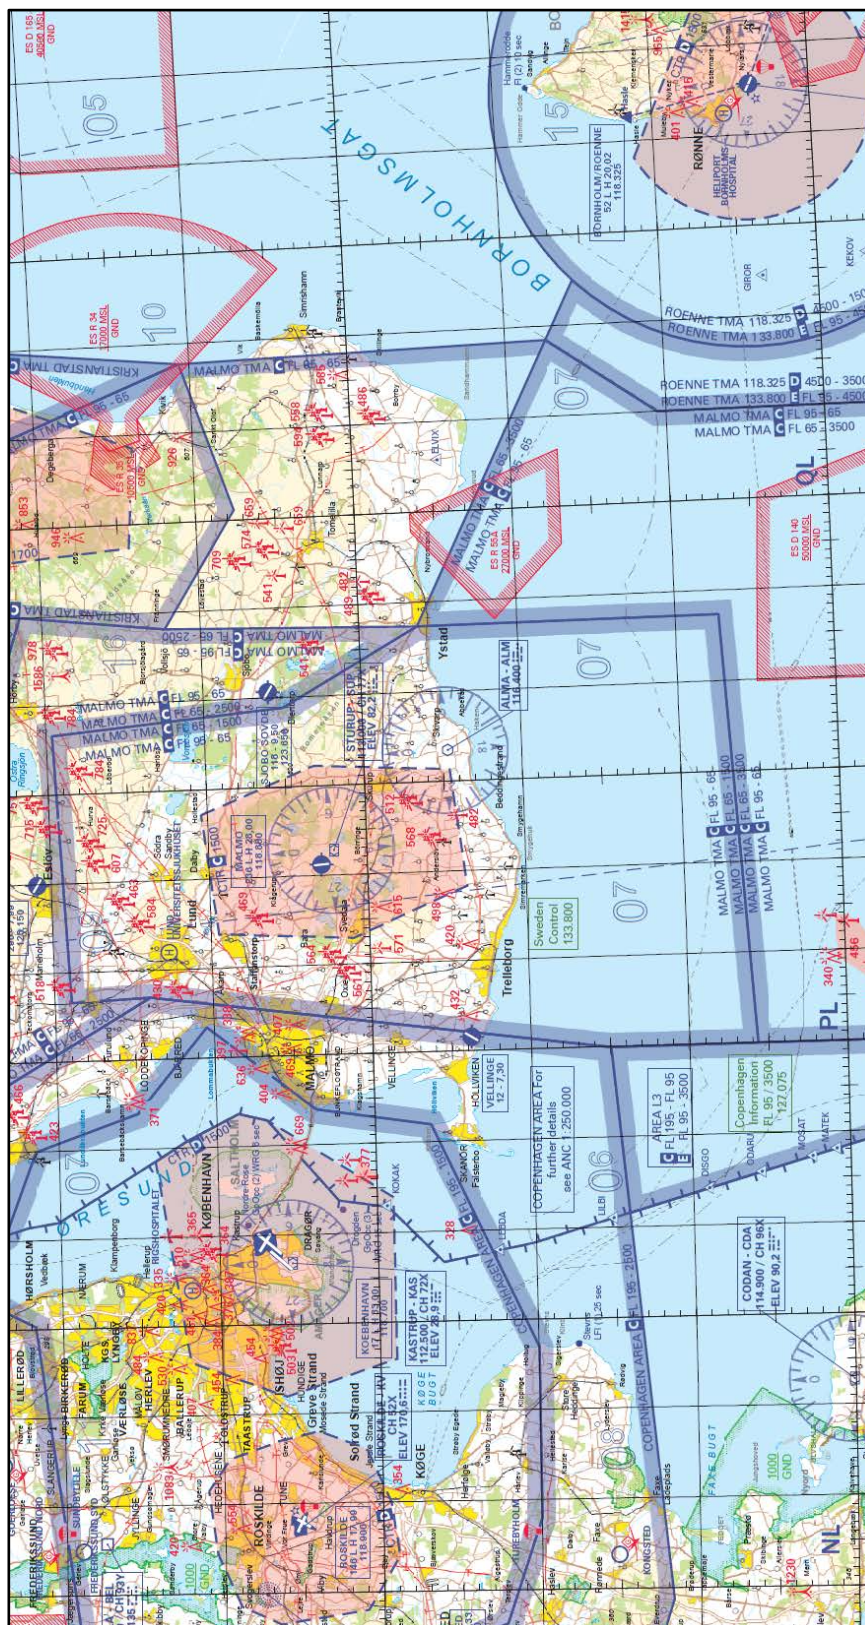
VFR Aeronautical Chart (“Paper chart”)

For layout comparison purposes, an extract of the VFR paper chart showing the same area is also presented.

See appendix 5.
