Boeing has developed tools, information, and training to help airlines repair the 787's composite structure and surfaces.

Making Composite Repairs to the 787

By Arne Lewis, Associate Technical Fellow, Commercial Aviation Services, 787 Service Engineering

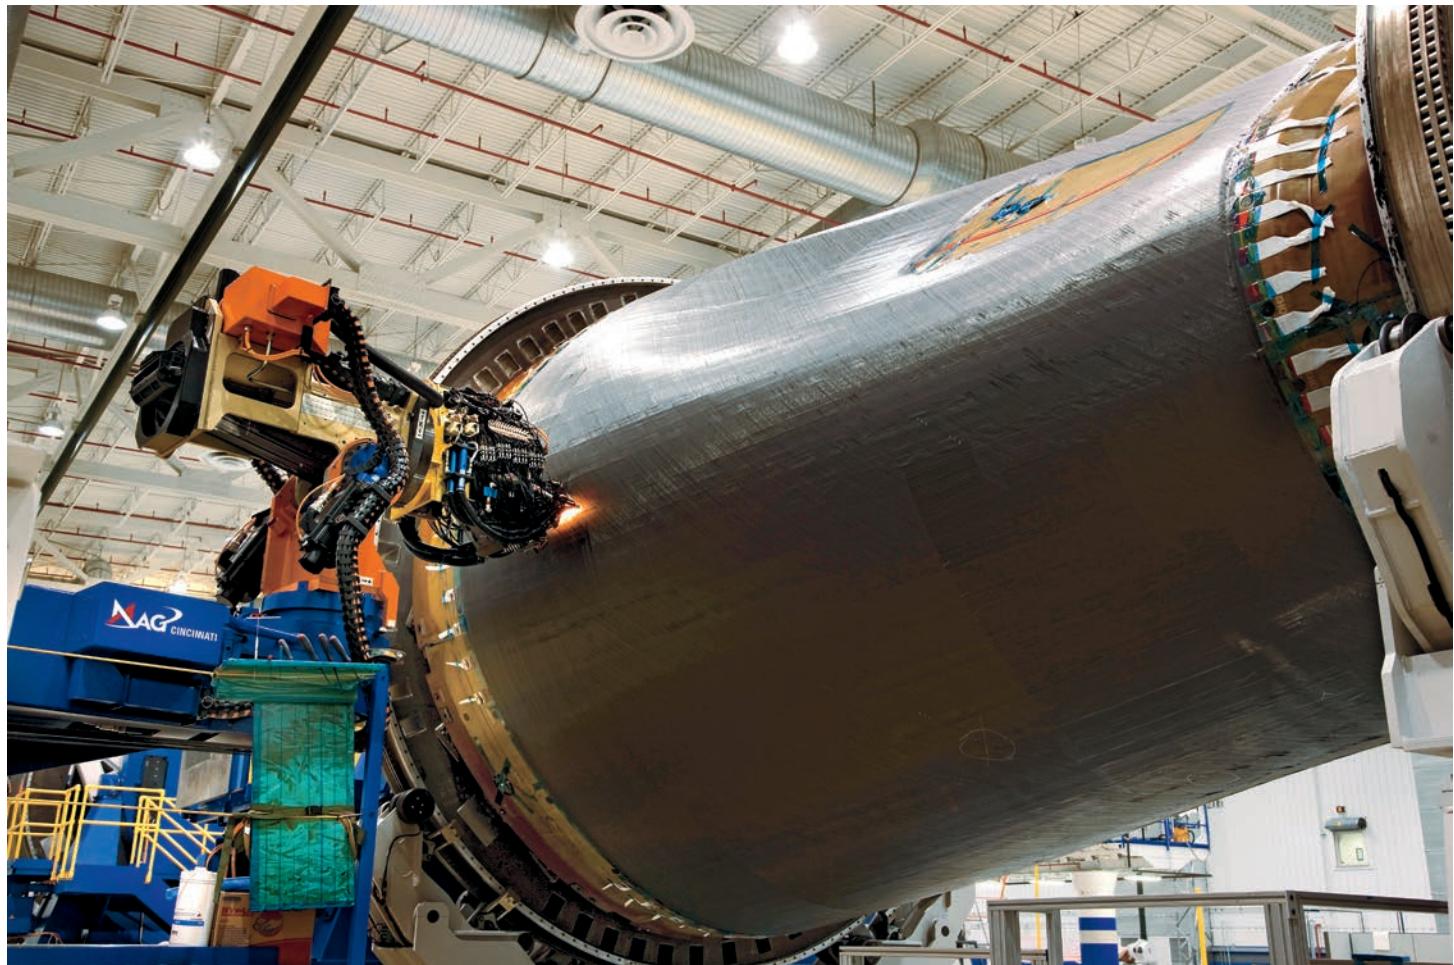
Figure 1: The aftbody sections of the 787 Dreamliner are created using an advanced carbon fiber placement technology

As pictured here, an automated fiber placement (AFP) machine in Boeing's South Carolina facility lays carbon fiber tape using precise patterns and layers to maximize the strength of the barrel.

steadily over the last 45 years. Composite structures on commercial airplanes (see fig. 1) can be all fiberglass layers, all carbon layers, a mixture of the two (often referred to as hybrid parts), or cured with honeycomb core (see fig. 2). Over time, tougher composite materials and enhanced, robust designs have been developed and are being used for primary structure on both the 777 and the 787.

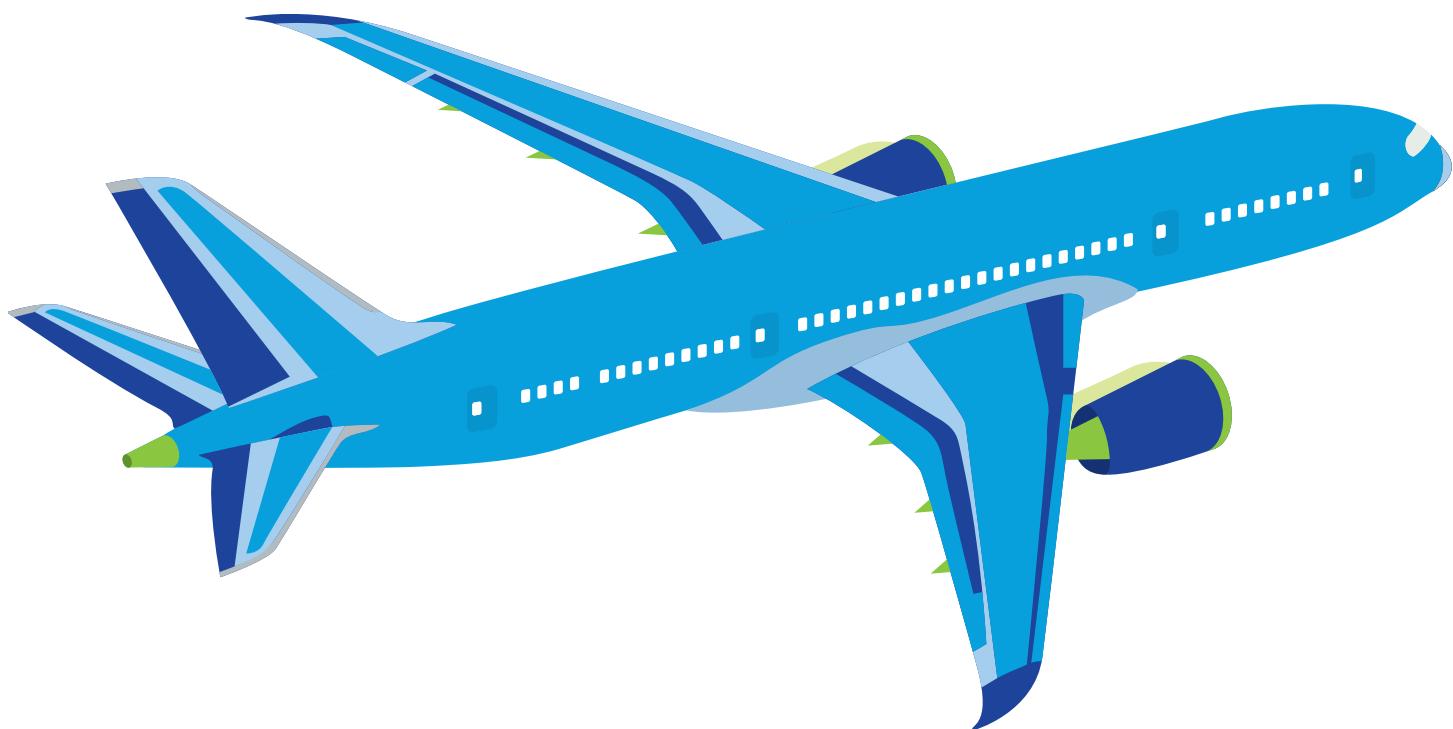
Figure 3: Composites on the 787

Composites comprise more than 50 percent of the 787 airframe.

Materials

■ Carbon laminate ■ Carbon sandwich ■ Other composites ■ Aluminum ■ Titanium ■ Titanium/Steel/Aluminum

Materials by weight

■ Composite ■ Aluminum ■ Titanium ■ Steel ■ Miscellaneous

structure for function, load carrying capability, and durability. This evaluation resulted in composite materials being used extensively on the 787 airframe, making these materials dominant in areas that are traditionally aluminum (see fig. 3).

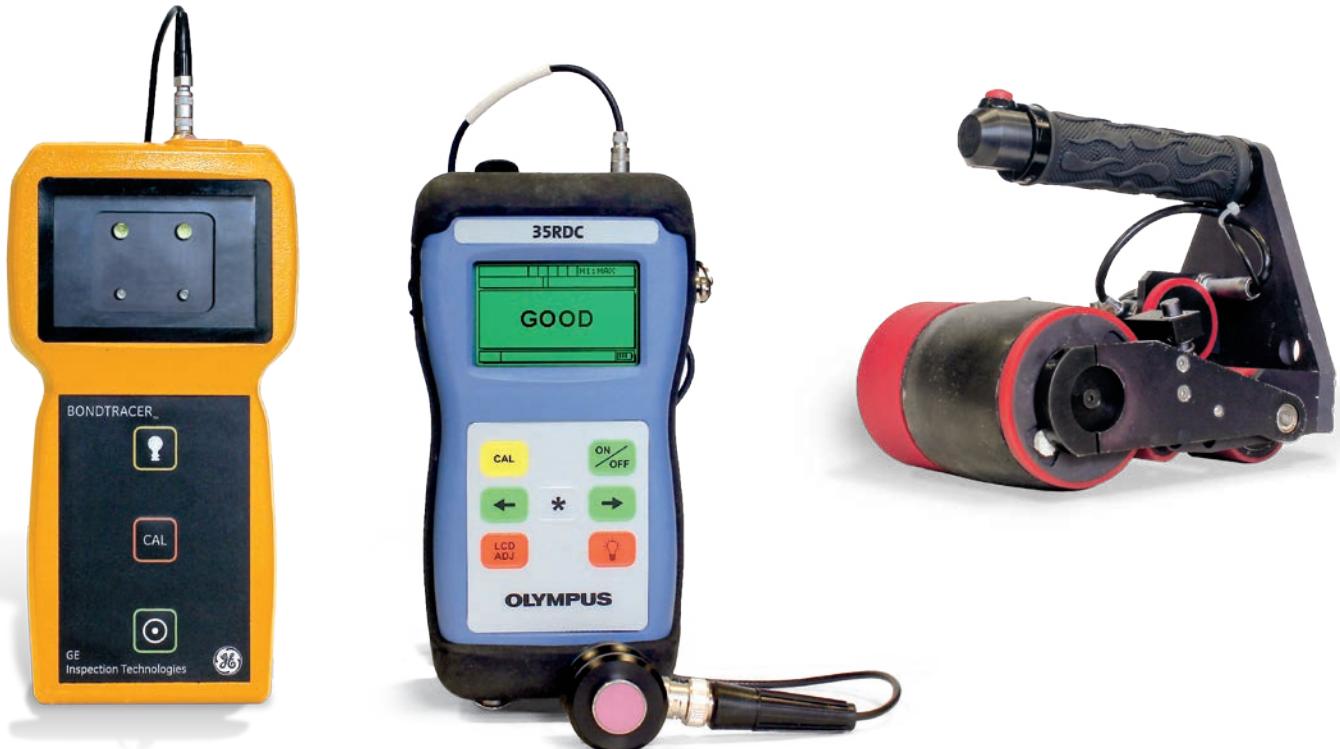
Figure 5: New inspection techniques

Maintenance personnel can first use a ramp damage checker (left and center) and, if necessary, the wheel probe (right) to quickly assess the condition of laminate and sandwich structures on the 787.

The development of the 787 also included the creation of a simplified inspection device to aid maintenance personnel in assessing the extent of damage. The inspection device, called the ramp damage checker, was developed specifically for the ramp technician. For additional damage characterization and more in-depth inspections, a wheel probe was developed to speed and simplify the assessment of laminate and sandwich structures (see fig. 5). Heat damage can be detected using instrumented inspection

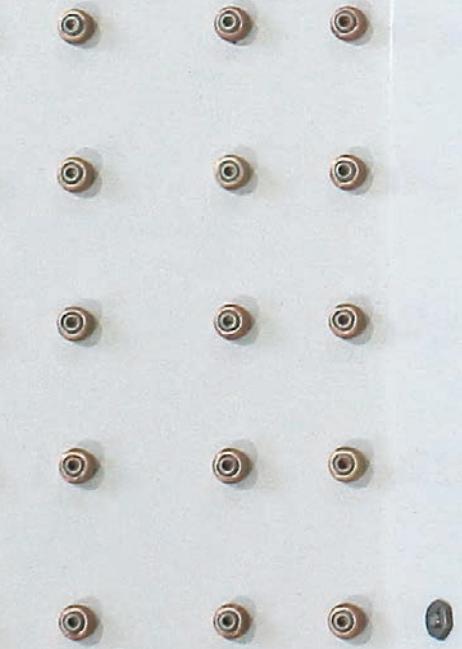
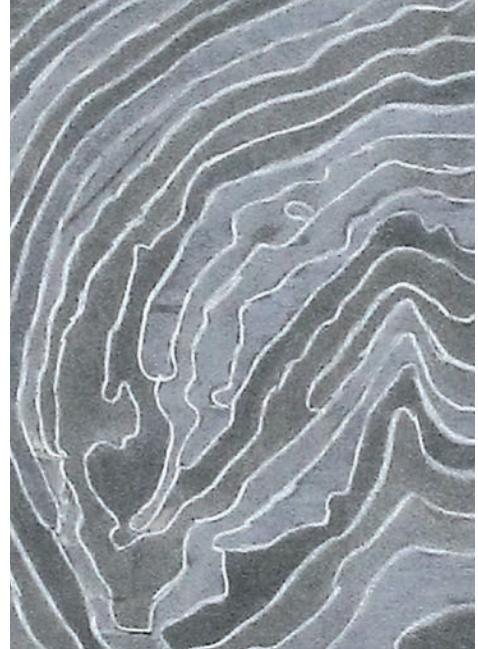
Figure 6: Repair method considerations

Airlines have the option of bolted or bonded repairs. Each approach has its advantages.

BOLTED REPAIR	BONDED REPAIR
Benefits	<ul style="list-style-type: none">■ Faster processing time.■ No risk of heat damage.■ Repair material not sensitive.	<ul style="list-style-type: none">■ No protruding parts.■ Lightweight.■ Category A (permanent repair).
Other Considerations	<ul style="list-style-type: none">■ Heavier.■ Hole drilling must be done with care and caution.■ Repairs may be Category B (require inspections).	<ul style="list-style-type: none">■ Slower processing time.■ Risk of heat damage and porosity.■ Material is time, temperature, and moisture sensitive.

Boeing's research and in-service experience have demonstrated repairs for all areas of composite structures using bonded repairs, bolted repairs, or a hybrid comprising bonding with a bolted substructure (see fig. 6). There are various factors an airline needs to consider when choosing which type of repair to make. The SRM only allows you to choose the repair
