Just Culture conversation between aviation and  
judiciary

Castelldefels 26 May 2017

Occurrence Scenario 2

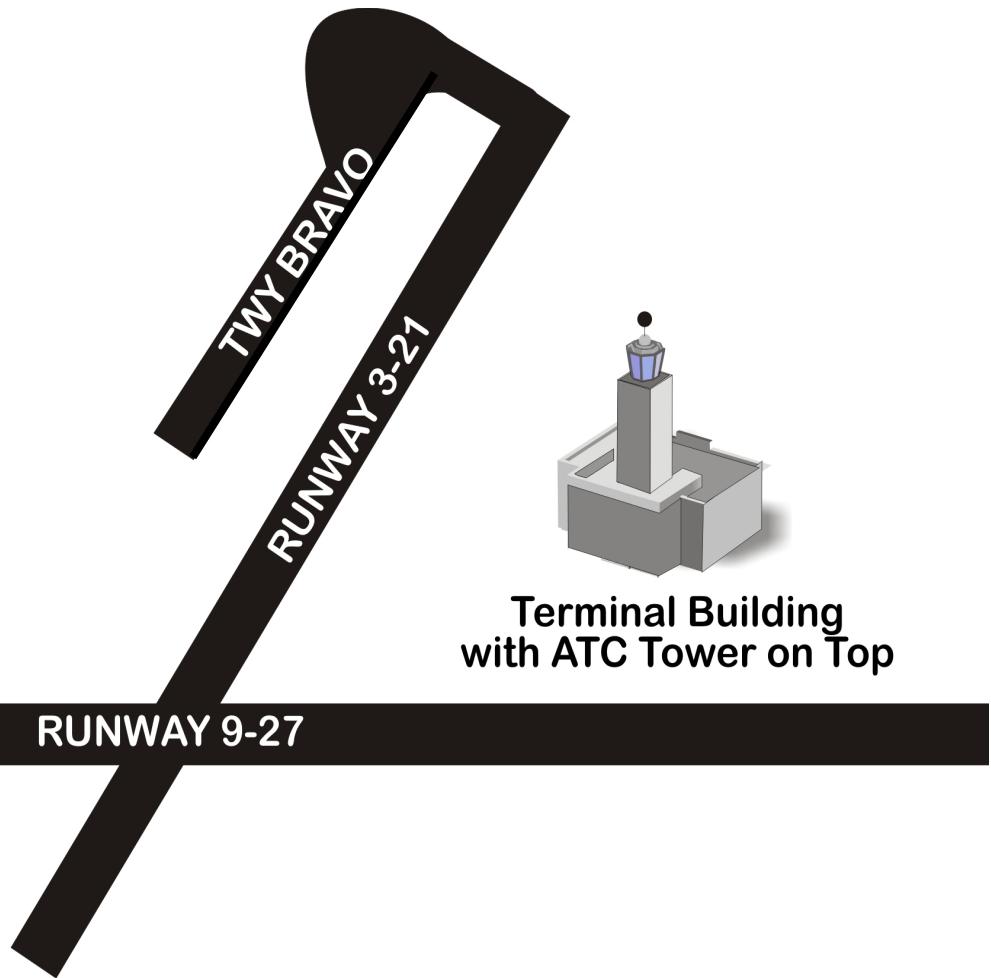
# Selective schematic of airport

- Is a major international aerodrome with heavy traffic.
- Has two runways, an east-west runway that is 3,700 meters long, and a northeast-southwest runway that is 2,500 meters long.
- The runways intersect at about the mid-point of the longer one.
- The terminal building is located in the northeast quadrant of the airport, with the ATC tower located on the top of the terminal.

Terminal Building  
with ATC Tower on Top

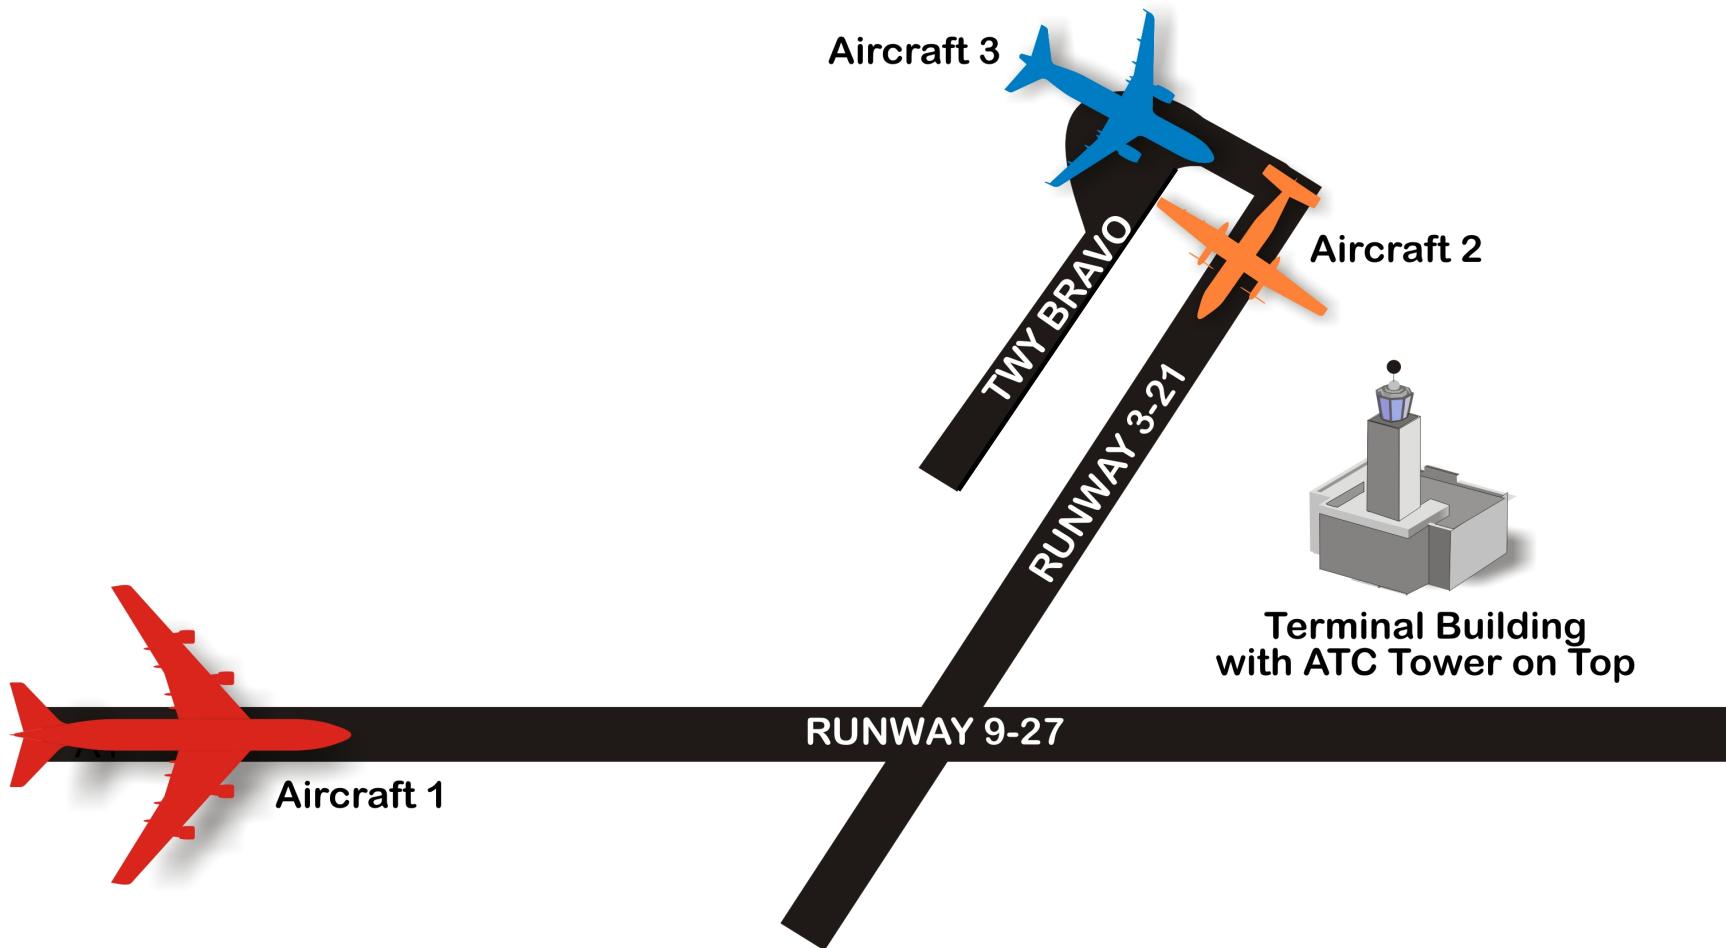
# Aircraft Locations

- Aircraft #1 (B747) is lined up for takeoff on RWY 9.
- Aircraft #2 (DHC8) is lined up for takeoff on RWY 21.
- Aircraft #3 (A320) is holding short of RWY 21 on TWY Bravo.

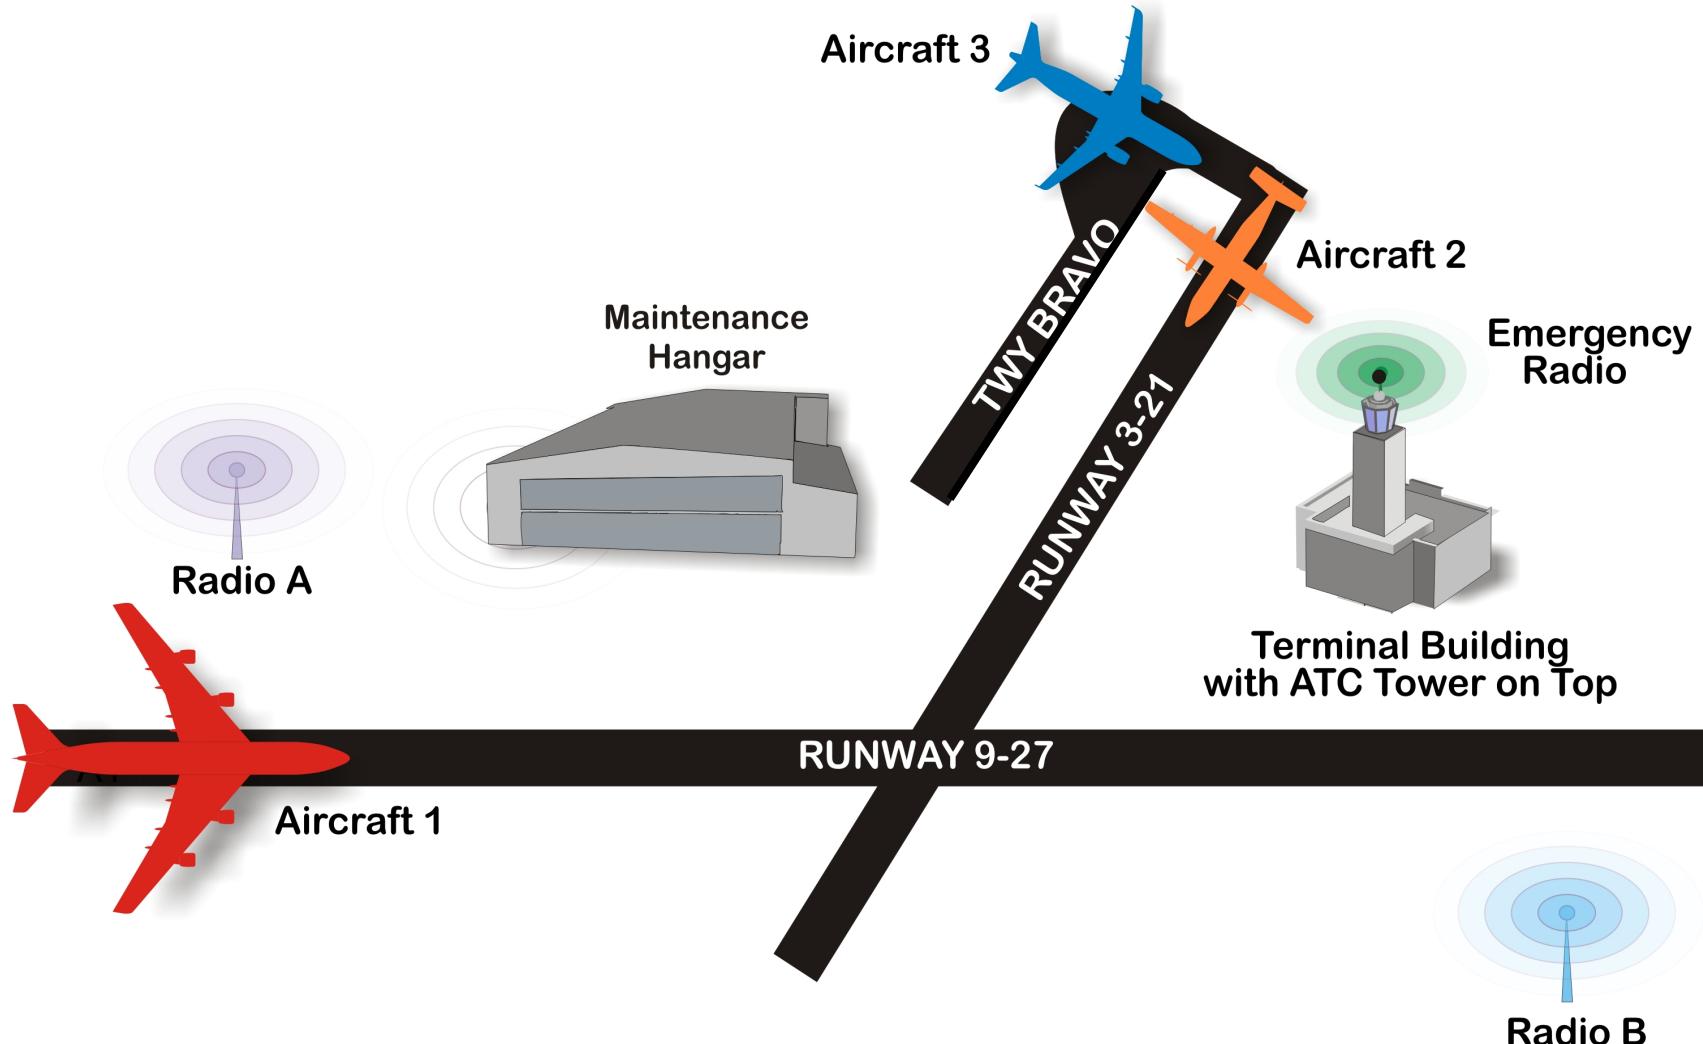
# Radio Antenna Locations

- The Radio A antenna is physically located at the west end of the airport, north of the runway.
- The Radio B antenna is located at the east end of the airport, south of the runway.
- There is an automatic switching system that activates the radio with the strongest signal. Only one radio at a time is activated.

- Aircraft #1(B747)'s proximity to Radio A was such that Radio A was selected automatically when Aircraft #1 transmitted.
- Aircraft #2 (DHC8) could hear the controller on Radio A, but maintenance hangars blocked line-of-sight between the aircraft and the radio site – the weaker transmission from the aircraft was not heard by the controller.
- The controller did not hear anything indicating that two aircraft were transmitting at the same time.
