Operational Safety Study

Sudden High Energy Runway Conflict (SHERC)

Edition Number	:	1.0
Edition Date	:	03/03/2017
Status	:	Released Issue
Intended for	:	General Public

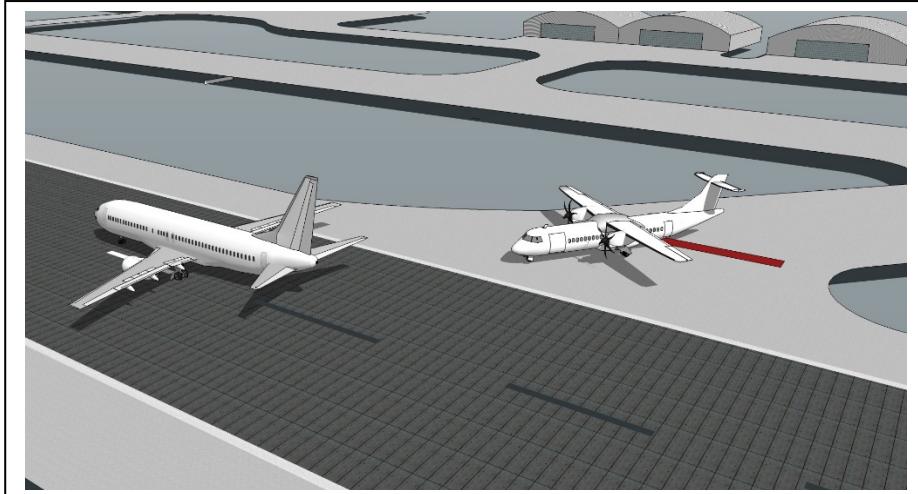
The A321 takes off. B737 is given clearance to land and ATR42 begins to move onto rwy. When the B737 landed, the ATR42 is 40m from the rwy c/l. The B737 crew saw the ATR42 and deviated to left as soon as possible.

ATC did not see the ATR42 until the pass was taking place. ATR42 crew said they saw the A321 pass them and assumed that was the landing aircraft in the conditional clearance. The holding point that the ATR42 was using was a Rapid Exit Taxiway (RET) for the other end and therefore the view from the flight deck of the ATR42 towards the approach was restricted.

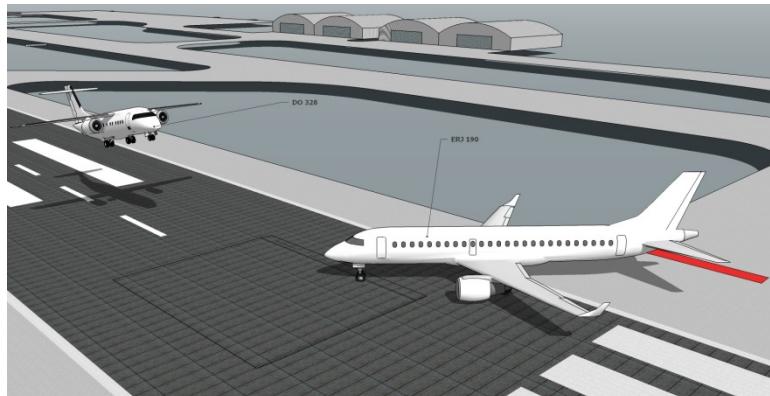
The Dornier Do-328 was cleared to line up runway 15 and subsequently cleared for take-off from runway 15, as the Embraer went past the hold short line runway 33 and lined up runway 33. The Dornier rotated and climbed out over the Embraer.

The distance between the two runway entry points is 1350 meters.

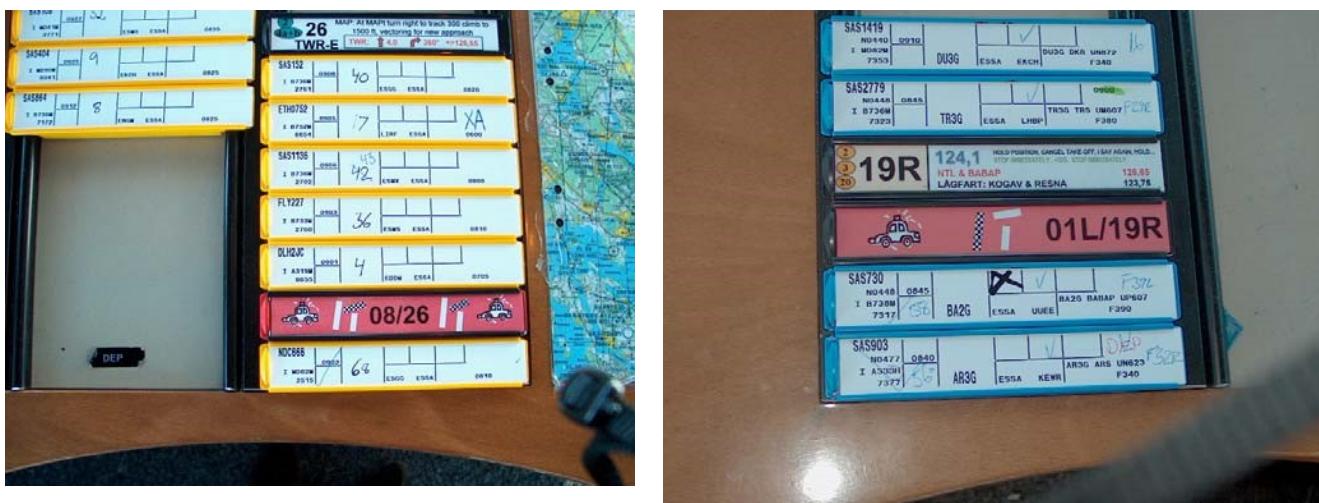
Fig 1 Dedicated flight strip for runway inspection (one per runway)

This may be placed in a dedicated Strip holder of a different colour, usually red, to make it more noticeable.

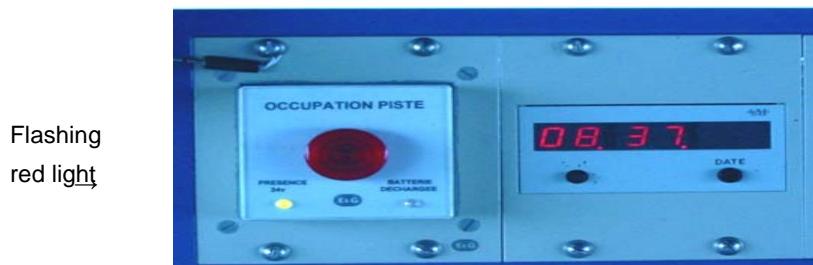
Figure 3: "A runway occupied box" display panel

Runway occupied boxes are a tool to remind a controller that the runway is occupied by a vehicle. It requires manual input by the controller. The controller places the box on the flight strip board during occasions when a vehicle is authorised to enter the runway. These types of devices normally have a flashing red light to remind the controller that the runway is occupied.

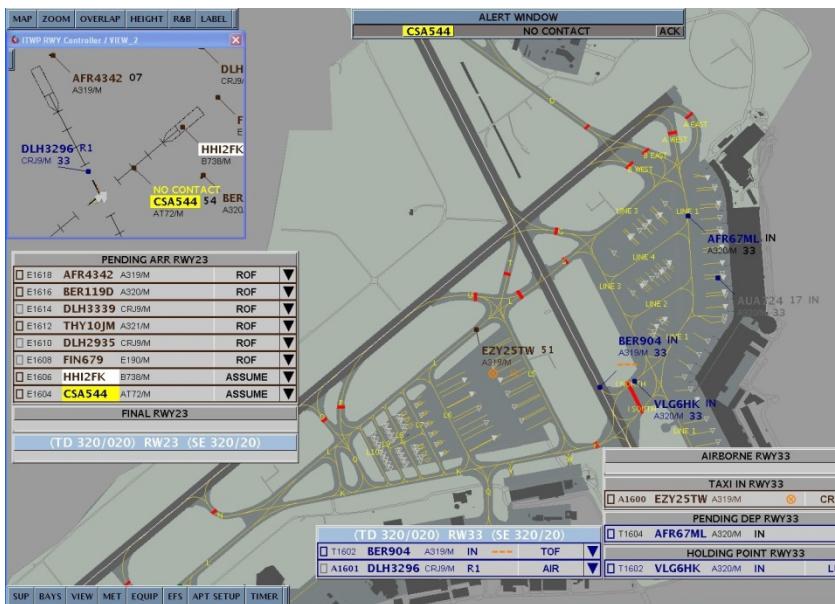
Fig 9. Yellow Highlight appears in Alert Window at top of display and yellow highlight on ATM element for no TWR frequency contact with an aircraft within 4 miles.

This alert is generated for an aircraft on short final (less than 4NM) that is not on the RWY frequency.

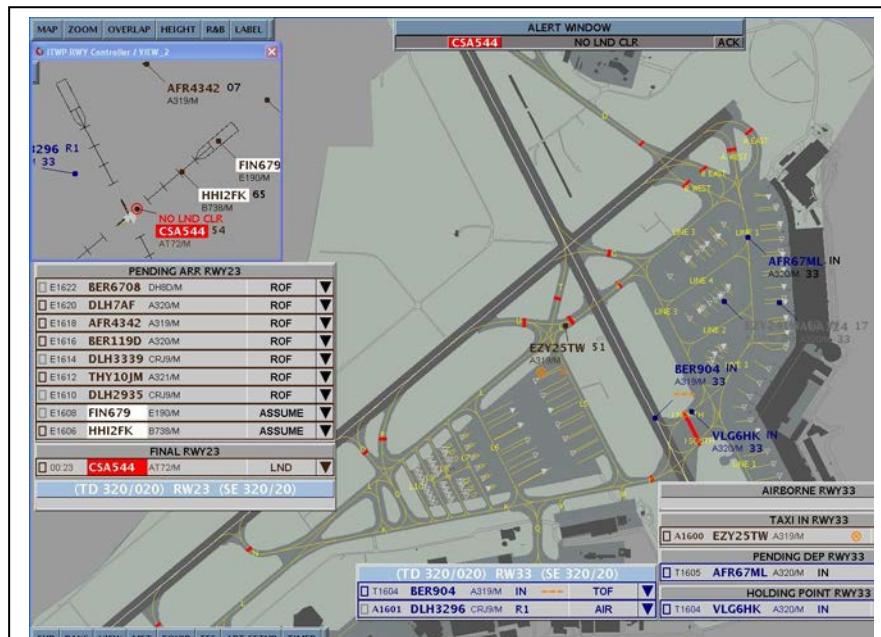
Fig 10. Red highlight appears in Alert Window at top of display and red highlight on ATM element and Arrivals elements for aircraft with no landing clearance within 1 mile.

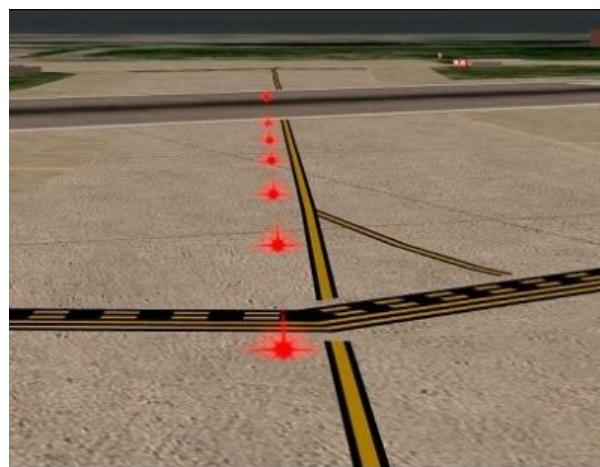
Fig 15. Pilot view of illuminated RELs

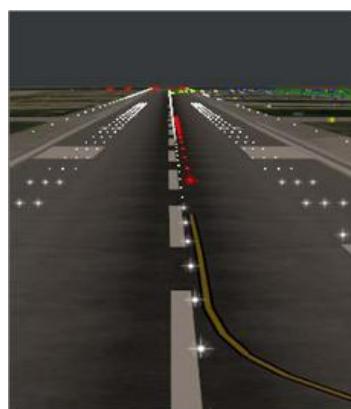
Fig.17 Pilot view of Take-off Hold Lights

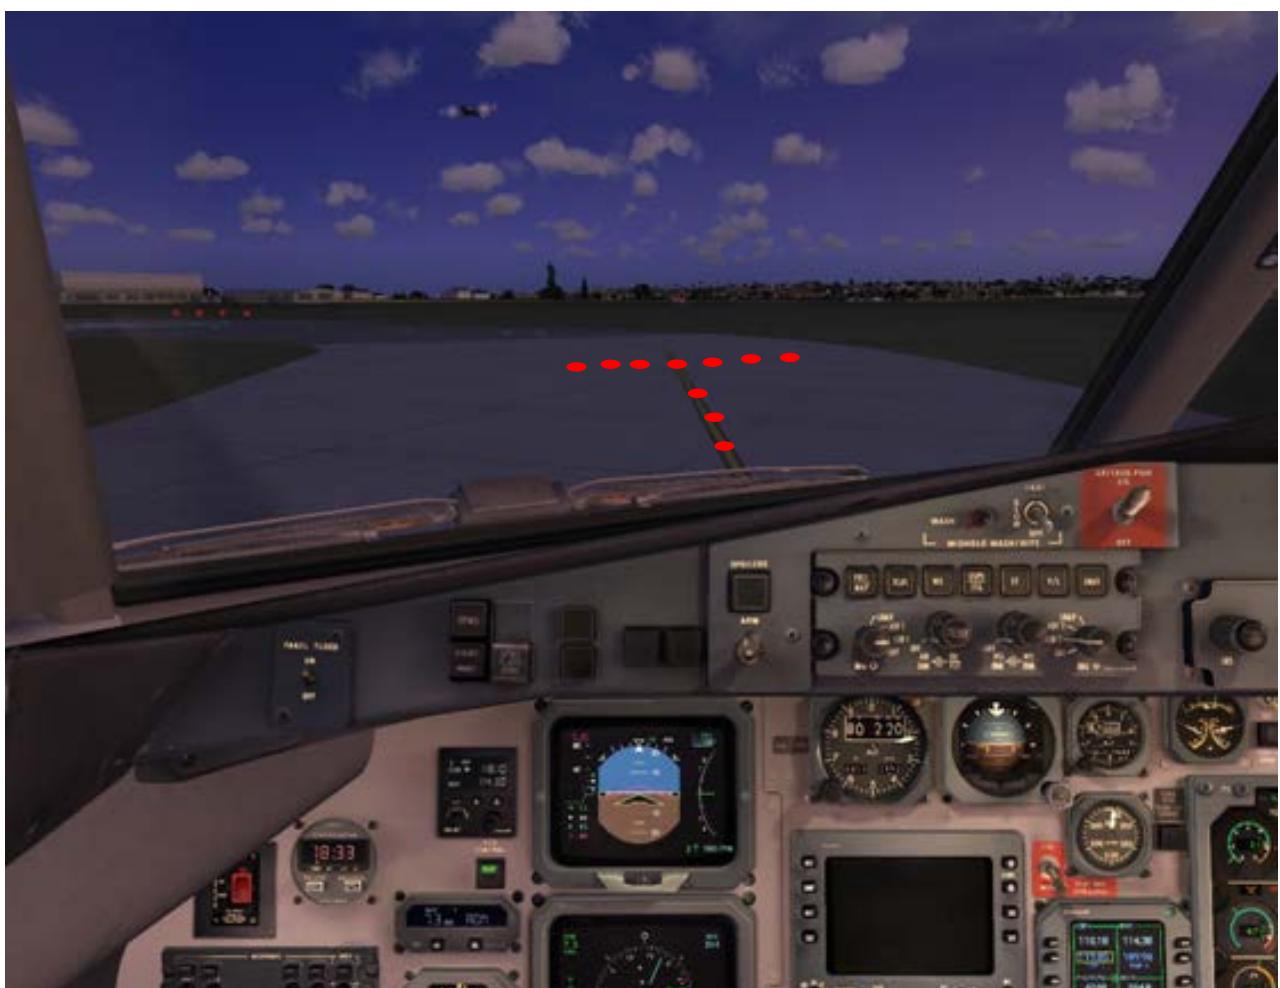
Fig. 19 Pilot view of SCIPS alert. Crossing an illuminated stop-bar results in array of Red Lights.⁵

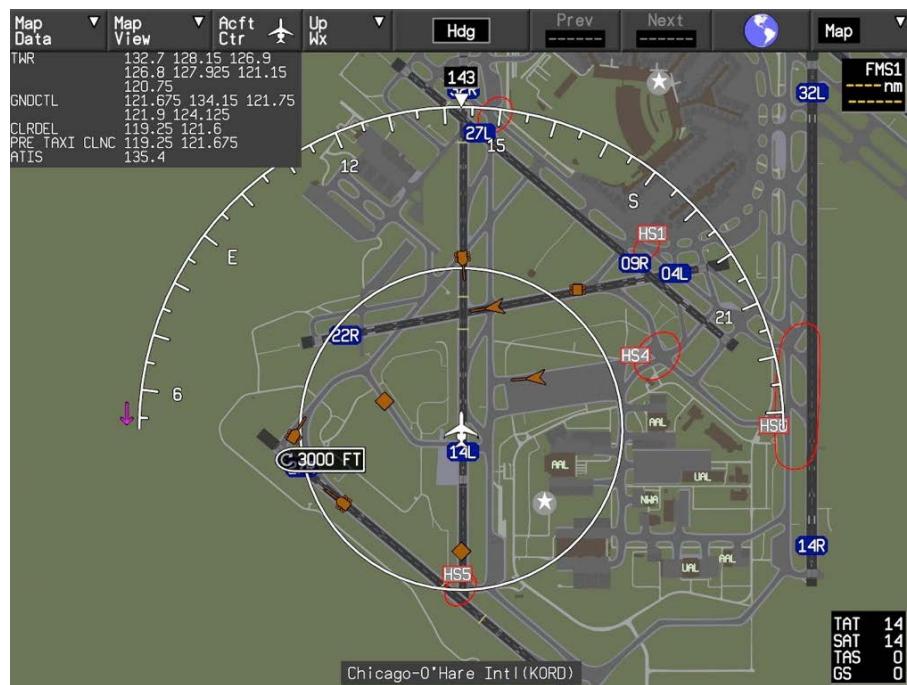
Fig 21 2D Airport Moving Map on Flight Deck Navigation Display⁷

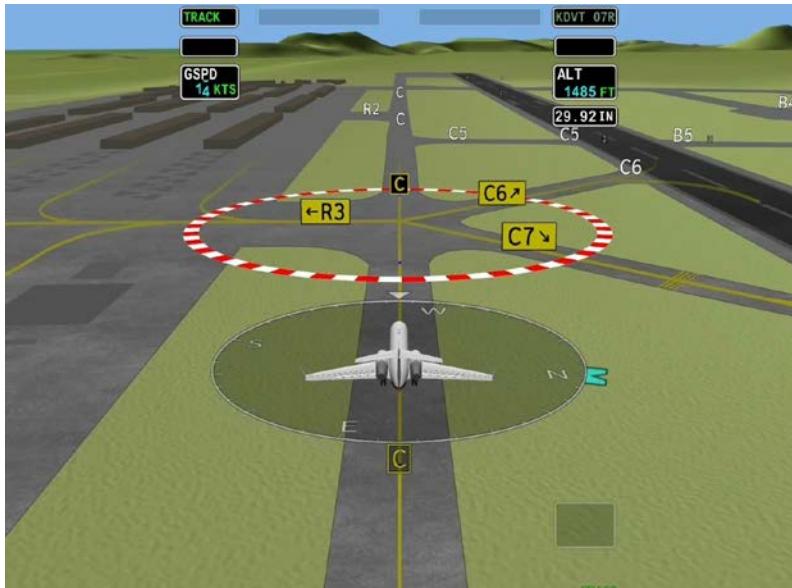
Fig 22. 3D Airport Moving Map on Flight Deck Primary Flight Display⁸

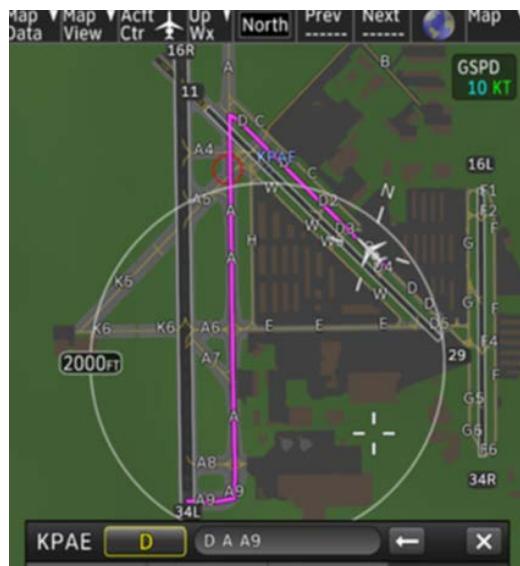
Fig 23 Flight Deck Taxi Wizard⁹
