**DOT/FAA/TC-18/2**

# **Problematic Taxiway Geometry Study Overview**

January 2018

Final Report

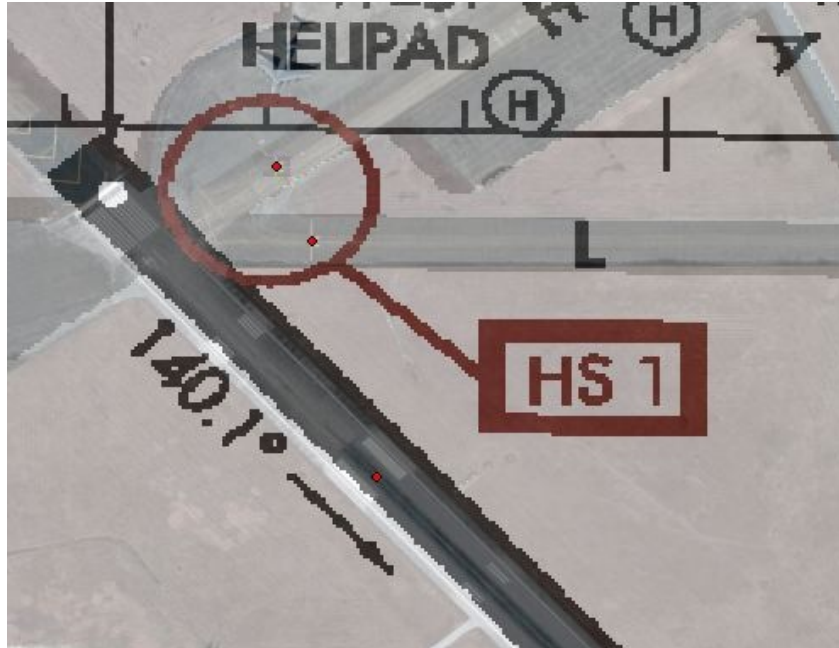
The first type of geometry location point is a hot spot. According to the FAA, areas identified as hot spots often have a history of runway incursions or surface incidents, or are areas known to require increased vigilance from air traffic control. They are designated by local Runway Safety Action Teams (RSAT). RSATs are made up of airport users that meet to discuss safety issues involving moving around the airport and airspace and make recommendations to enhance safety. Hot spots remain charted on the airport diagram until the factors that contribute to the increased risk are mitigated [7]. An example of a hot spot marking, labeled HS 1, is shown in figure 3.

Figure 3. Hot Spot Depiction on Airport Diagram

To georeference existing hot spot locations, points were created in the database and numbered according to the current airport diagram. The three-letter airport identifier was also added to each existing hot spot point (e.g., BWI-HS1).

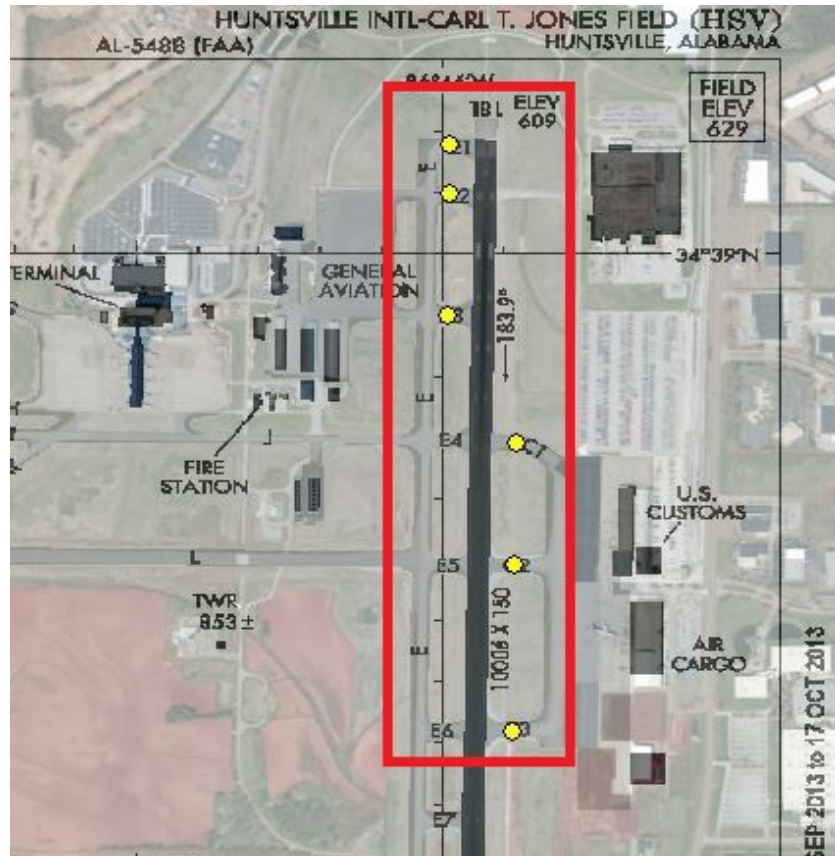
The second type of geometry location point includes all other locations that met the criteria to be considered PTG. This criterion is described in EB 75, and relates to a taxiway's "location, alignment, width, and operational use" [4]. Also referenced were the criteria detailed in the taxiway design standards provided in AC 150/5300-13A [3] and airport geometry data elements identified by the Office of Runway Safety (AJI-14) [9]. This study focused on the guidance-documented PTG, plus other PTG to obtain the 19 most common geometry elements associated with a runway/taxiway intersection, known as geocodes. The points identified as having PTG were depicted as yellow circles when viewed in the geodatabase, as shown in figure 4.

Figure 4. Problematic Taxiway Geometry Locations

PTG points were located by analyzing an airport's diagram and aerial imagery. Where applicable, PTG points were located at the intersection of the runway or taxiway centerline and a runway holding position marking. Each location identified was assigned a code consisting of the airport's three-letter identifier and a sequential number (e.g. ORD-01, ORD-02, etc.).

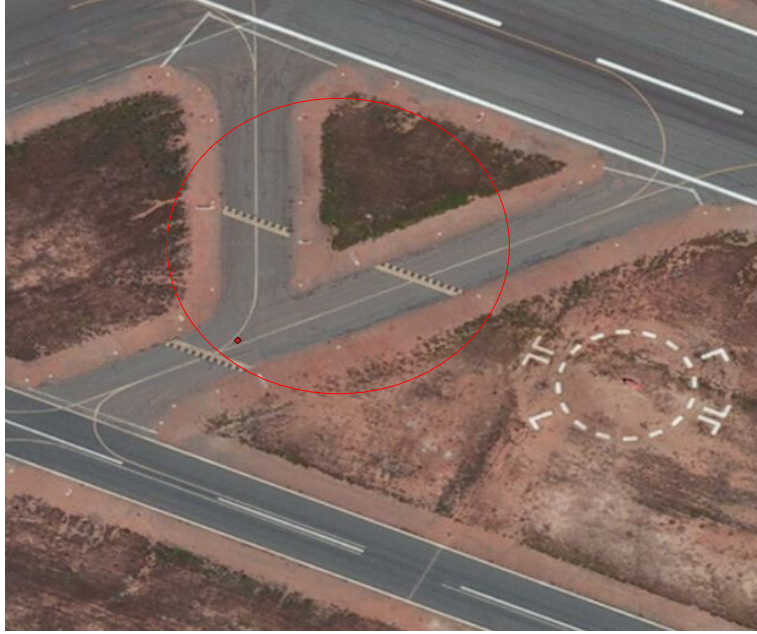
Multiple taxiway entrances at one runway location, such as Y-shaped connectors, present opportunities for ground navigation errors as a result of wide expanses of pavement, difficulties in reading signage, etc., which promote the potential for runway incursions and for aircraft vacating one runway to enter a wrong taxiway or a different runway [3]. An example of this is shown in figure 5. Limiting the routing options available to pilots on each runway entrance or exit may help to avoid runway confusion.

Figure 5. Y-Shaped Taxiways

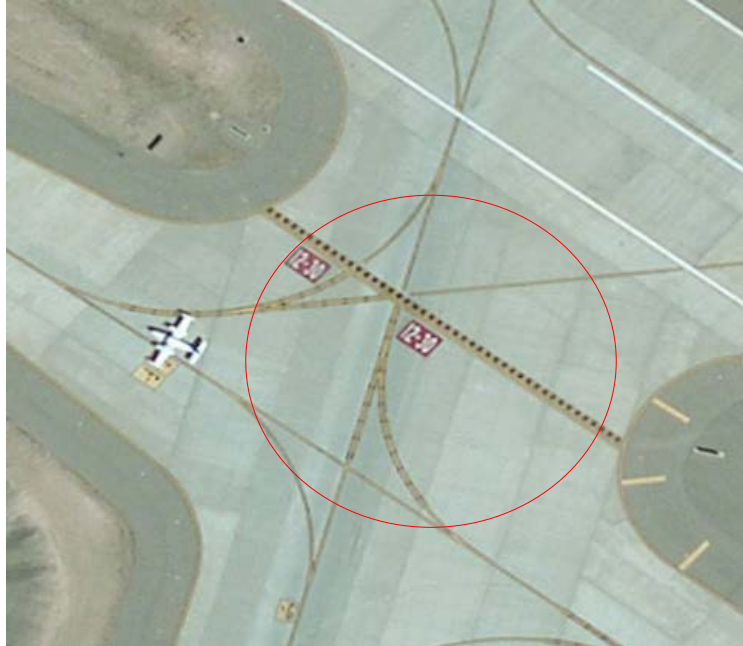
Taxiway configurations with multiple taxiways entering a runway create large expanses of pavement that make it difficult to provide proper signage, marking, and lighting, as shown in figure 8 [3]. This configuration also violates the three-node concept of taxiway design as described in AC 150/5300-13A [3].

Figure 8. Converging Taxiway Types for a Runway

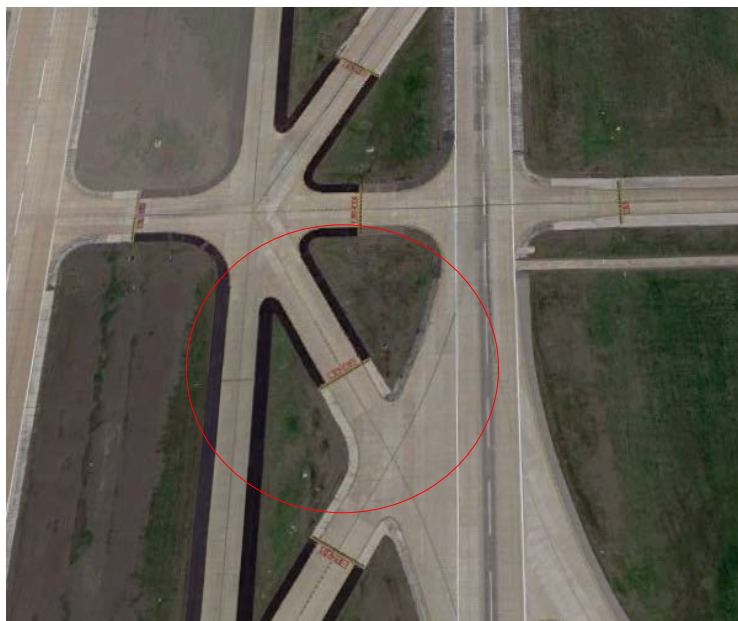
A high-speed exit that crosses or connects with another taxiway directly entering a runway can result in a runway incursion, as shown in figure 9 [4]. The main safety issues with this design are the difficulties with marking, signing, and lighting the resultant wide expanses of pavement.

Figure 9. High-Speed Exit Taxiway Crossing

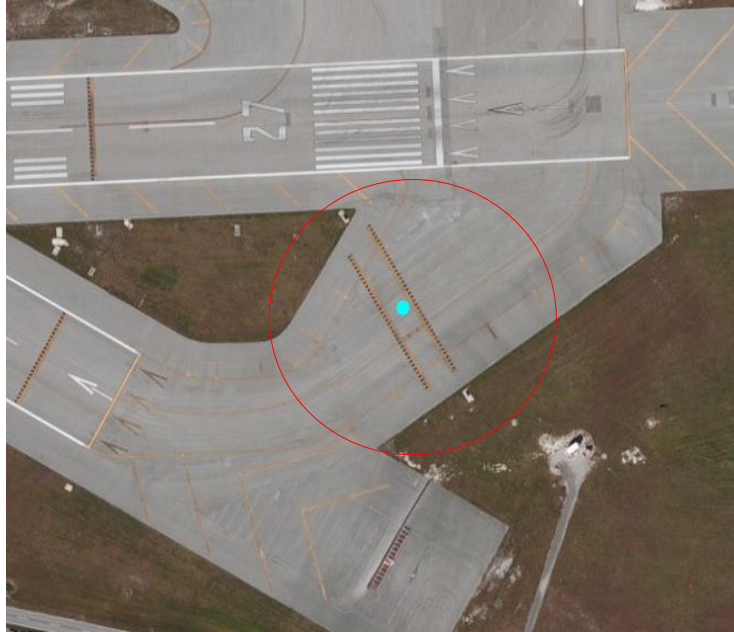
Configurations where runway thresholds are too close together are not recommended, as shown in figure 10. This type of configuration can be confusing to pilots, resulting in runway incursions, as well as wrong runway takeoffs [3].

Figure 10. Runway Thresholds in Close Proximity

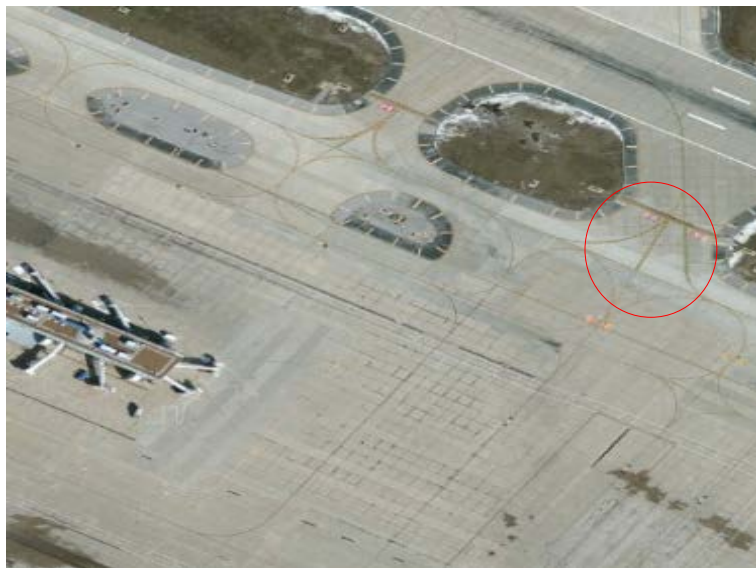
Taxiways that lead directly from an apron to a runway, as shown in figure 12, are not recommended. These configurations may create the false expectation of a parallel taxiway prior to the runway (basic design standard), which could lead to confusion and runway incursions [3].

Figure 12. Direct Access to Runway From Ramp

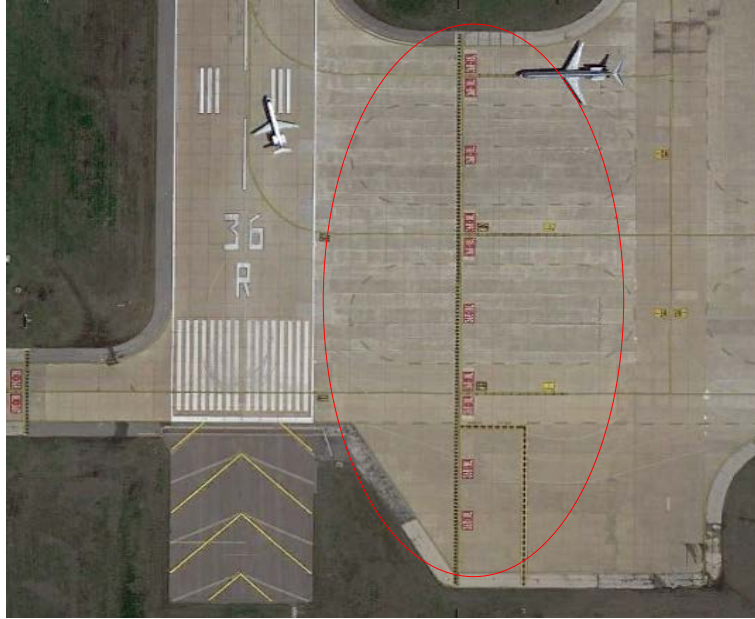
Nonstandard markings and/or signage could include, but are not limited to, overlapping hold bars, nonstandard hold bar placement, and runway intersections with multiple hold lines. Nonstandard location or lack of placement and visibility of the markings, lighting, and signage on taxiways, as shown in figure 14, decreases the pilot's situational awareness within the area/location. [9].

Figure 14. Nonstandard Marking Placement

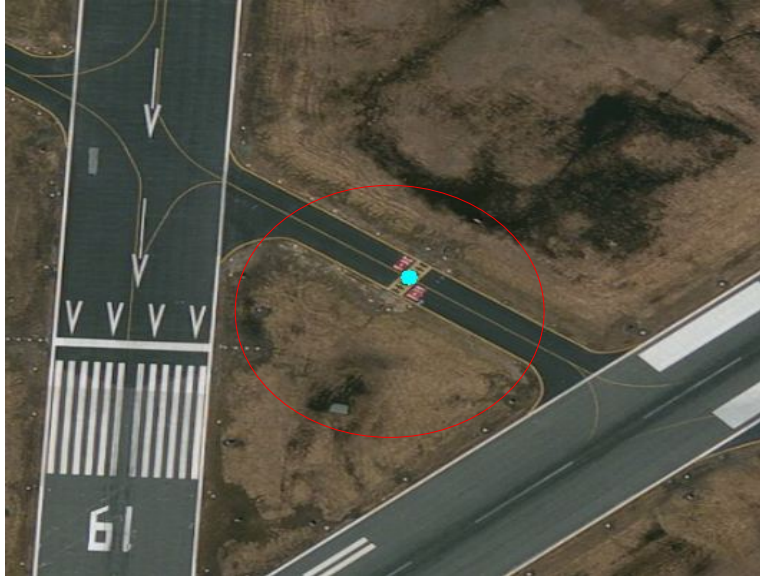
One taxiway leading to an area with multiple runway thresholds located in close proximity to one another, as shown in figure 16, can result in hold lines in short proximity. This can result in a failure to hold short and a runway incursion [9].

Figure 16. Taxiway Connecting V-Shaped Runways

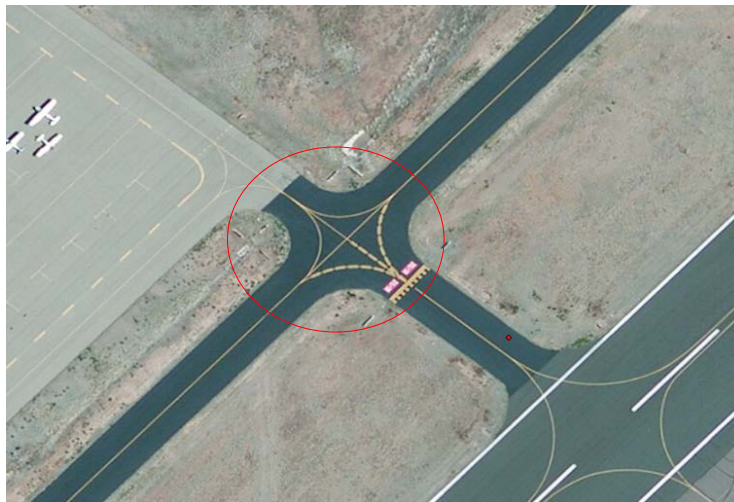
A short taxi distance, compared to a direct ramp-to-runway configuration, between the terminal and the runway requires pilots to complete the same number of checklist items in a shorter timeframe than longer taxi routes. Therefore, during the head-down period, the pilot(s) may taxi through the runway hold line (loss of pilot's situational awareness) [9]. An example of this type of geometry is shown in figure 18.

Figure 18. Short Taxi Distance to Runway From an Apron

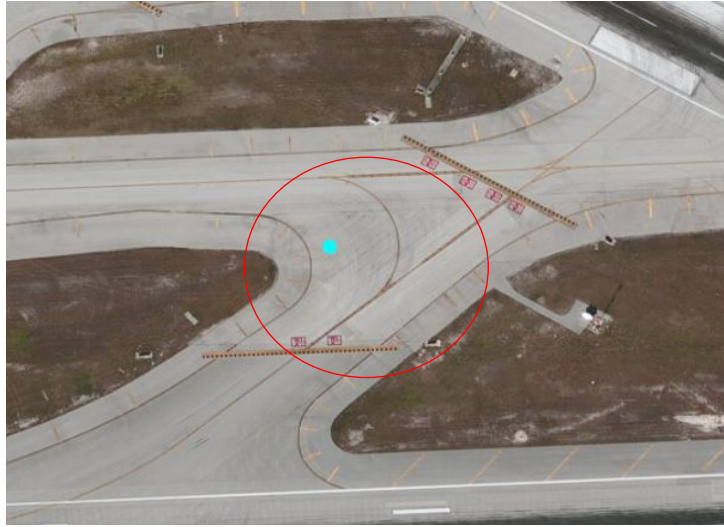
crossing the adjacent runway's hold line. This configuration, as shown in figure 19, has resulted in runway incursions.

Figure 19. High-Speed Exit Leading Directly to Another Runway

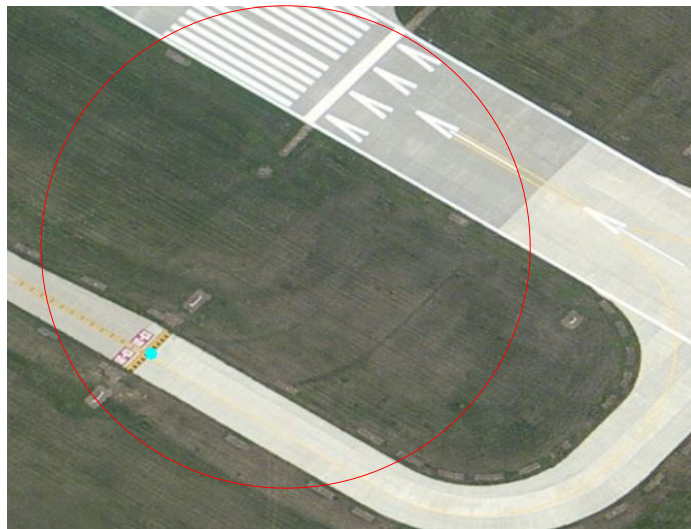
This placement is unexpected by the pilot and may cause the pilot to ignore/not expect the hold position point, resulting in a possible runway incursion. An example of a problematic displaced runway threshold is shown in figure 22.

Figure 22. Displaced Threshold With Holding Position Marking on Parallel Taxiway

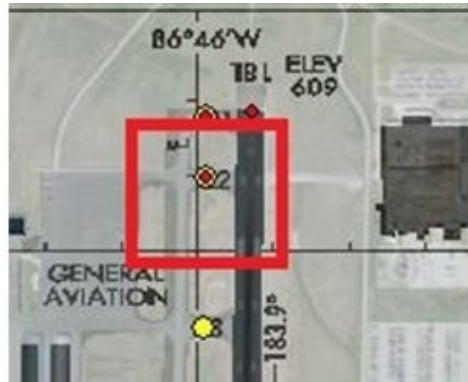
Taxiway Echo 2 centerline and the runway hold short line. The Geometry field would be logged as Y, and the GeoAssoc field would contain the associated geometry point located at the intersection, shown in figure 25.

Figure 25. Georeferenced Runway Incursion

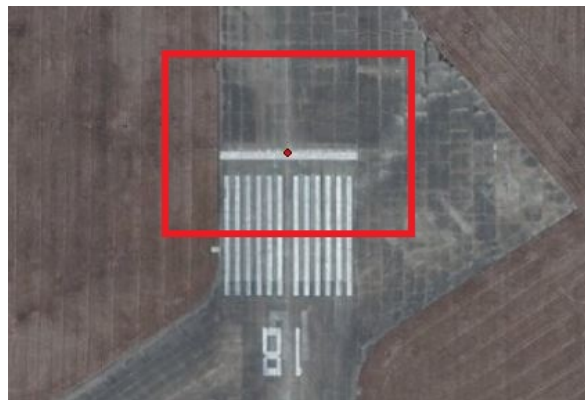
Therefore, the runway incursion was plotted at the position, centered on the runway 18 threshold, as shown in figure 26.

Figure 26. Landing Aircraft Incursion

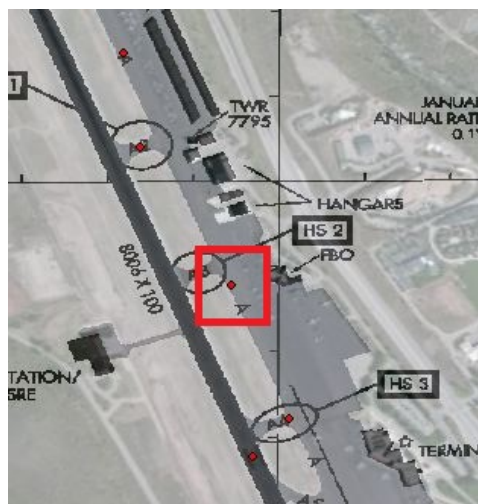
Taxiway Alpha runs the entire apron area length, as shown in figure 27; therefore, it cannot be known with certainty where on the taxiway this incident occurred. Consequently, the incident was depicted at the half-way point of this taxiway. Similar undefined narratives also existed for the same airport, resulting in several other points being collocated at this position, based on similar reasoning. In such cases, discretion is required to interpret the applicability of these points for use in planning.

Figure 27. Unidentified Incident Location

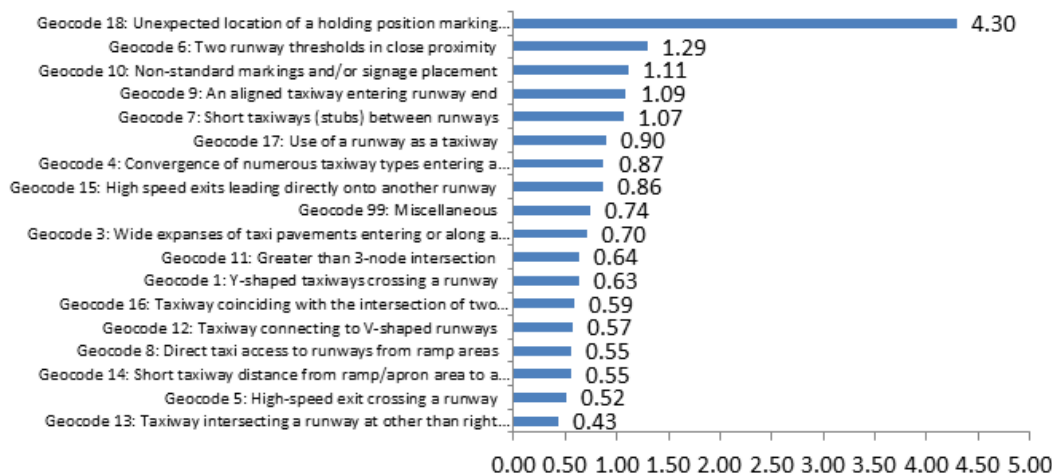
To determine the relationship between the geocodes at a location to the number of PD and V/PD runway incursions occurring there, the incursion totals were divided by the number of locations exhibiting the geometric characteristics. Using this criterion, an unexpected location of a holding position marking on a parallel/entrance taxiway was associated with the highest rate of incidents (4.30 per location on average), as shown in figure 36.

Figure 36. Runway Incursion Rate of Each Geometry Type for all Categories
