18th October 2018

Runway Incursion TAP Perspective

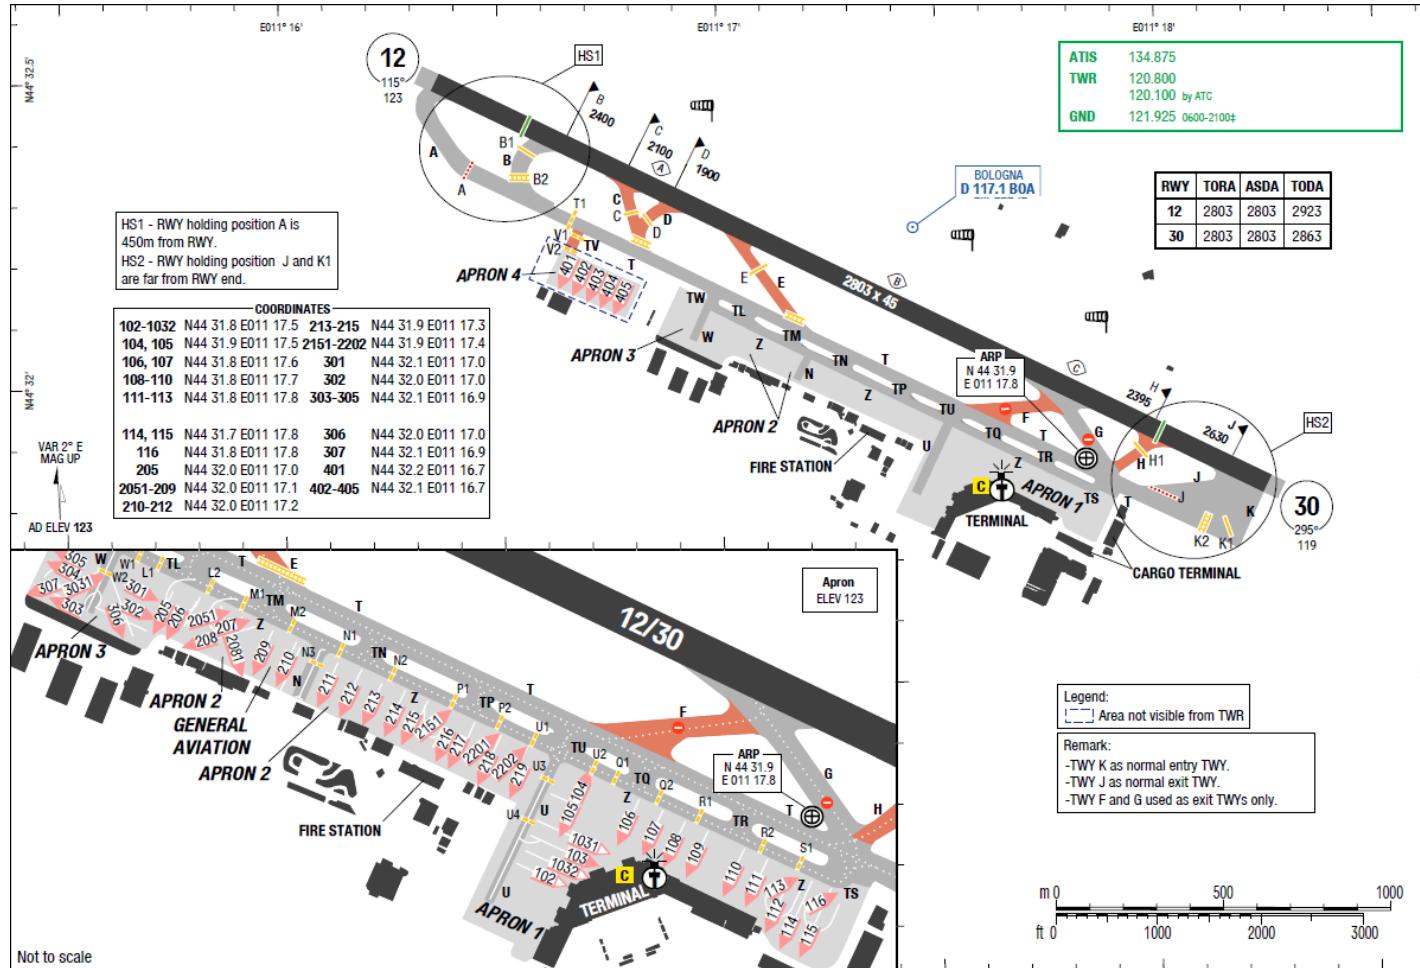
March 2017

HS1 - RWY holding position A is 450m from RWY.
HS2 - RWY holding position J and K1 are far from RWY end.

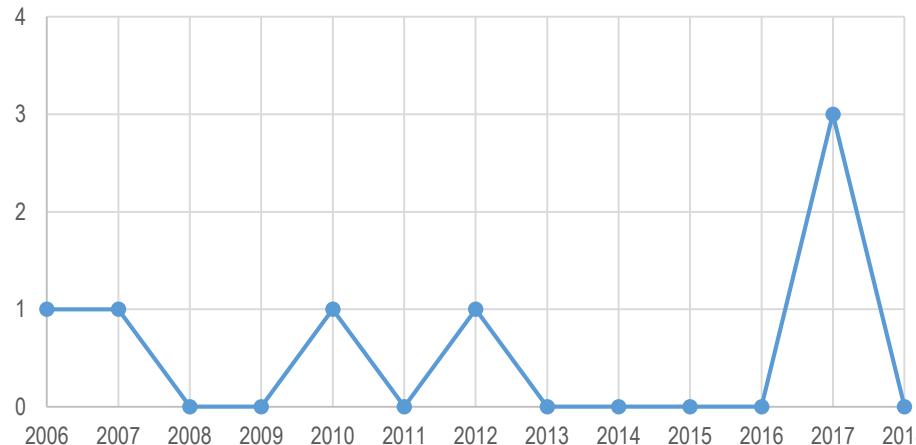
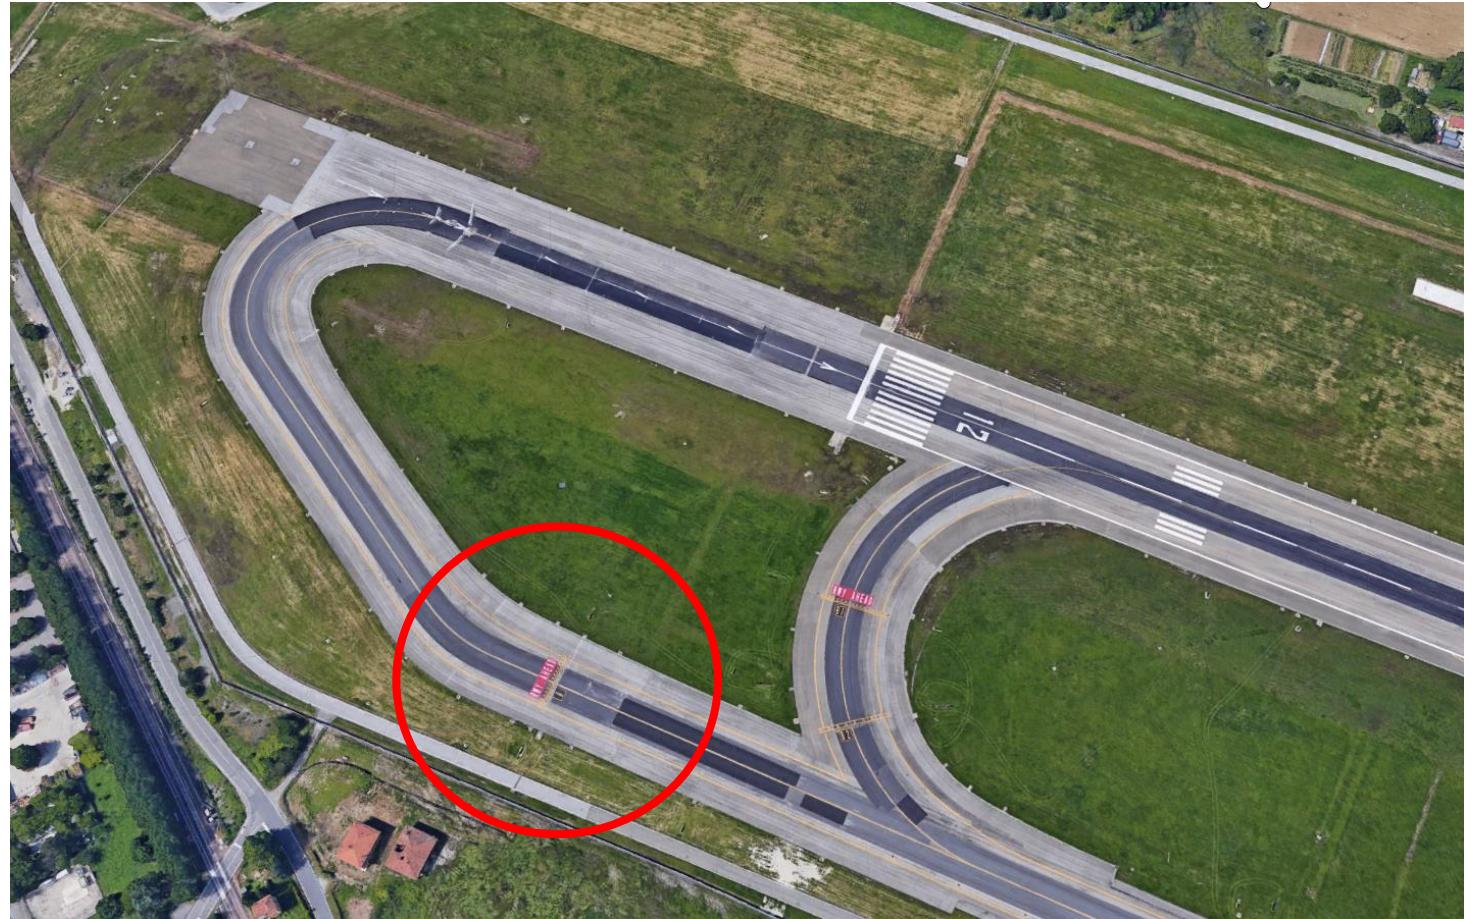
BLQ – Holding point A

Holding point A to RWY 12

Crew was instructed to taxi to holding point A RWY 12.

We were taxiing very slowly. During the FLT CTL check we noticed that we were reaching the holding point and brake, even so we passed the holding point about 10 to 15m. We reported it to the tower and they replied that there was no problem because there was no traffic at the moment. We stayed on that position until instructed to line up.

Runway 12 incursion via taxiway A. After major delay, airport closure for departures due WX, flight was cleared for taxi to Runway 12 via T to holding point A1 and contact tower. Heavy workload on flightdeck because of runway change, performance computations, second engine to be started and all the normal checks to be performed for the new runway. Flight crew overshot position A1 without clearance. Tower was called and flight was instructed to vacate runway.

When holding point "A" RWY12 TWR asked if the crew had visual with traffic on short final. With traffic insight crew were cleared to expedite to line up and wait and due the long distance between holding point and RWY12, crew started taxing and pass about 3m beyond holding point before the landing aircraft passes over TDZ. There was no impact in Safety.

- HS1: bear in mind that holding position A is located 450m from the runway.
- HS2: bear in mind that holding positions J, K1 and K2 are also located at a considerable distance from the runway.

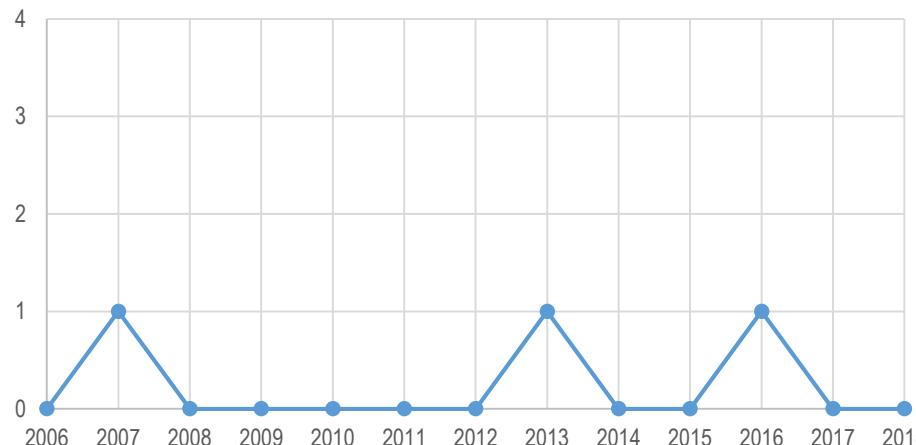
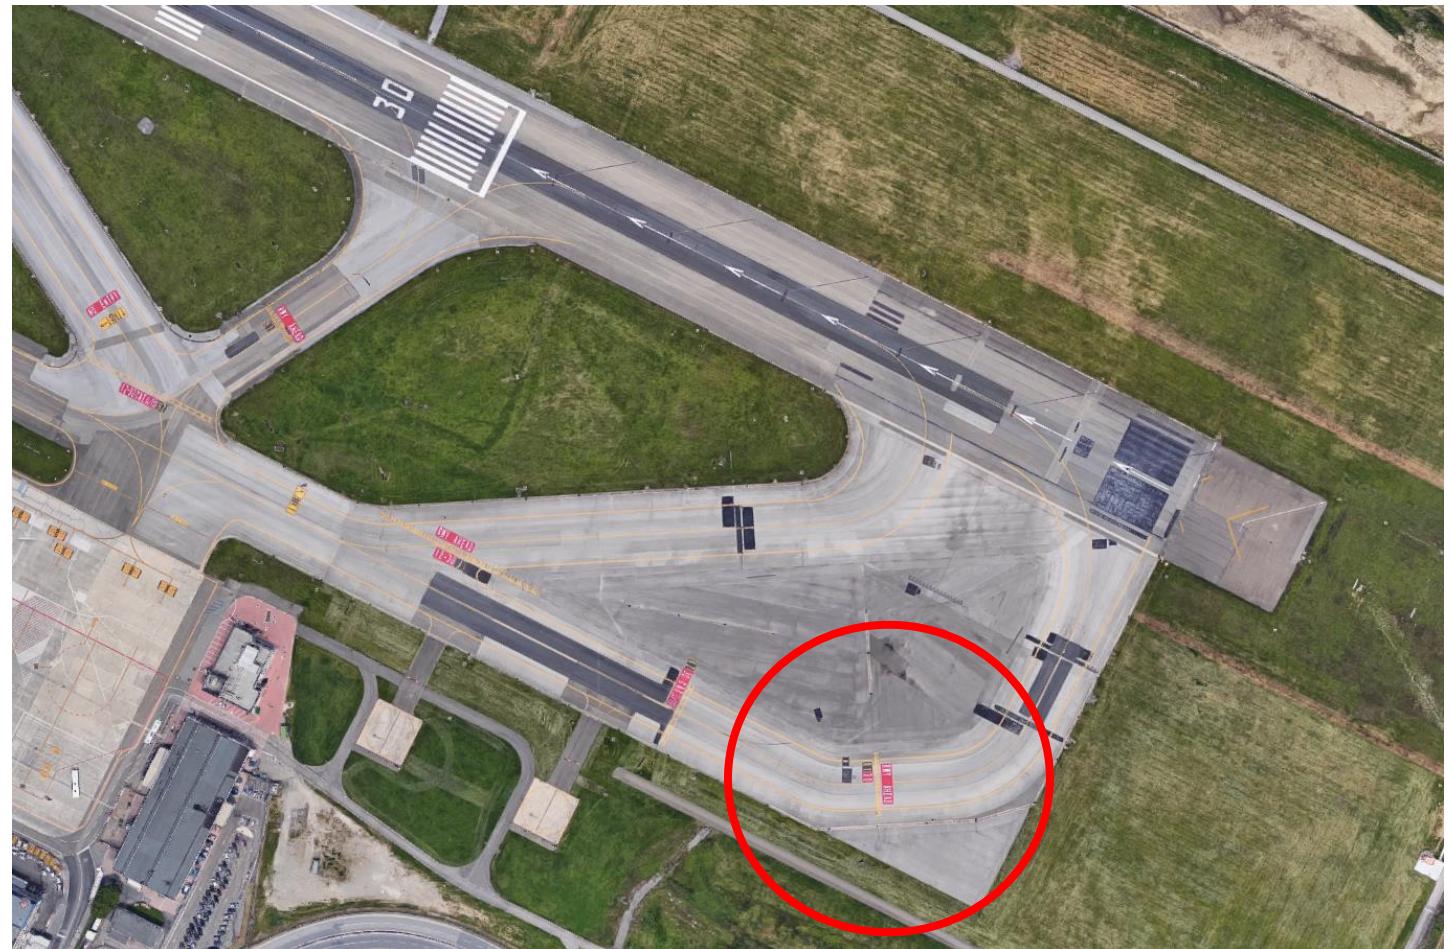
BLQ – Holding point K1

Holding point K1 to RWY 30

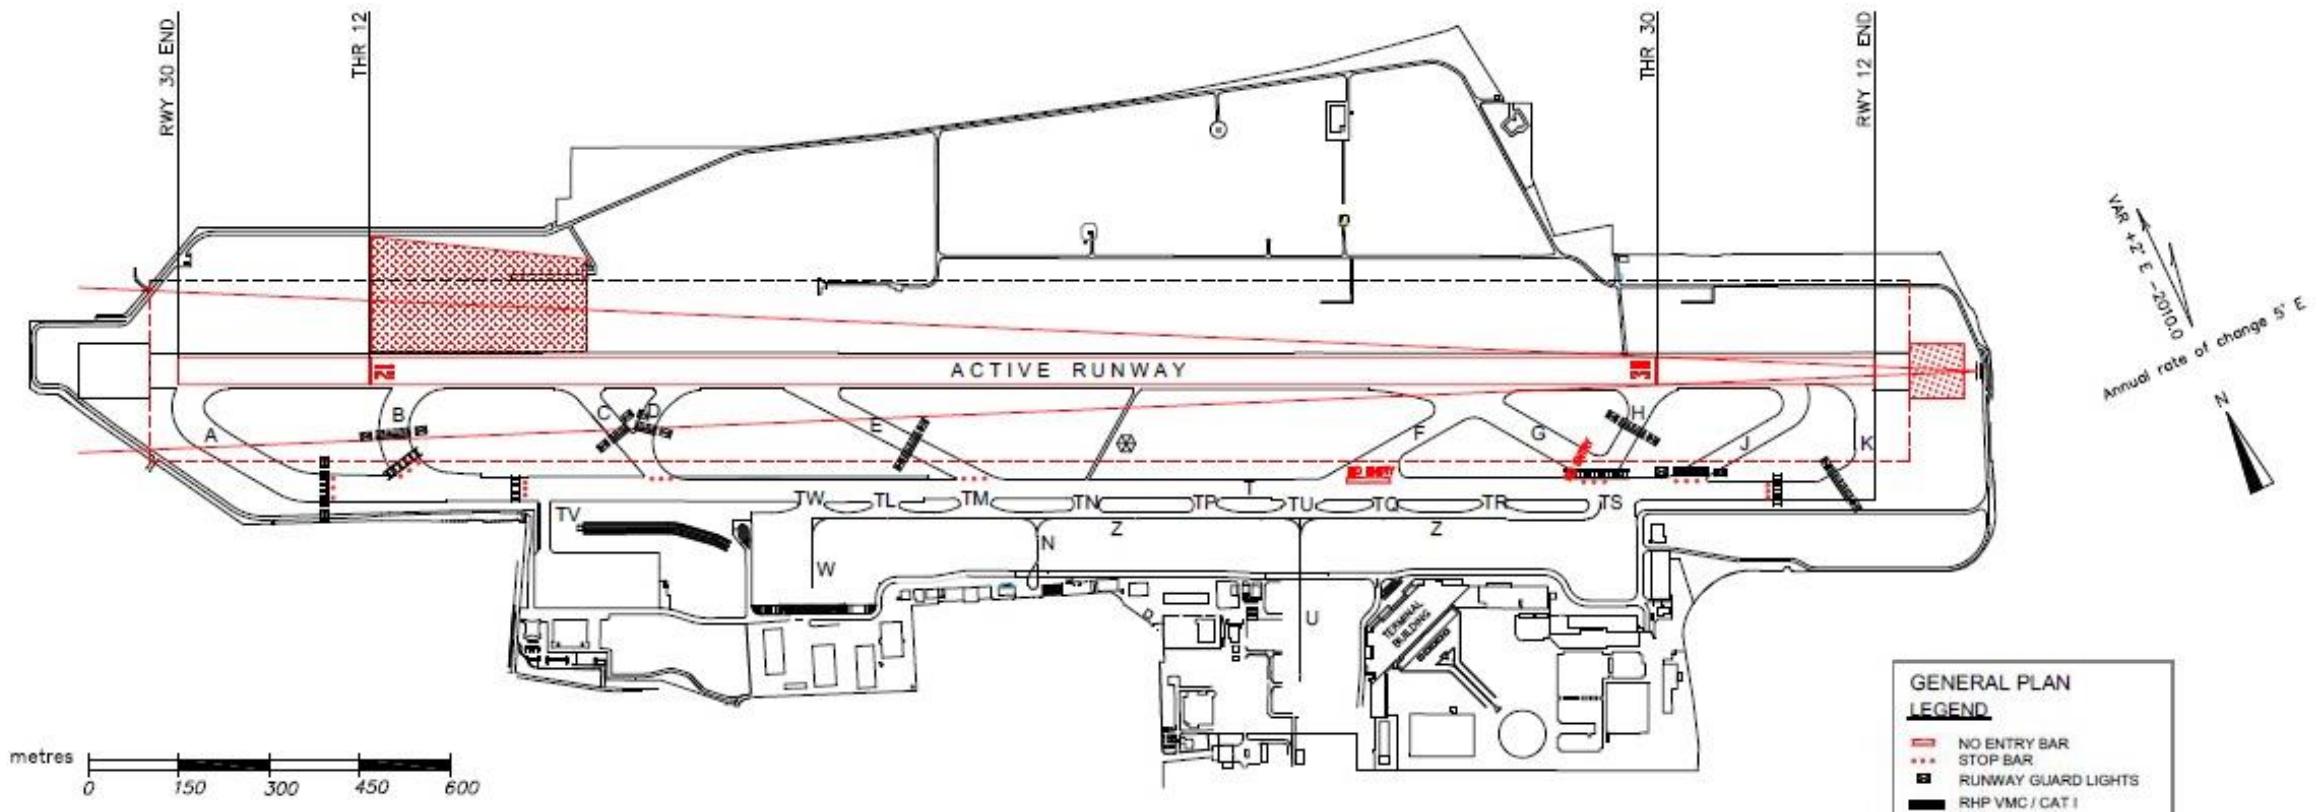
Sensitive Area Limits

LOW VISIBILITY PROCEDURES CHART

AD 2 LIPE 2-5

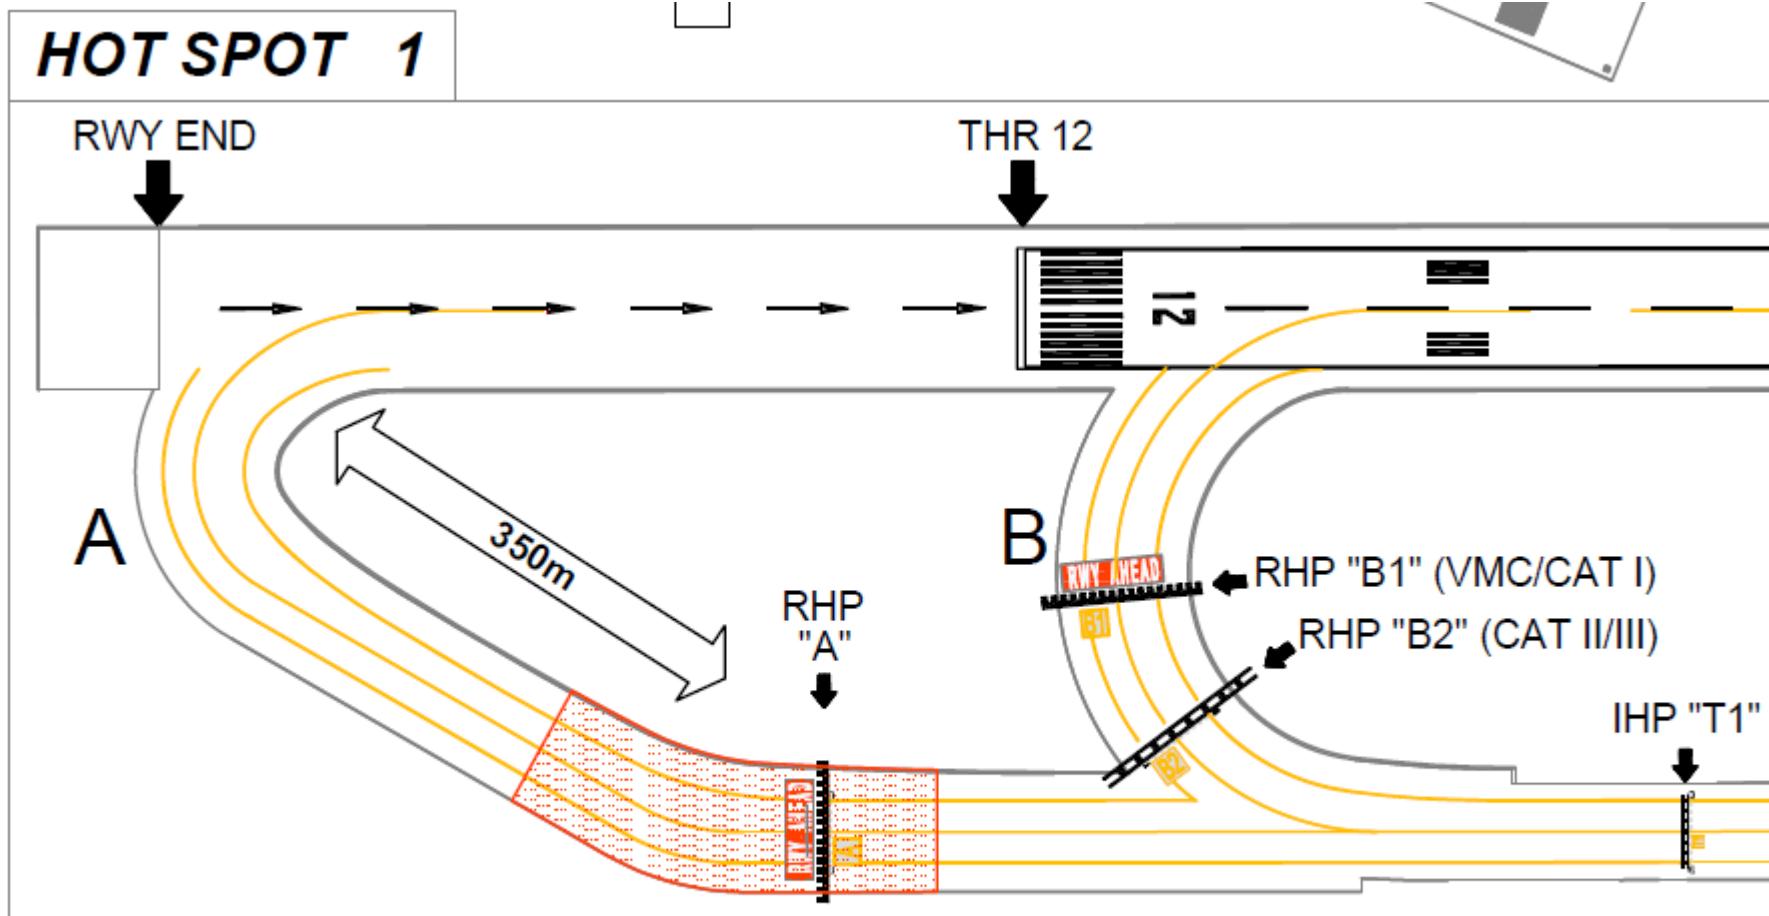
RHP A is about 350 m from runway end.

NOTE RHP A has to be used in all weather conditions.

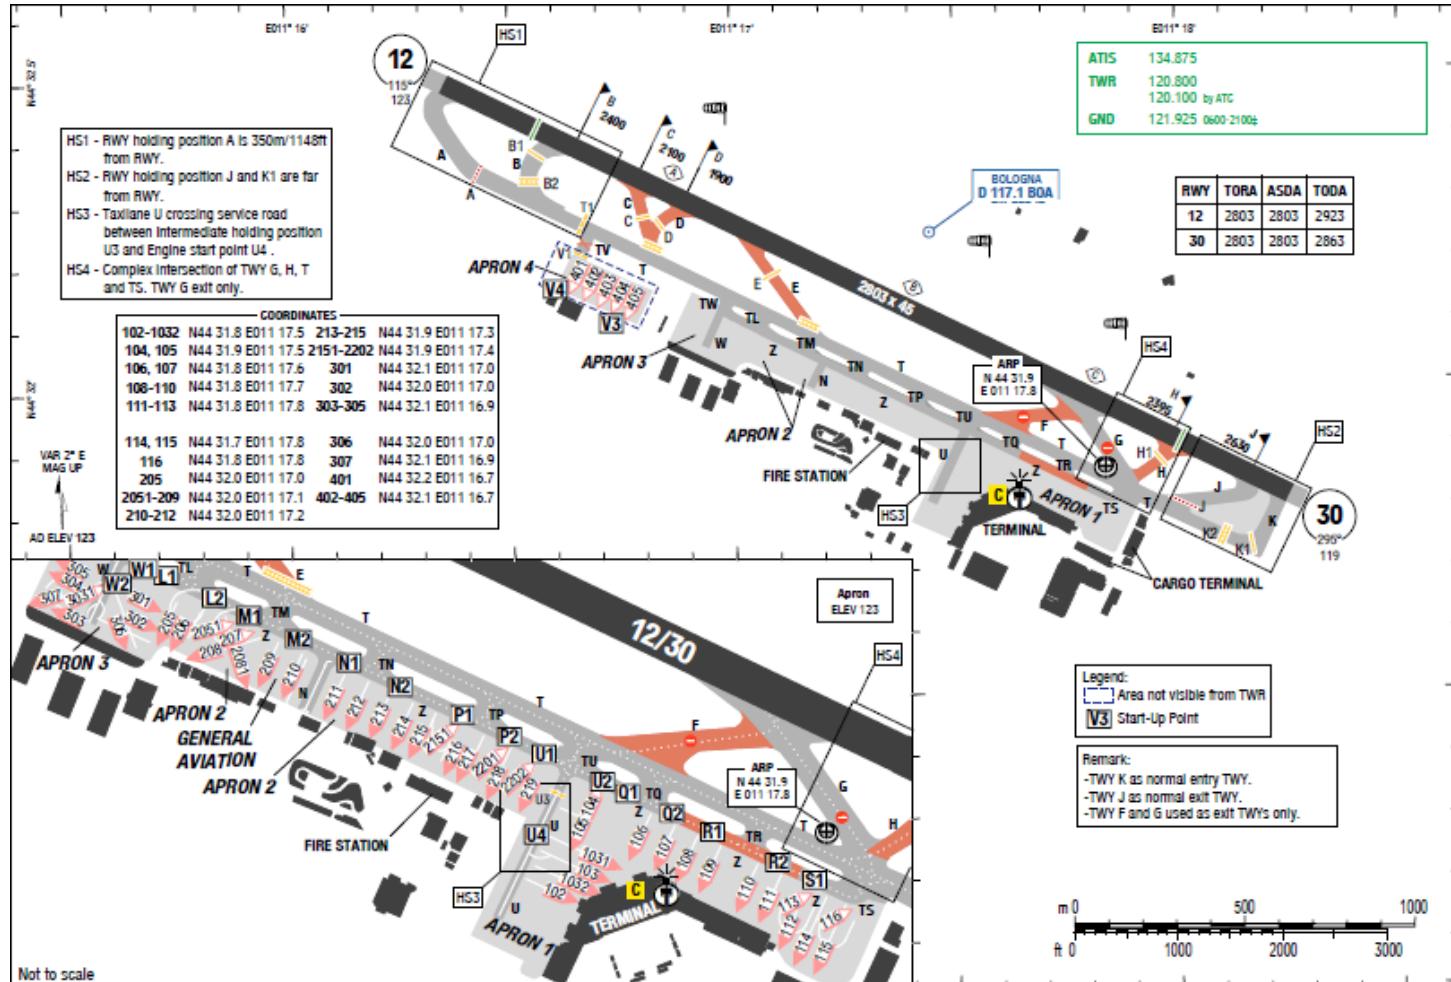
October 2018

HS1 - RWY holding position A is 350m/1148ft from RWY.
 HS2 - RWY holding position J and K1 are far from RWY.
 HS3 - Taxilane U crossing service road between Intermediate holding position U3 and Engine start point U4 .
 HS4 - Complex intersection of TWY G, H, T and TS. TWY G exit only.

- HS1: bear in mind that holding position A is located 350m from the runway.
 - HS2: bear in mind that holding positions J, K1 and K2 are also located at a considerable distance from the runway.
