Just Culture Practical Exercise/Case Istanbul September 20-21, 2012

The objective of the practical exercise/case is the creation of a simulated aviation occurrence to serve as a discussion between judicial and ATM & aviation experts to provide a forum on the issues associated with criminal investigations resulting from aviation incidents or accidents.

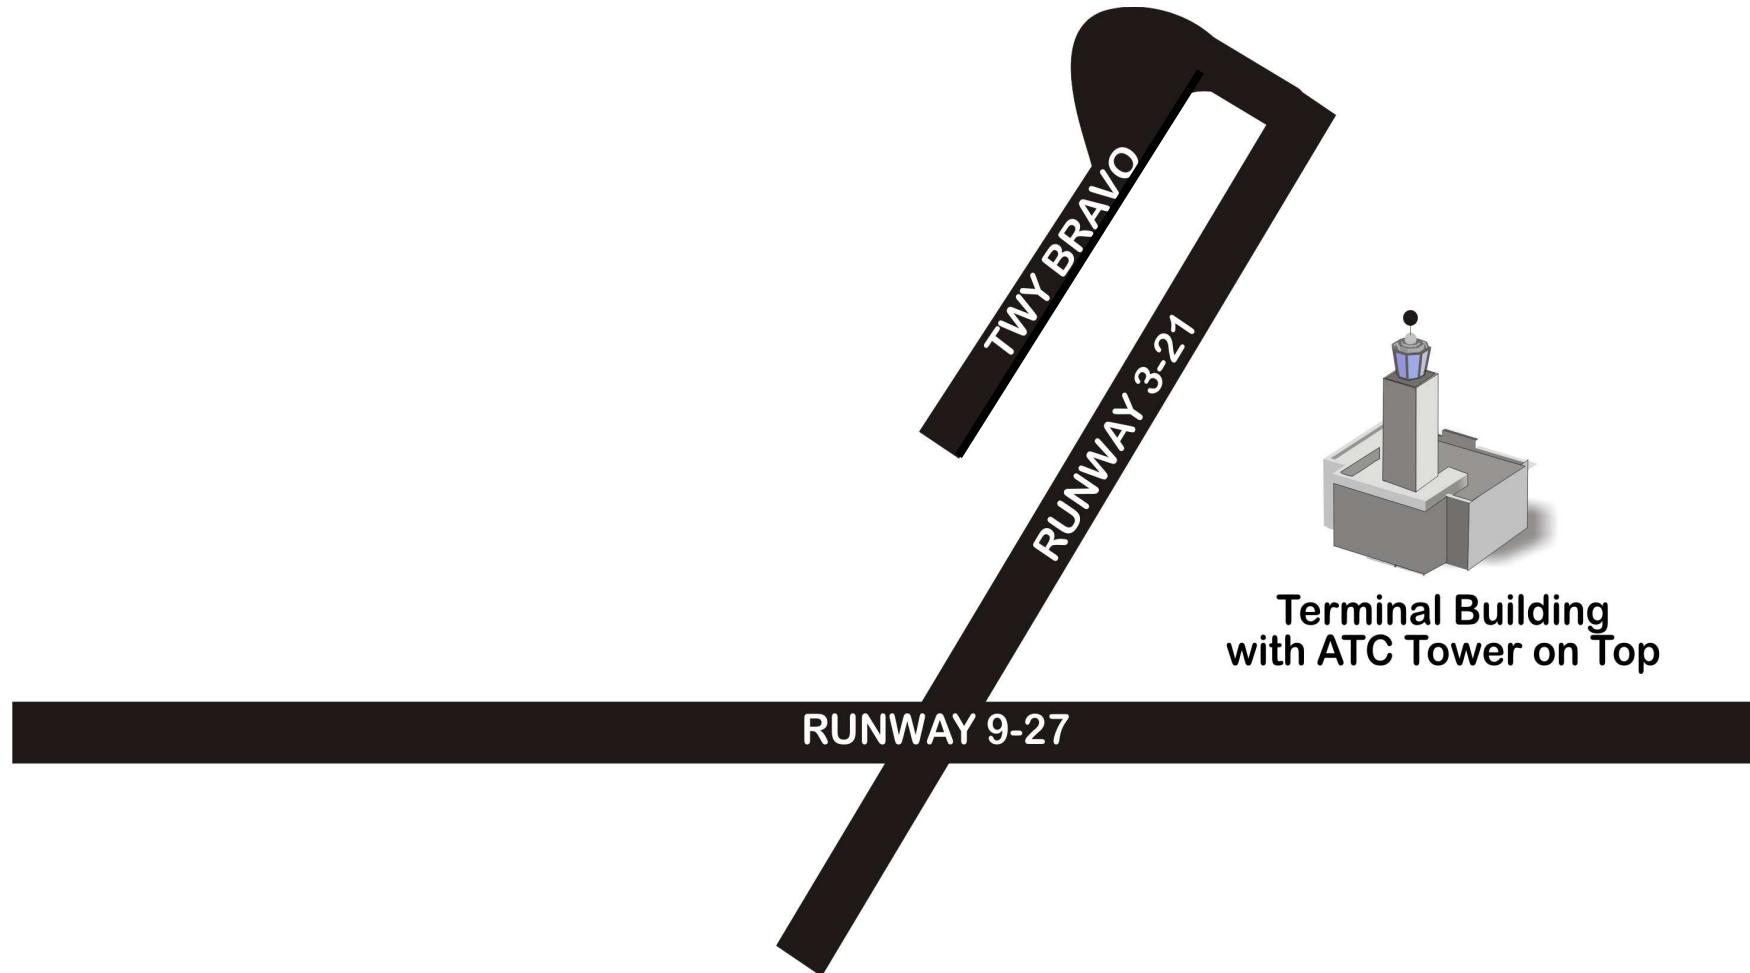
Selective schematic of airport

- Is a major international aerodrome with heavy traffic.
- Has two runways, an east-west runway that is 3,700 meters long, and a northeast-southwest runway that is 2,500 meters long.
- The runways intersect at about the mid-point of the longer one.
- The terminal building is located in the northeast quadrant of the airport, with the ATC tower located on the top of the terminal.

(Not to scale)

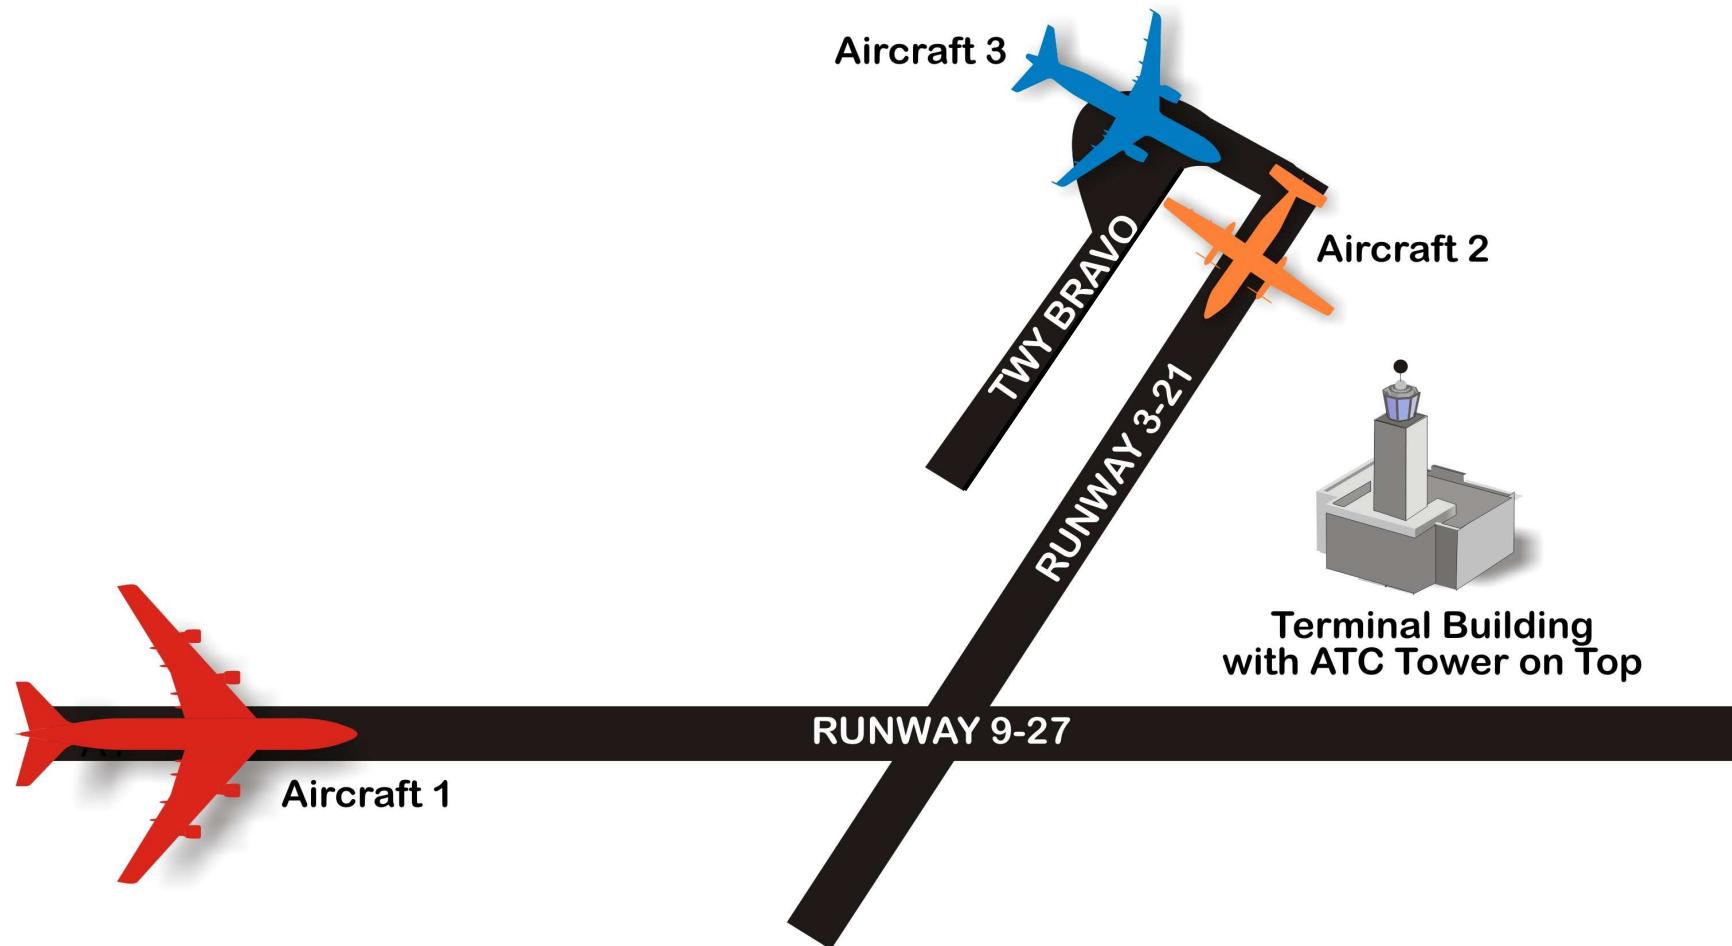
Aircraft Locations

- Aircraft #1 is lined up for takeoff on RWY 9.
- Aircraft #2 is lined up for takeoff on RWY 21.
- Aircraft #3 is holding short of RWY 21 on TWY Bravo.

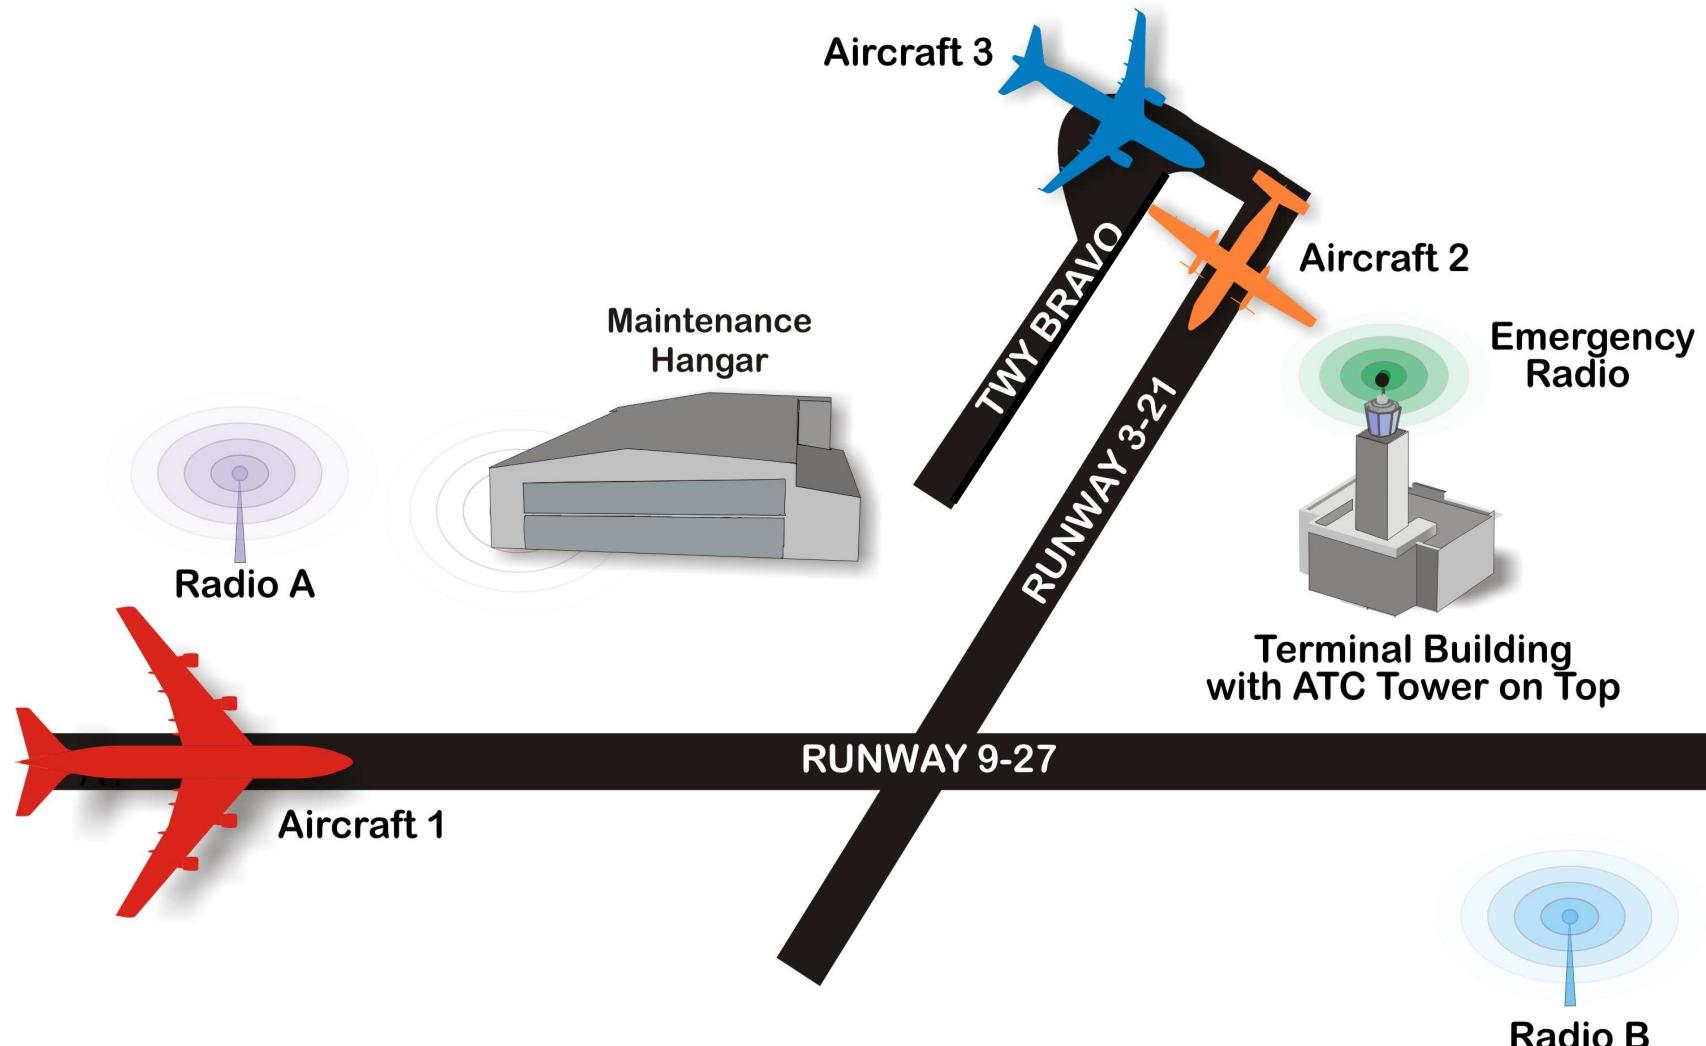
Radio Antenna Locations

- The Radio A antenna is physically located at the west end of the airport, north of the runway.
- The Radio B antenna is located at the east end of the airport, south of the runway.
- There is an automatic switching system that activates the radio with the strongest signal. Only one radio at a time is activated.

- Aircraft #1's proximity to Radio A was such that Radio A was selected automatically when Aircraft #1 transmitted.
- Aircraft #2 could hear the controller on Radio A, but maintenance hangars blocked line-of-sight between the aircraft and the radio site – the weaker transmission from the aircraft was not heard by the controller.
- The controller did not hear anything indicating that two aircraft were transmitting at the same time.
