Safety Investigation Report

Ref. AAIU-2018-02-23-01

During departure from Runway 07R of Brussels Airport 2 subsequent aircraft were put on a converging course by ATC. This triggered a reaction from the ATC controller and eventually a TCAS RA around FL 70. The closest point of approach between the two airplanes is estimated to be 400 ft vertically and 1.36 NM horizontally.

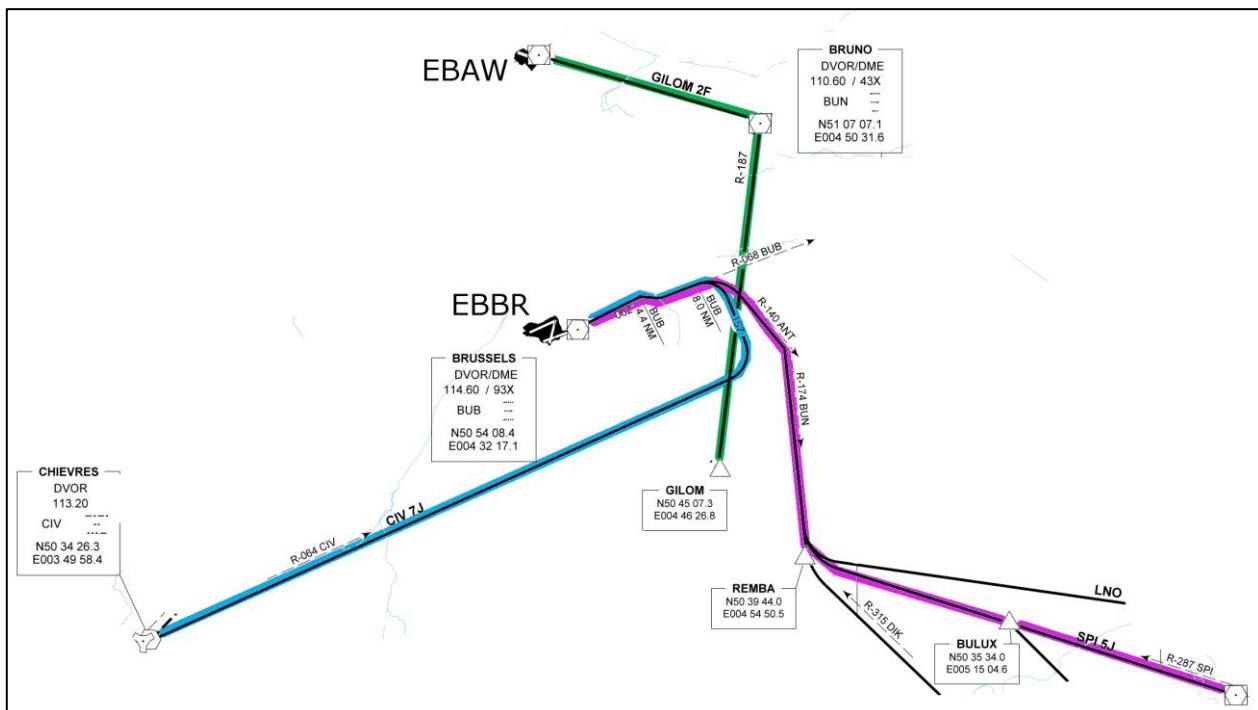
Figure 1: showing the 3 cleared departure routes: GILOM 2F (green) for the B350, SPI 5J (blue) for the ERJ195 and CIV 7J (magenta) for the A320 (superposition of the different available charts, not on scale)

Aircraft taking off from Brussels under an IFR (instrument flight rules) plan are assigned published routes, the Standard Instrument Departure (SID). A SID is a coded departure procedure that has been established at certain to simplify clearance delivery procedures. It strikes a balance between terrain and obstacle avoidance, noise abatement (if necessary), and airspace management considerations. Such a route will guide the aircraft to the cruise track and cruise level. The assigned routes are visualized on Figure 1.

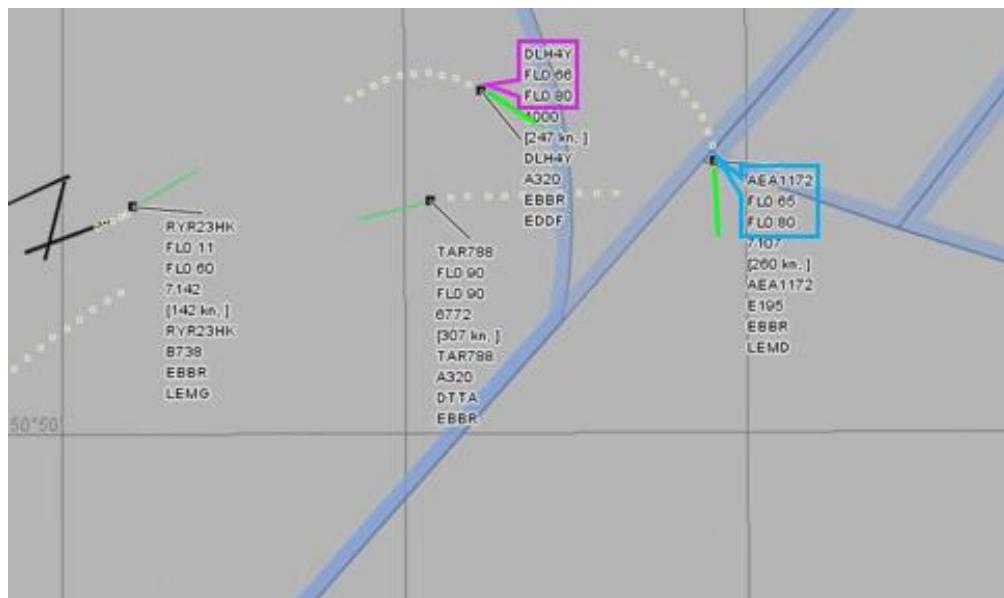
Figure 4: radar replay at 10:34:34 showing the right-hand turn of the A320 (magenta)

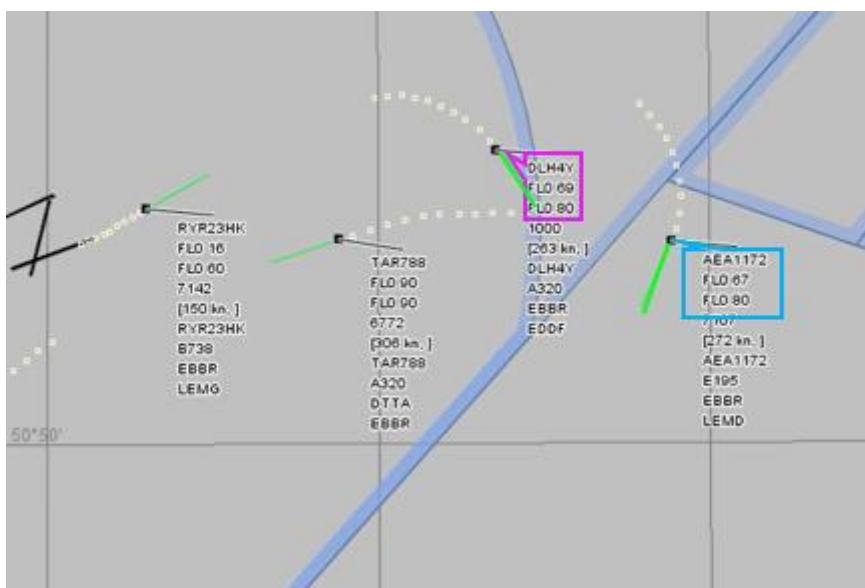
At 10:34:45, RYR23HK, a Boeing 737 just taken off from Brussels, was calling in on the frequency. During the call, at 10:34:49, the Short Term Conflict Alert (STCA) became visible on the radar display. The A320 was passing FL 69 (+1200 ft/min) and was 4 NM laterally separated from ERJ195, who was passing FL 67 (+700 ft/min).

Figure 5: radar replay at 10:34:49, the moment the STCA pops up on the ATCO's display

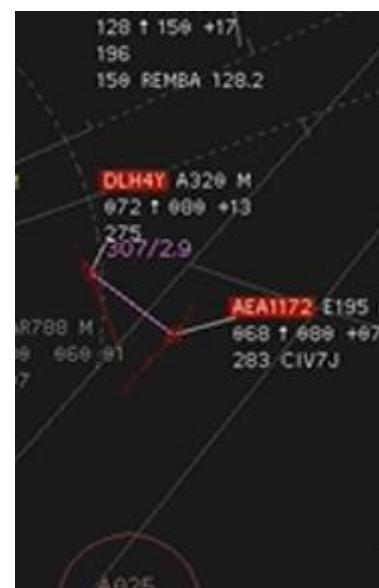
Figure 6: how STCA is shown on radar display

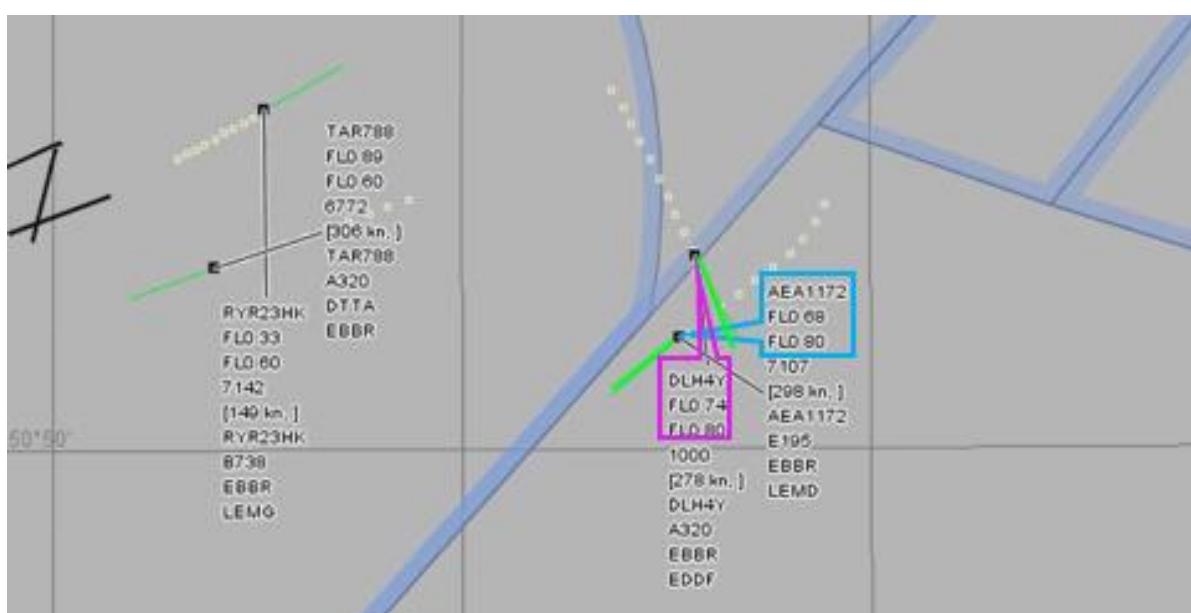
Figure 7: radar replay during closest point of approach (CPA) at 10:35:27

At 10:35:05, separation lost; 2,9 NM – 400 ft
At 10:35:17: 1,9 NM – 400 ft
At 10:35:21: 1,6 NM – 400 ft
At 10:35:25: 1,4 NM – 500 ft (gradually increase of vertical separation)
At 10:35:30: 1,3 NM – 700 ft (just past the closest point of approach)
At 10:35:33: 1,3 NM – 800 ft (gradually increase of horizontal separation)
At 10:35:37: 1,5 NM – 800 ft
At 10:35:48, the vertical separation was restored: 2,2 NM – 1000 ft

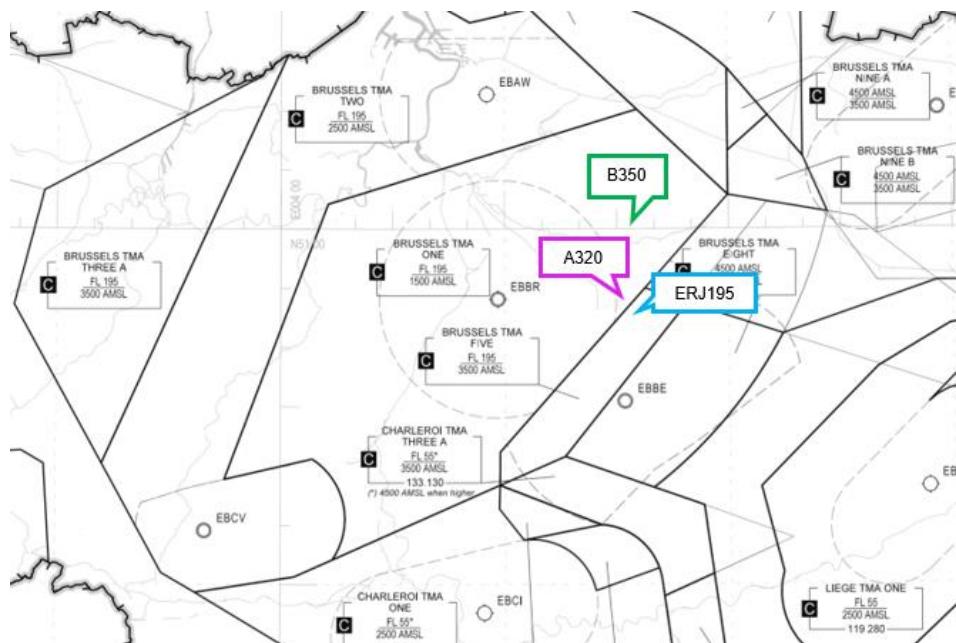
The incident occurred in terminal control area, also known as a terminal manoeuvring area (TMA) of Brussels Airport. It is a designated area of controlled airspace surrounding a major airport where there is a high volume of traffic. The Brussels TMA is divided into different segments each having different vertical limits. At the closest point of approach (CPA), aircraft one was flying in Brussels TMA 5 (with lower limit of 3500 ft AMSL) and aircraft 2 was flying in Brussels TMA 1 (with lower limit of 1500 ft AMSL). However both TMA's are airspace class C and under control of the same unit on the same frequency ('Brussels Departure').

Airspace class C means that all aircraft are subject to clearance and that separation is provided by ATC between IFR and IFR flights and between IFR and VFR flights. The minimum separation required in Brussels TMA is 1000 ft vertical and reduced to 3 NM horizontal (due to the capability of the airport terminal surveillance radar).

Figure 8: airspace configuration

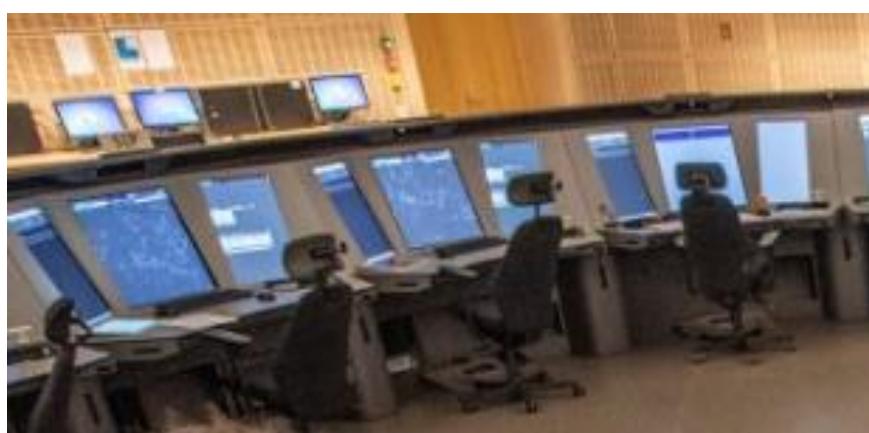
The Belgian Air Traffic Control Center, called CANAC 2 (Computer Assisted National Air Traffic Control Center) features 4 integrated work areas or so-called 'petal' (ACC West, ACC East, APP and training) coordinated by a Supervisor and a Traffic Manager. Each work area groups 14 working positions and is under the monitoring of a team leader.

Figure 10: part of a work area (like APP) at CANAC 2

Each working position is manned by one controller (or by a trainee and his instructor) and consists of 3 screens:

In case of a trainee controller, the instructor sit next and a little bit behind of him. The instructor also wears a headset but has no full view on the radar display as the trainee has.

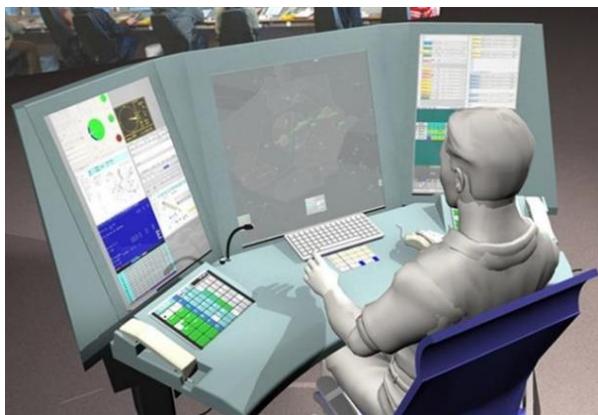
- The middle screen displays the radar images, containing crucial flight data of the aircraft
- The screens and right hand side display operational applications which can be modified by the controller

Figure 11: layout of the ATCO working position
 (source <https://www.symbio.pro>)

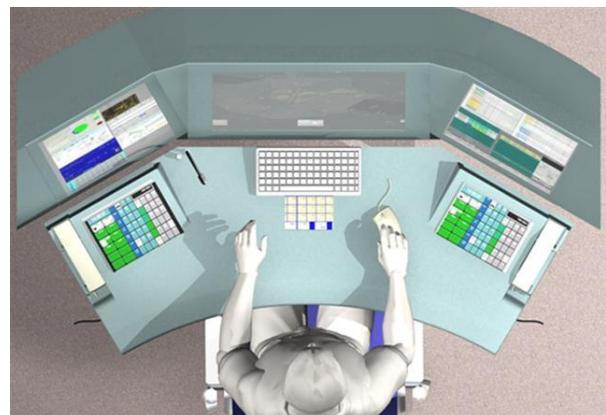
Figure 12: top view of the ATCO working position

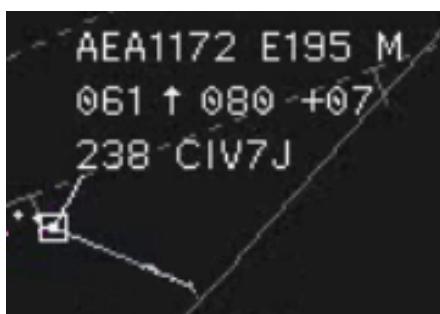
On the radar screen, the Air Traffic Controller gets information regarding the flight. A dot in a square indicates the position of the aircraft. The orientation of the line starting from the dot indicates the track of the aircraft and its length indicates the speed.

Figure 13: flight data on a radar screen

AEA1172 – the flight Number

E195 – the type of aircraft (Embraer 195)

061 – the current altitude of the aircraft (x 100 ft) (flight level as from transition altitude)

↑ - the arrow indicates a climb or a descent

080 – indicates the altitude assigned to the aircraft (x 100 ft)

+ 07 – indicates the rate of climb (700 ft/min climbing)

238 – indicates the speed (kt)

CIV7J – indicates the route assigned to the aircraft

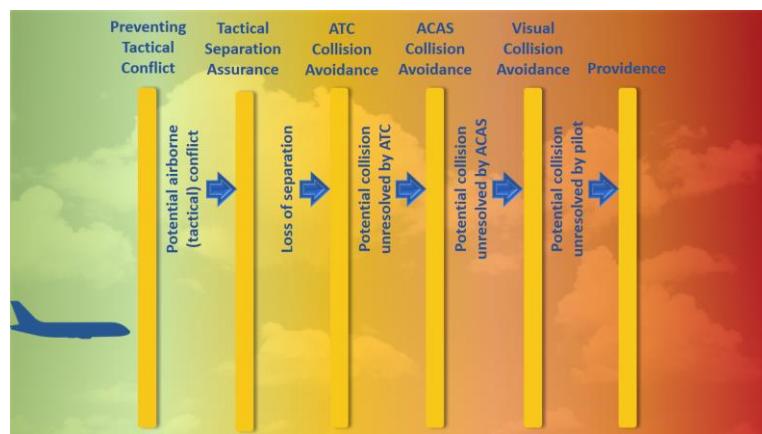
- Preventing tactical conflict by the design of the routes and procedures
- Tactical separation assurance by the ATCO by being proactive
- Ground (ATC) automated collision avoidance system
- Air automated collision avoidance system
- Visual collision avoidance (provided that visual meteorological conditions prevail)
- Providence

Figure 14: schematic of the different safety nets

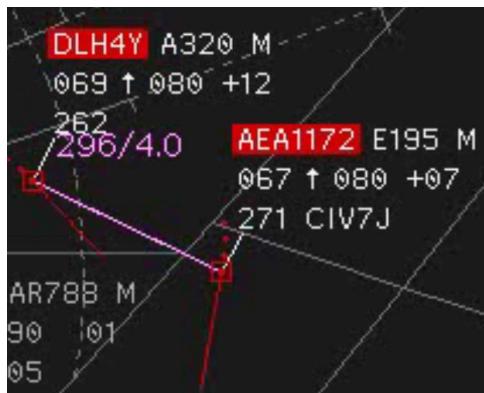
A Short Term Conflict Alert (STCA) is a system to warn the ATCO of any situation where user defined minimum separation distances between any pair of surveillance tracks is, or is predicted to be violated within a short look ahead time (usually 2 minutes). It gives a warning on the screen of the Traffic controller by marking the call signs and aircraft symbols steady red. It gives no resolution for the conflict as a TCAS does.

Figure 15: Visualisation of STCA at radar display

It is recommended that Skeyes improves the STCA spatial presentation of aircraft in flight when a potential conflict is detected.

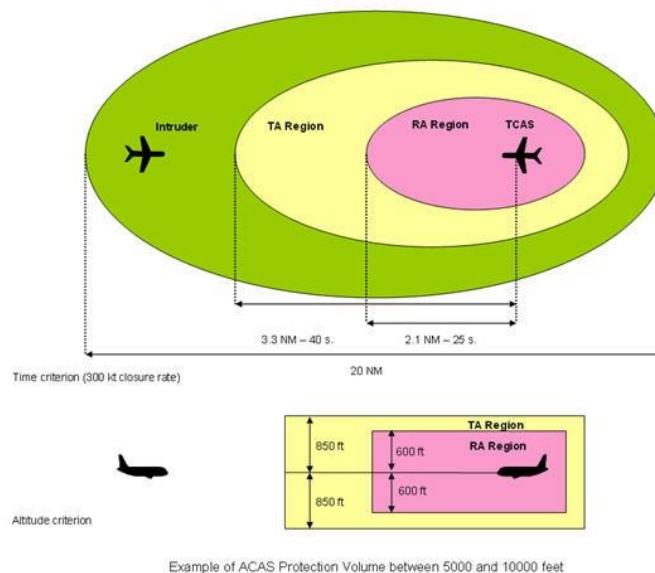
The TCAS systems of the concerned aircraft work in a coordinated manner. In function of the respective aircraft position, heading and speed, the systems of both aircraft are generating coordinated instructions to the crew (one would be instructed to climb, while the other would be instructed to descend)

Example of ACAS Protection Volume between 5000 and 10000 feet

Figure 16: TCAS principle

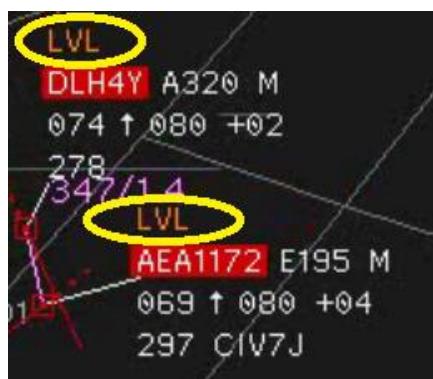
For the Belgian ATC system, the TCAS resolution instruction (RA) for each aircraft is relayed to the radar screen of the ATC controller. TA’s are not downlinked.

Figure 17: visualisation of the TCAS RA on the radar display

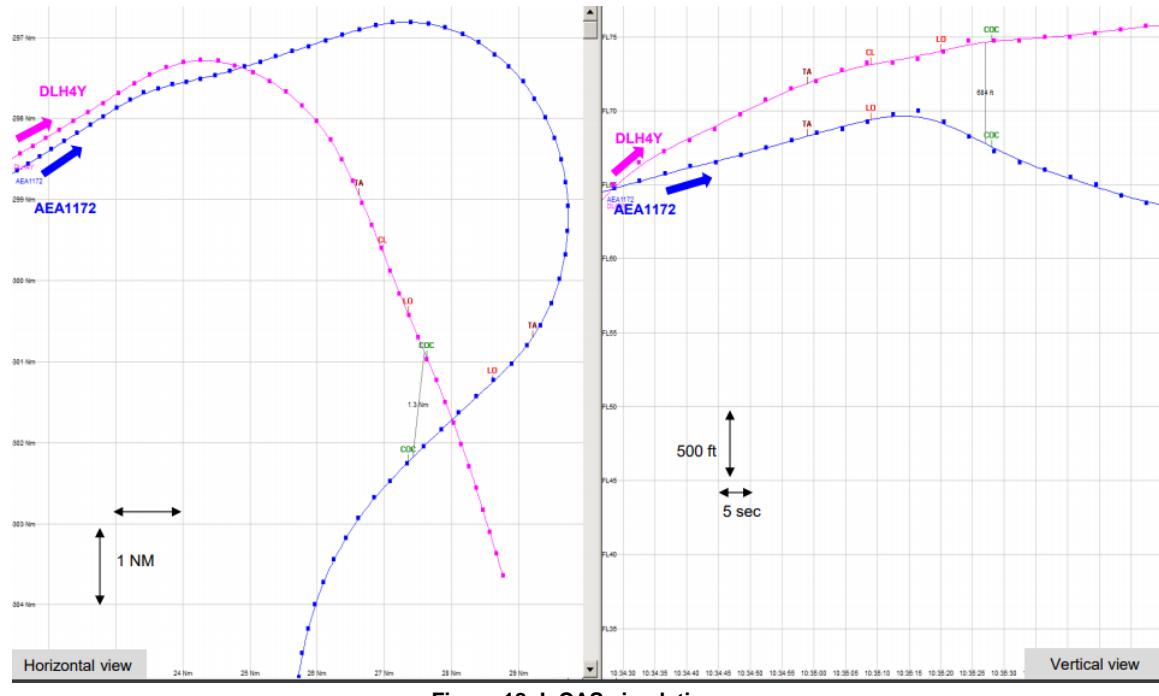
Eurocontrol, the European organisation for the safety of air navigation, analysed the incident with InCAS² v4.1.1. The available radar data were used to re-create the situation in order to cross check this versus the recorded RA downlink messages

Table 6: InCAS simulation and Mode S downlinks compared

Time (InCAS)	Tim (downlinked Mode S)	Difference	Event (cockpit aural annunciation)
10:35:09	10:35:12	- 3 seconds	AEA1172 Level Off Resolution Advisory ("LEVEL OFF, LEVEL OFF")
10:35:09	10:35:12	- 3 seconds	DLH4Y Climb Resolution Advisory ("CLIMB, CLIMB")
10:35:20	10:35:24	- 4 seconds	DLH4Y Level Off Resolution Advisory ("LEVEL OFF, LEVEL OFF")
10:35:28	10:35:32	- 4 seconds	AEA1172 & DLH4Y Resolution advisories terminated ("CLEAR OF CONFLICT")

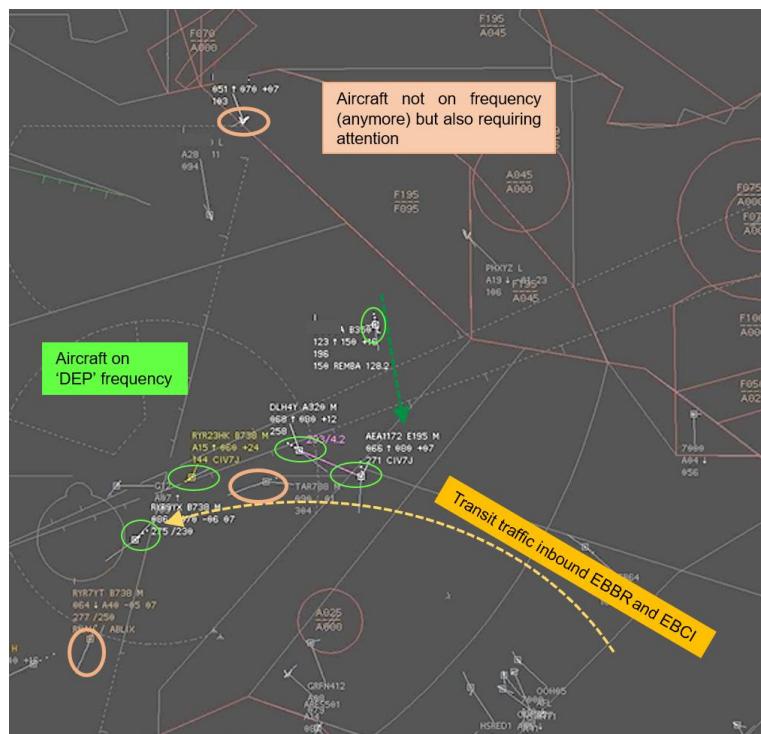
Figure 19: situation just prior to the STCA

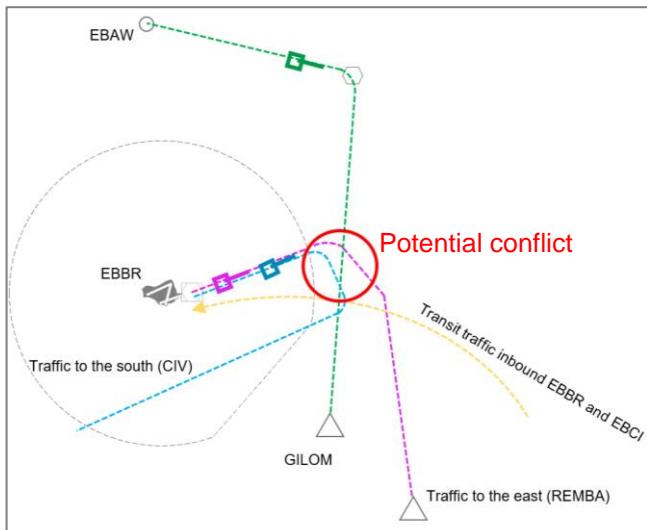
The B350 to REMBA, from the North, is a smaller turboprop aircraft and thus has less climb performance. In anticipation of a possible conflict, the ATCO decided to have the A320 initiate his turn earlier than usual. This would put both aircraft with more lateral separation and would have allowed the A320 to climb higher than the B350 before lateral separation of 3 NM would have become a problem.

Figure 20: potential conflict following the published routes

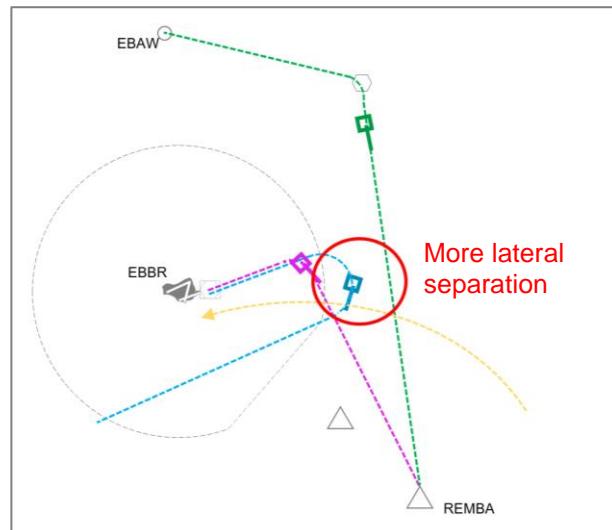
Figure 21: intended solution

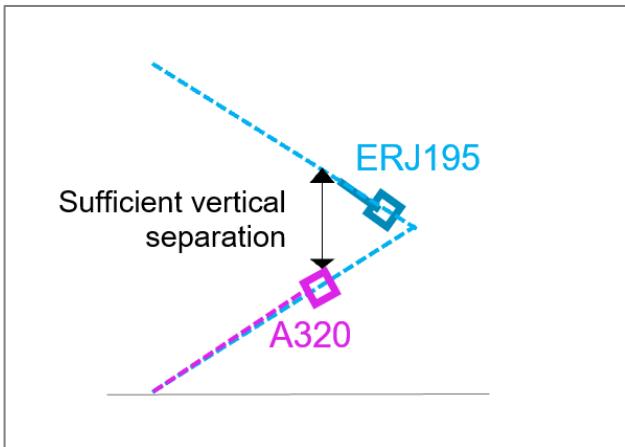
However, in this case, the lead aircraft ERJ195 had received information regarding aircraft above him and therefore had reduced its rate of climb to a lower value. It resulted that DLH4Y was climbing much faster than AEA1172. Although the information is available to the trainee ATCO on the screen, he did not look and notice that information.

Figure 22: how the ATCO assumed the vertical separation was

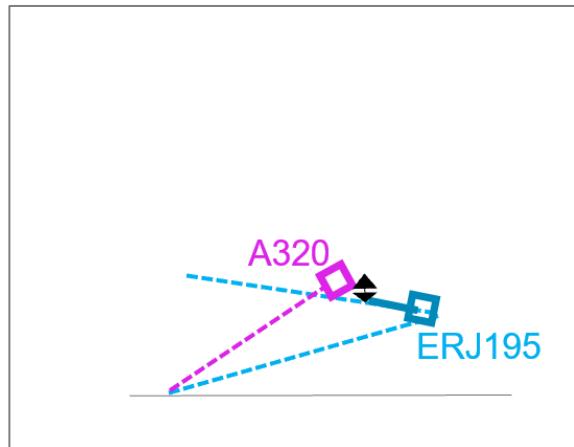
Figure 23: to the situation really was, the A320 already slightly above the ERJ195

Indication to this is that when the STCA went on, the first reaction of the trainee ATCO was to instruct DLH4Y to stop climbing, although at that time, DLH4Y was at a higher altitude than AEA1172 that was still climbing.

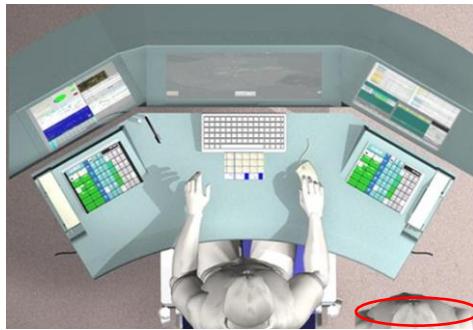
- The instructor is sitting next to the trainee ATCO and he does not have the same view on the radar screen. He has to look 'above the trainee shoulder';
- The trainee speaks naturally with a low voice and keeps his instructions to aircraft short, shorter than usual for an ATCO. This made that the initiation of the problem – the instruction given to DLH4Y to turn to REMBA - was not heard by the instructor;
- The confidence of the instructor in the capacity of the trainee to perform.

Figure 24: sketch showing that due to the configuration it's impossible for the OJTi to have the same view
