Incidents in Air Transport

Number 3 - April 2005

Visual avoidance maneuver following clearances leading to conflict

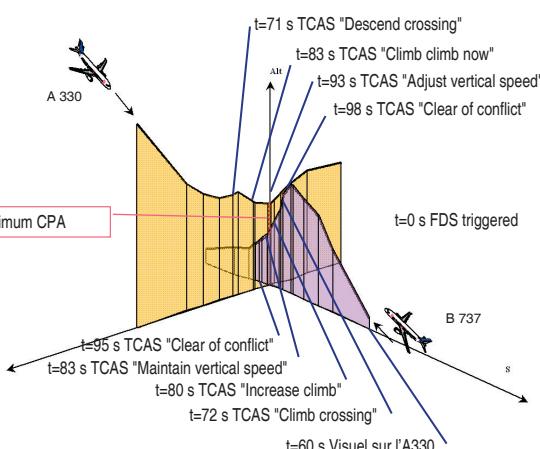
The position controlling the A330 was handling an elementary sector, whereas the position controlling the B737 was handling two grouped sectors whose limit was at FL315 (see picture). The latter control position was manned by two trainees, each under the supervision of an instructor.

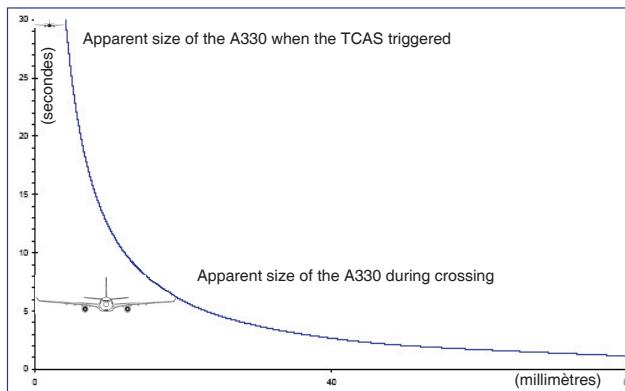
of the A330 seen from the B737 cockpit was equivalent to a 5 mm object held at arm's length (see illustration).

The speed of each aircraft was about 450 kt and they were converging at an angle of 120°, which resulted in a relative approach speed of about 660 kt (11 NM/min). Transport pilots are not at all used to assessing distances and positions of other aircraft for

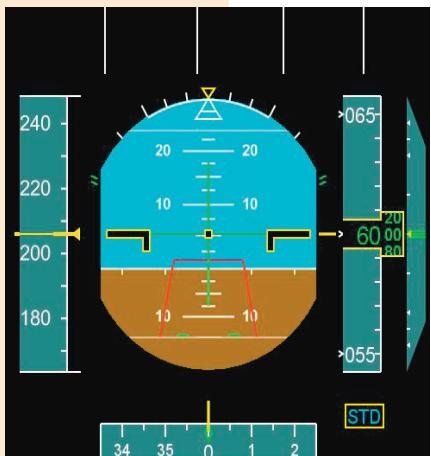
While the airplane was stabilized on the downwind leg on the aerodrome circuit, the TCAS “Monitor vertical speed” alert was triggered and the display (pictured left) appeared on the screen.

On the screen, the red goalpost indicates the no-fly zone. The symbolic airplane must then be positioned outside of this area. In practice, to limit the amplitude of the pitch angle changes, the pilot tries to place the symbolic airplane on the upper bar of the red goalpost.

TCAS resolution advisories indicate the maneuver to be performed and the display allows the pilot to quantify the correction to be performed. In most cases, the pilot must move the airplane out of the red area: his action thus involves placing the symbolic airplane outside of the red goalpost overlaid on the horizon. However, in the case of the preventive "Monitor vertical speed" RA, the airplane is already outside of the red area, so nothing needs to be done. Nevertheless, since the display is the same for the other RA cases, the pilot would tend to react in the same way and move the symbolic airplane towards the upper bar of the goalpost.

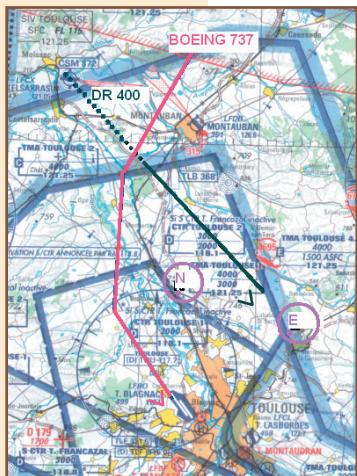
is the case for many aerodromes, is organized in volumes with descending sizes as the ground is approached. As airplanes generally descend steadily instead of step by step during approach, it is possible that they may pass through class E 5

airspace. This is what happened for the 737.

The descent of the Boeing from FL70 towards 3,000 ft was carried out by touching the edge of a class E area. This shows that it is sometimes difficult for pilots in IFR to know what airspace they are in. The definition of the area is done in order to protect IFR tracks. In seeking to optimize tracks, the margins are reduced and segregation is no longer guaranteed.
