DOT/FAA/DS-89/19

**Windshear Case Study:  
Denver, Colorado,  
July 11, 1988**

Final Report

16. Abstract On Monday, July 11, 1988, between 2207 and 2213 UTC (16:07-16:13 MDT), four successive United flights had inadvertent encounters with microburst windshear conditions while on final approach to Denver Stapleton Airport (DEN), each resulting in a missed approach, subsequent delay, and uneventful arrival. A fifth flight executed a missed approach without encountering the phenomena. All of the flight crews were trained utilizing the resources of the Windshear Training Aid. There was no damage to aircraft and no passenger injuries.  At the time the aircraft encountered the microburst, the Terminal Doppler Weather Radar (TDWR) Operations Test and Experiment (OT&E) was in progress and detected divergent flow that intersected the operating zones for the approach runways. The radar used to test the TDWR algorithm was the Massachusetts Institute of Technology Lincoln Laboratory 10 cm Doppler radar. MIT  This Windshear Case Study outlines the technical details of the encounter, as well as describes insights gained from this confrontation that should be applied to future investigations o

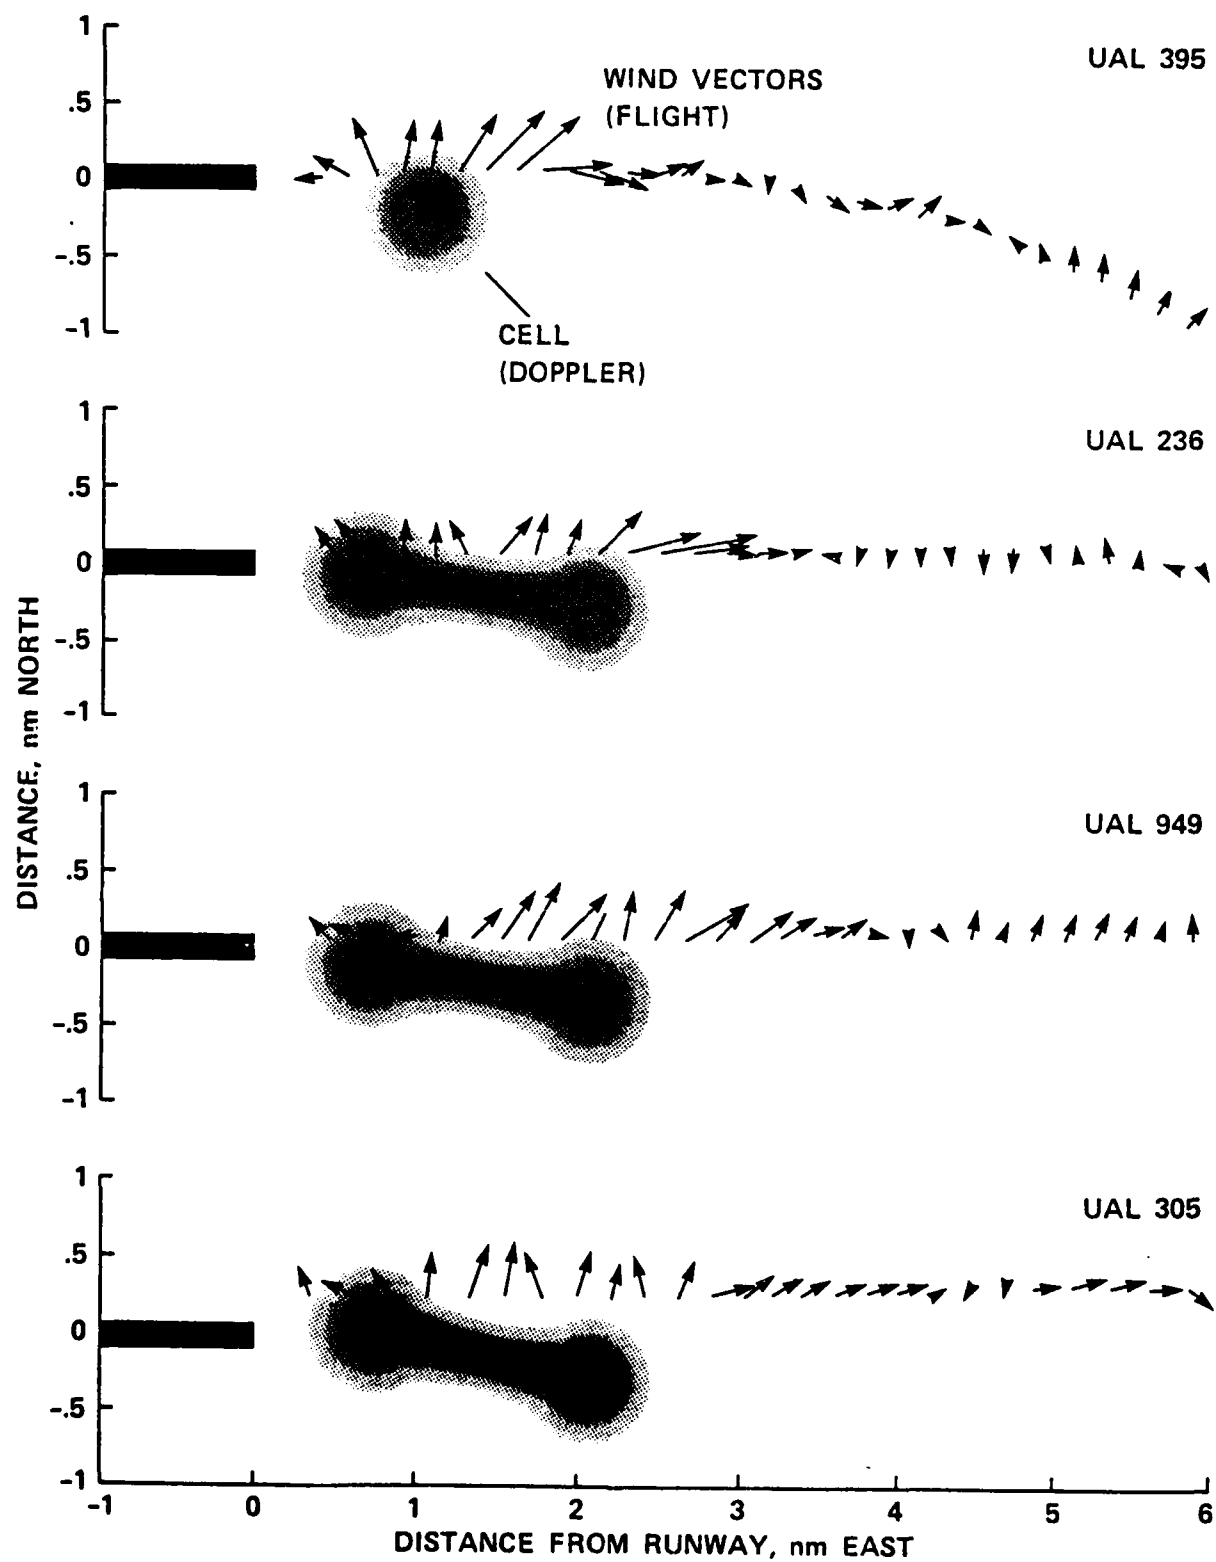
Fig. 13 Wind vectors from four airliners compared with microburst cells from dual Doppler.

The developing wind pattern from the flight data recorder analysis is in general agreement with the measurements from the Doppler radar and with the analytical results from the numerical TASS model. The aircraft data complement these other findings by providing a detailed analysis of the internal velocity fluctuations. The Doppler data was shown to not only validate the flight data, but also to add insight into the resulting wind profiles by suggesting the presence of a secondary microburst cell. It is possible that the appearance of this second downburst caused the internal fluctuations in horizontal winds observed in the flight data of the latter three aircraft.

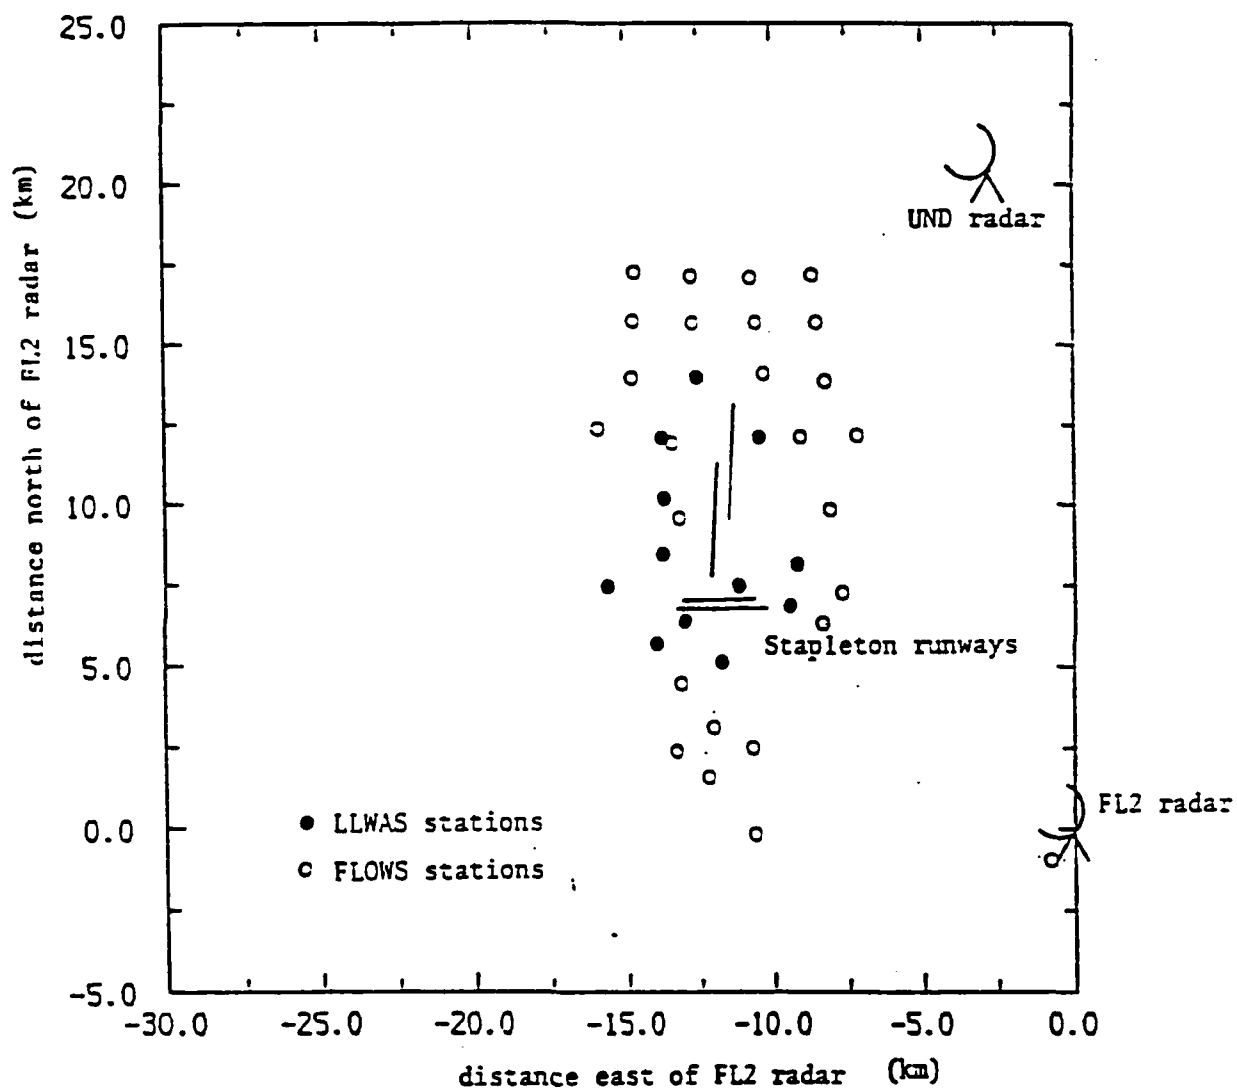
FIGURE 1. Locations of radars and surface mesonet stations during the 1988 TDWR OT&E at Stapleton International Airport, Denver, Colorado. The airport runways are also shown.

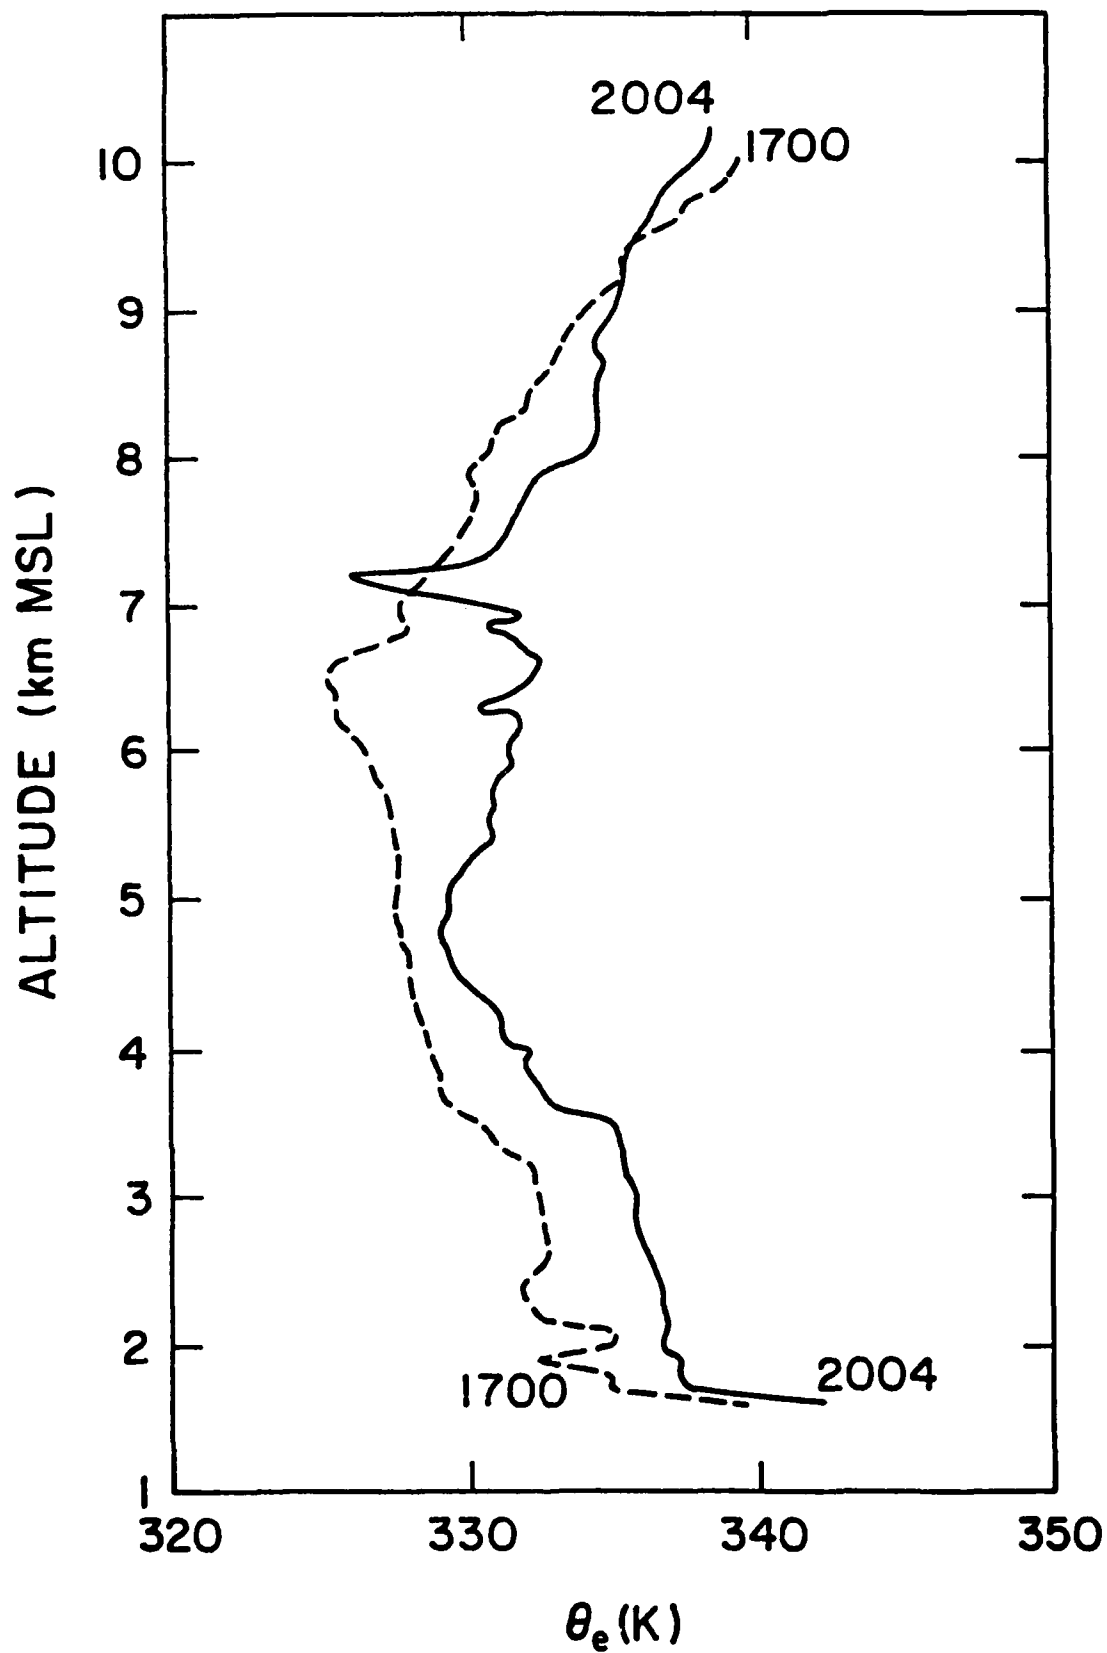
FIGURE 7. Equivalent potential temperature ( $\theta_e$ ) plotted against height from the 1700 and 2004 UTC CLASS soundings.

A CLASS sounding site was located at the Weather Service Forecast Office, just east of Stapleton International Airport. Two soundings were obtained prior to the microburst: at 1700 and 2004. The 1700 sounding (Fig. 6) shows a nearly dry adiabatic lapse rate from 3.4 km MSL, (1.8 km AGL, 68 kPa) to 6.0 km MSL (4.4 km AGL, 49 kPa). A moist layer (relative humidity greater than 50% ) exists between 5.4 and 6.1 km MSL (3.8 and 5.5 km AGL, 52.5 kPa to 48.5 kPa). There is marginal moist convective instability in this sounding, with a Lifted Index (LI) of -2. The equilibrium level is near 8 km (6.4 km AGL, 39 kPa). Equivalent potential temperature ( $\theta_e$ ) for both soundings is shown in Fig. 7; each trace is labelled accordingly. Above the moist layer, the atmosphere is quite dry and  $\theta_e$  decreases.

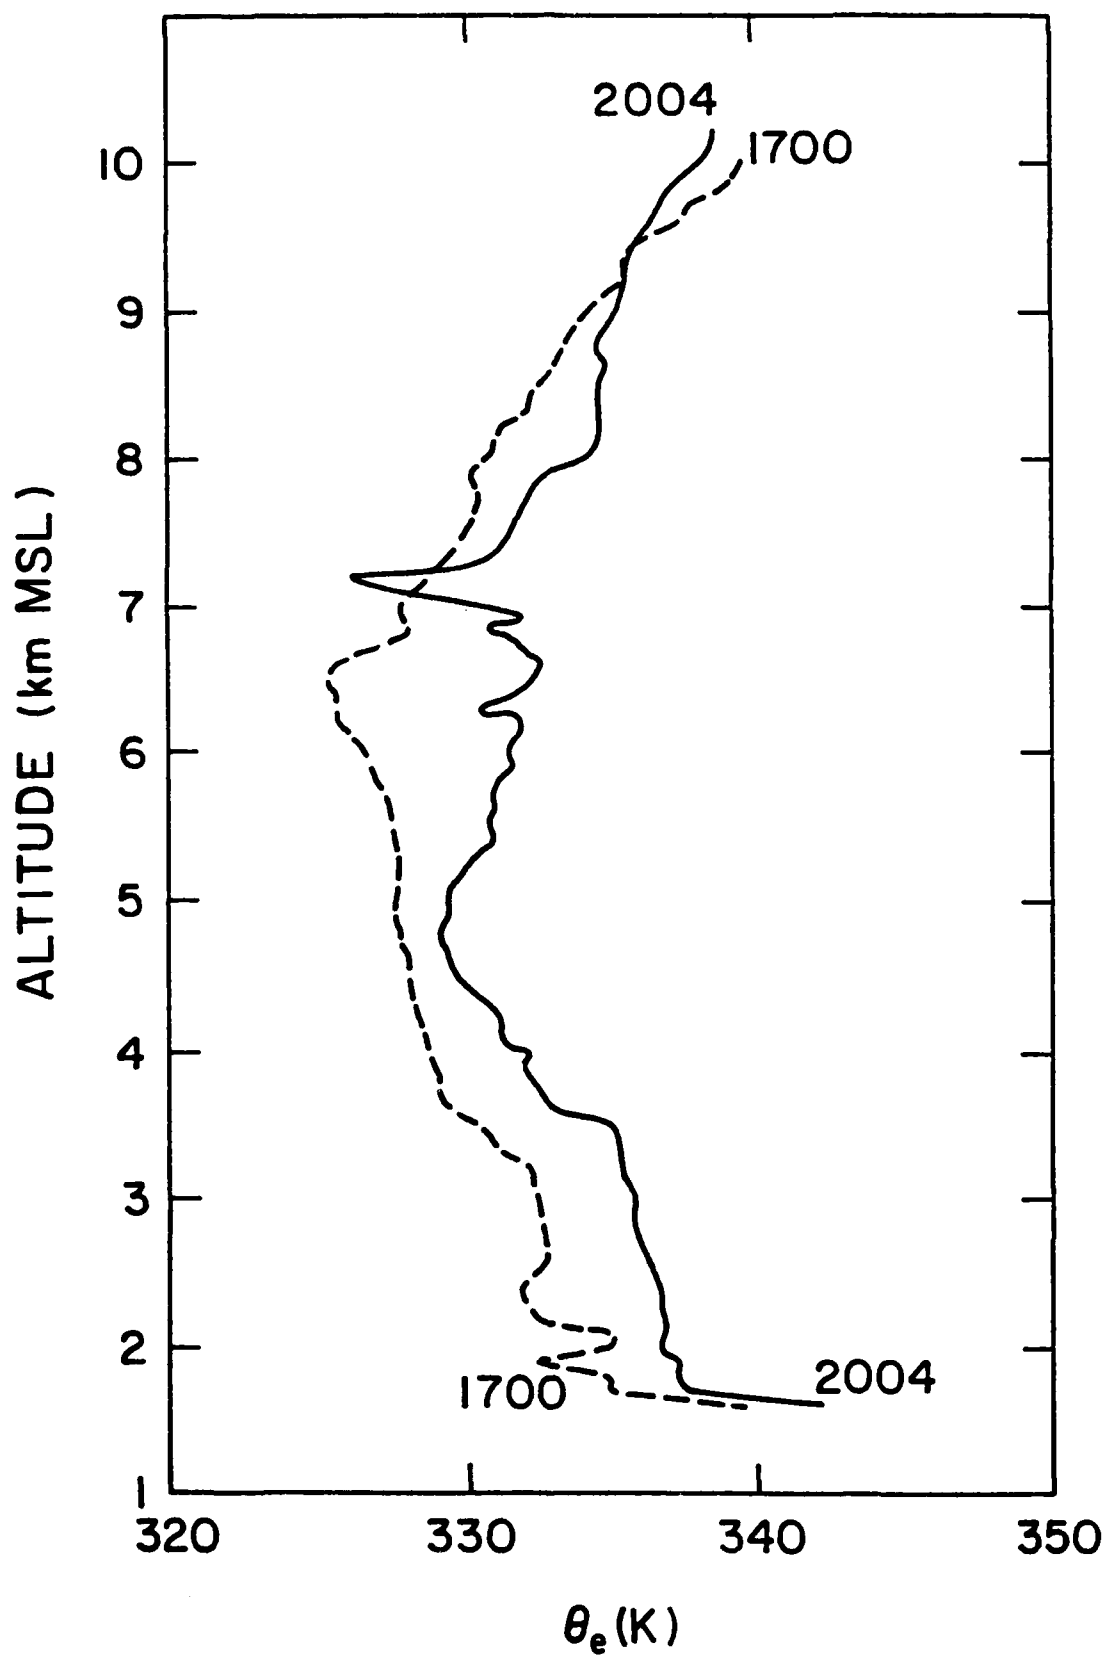
FIGURE 7. Equivalent potential temperature ( $\theta_e$ ) plotted against height from the 1700 and 2004 UTC CLASS soundings.

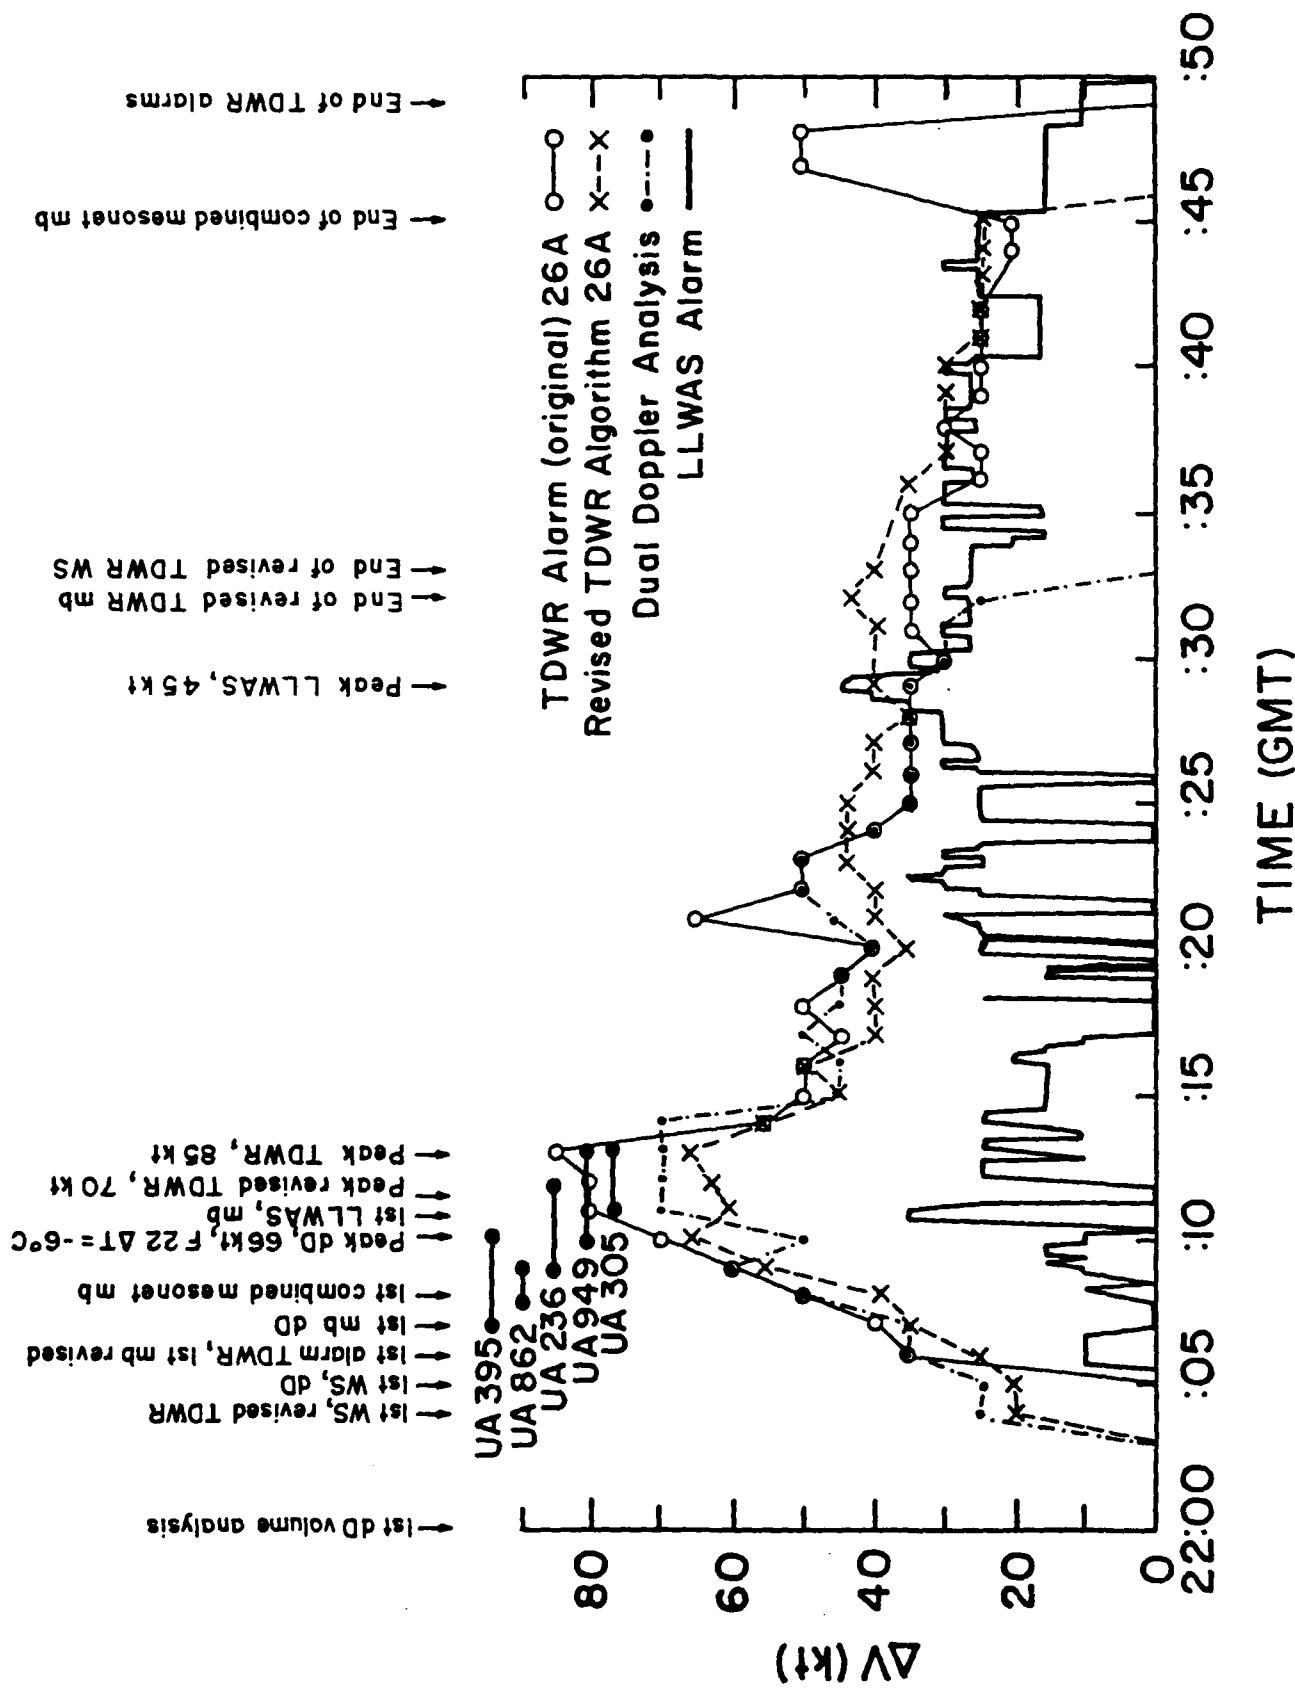
FIGURE 9. Events plotted against time for the 11 July 1988 microburst. A scale for wind shear difference in knots is indicated on the left. Data sources are indicated.

The first microburst begins at 2203 southeast of the airport. This event is not contained within in the airport alarm area. The TDWR algorithm detects it at 2204 (see the GSD displays in Appendix A). A larger, more intense microburst is first detected by the TDWR system at 2206. This event maintains a wind speed loss above microburst alarm levels ( $10 \text{ m s}^{-1}$  or 20 kt) until 2248. In post-analysis, the revised algorithm changed the ending alarm time to 2231. Operated off line, LLWAS did not issue a microburst warning until 2210:42. The microburst develops rapidly, reaching a maximum strength (in terms of wind speed difference across the feature) at 2213. Later, it expands in size and is joined by several other microburst cores that extend to the west-northwest. From the least-squares dual-Doppler analysis (Appendix D), a  $\Delta V$  of at least 15 kt is maintained until 2239;  $\Delta V$

of 10 kt or greater lasts until 2248. LLWAS-generated warnings were sporadic until the final one at 2249.

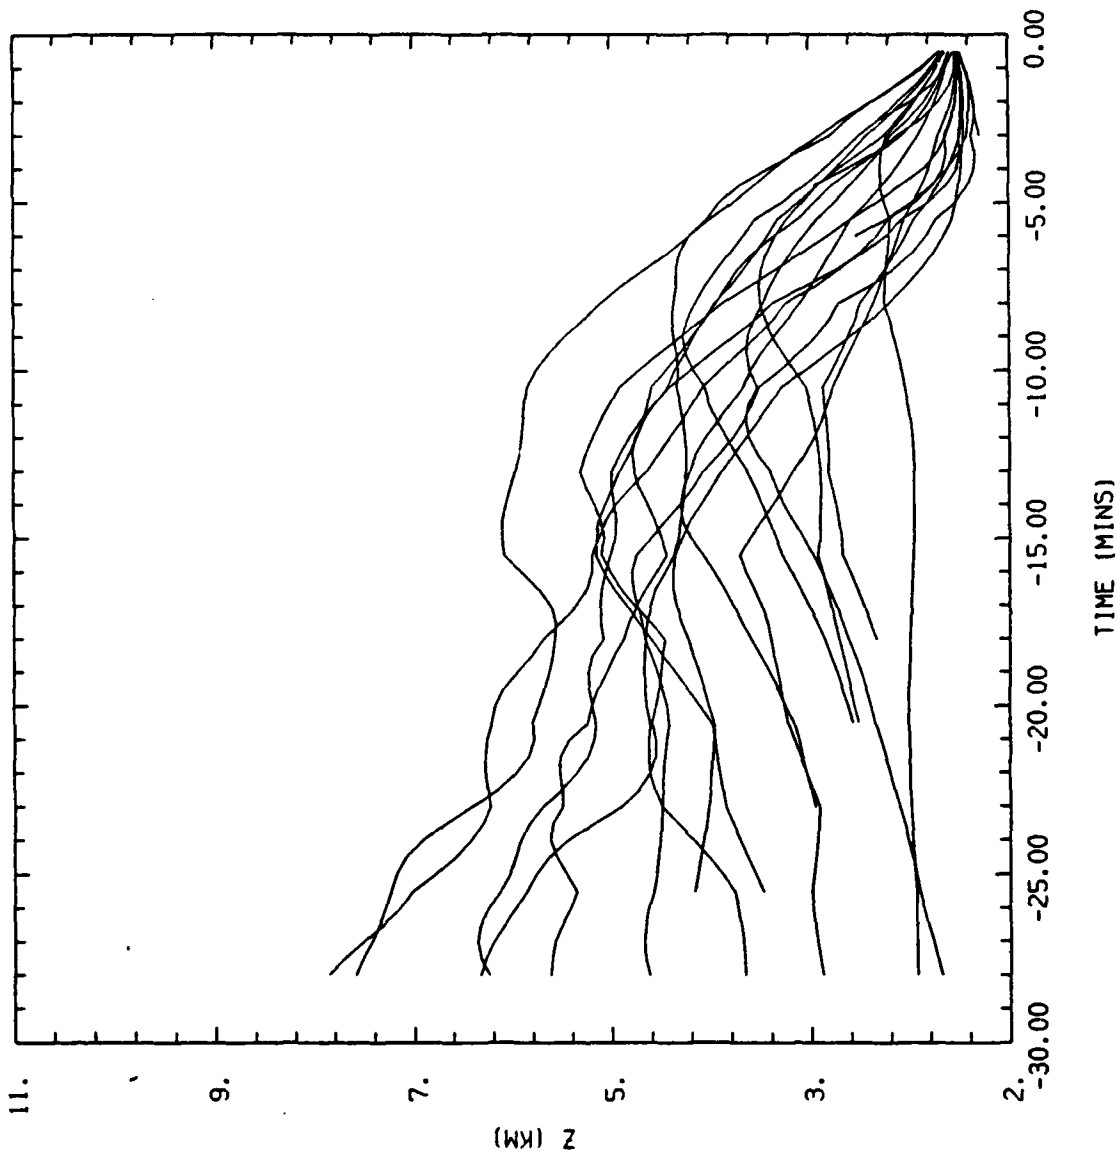
FIGURE 16. A set of 20 trajectories all initiated a 400 m AGL on a rectangular  $4 \times 5$  grid with  $0.75 \times 0.75$  km spacing. All trajectories are initiated at 2212 and proceed backwards in time. Time is along the horizontal axis while height is along the vertical axis.

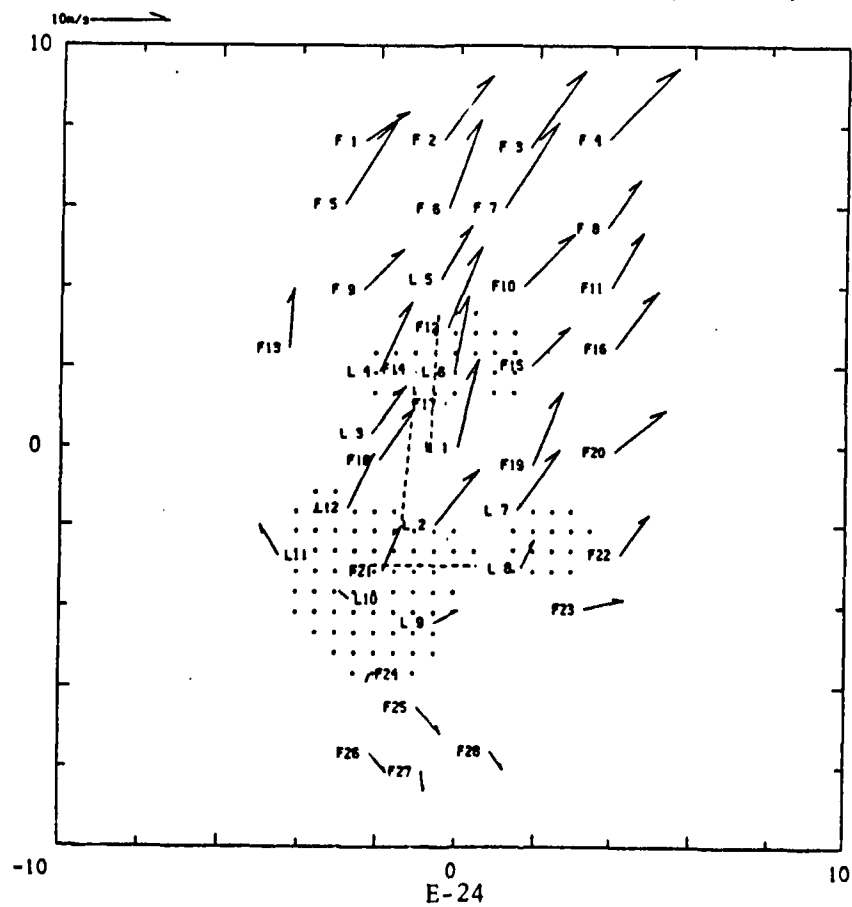
88/07/11-22:45:00 LLWAS-FLOWS MESONET (km x km)

Wind vectors (pointing in the direction the wind is blowing *toward*) are shown in these plots for the times pertaining to the microburst. "L" numbers are LLWAS stations and "F" numbers are FLOWS stations. A scale wind vector is shown on each plot. The Stapleton runways are shown. The plots are centered at the centerpoint (L1) of the runways and the axes are labelled in km away from that center. Dots indicate approximate areas for microbursts causing divergence levels above threshold value (approximately the TDWR "wind shear" alarm level) and crosses indicate those areas for stronger divergence (approximately TDWR "microburst" alarm level). Station F13 was not operating correctly throughout the time period.

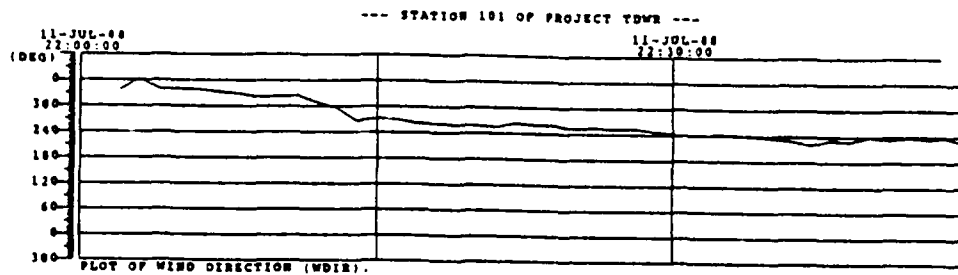
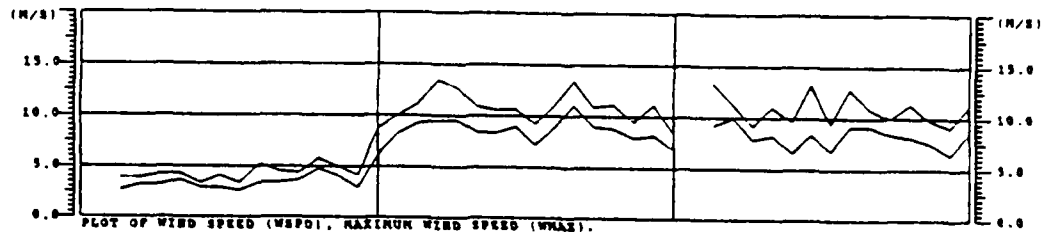
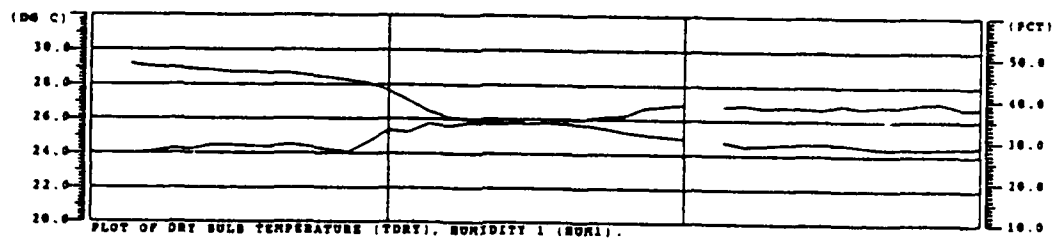
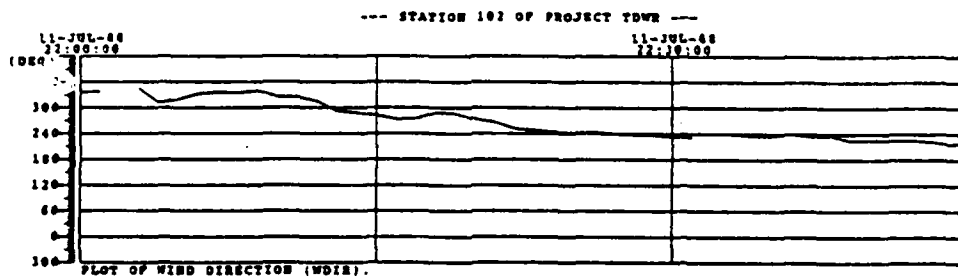
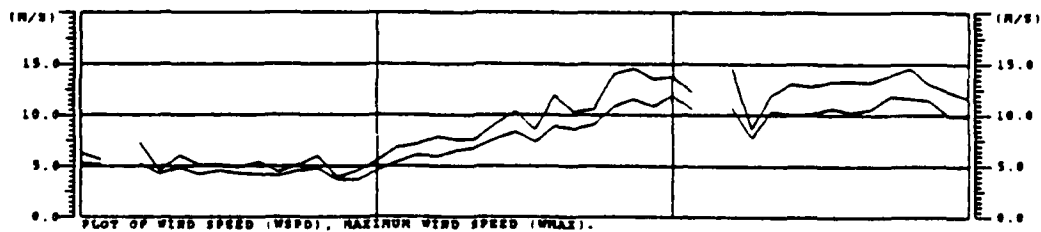
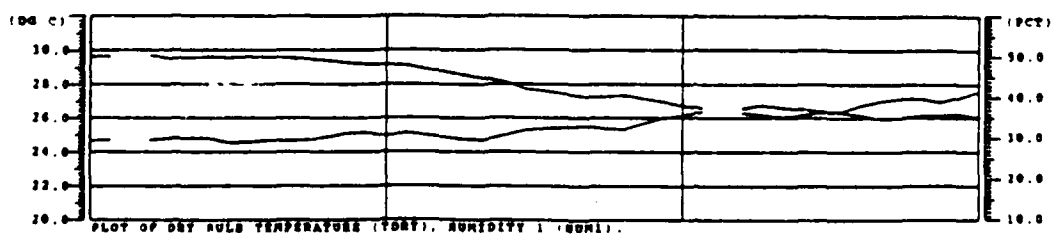
These plots show time series of temperature, relative humidity, average and maximum wind speed and wind direction (from true north) for the FLOWS mesonet stations. Axes are marked in the appropriate units.

The station locations are shown in Appendix J. Station F30 was located at the FL2 radar.

Prior to 2209 little evidence of the microburst was evident from the surface measurements. However, between 2209 and 2210, the temperature at station F23, which was near the center of the main microburst (see Appendix F of Appendix 5) dropped 10.8° from 84.2 to 73.4°F, and the windspeed increased from 14 to 30 knots. The relative humidity also increased, from 24 to 43 percent. During the previous minute, windspeed increased from 6 to 14 knots; the winds apparently indicated outflow arrival prior to any temperature or humidity signatures.

Temperatures across the FLOWS mesonet slowly declined during the dissipation of the storm. The main microburst actually affected only a few stations, F23, F22, and possibly F21. The rest of the mesonet was affected by multiple outflow centers, which did not produce the equivalent intense winds and temperature falls as did the main microburst. Temperatures decreased 9 - 14.4°F while relative humidity increased by 8 - 21 percent over the mesonet as a result of the microburst and storm outflow.
