Automatic missed approach and late go-around detection

Job Brüggen
Safety Manager
ATC The Netherlands

18th June 2013

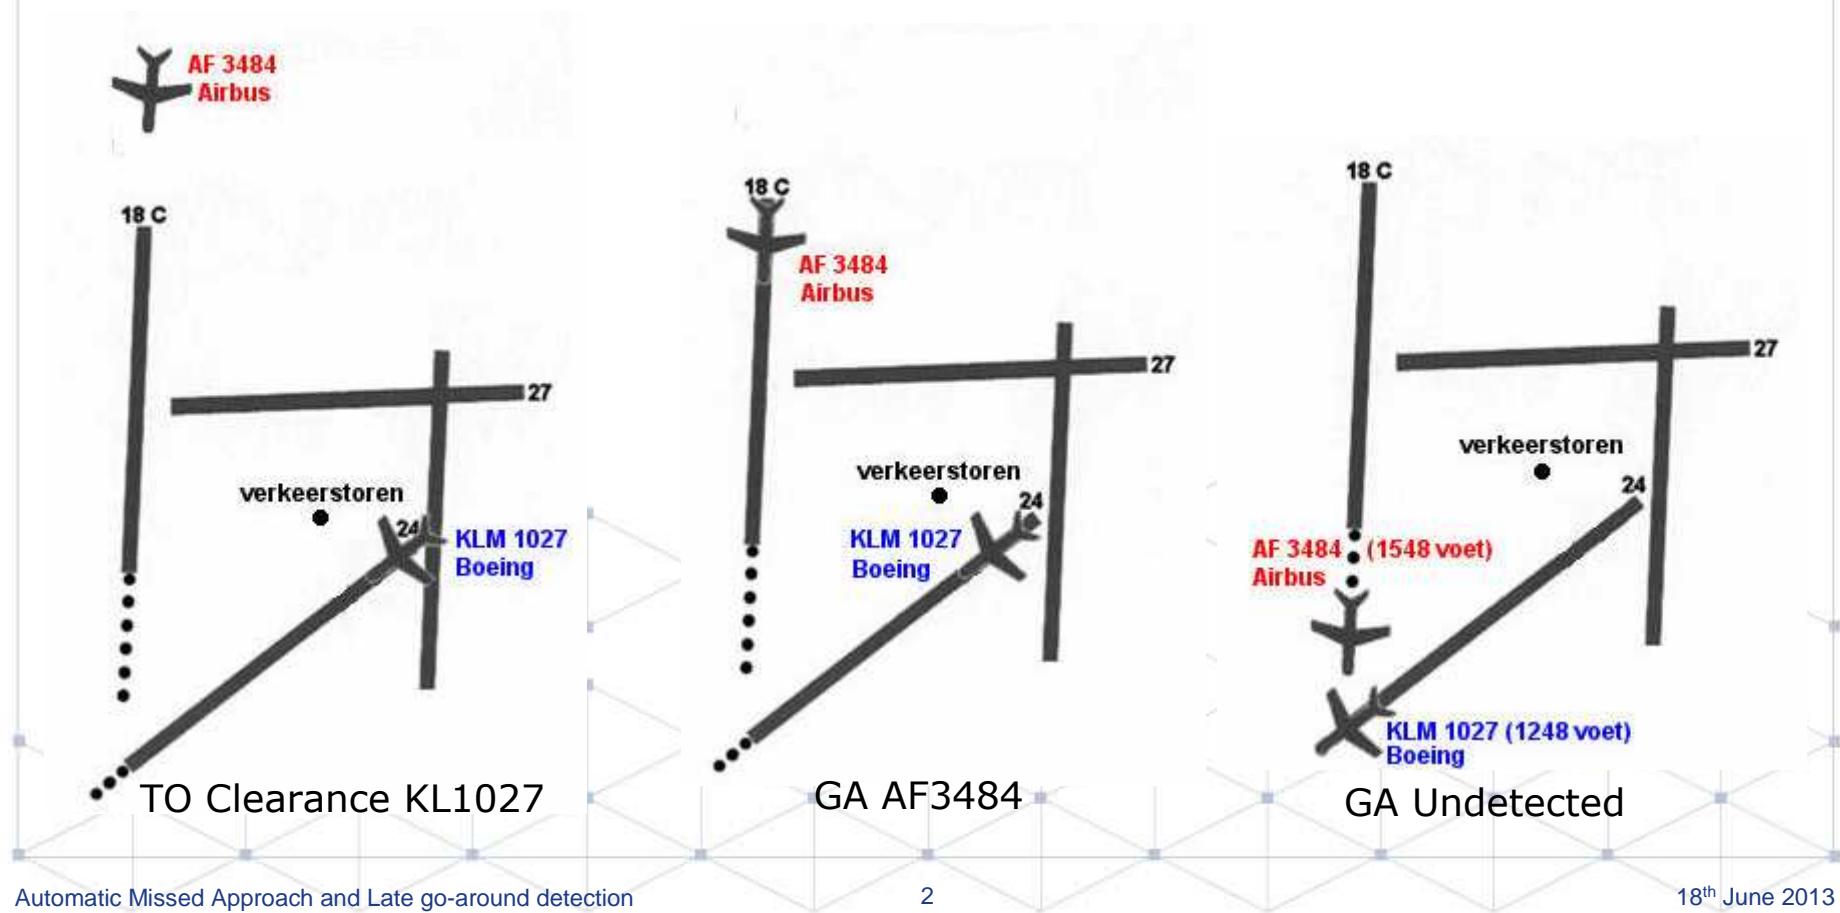
Background (2007)

- Near mid-air collision at Schiphol between Airbus A318 approaching to RWY18c and Boeing 737 departing from RWY24.
- Airbus A318 made a missed approach and crossed path of the departing B737. Closest distance 460m at same altitude.

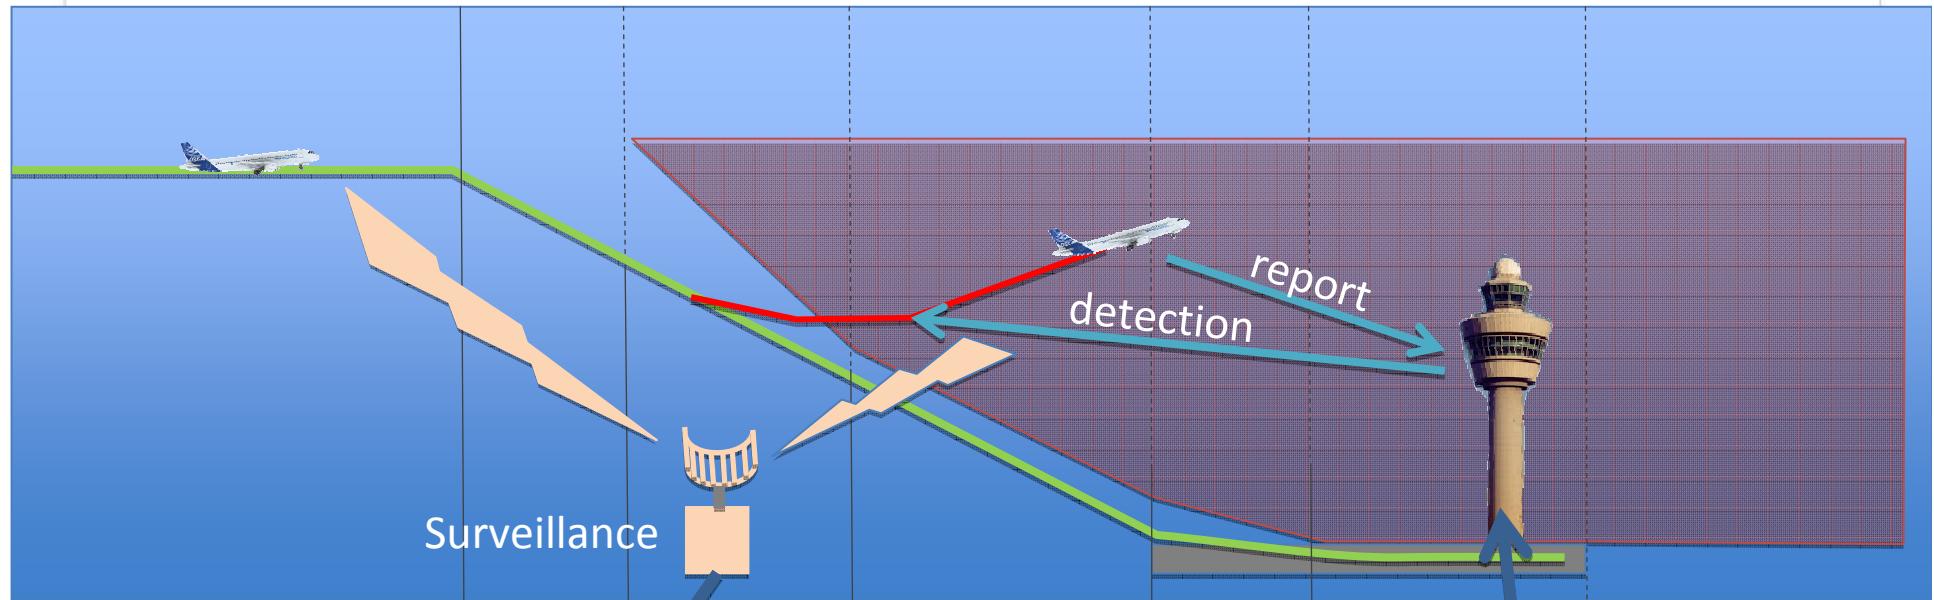
5.3 automatic go-around detection

Surveillance

Landing
Aircraft?

yes

Non-nominal
landing
parameters?

Alert!

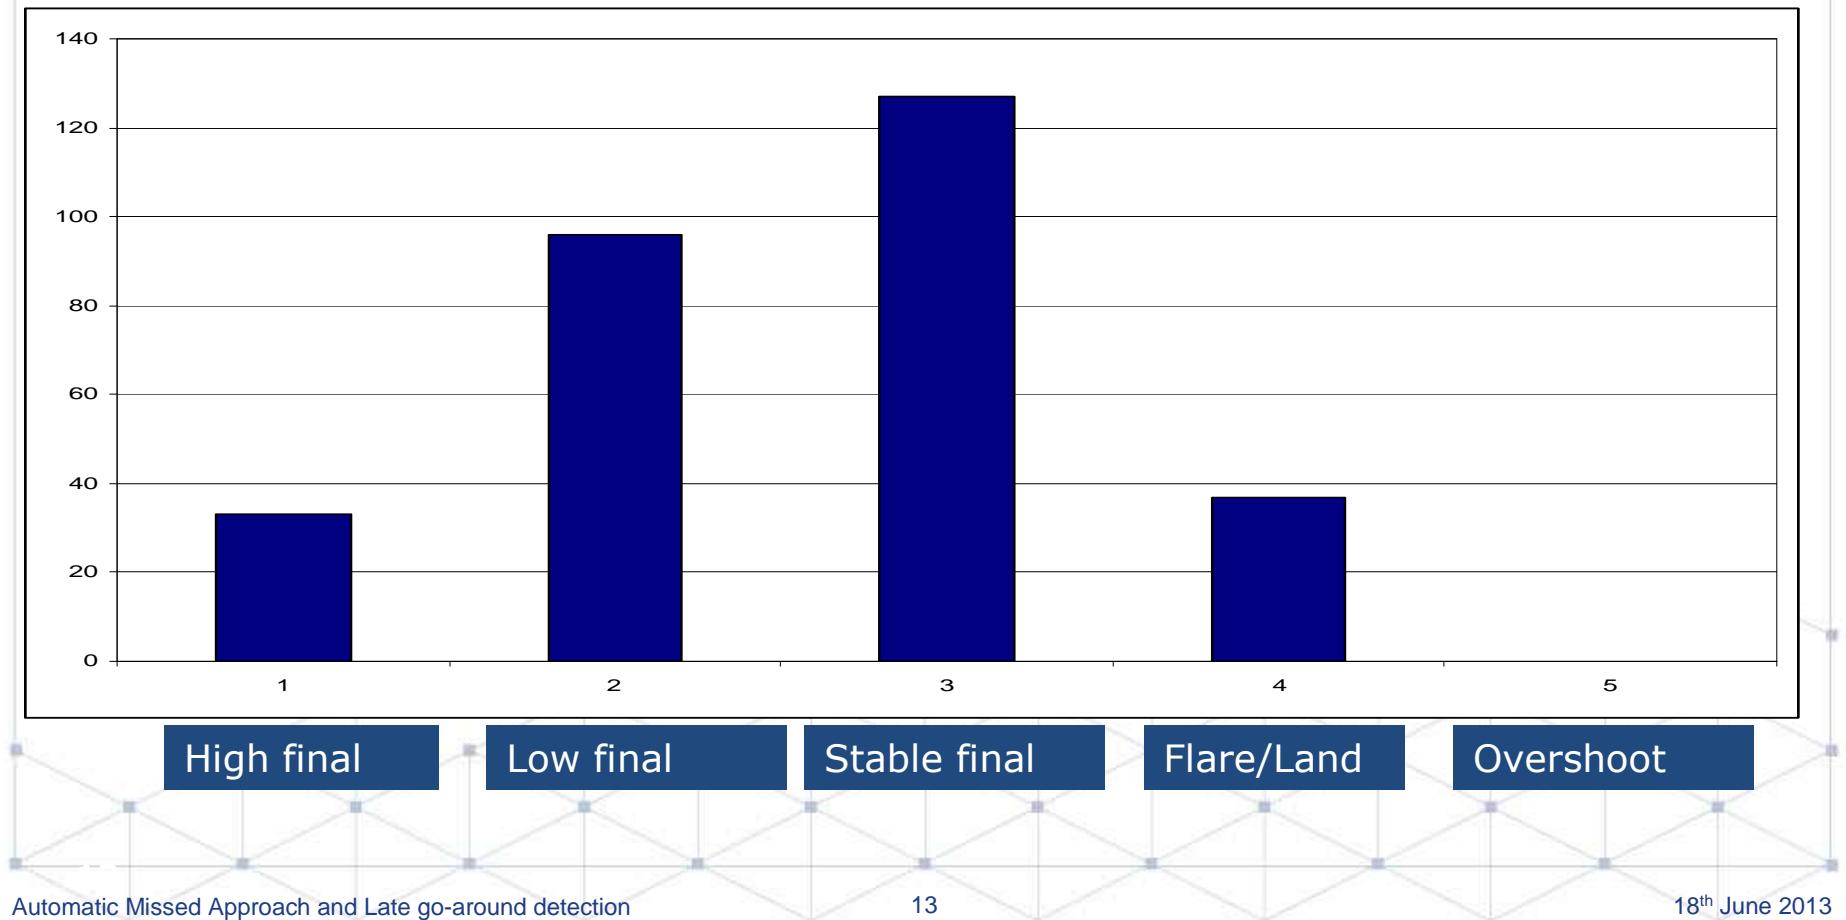
Number of Detections per Phase (293 cases, 2011)

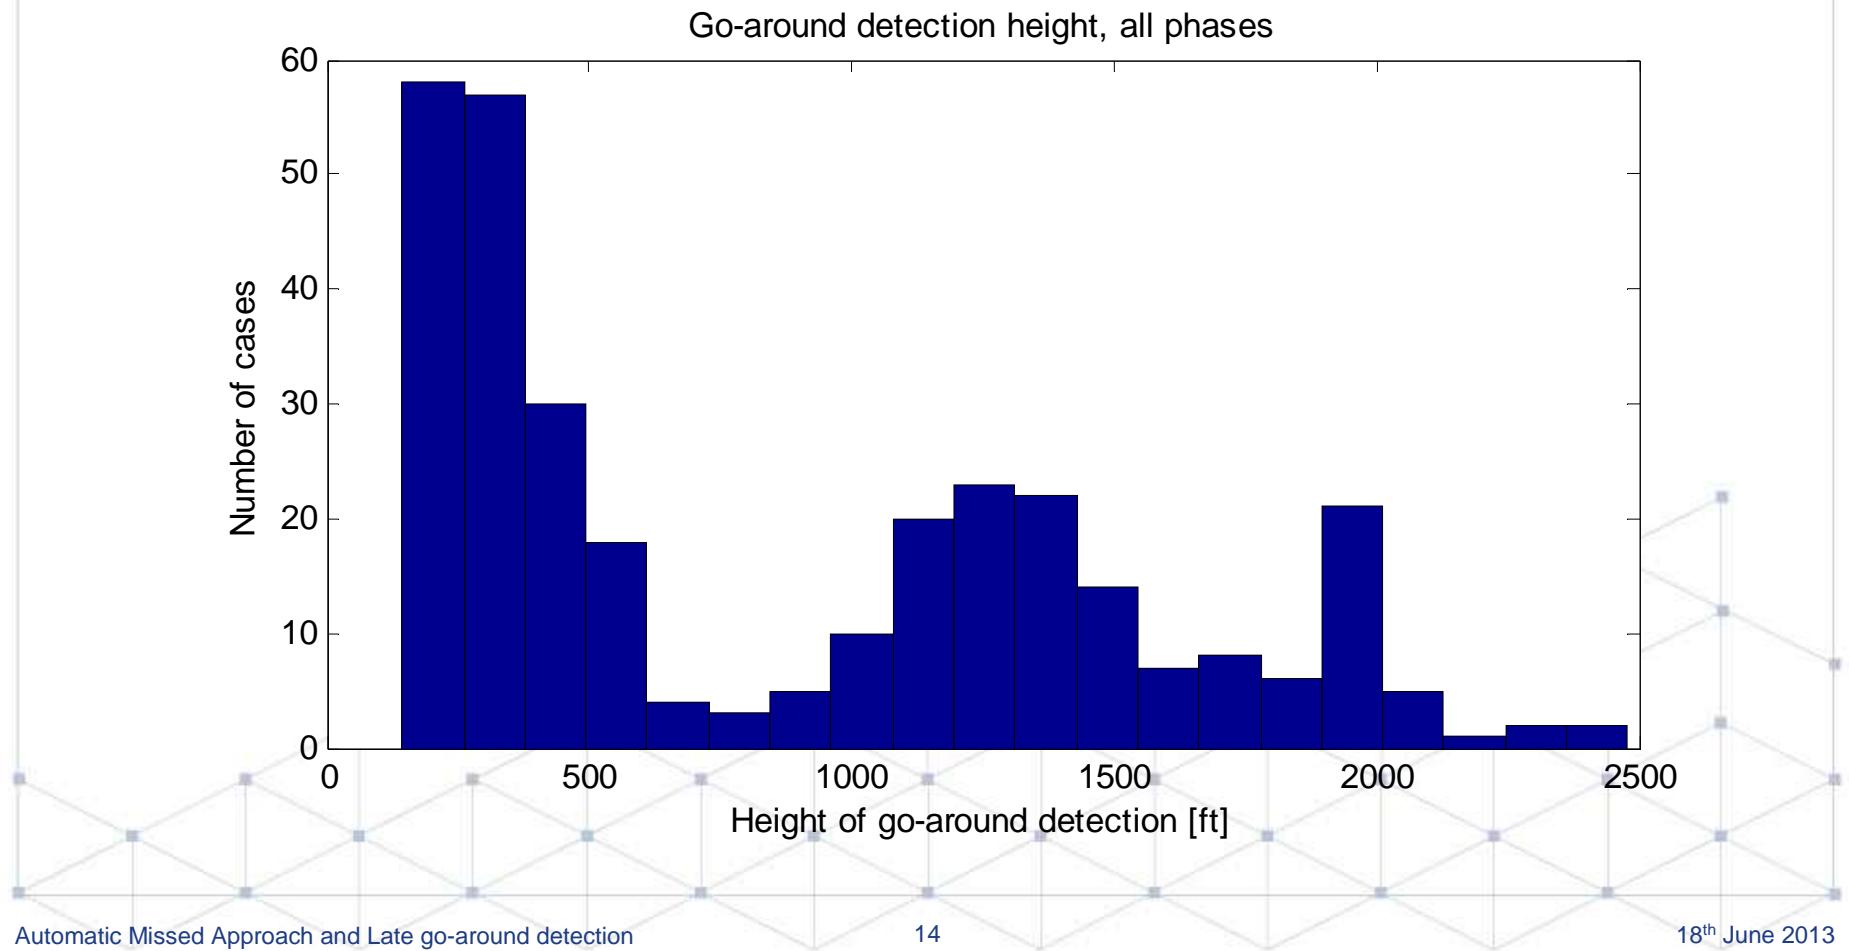
Identified Go-around Altitude (293 cases, 2011)

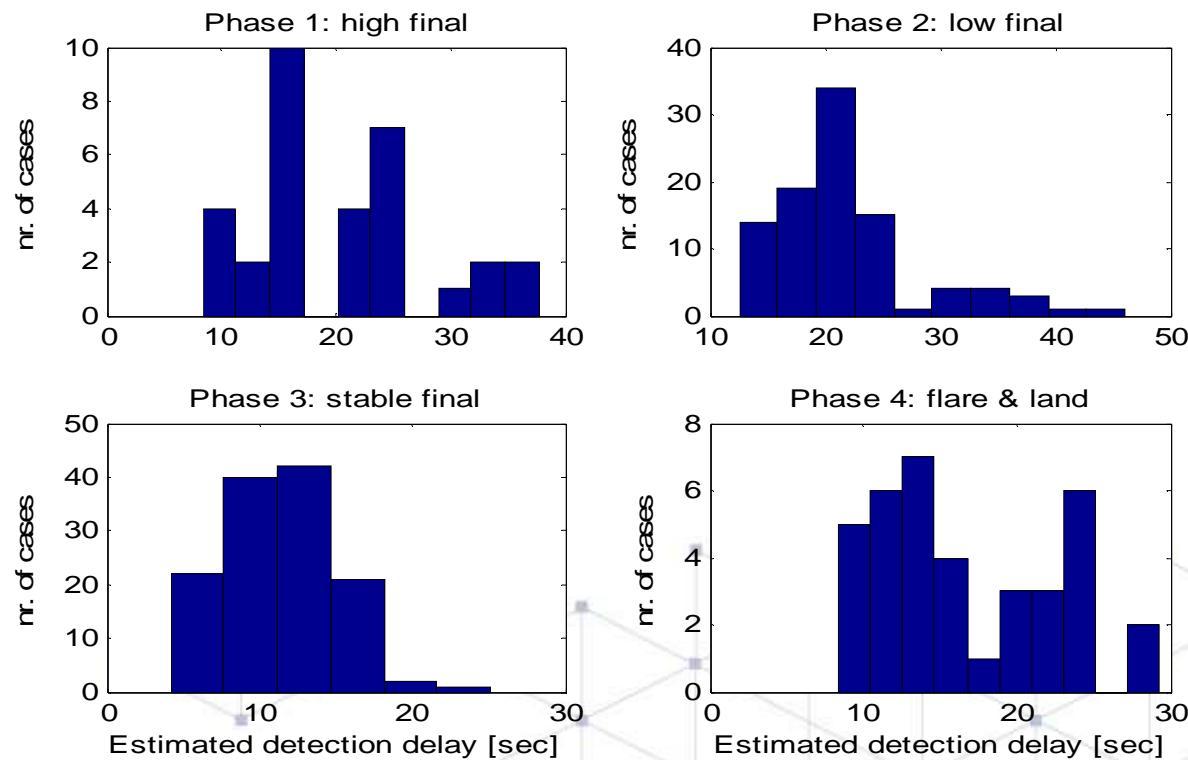
Estimated Detection Delay per Phase

MEAN [SEC]	STANDARD DEVIATION [SEC]
Phase 1	20.6	8.1
Phase 2	21.5	6.8
Phase 3	10.7	4.4
Phase 4	16.9	6.3

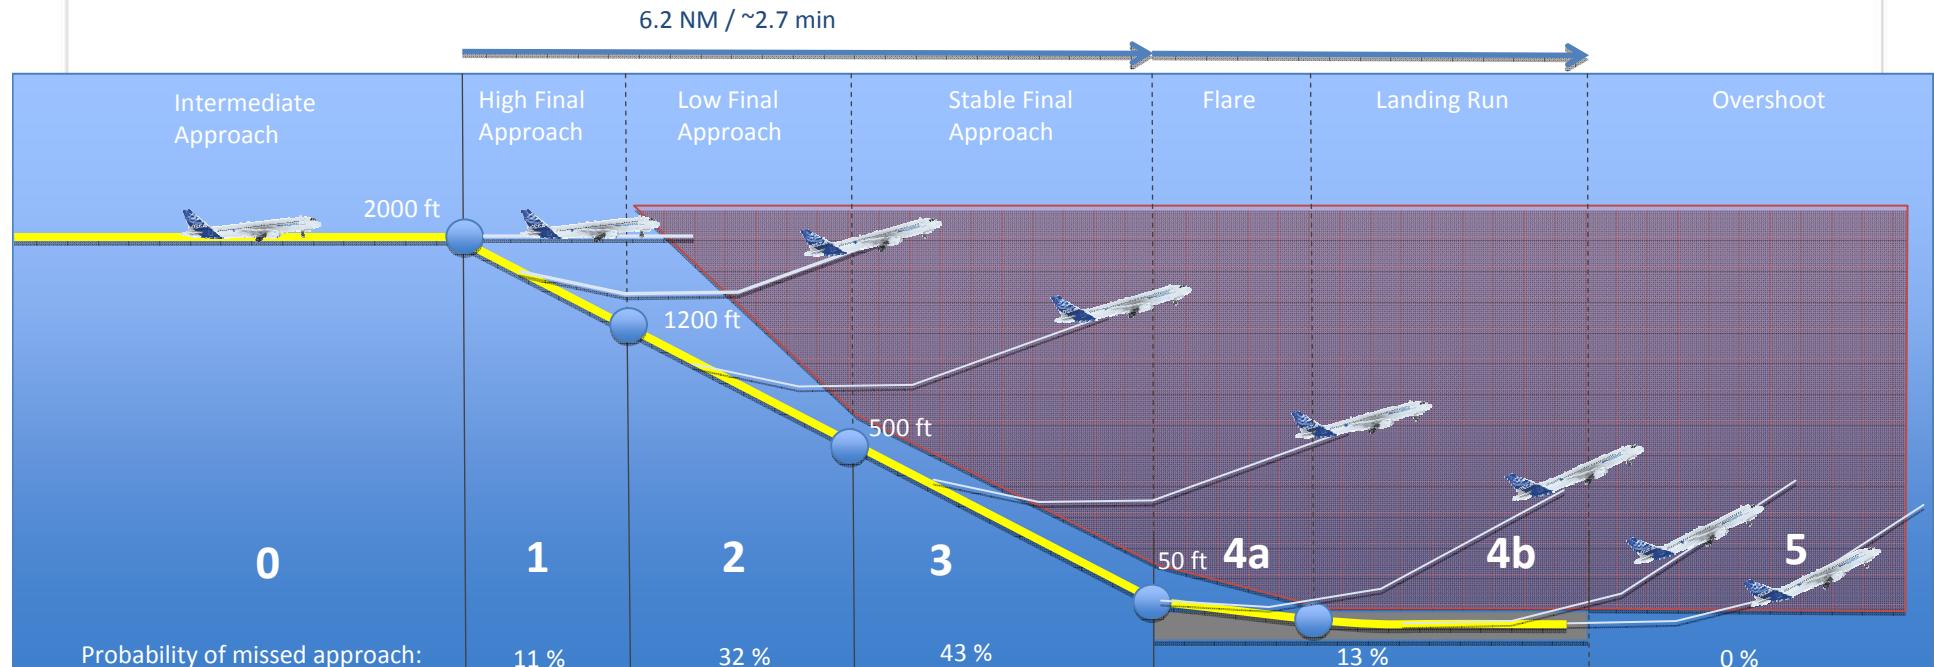
Achievable responsiveness

21 s

22 s

11 s

17 s

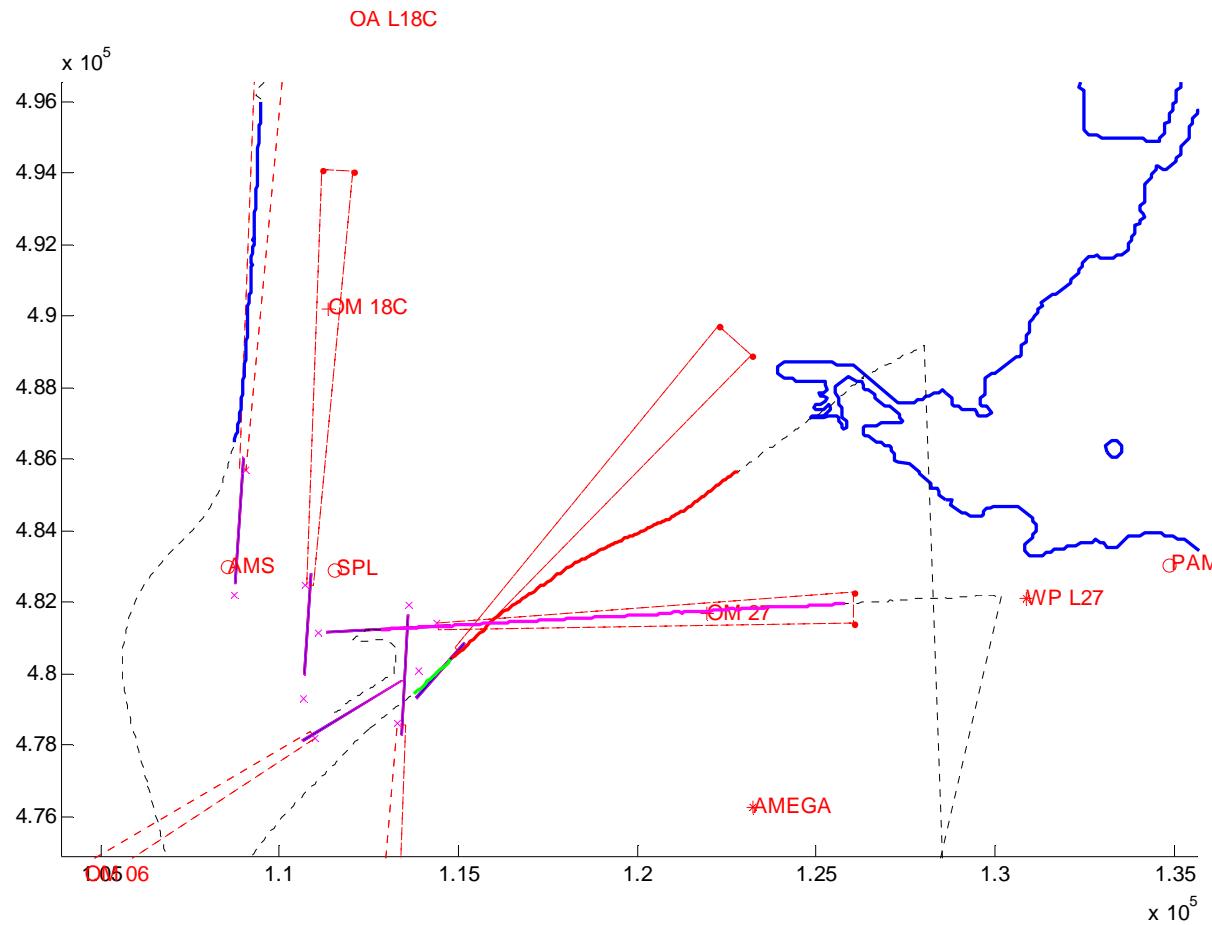
Complications

Approach 18R, MA 18R identified, approach 24, circling 22, MA 22, circling 27 all correctly identified.
