ATSB TRANSPORT SAFETY INVESTIGATION REPORT  
Aviation Occurrence Report 200501977  
Final

Collision with Terrain  
11 km NW Lockhart River Aerodrome  
7 May 2005  
VH-TFU  
SA227-DC (Metro 23)

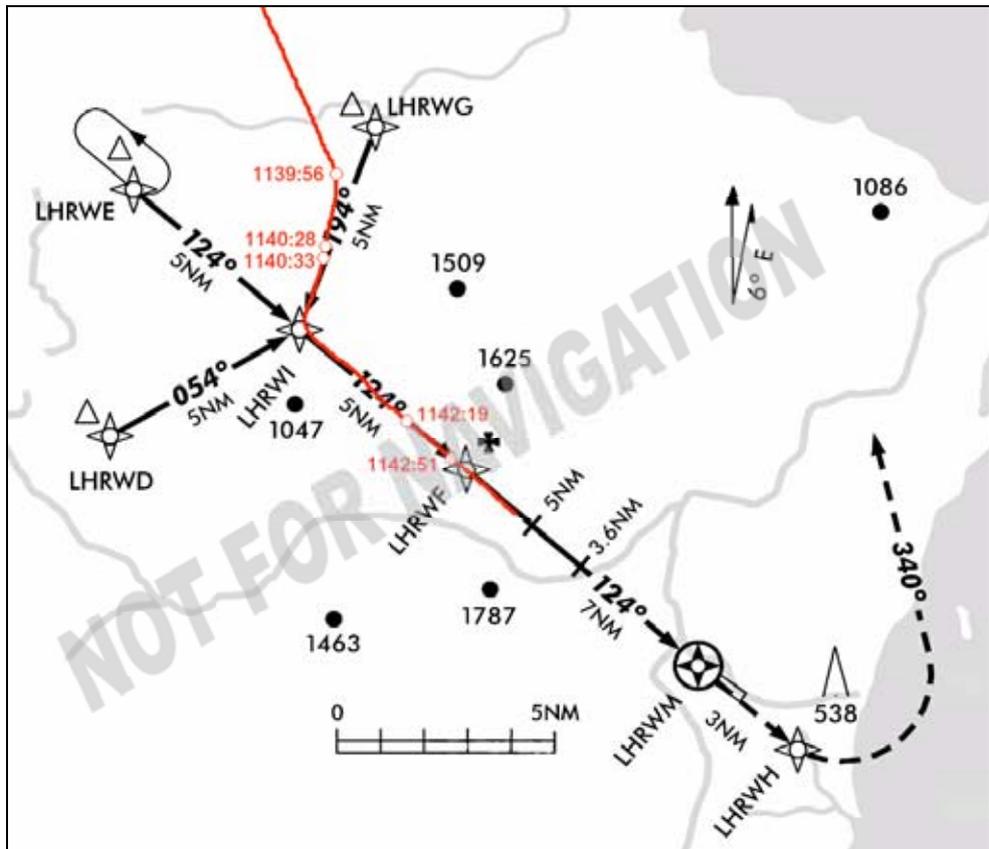
Figure 4: Approach track (in red) derived from FDR data overlaid on an extract of the Airservices Australia Runway 12 RNAV (GNSS) approach chart<sup>17</sup>

The accident site was located on the published Lockhart River Runway 12 RNAV (GNSS) final approach track (Figure 4). The initial impact point with trees was at an elevation of 1,210 ft AMSL. At that point on the approach, the segment minimum safe altitude was 2,060 ft AMSL (Figure 5).

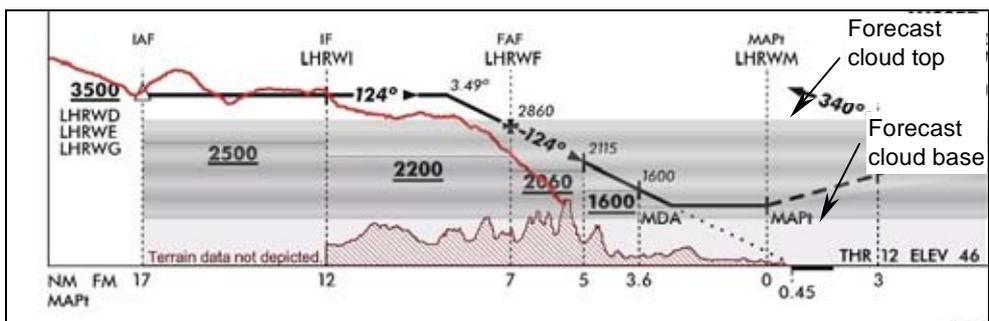
Figure 5: Approach profile (in red) derived from FDR data and terrain profile (in brown) overlaid on an extract of the Airservices Australia Runway 12 RNAV (GNSS) approach chart<sup>17</sup>

1141:07	Aircraft over LHRWI waypoint. Altitude: 3,596 ft IAS: 176 kts
1141:11	Descent recommenced at 4.8 NM from the LHRWF waypoint. This was 3.1 NM before the descent point specified on the approach chart for the 3.49 degree constant angle approach path to the missed approach point (Figure 5). Altitude: 3,588 ft IAS: 179 kts
1141:52	Aircraft levelled. Altitude: 2,998 ft IAS: 188 kts
1142:19	Second stage (18 degrees) of flap selected. Altitude: 3,039 ft IAS: 180 kts
1142:29	Aircraft commenced descent 1.4 NM before the LHRWF waypoint. This was 0.3 NM (approximately 7 seconds) after the descent point specified for the constant angle approach path (Figure 5). Average rate of descent was 1,000 ft/min. Altitude: 3,043 ft IAS: 174 kts

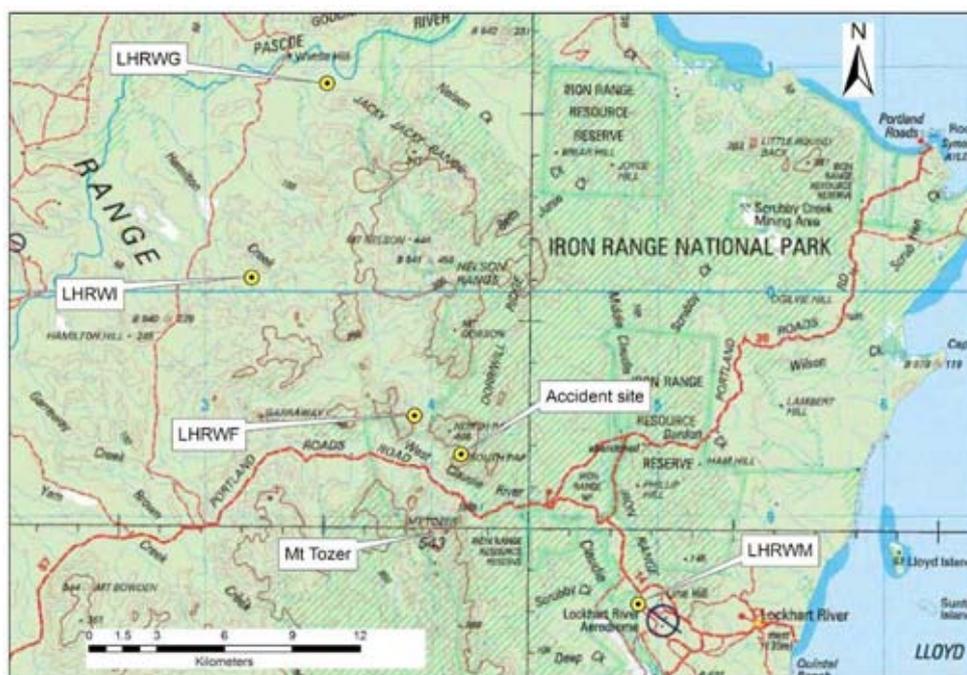
**Figure 6: Topographic map of Lockhart River area with accident site and RNAV(GNSS) approach waypoints**

At 1158, when the crew had not reported having landed at the Lockhart River aerodrome, ATC declared an uncertainty phase. When attempts to contact the crew were unsuccessful, a search for the aircraft was commenced. AusSAR<sup>18</sup> reported that there were no signals from an emergency locator transmitter received in the Lockhart River area at or about the time of the accident. At 1625, the burnt wreckage of the aircraft was located in the Iron Range National Park on the north-western slope of South Pap, a heavily timbered ridge, approximately 11 km north-west of the Lockhart River aerodrome (Figure 6).

The aerodrome was located on a coastal plain 4.5 km west of the Lockhart River township. The Great Dividing Range was nearby with the terrain rising to over 800 ft to the south-west and west within about 8 km of the aerodrome (Figure 6). The highest terrain in the vicinity was Mount Tozer at 1,787 ft, which was located 11 km west-north-west of the aerodrome and about 4 km south of the accident site at South Pap. There was a valley between Mt Tozer and the accident site.

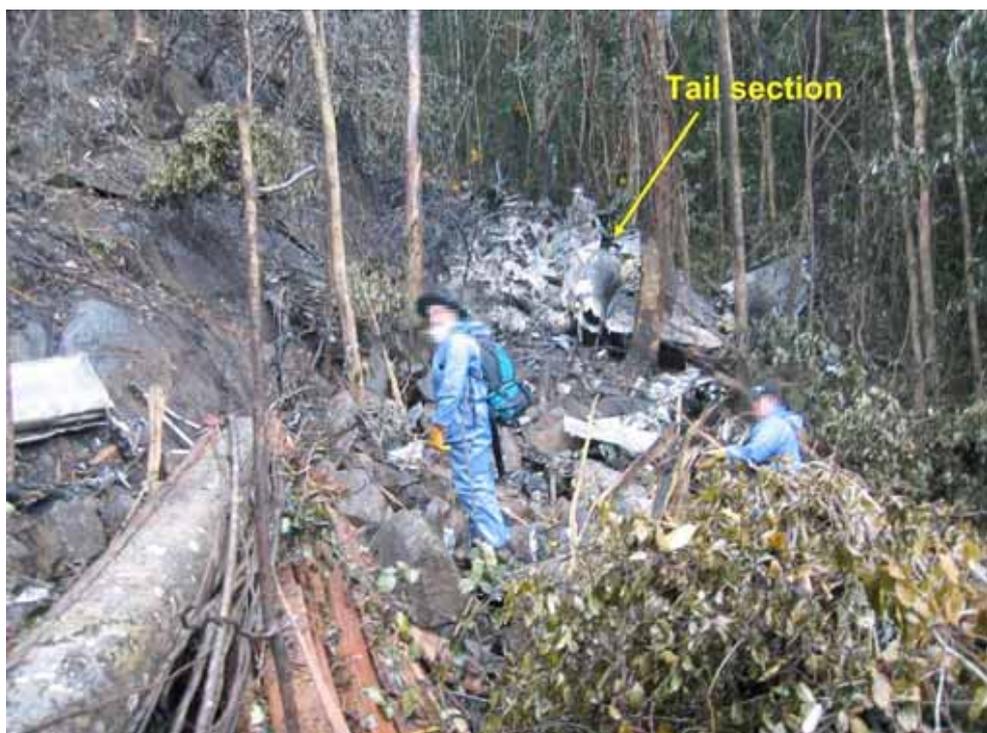
**Figure 21: View along the direction of travel showing the rock outcrop and main wreckage in the background**

As the aircraft flew through the crowns of the trees, the outboard sections of both wings and the blades of both propellers separated from the aircraft. The aircraft continued along a descending flight path, contacting tree trunks and branches. This resulted in further sections of both wings, the engines and sections of the horizontal stabiliser and elevators being torn off. The nose of the aircraft then impacted boulders and broke up. The remaining left wing structure then impacted a rock outcrop causing the fuselage to roll to the right approximately 50 degrees (Figure 21).

The remaining wreckage then continued about 20 m up the steeply sloping ground before stopping. It was then consumed by an intense, fuel-fed, post-impact fire (Figure 22).

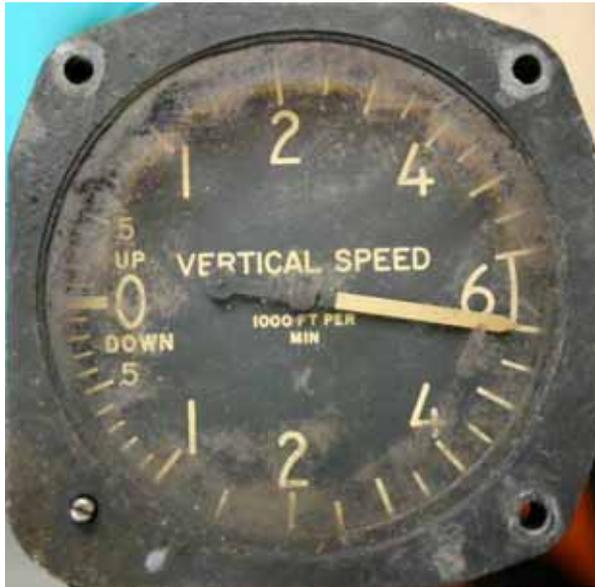
**Figure 24: Vertical speed indicator (recovered from VH-TFU)**

Only the pilot in command's VSI was recovered from the accident site. The glass face was intact and the pointer was indicating a rate of descent of about 6,000 ft/min (see Figure 24). Due to internal damage from the impact, the indication was considered unreliable. There was no evidence to suggest that the instrument was not functioning prior to the impact and fire.

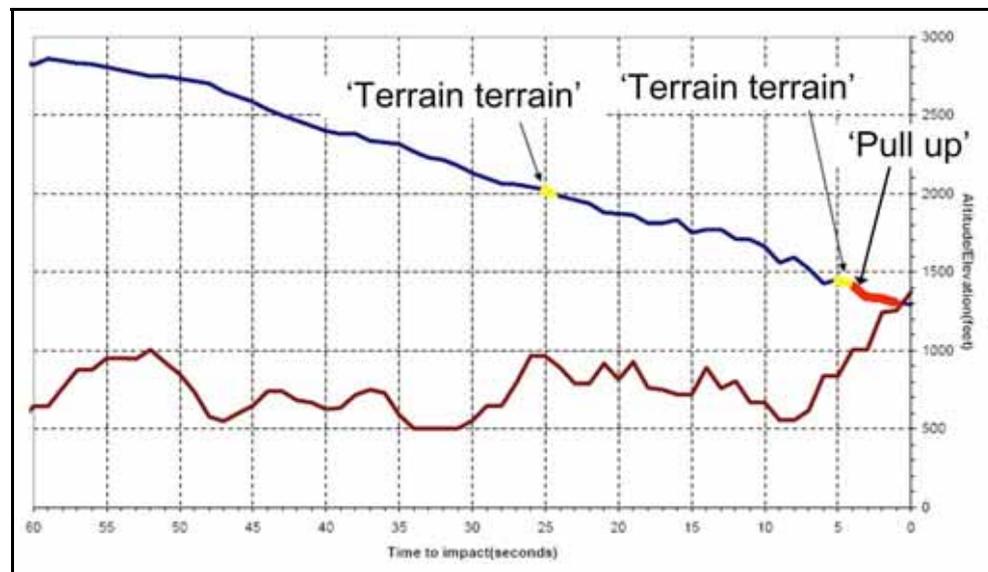
**Figure 26: Accident flight simulation showing GPWS alerts and warnings<sup>88</sup>**

The simulation (Figure 26) indicated that the GPWS should have provided a single 'terrain terrain' alert of about 1-second duration at about 25 seconds before impact. This was followed by a second 'terrain terrain' alert and then a repetitive 'pull up' warning during the final 5 seconds of the flight.

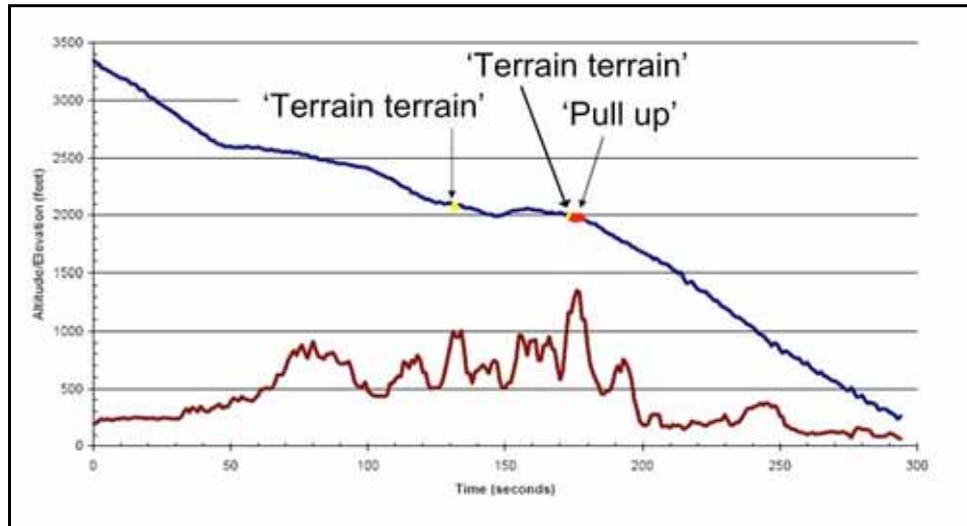
**Figure 27: Simulation for Bamaga to Lockhart River on 27 April 2005 showing GPWS alerts and warnings<sup>88</sup>**

Data from the FDR of the only other Lockhart River Runway 12 RNAV (GNSS) approach apart from the accident flight was also provided to Honeywell for a GPWS simulation. The simulation indicated that the GPWS should have provided GPWS mode 2 alerts and warnings when the aircraft was in the vicinity of South Pap (Figure 27).

The copilot of this flight initially reported that he had not received any GPWS alerts or warnings when flying the Lockhart River Runway 12 RNAV (GNSS) approach in cloud, but ‘had it go off when visual’ (that is, flying the approach in visual conditions). Later in the investigation when asked about the flight on 27 April 2005, the copilot could not recall this particular flight.

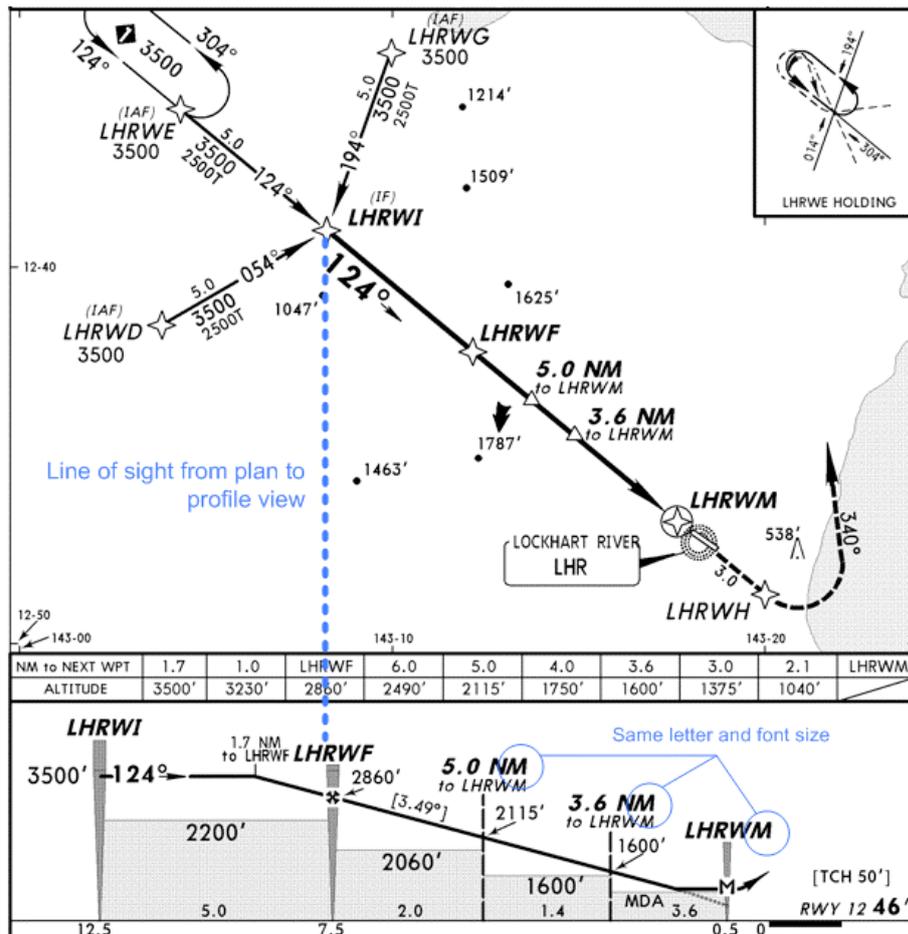
**Figure 35: Jeppesen chart line of sight between diagrams**

Unlike the Aircservices charts, the Jeppesen charts did not display the first segment of the approach in the profile diagram from the initial approach fix (waypoints LHRWG/E/D) to the intermediate fix (waypoint LHRWI) (Figure 35). Instead, the profile diagram commenced from the intermediate fix. Jeppesen reported that this was to maximise the space available to display the details of the profile view. The plan-view provided details of all segments, starting from the initial approach fix.

For the Lockhart River runway 12 approach, the plan and profile-views superficially followed a similar spacing, but with one less segment on the profile diagram. As such, on the Lockhart River Runway 12 RNAV (GNSS) approach chart, the second waypoint (LHRWI) on the plan diagram was coincidentally aligned with the second waypoint (LHRWF) in the profile diagram (Figure 35).

On Jeppesen charts, the beginning of the intermediate altitude limiting steps (in between waypoints) was printed with the first line using the same font type and size, using capital letters for the nautical mile indications, and in the same

positions, as the waypoint names (Figure 35).<sup>160</sup> The final letter on the first line was ‘M’, as was the final letter for the missed approach waypoint before the runway. Furthermore, as explained in Section 1.19.4, pilots needed to focus on the last letter of a waypoint (as the first four letters were the same for all waypoints) to identify their position.

The Lockhart River Runway 12 RNAV (GNSS) approach chart was produced by Jeppesen only in black and white printing. On the plan-view diagram, the ocean was shaded grey and the terrain was white with high terrain depicted using spot heights (Figure 35), but no contour lines or terrain elevation shading. The ICAO Annex 4 *Aeronautical Charts*<sup>161</sup> stated ‘Appropriate spot elevations are those provided by the procedures specialist.’ The spot heights depicted that were closest to the approach were Mount Tozer to the South, (1,787 ft, highlighted by an arrow as the highest terrain on the chart) and Mount Dobson to the north (1,625 ft). North Pap and South Pap were not depicted. Therefore, there was no indication on the chart of the existence of terrain under the approach path.

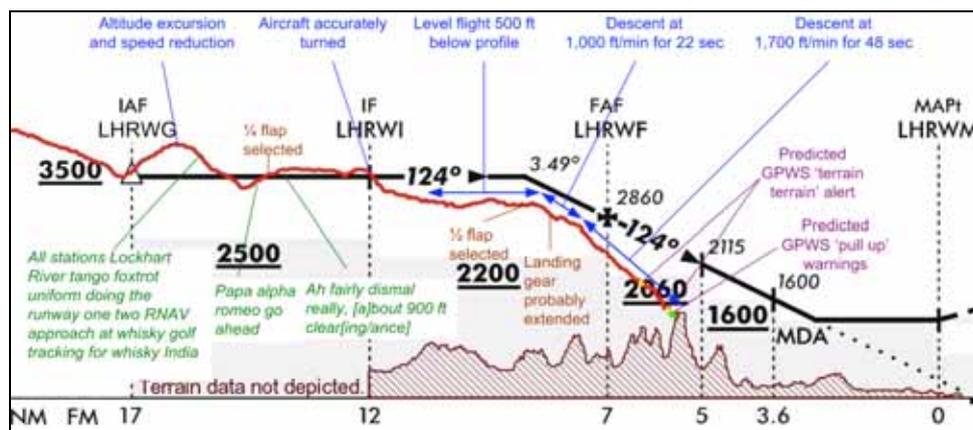
**Figure 40: Vertical approach profile.**

The FDR data also showed that as the aircraft passed abeam waypoint LHRWG (the initial approach fix, or IAF), the crew descended the aircraft to 3,500 ft above mean sea level (AMSL), which was the initial recommended approach altitude (see Figure 40). An altitude excursion to about 4,000 ft occurred after the aircraft passed the initial approach fix. The investigation was unable to determine the reason for this excursion, but it may have been an intentional manoeuvre to decelerate the aircraft.

At 1.4 NM before waypoint LHRWF (the final approach fix, or FAF), the crew recommenced the descent at 1,000 ft/min for about 22 seconds. The crew then reduced engine power from about 36 per cent to about 30 per cent, which further increased the rate of descent to an average of 1,700 ft/min over the final 48 seconds before the aircraft collided with trees at 1,210 ft AMSL. During this final descent, at about 28 seconds before the impact with terrain, the crew descended below the segment minimum safe altitude of 2,060 ft.

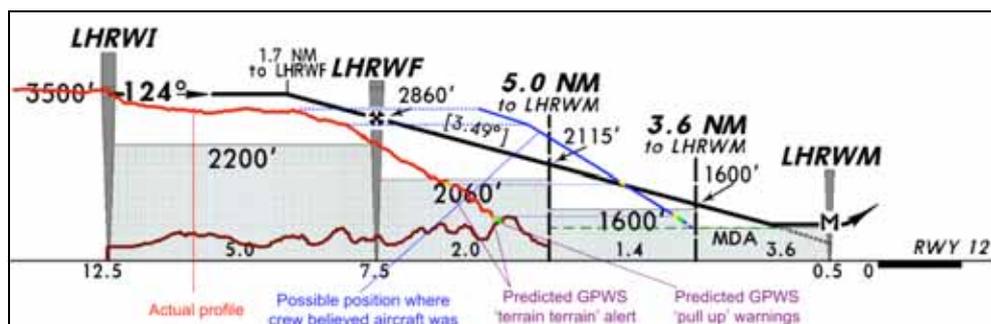
**Figure 41: Profile that the crew may have believed they were following overlaid on a Jeppesen profile diagram. (Note: diagram not to scale.)**

Rather than confusing one waypoint with another, the crew may have confused the altitude limiting steps. The FDR data indicated that, at the descent rate recorded, the aircraft would have reached between 900 and 1,000 ft at about the altitude limiting step ‘5.0 NM to LHRWM’ (5 NM to the missed approach waypoint) on the Jeppesen chart (see Figure 2 on page 2). This would have placed the aircraft at about the minimum descent altitude (MDA, or 1,040 ft) at the ‘5.0 NM to LHRWM’ position. Therefore, the crew may have confused the ‘5.0 NM to LHRWM’ position with either the ‘3.6 NM to LHRWM’ position or the LHRWM waypoint. The blue profile shown on Figure 41 corresponds to what the crew would have believed the flight path to be according to such a scenario. The red profile corresponds to the actual flight path of the aircraft.

Alternatively, the distance from the LHRWF to the LHRWM was 7 NM, whereas on most approaches the distance between the final approach fix and the missed approach point was 5 NM. If the crew thought they were 2 NM closer to the missed approach point prior to reaching LHRWF, then the initiated rate of descent would have also placed the aircraft at the minimum descent altitude at about the '5.0 NM to LHRWM' position (or where the crew thought was about 3 NM to the missed approach point). This scenario would also correspond to the blue profile on Figure 41.

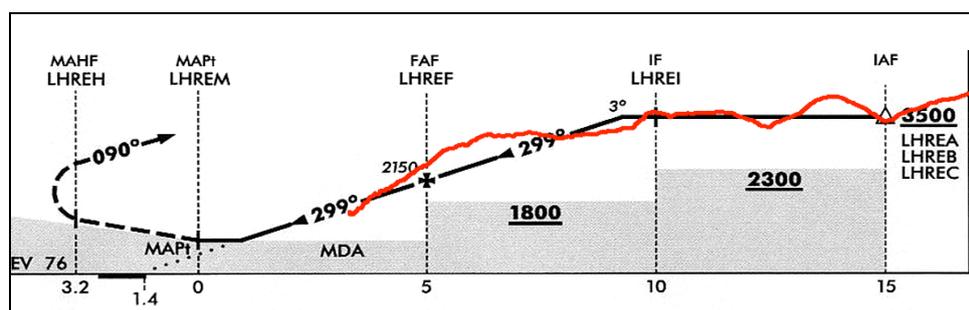
**Figure 42: Vertical profile of VH-TFU overlaid on a Lockhart River Runway 30 RNAV (GNSS) approach profile diagram**

Another possible scenario considered by the investigation was whether the crew may have inadvertently selected the Lockhart River Runway 30 RNAV (GNSS) approach chart instead of the chart for the runway 12 approach. When the accident flight path was superimposed on the runway 30 chart, the descent from 3,500 ft began at about the point where the runway 30 recommended descent profile commenced. The waypoint names for the intermediate fix, final approach fix, and missed approach point only differed by one letter between the two approaches.

However, this scenario would not be consistent with the aircraft levelling out at about 3,000 ft. In addition, the crew had broadcast that they were conducting a runway 12 approach via the 'whiskey golf' waypoint. The equivalent point on the runway 30 approach was 'echo charlie'. The GPS unit would also have been showing 7 NM instead of 5 NM after passing the intermediate fix (LHREI).

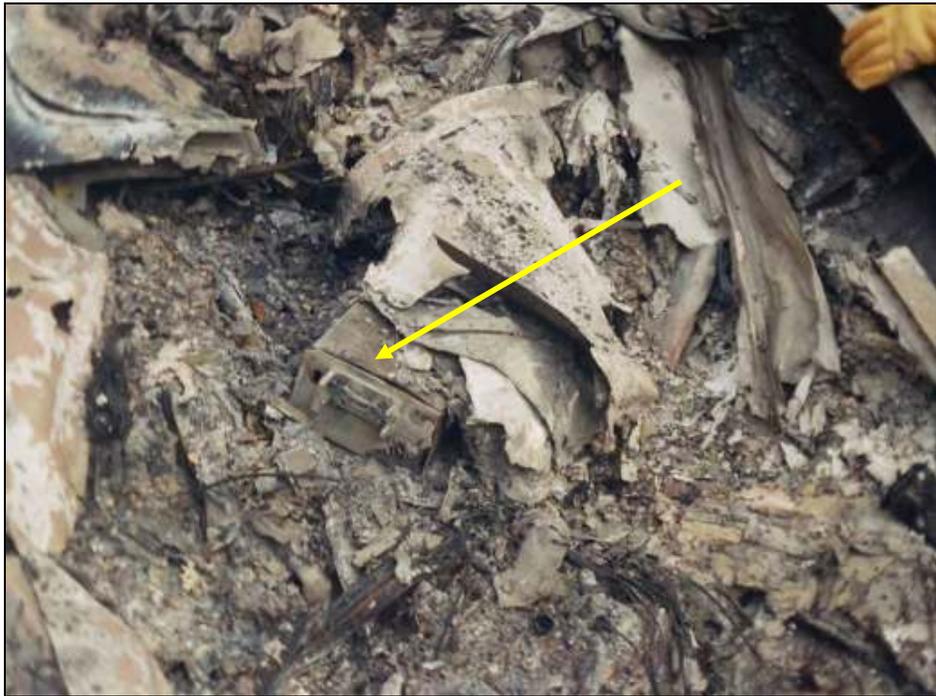
**Figure A-4: FDR at the accident site**

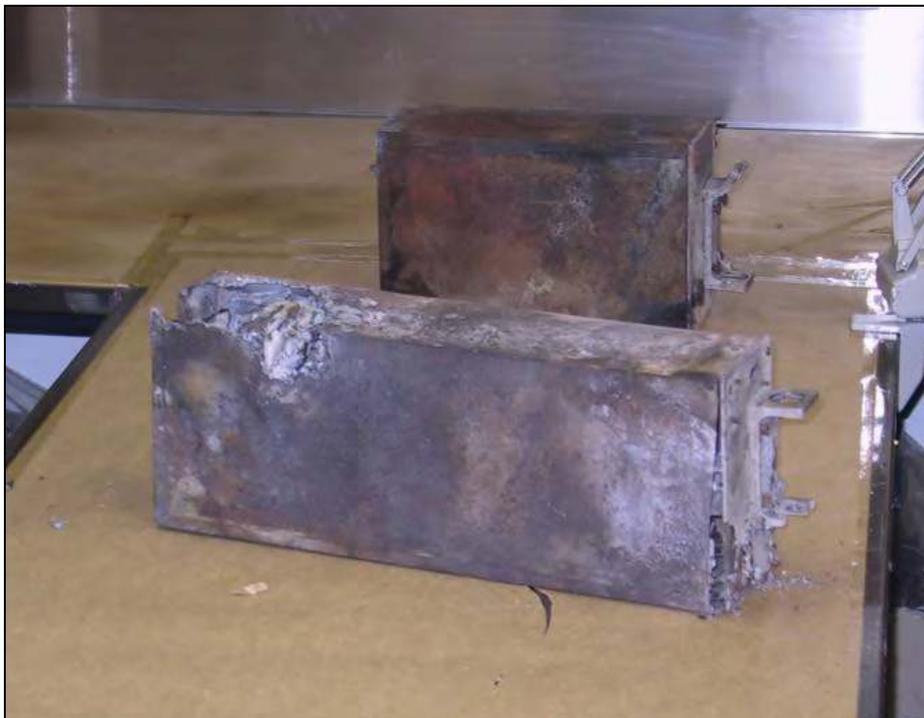
**Figure A-5: FDR (foreground) at the ATSB laboratory in Canberra**

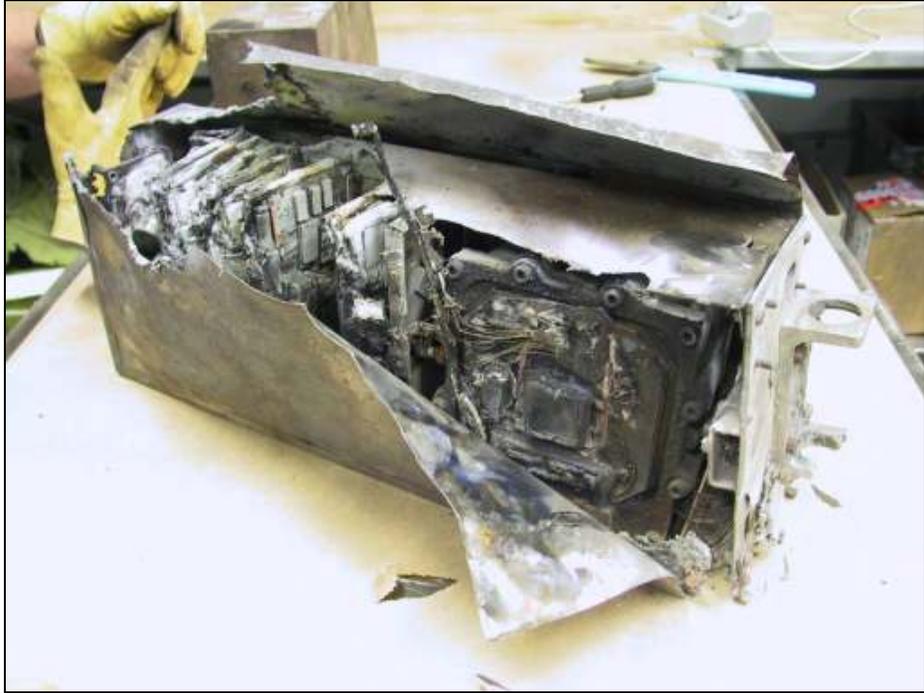
**Figure A-6: FDR with the crash-protected memory module visible**

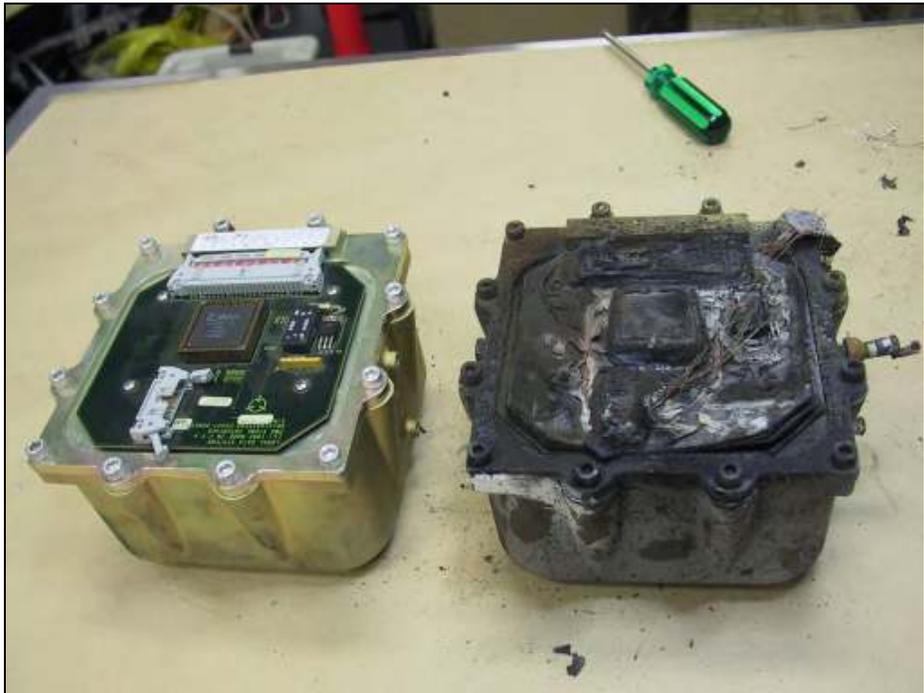
**Figure A-7: Crash-protected memory module with a comparison unit**

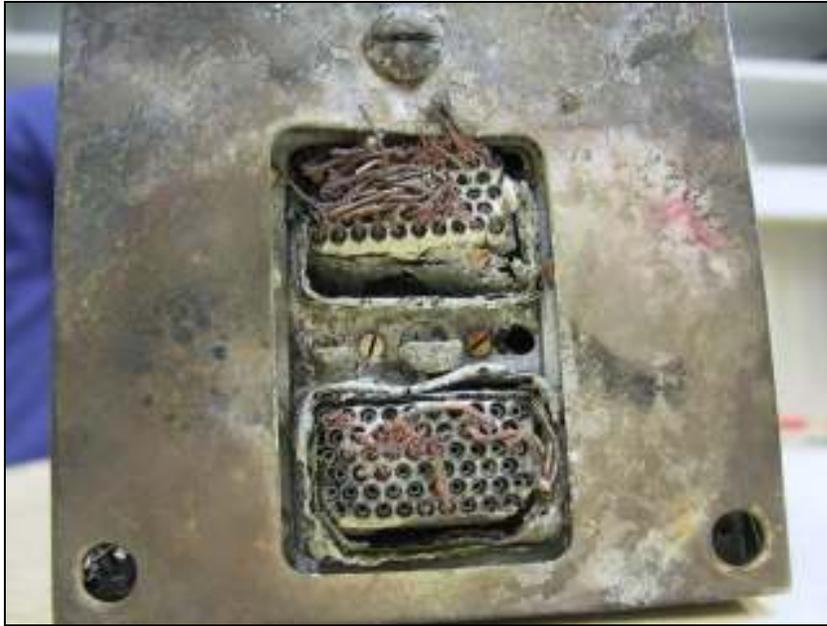
**Figure A-10: FDR rear connectors**

The FDR rear connectors (refer to A-10), as well as the raw data, were scrutinized to ensure that all the recorded engineering parameters were detected.

Examination of the rear connector showed that a trip and date encoder was not fitted.

Examination of the rear connectors showed no evidence of connections to the following pins:

J1A: 1-4, 7-20, 23-29, 35-37, 39, 44, 47 & 50-57.

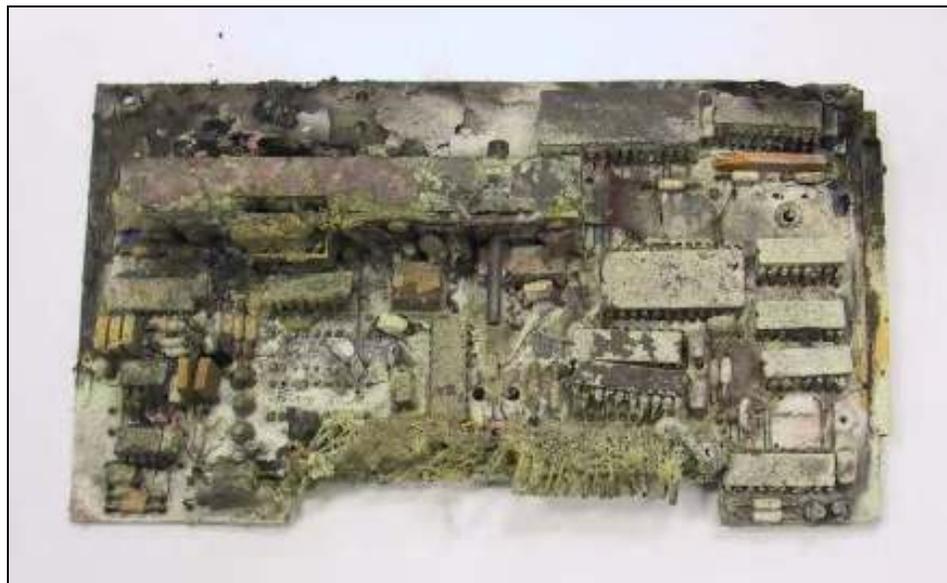
**Figure A-16: Pneumatic printed circuit board from VH-TFU**

The recorded altitude data was initially processed using the manufacturer's standard polynomial conversion equation. Examination of the results showed that the altitude values were unreasonable i.e. cruise levels did not agree with the cruise flight levels documented in the operator's trip records. The damage to the pneumatic PCB from VH-TFU precluded any direct testing/calibration so recorded radar data was used to calibrate the altitude data recorded by the FDR.

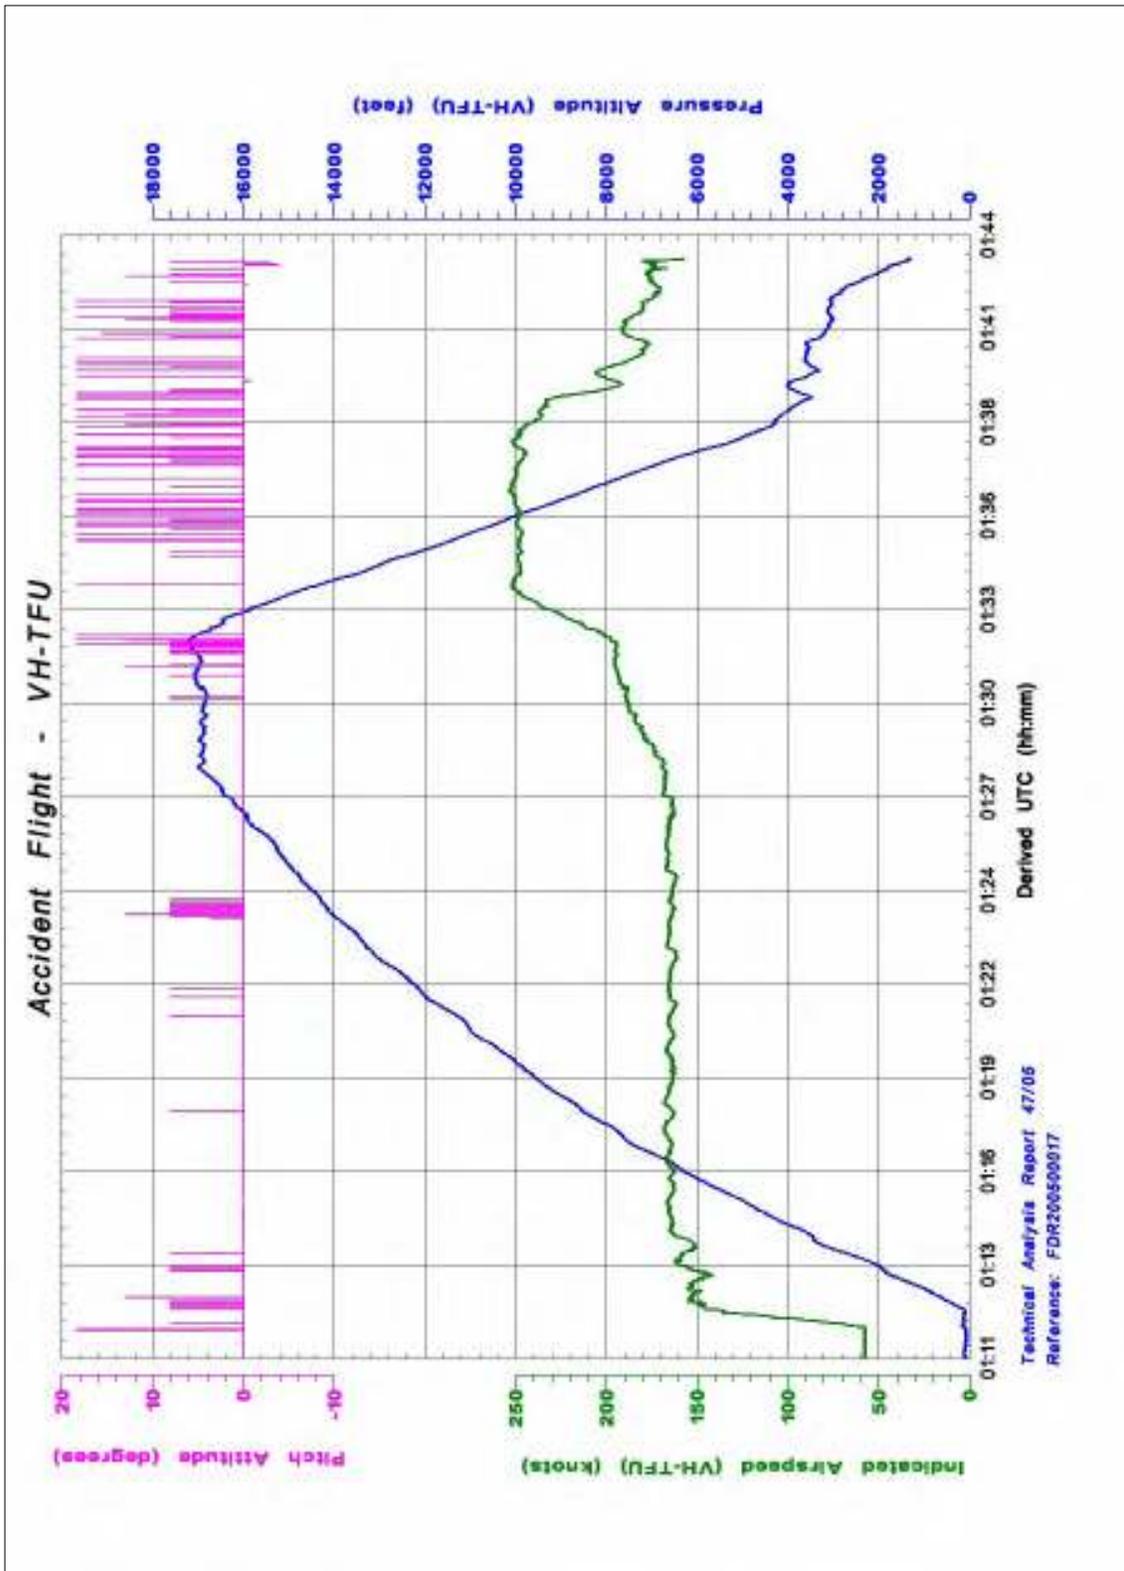
Figure A-38: Pitch attitude data

1. The aircraft was shown in clear weather conditions and not the actual lighting, visibility and weather conditions that existed at the time of the accident.
2. Due to an FDR recording system unserviceability, the aircraft pitch attitude was always shown as zero i.e. nose level. In reality, the aircraft pitch attitude would have varied and not been constant at zero degrees.

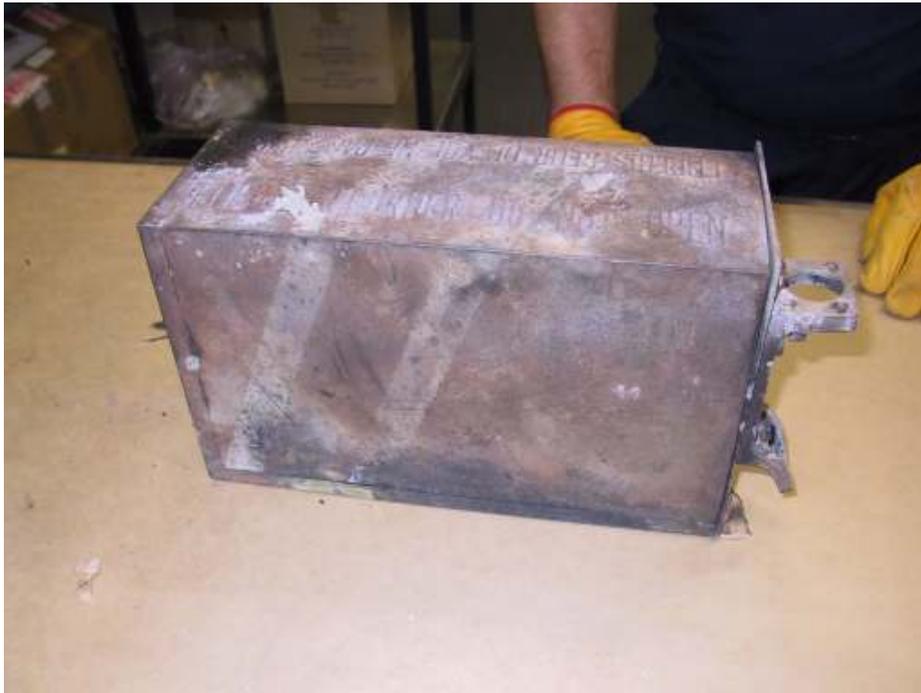
The CVR had been significantly exposed to fire with the paint on the outer casing burnt off. The pattern left from where reflective tape had been affixed, was visible. Several spots of molten metal had become fixed to the outer case. The underwater locator beacon (ULB) mount had molten metal attached. The ULB mount had been distorted during recovery at the accident site as the damaged ULB was removed from the CVR unit before transport. A photograph of the CVR as received, see Figure B-1.

**Figure B-1: L-3 Communications Aviation Recorders Fairchild model A100A CVR recovered from VH-TFU**

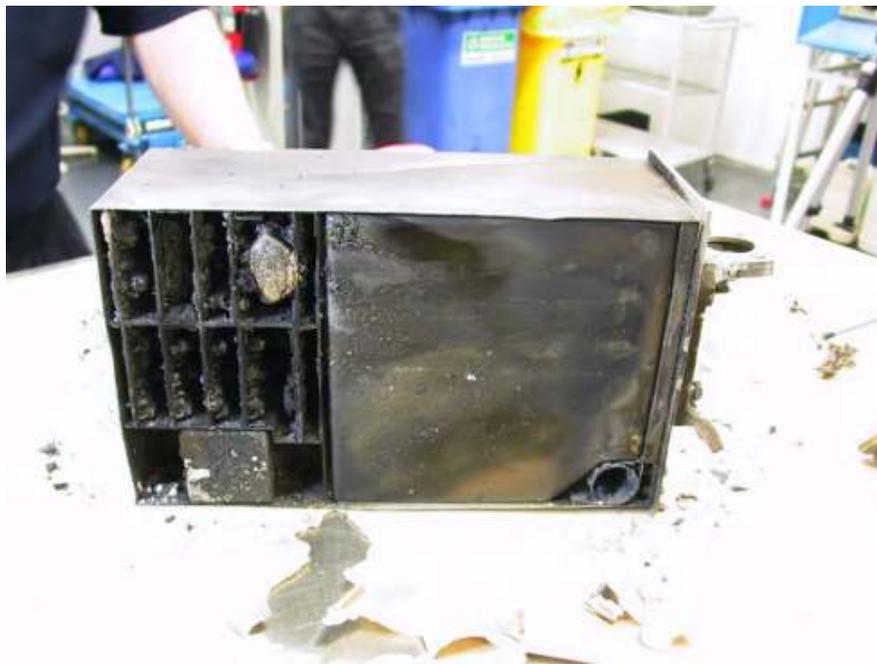
The dust cover was removed in a normal manner by removing the retaining screws and sliding off. This revealed that the electronic assemblies contained in the CVR were significantly heat affected, see Figure B-3.

**Figure B-3: CVR with casing removed**

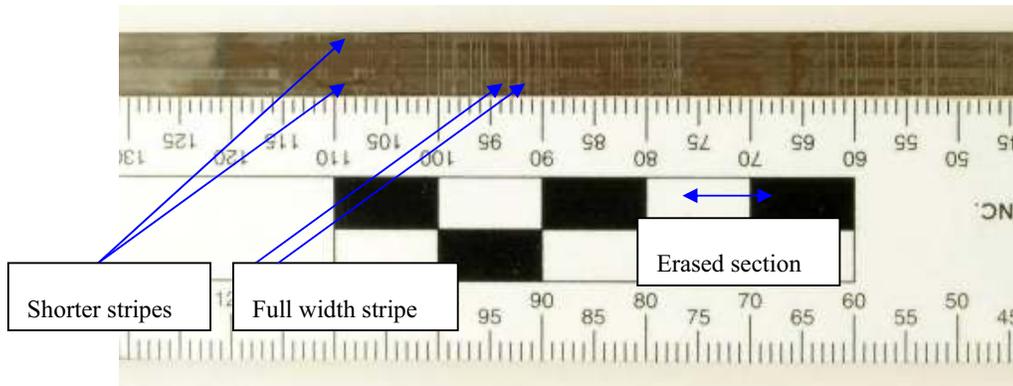
Figure B-9 shows the signals recorded on a section of the tape recovered from the CVR fitted to VH-TFU that were made visible by Magnasee. The interference signal 'spikes' are indicated by the light grey transverse stripes visible on the tape. Sources of the spikes are characterised by the stripes visible across the width of the 0.25 in (6.4 mm) tape. Present are single full-width stripes and shorter stripes that are broken into four segments across the tape. Only the erase head is able to impress a signal across the full width of the tape. The four segments represent the four tracks produced by the four pole pieces of the recording head. The second track from the tape edge where the scale is located, see Figure B-9, has more signals visible than the other tracks. This track contains signals originating from the CAM. Replay of the CAM showed that signals relating to propeller noise associated with the operation of the aircraft were present on this portion of tape.

From about 62 mm to 77 mm, there are no stripes visible. This corresponds with the physical area of tape that existed between the erase head and the record head (about 15.5 mm) at the time of stoppage. The absence of stripes indicates the erase head was functioning. The magnified image of the section of tape following the erased portion, see Figure B-10, and preceding the erased portion, Figure B-11, clearly shows the visible stripes.

**Figure B-9: Recovered tape with Magnasee applied**

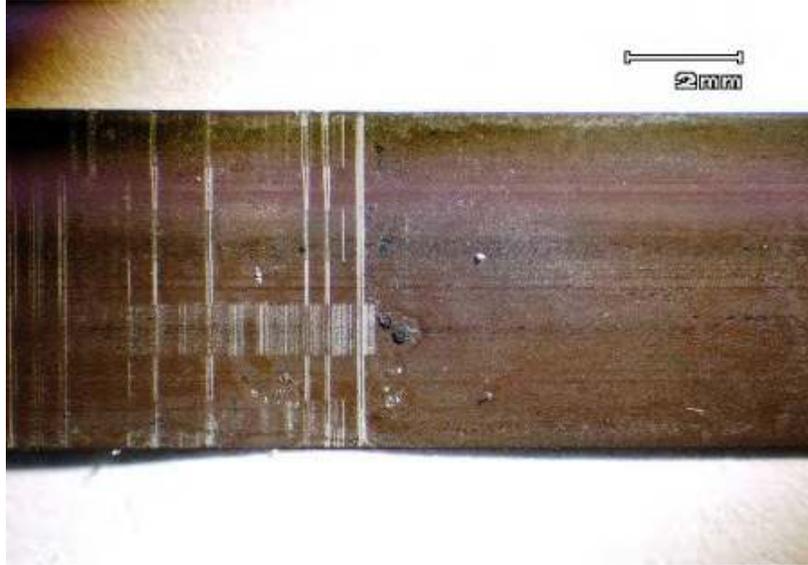
**Figure B-10:** The newest information recorded on the CVR tape, showing stripes indicating 'spikes' that are present for individual tracks and full width of the tape. Also illustrated is part of the erased section of tape.

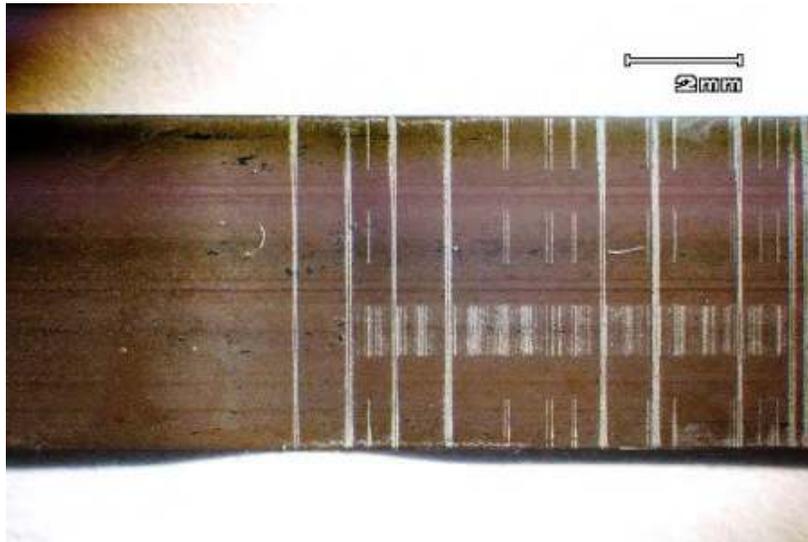
**Figure B-11:** Recovered tape with Magnasee applied, magnified to oldest information recorded.

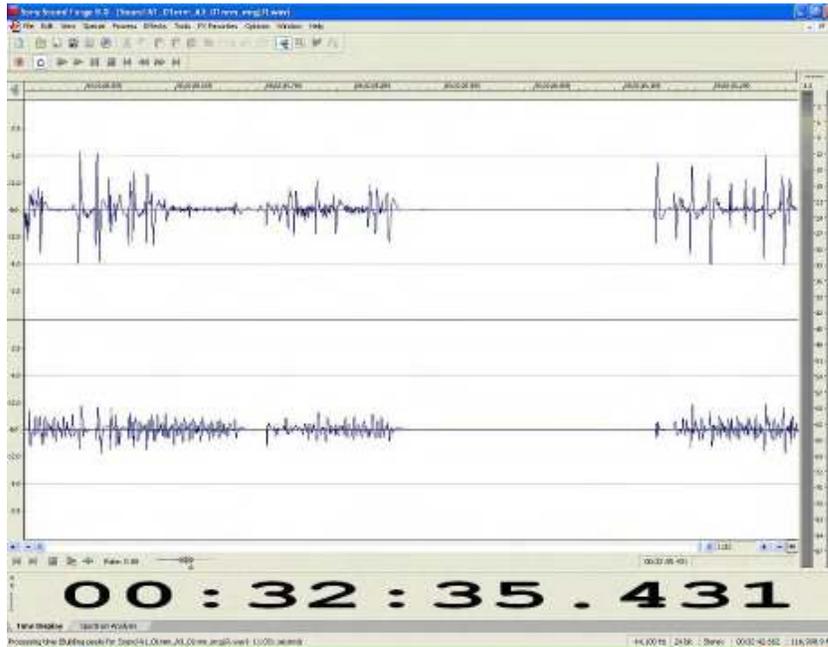
Figure B-12 is a time domain or oscillograph presentation of the spikes. The top trace relates to a recording made of a crew position and the bottom trace relates to audio recorded from the CAM. The spacing, duration and amplitude exhibited by the spikes contained in the CVR recording were examined. Although the spikes appeared to be present at certain intervals or groupings in certain areas, the timing and amplitude varied throughout the recording. No characteristic pattern or attributes of the spikes could be determined across the recording.

**Figure B-12: Oscillograph plot of interference signal (note flat line area correlates with erase area in Magnasee view).**

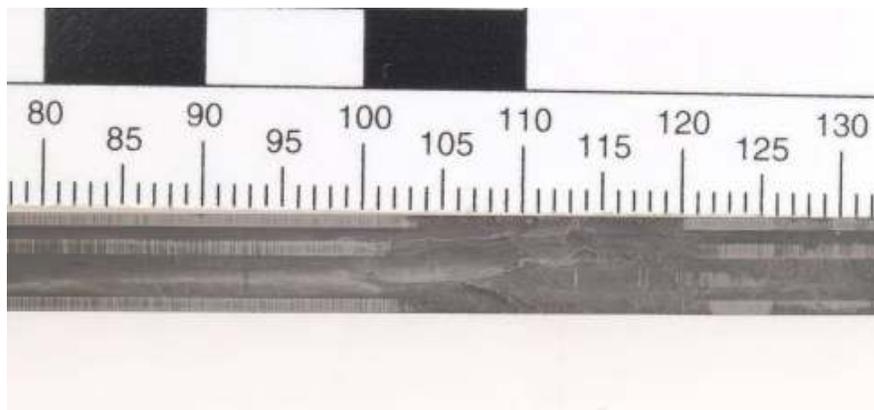
**Figure B-13: Tape from another Fairchild A100A with Magnasee applied**

As an example, a tape from another L-3AR model A100A, which contained an accident flight recording where the audio signals were recovered successfully, was also examined with Magnasee. The three grey longitudinal lines, see Figure B-13, represent three of the four tracks provided by the four pole pieces of the recording head. This is consistent with the CVR installation of two-crew channels and area microphone channel being recorded on three tracks. In this case, the fourth channel was not allocated to a signal source. The characteristics of these longitudinal lines show a more even distribution of Magnasee, which indicates a recording of consistently varying signals such as voice and aircraft operating sounds, rather than the distinctive stripes or spikes that extend across the full width of the tape recovered from VH-TFU. From about 104 mm to 120 mm there are no longitudinal lines visible. This indicates the erased portion of tape that corresponds with the physical area of tape that existed between the erase head and the record head.

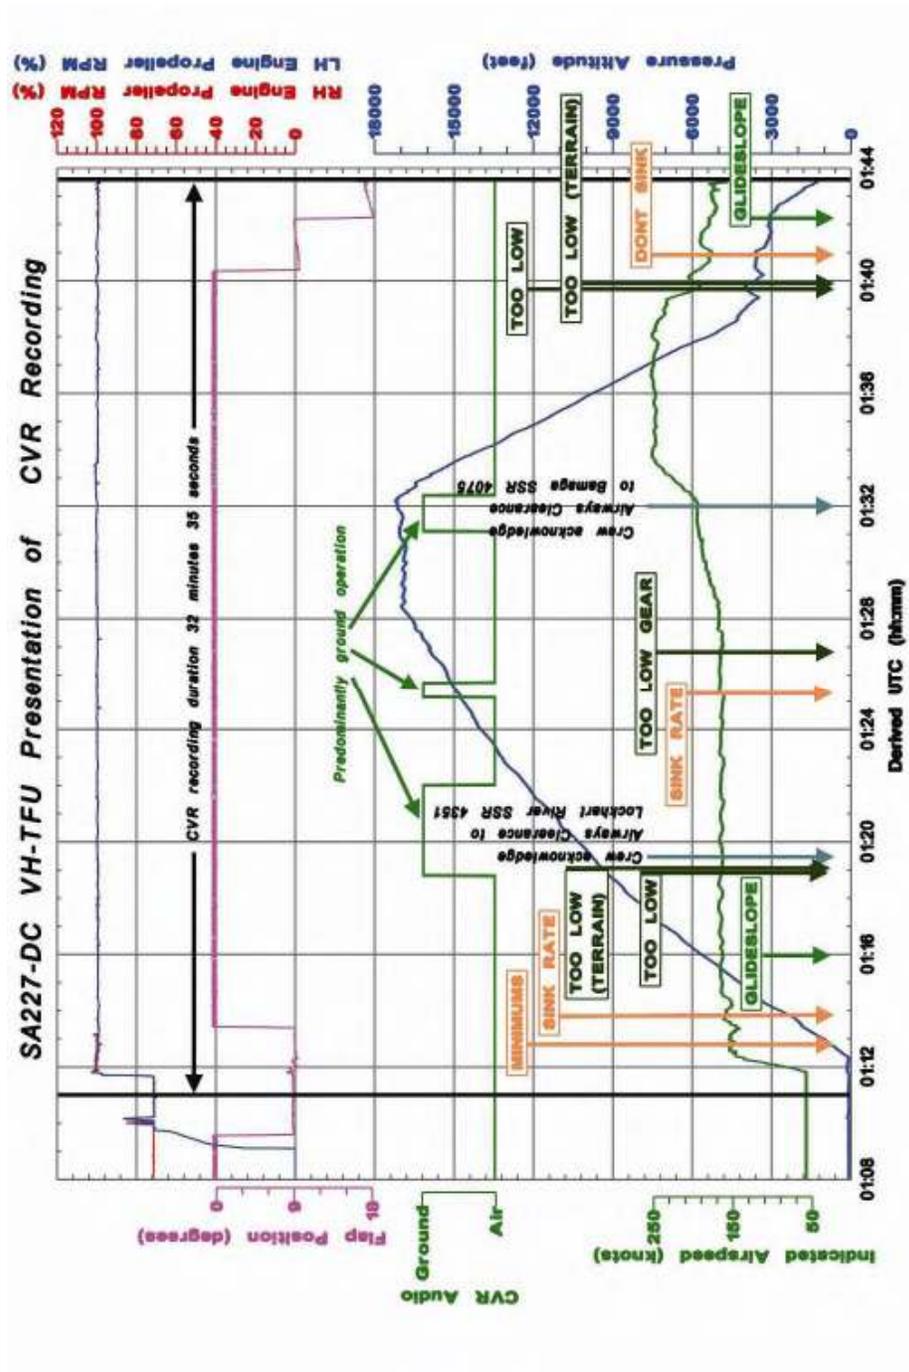
Figure B-15: Synopsis of significant events recorded by CVR and FDR

A synopsis of significant events detected on the CVR and overlaid with FDR data, is presented in pictorial form as Figure B-15. The presentation also indicates areas detected during the recording where the aircraft was predominantly on the ground.

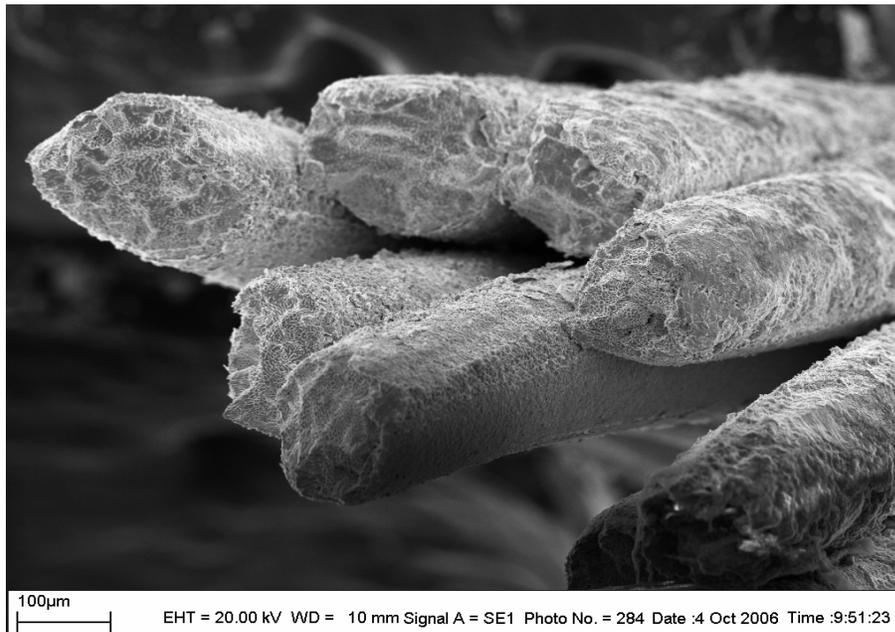
**Figure B-18: Highly magnified electron microscope image of wire strands connected to pin 9 of the aircraft interface connector**

Examination of the wire strands showed they had failed in overload and exhibited ductile 'necking' and a crystalline fracture surface, as shown in Figure B-17. A similar characteristic was exhibited by the broken strands of the wire connecting to pin 9, the connection to the aircraft 27.5 V d.c. power supply. A close up photograph is shown in figure 18.

If electrical power had been present at the time the wire strands parted, the strands would exhibit a smooth surface formed by the copper melting due to heating from electrical arcing as the wire strands separate. The absence of electrical arcing indicates that d.c. power had not been present to the CVR unit when the wire strands parted, probably due to operation of the ‘g’ switch.
