ATSB TRANSPORT SAFETY INVESTIGATION REPORT  
Aviation Occurrence Report 200501977  
Final

Collision with Terrain  
11 km NW Lockhart River Aerodrome  
7 May 2005  
VH-TFU  
SA227-DC (Metro 23)

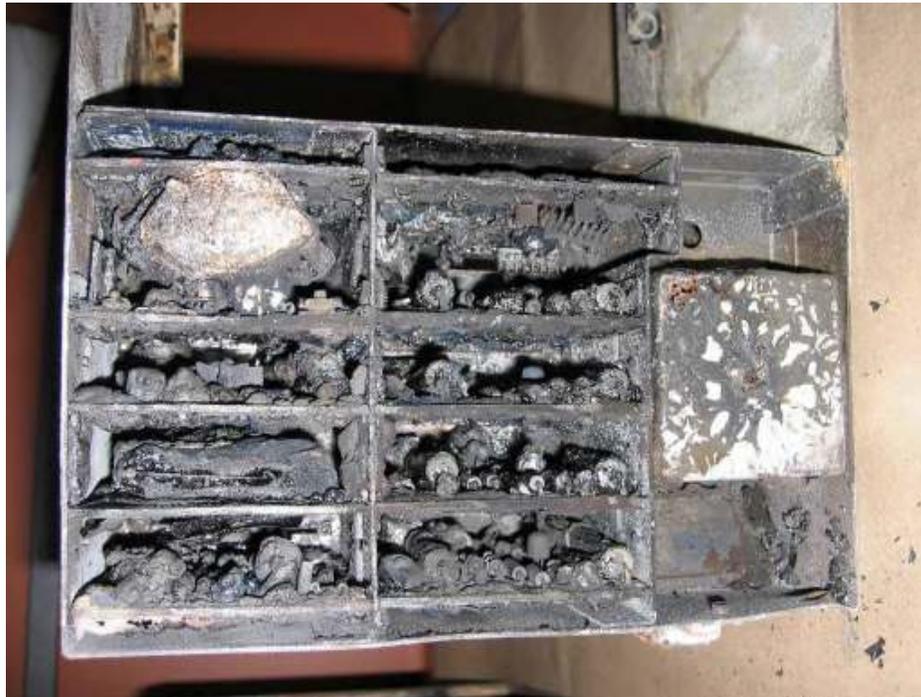
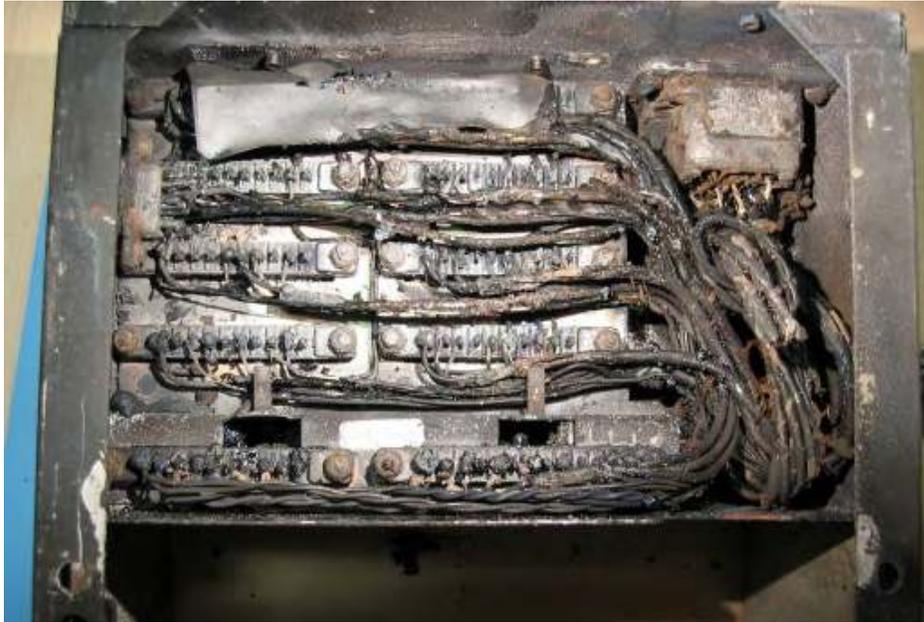
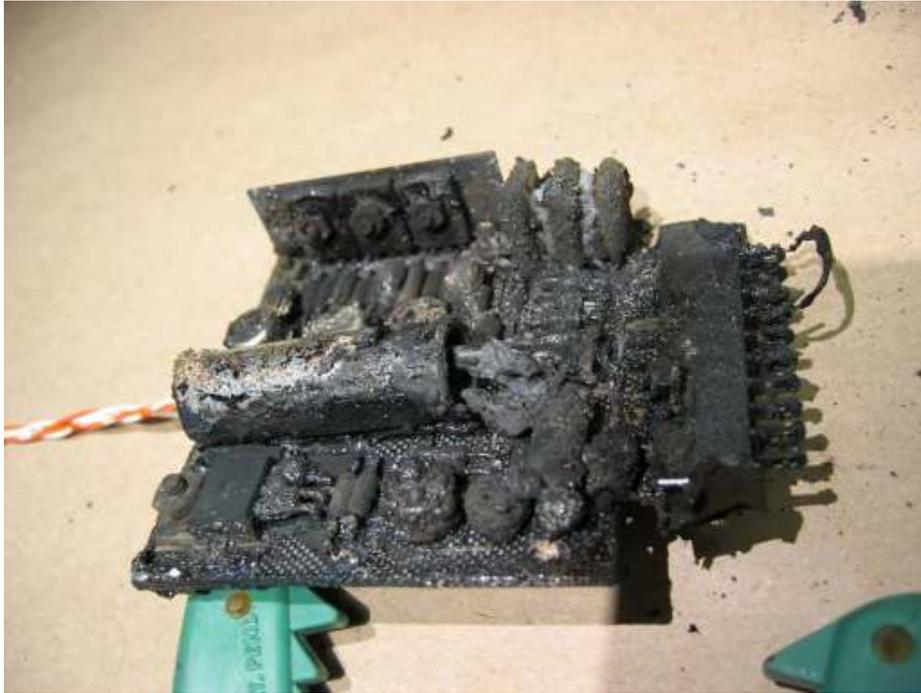
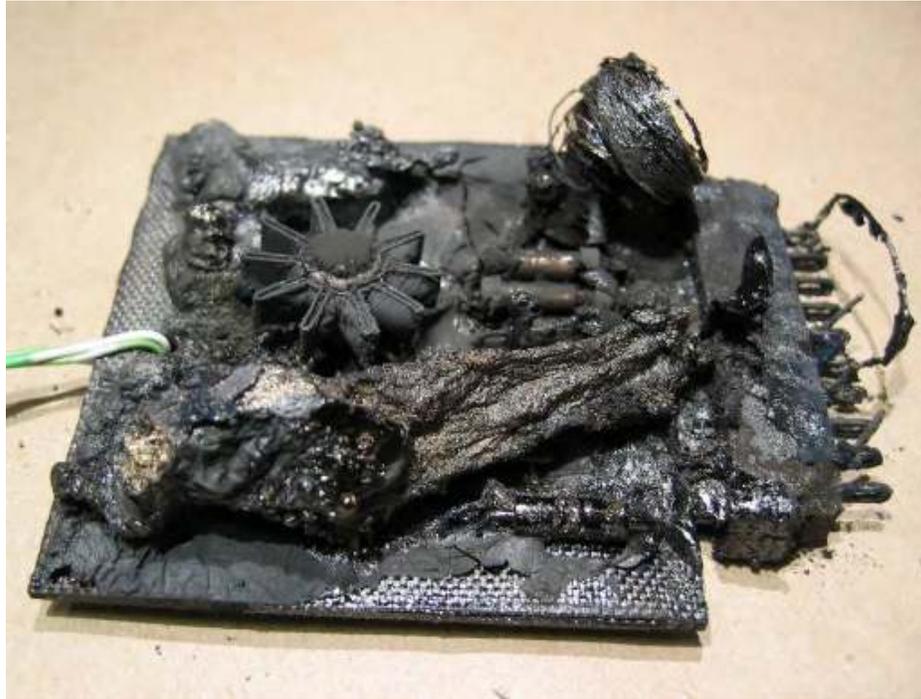
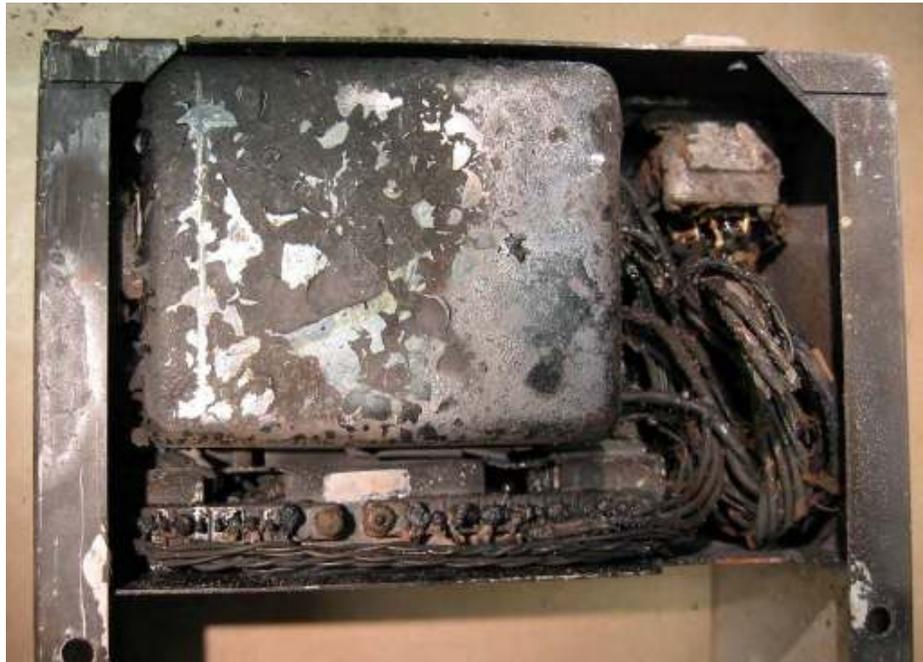
The CVR had been subjected to intense heat. This resulted in the solder, found at wiring connections and printed circuit assemblies, having been melted, running from the connection, and in some instances having the appearance of having been boiled and oxidised.

The printed circuit assemblies had parts of the interconnecting copper foil missing. Heat had affected the base substrate, in this case fibreglass. In places, the epoxy resin in the board had evaporated, exposing the layers of glass fibre mat.

Figures 19 through 27 show the extent the CVR unit was affected by heat and fire. The integrity of the printed circuit assemblies and the CVR unit interwiring could not be determined due to the damage.

Figure B-19: VH-TFU CVR printed circuit card assemblies

**Figure B-21: VH-TFU CVR printed circuit card assembly wiring**

Figure B-23: VH-TFU power supply assembly

Figure B-25: VH-TFU bias oscillator assembly

**Figure B-27: VH-TFU CVR inverter assembly**

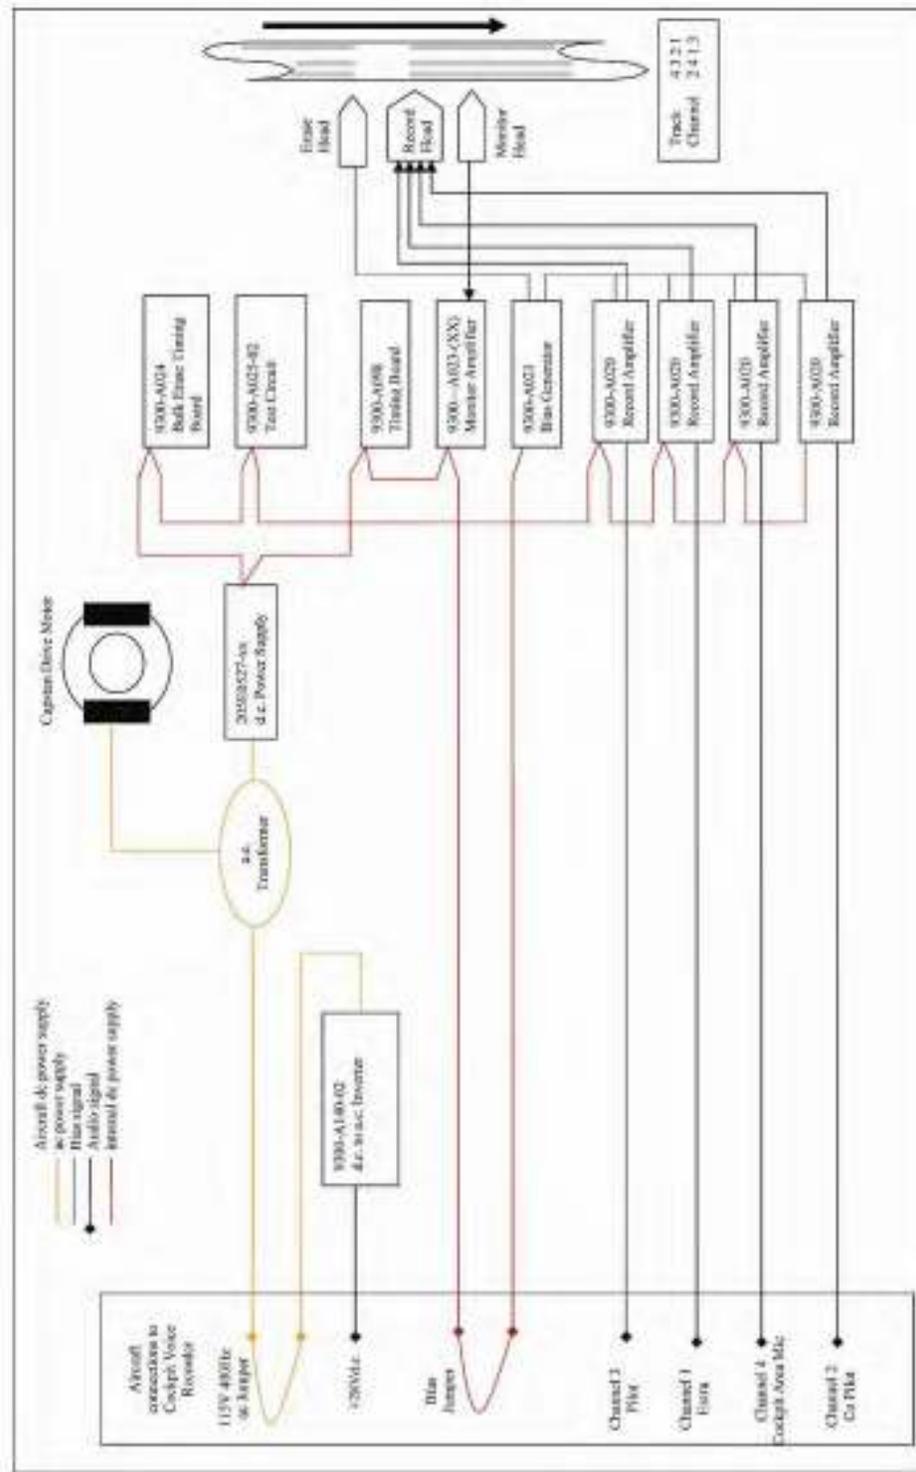
Figure B-29: Simplified block diagram of the power supply and input signal electrical paths

- The spikes present across the full width of the tape (seen with Magnasee), indicates that the signal was impressed on the tape from the erase head pole piece. The presence of spikes on individual tracks, indicate that the signal was impressed on the tape from the record head pole pieces. Both signals are present at different times. This indicates a possible failure of the output of the Bias Oscillator.<sup>37</sup>

<sup>37</sup> The Bias Oscillator card provides the electrical signal to the record amplifier and to the erase head via discrete connections.

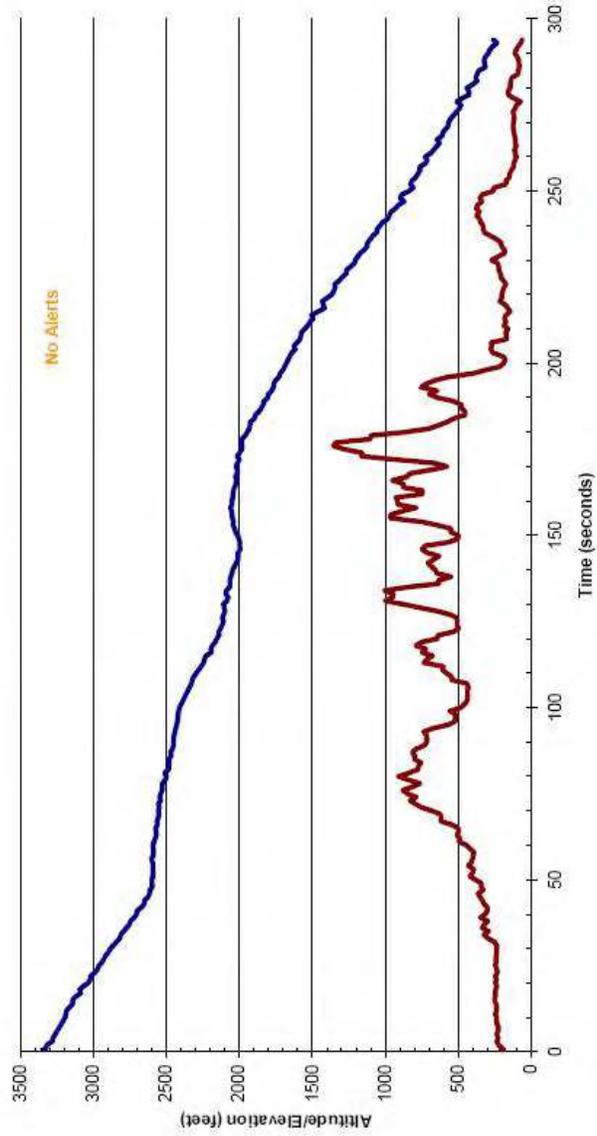
Lockhart River, QLD, Australia (YLHR)  
RNAV Approach Rwy 12  
Based on FDR data from Accident Aircraft  
Flap OVRD Switch On
