FINAL REPORT

SERIOUS INCIDENT
to
MD 11
N803DE
at
Dublin Airport

3 February 2002

AAIU Report No: 2003/004

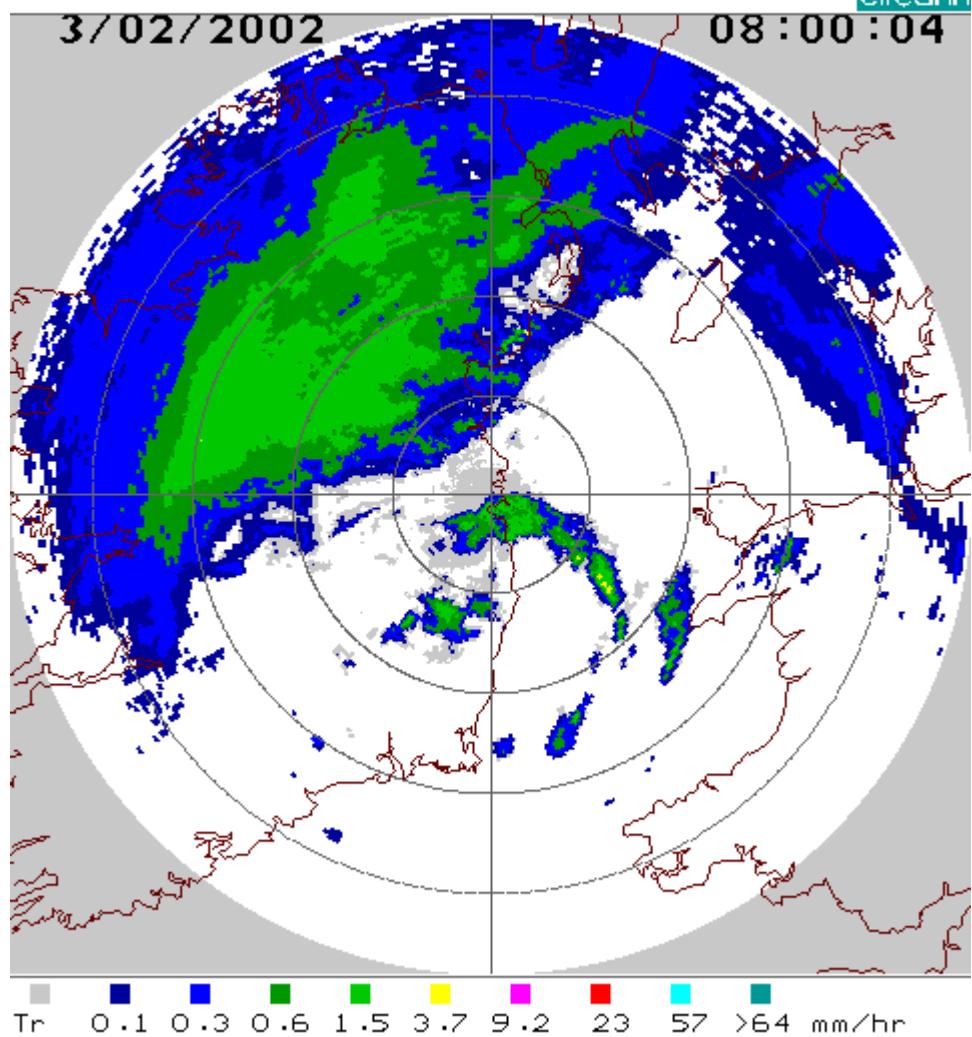
APPENDIX D(a)

MET EIREANN RADAR PICTURE
FILE: LKTEMP.PCZ
DATE: 3/02/2002 08:00:04
RANGE: 240 KM HEIGHT: 1.5 KM
RADAR: DUBLIN AIRPORT
TYPE: PSEUDO-CAPPI RAINFALL
CLUTTER: NONE

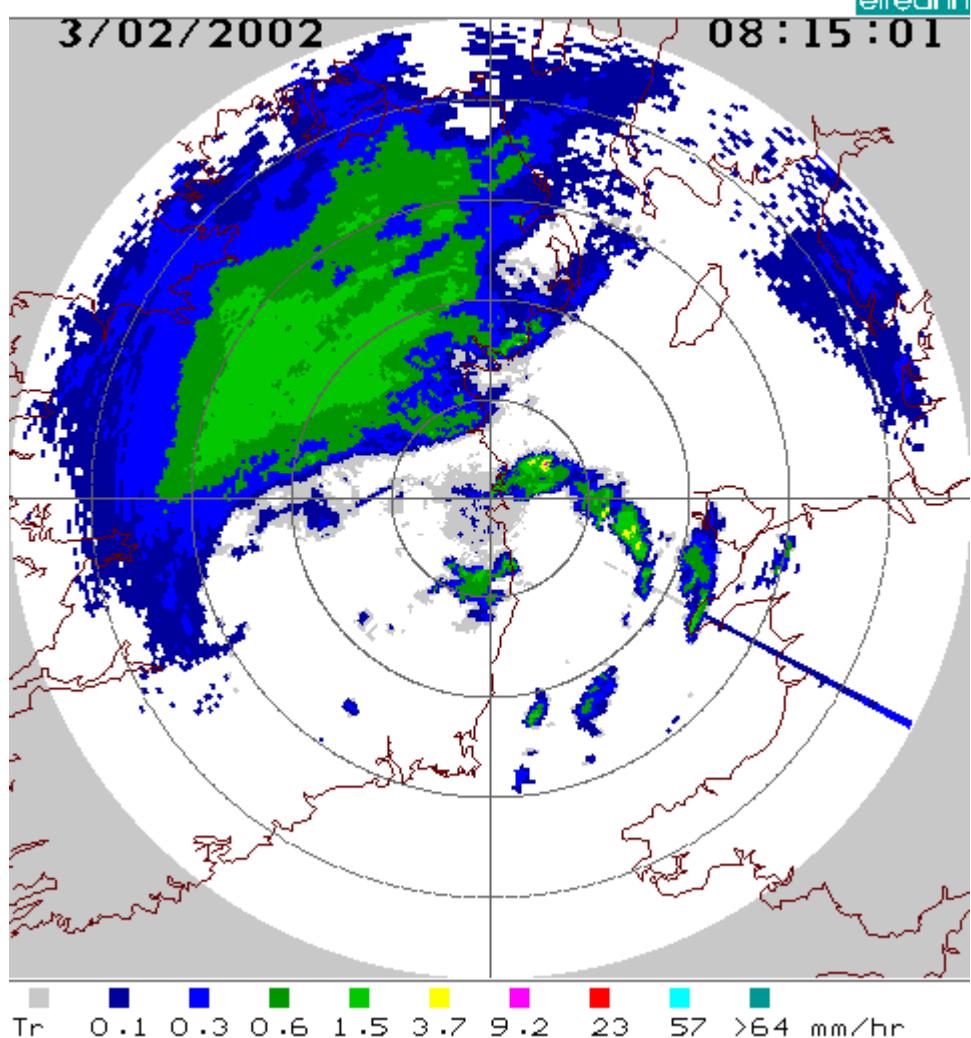
APPENDIX D(b)

MET EIREANN RADAR PICTURE
FILE: LKTEMP.PCZ
DATE: 3/02/2002 08:15:01
RANGE: 240 KM HEIGHT: 1.5 KM
RADAR: DUBLIN AIRPORT
TYPE: PSEUDO-CAPPI RAINFALL
CLUTTER: NONE

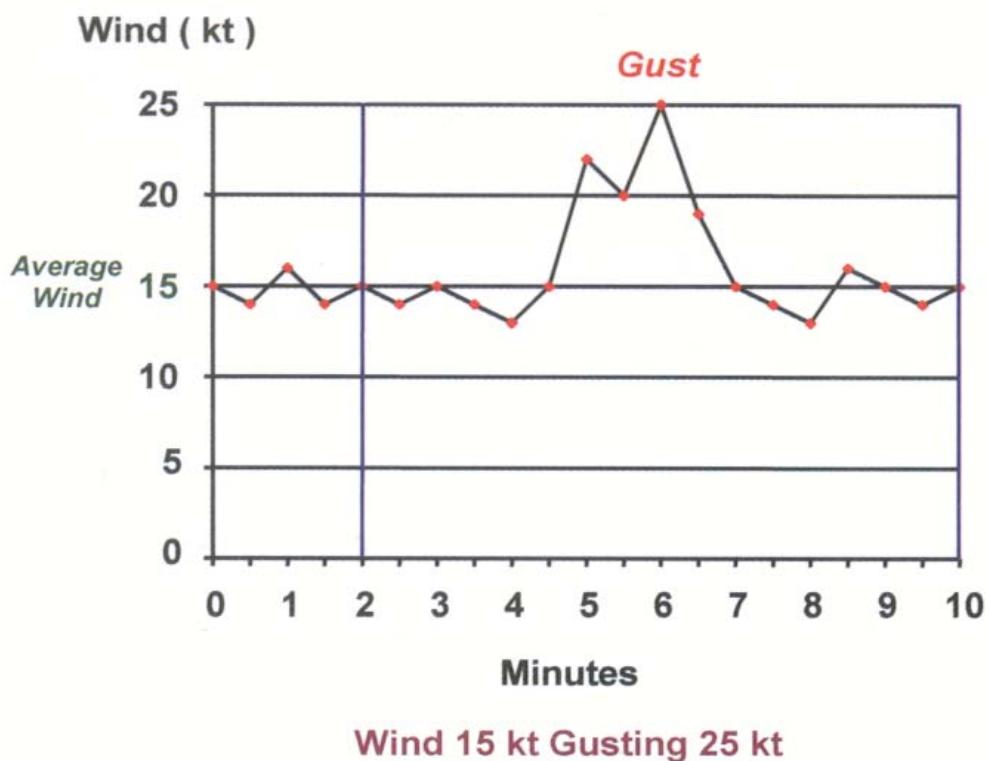
Figure 1 below shows a 10-minute wind profile featuring:

- A 2-minute average wind of 15 KT; and,
- A 10-minute gust of 10 KT (i.e., a 25 KT peak wind velocity during the 10-minute period).

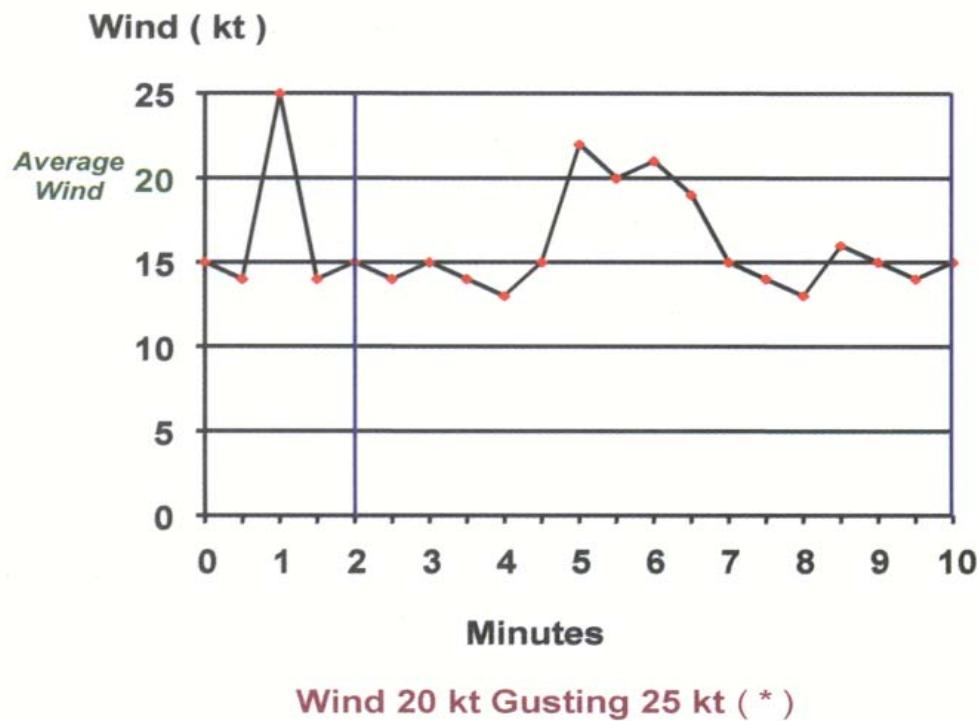
Figure 2

If the wind peak value is observed during the last 2-minute period, the gust becomes part of the average wind, as illustrated by Figure 2.

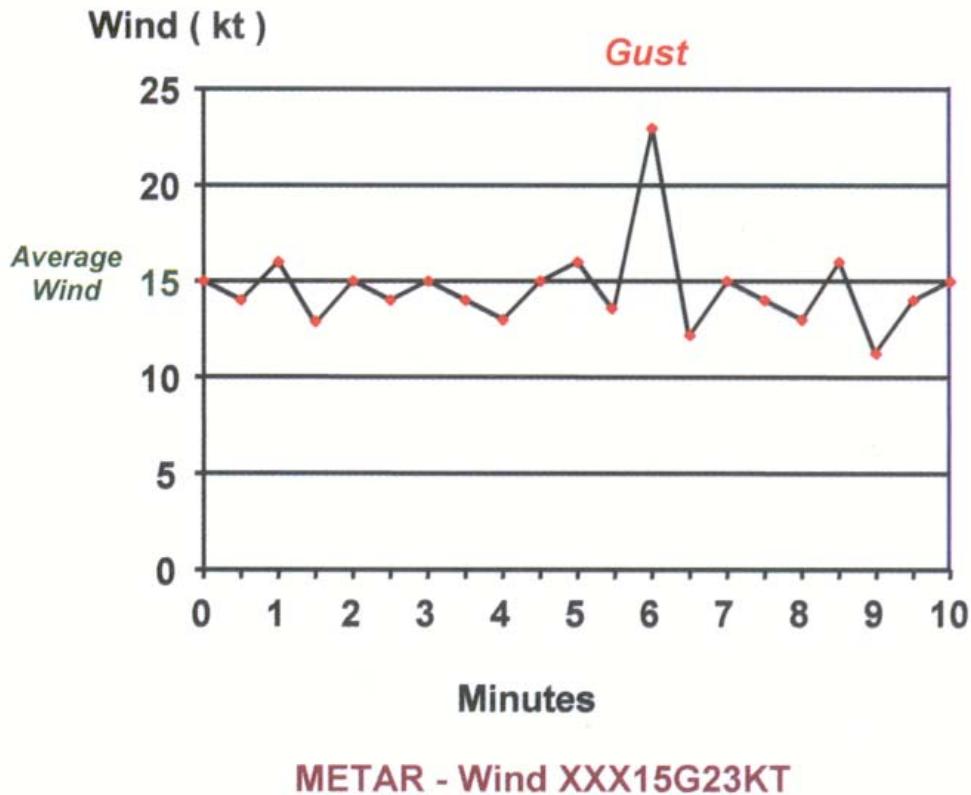
METAR observation messages include a 10-minute average-wind and the 10-minute gust, as illustrated by Figure 3 (XXX is the wind direction, referenced to the true north).
