AVIATION INVESTIGATION REPORT
A07A0134

TOUCHDOWN SHORT OF RUNWAY

JETPORT INC.
BOMBARDIER BD-700-1A11 (GLOBAL 5000) C-GXPR
FOX HARBOUR AERODROME, NOVA SCOTIA
11 NOVEMBER 2007

A07A0134

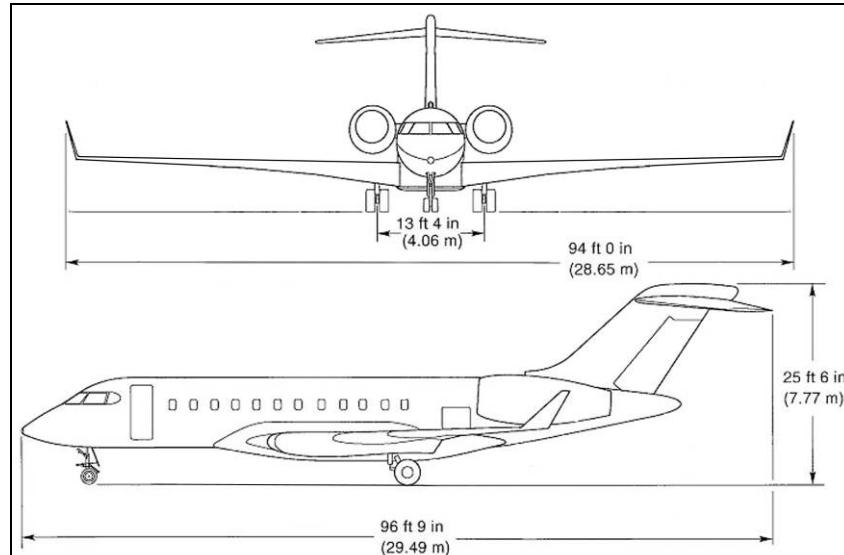
Figure 1. Global 5000 dimensions

The Global 5000 design (see Figure 1) is based on the slightly larger Global Express corporate business jet, which entered service in 1996. Its take-off and landing performance, unlike some older generation business aircraft, allows it to operate from the shorter runways found at smaller aerodromes. Although used mostly as a business jet, the Global 5000 is considered a transport category aircraft.

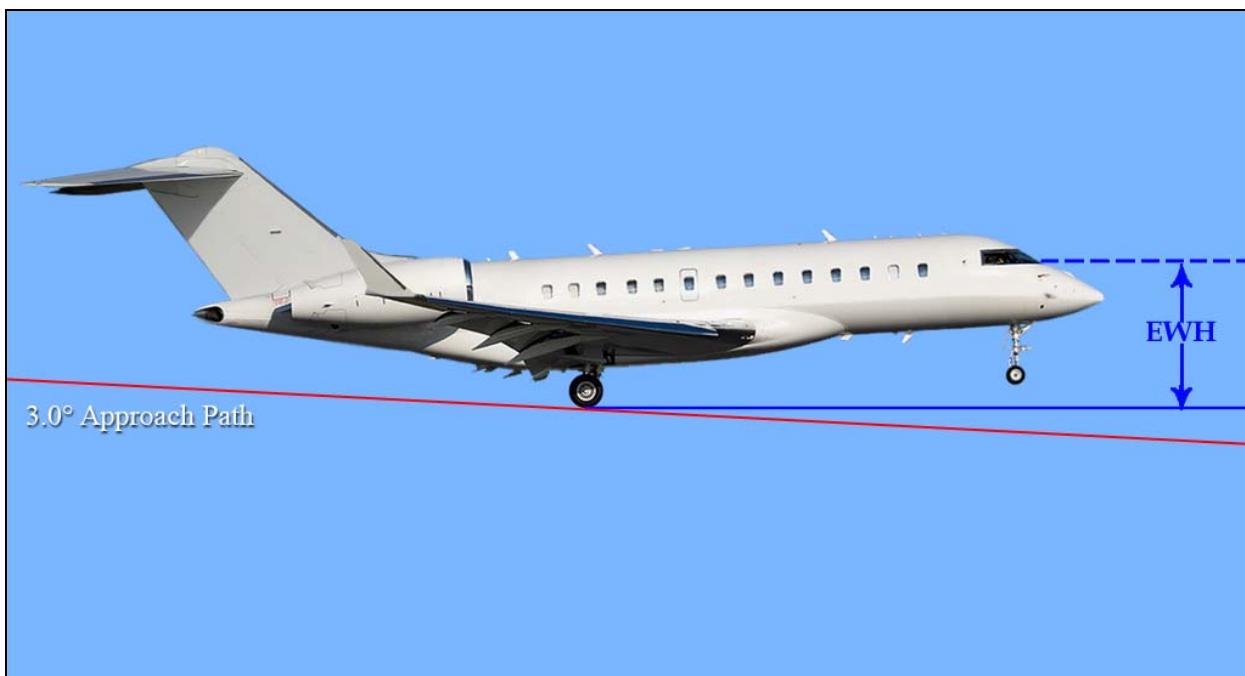
Photo 5. Aircraft eye-to-wheel height

The vertical distance from a pilot's eyes to the lowest portion of the aircraft in the landing attitude is called the eye-to-wheel height¹² (EWH) (see Photo 5). This distance varies from less than 4 feet to 45 feet for some wide-bodied aircraft, such as the Boeing 747. Knowledge of an aircraft's EWH is necessary for flight crews to assess the adequacy of a visual glide slope indicator (VGSI) system for the aircraft type flown.

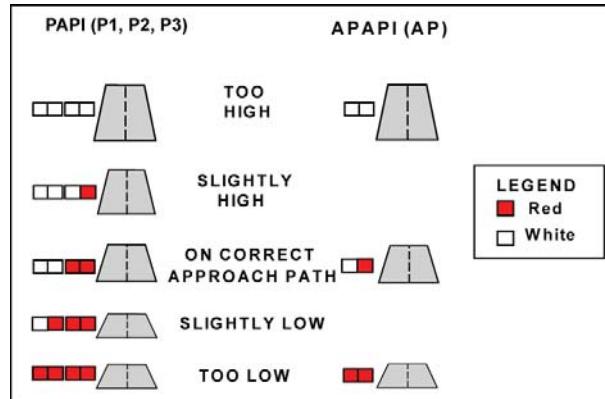
Figure 2. PAPI indications

Although both the PAPI and APAPI offer visual glide path indications to pilots, a PAPI has the advantage of giving incremental deviation indications (see Figure 2) because it has four light units instead of the APAPI's two light units. This allows the pilot to better anticipate flight path corrections. This is especially important when making flight path corrections at low altitude, as the width of the visual signal narrows and it is easy to fly through the signal, from a white/white too-high, through the red/white on correct approach path, to the red/red too-low indication.

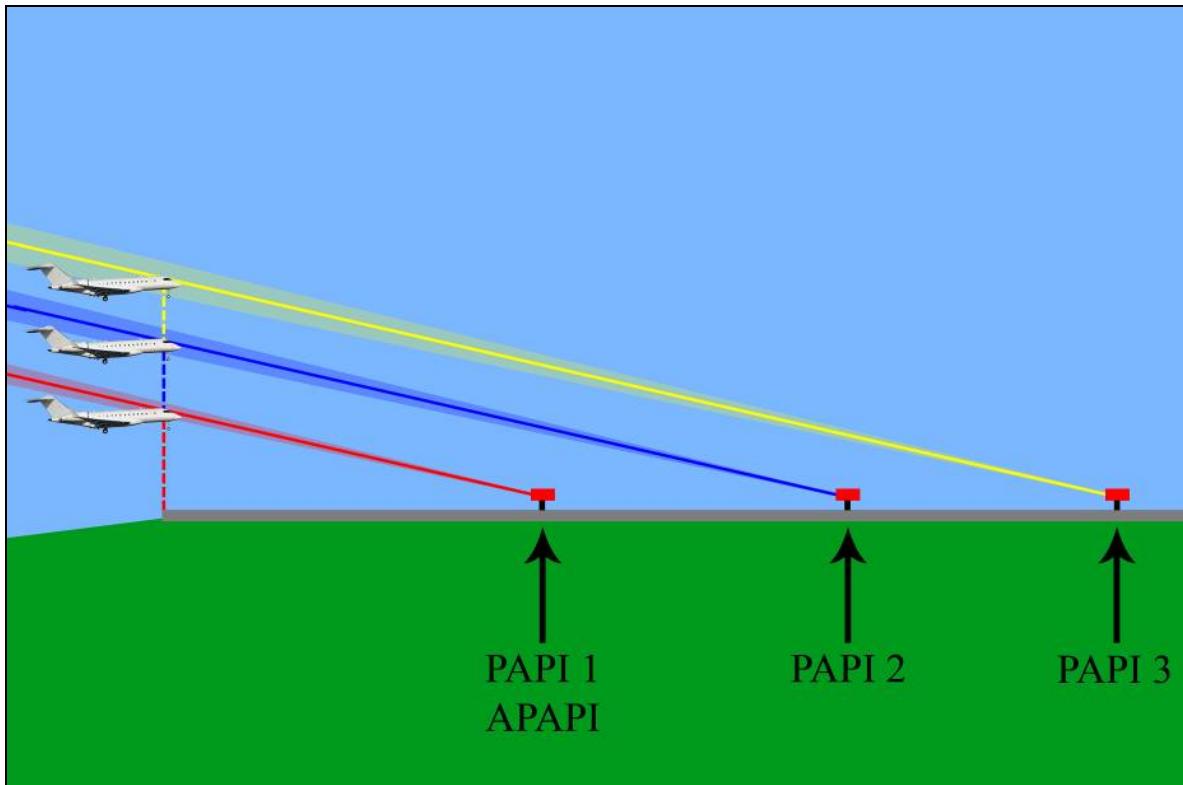
Figure 3. Depiction of different PAPI types and associated threshold crossing height

It is possible to provide for safe wheel clearance over the threshold for aircraft with different EWH by varying the distance of the wing bar from the runway threshold (see Figure 3). By increasing the distance between the threshold and the PAPI units, a greater TCH is obtained. A PAPI 2 is required to ensure safe TCH for the Global 5000 with its EWH of 17.2 feet.

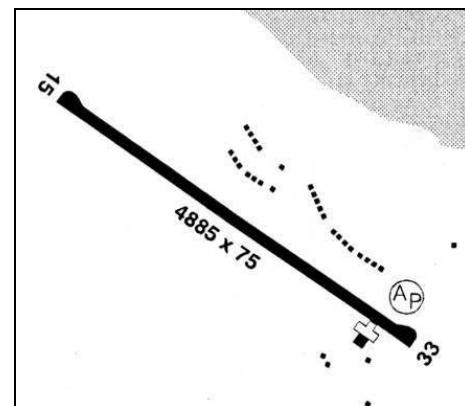
Figure 4. Fox Harbour aerodrome (CFH4) *Canada Air Pilot* chart

Information regarding the type of VGSI currently in use in Canada can be found in the *Canada Air Pilot* (CAP) published by NAV CANADA. The VGSI configuration appears on a legend found in the CAP general pages (CAP GEN). For any given instrument approach published, an aerodrome chart is located at the bottom right of the page. On this chart, a circle is displayed in which the type of VGSI is indicated (see Figure 4). By taking a quick glance, a pilot knows exactly the type of VGSI in use for the runway on which he plans to conduct an approach.

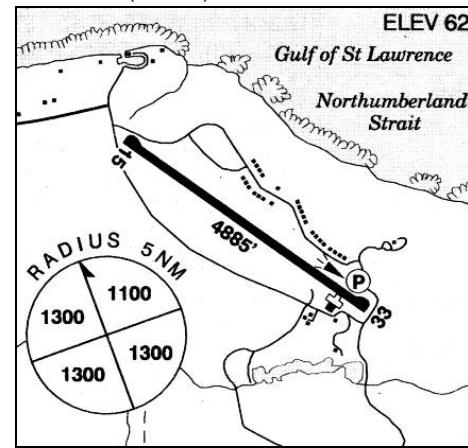
Figure 5. Fox Harbour aerodrome (CFH4) *Canada Flight Supplement* chart

Information is also available in the *Canada Flight Supplement* (CFS) published by NAV CANADA, but it is displayed differently. The CFS aerodrome chart is very similar to the aerodrome chart found in the CAP; however, the symbol used to display the type of VGSI is simply a circle in which the letter "P" or the letter "V" indicates to the pilot whether a PAPI or a VASIS is available (see Figure 5). To confirm the type of PAPI or VASIS, the pilot has to refer to the lighting section of the aerodrome description. In that section, the description of all lighting available for each runway is available. The type of PAPI is indicated as AP, P1, P2, or P3, while the type of VASIS is indicated as AV, V1, V2, or V3.

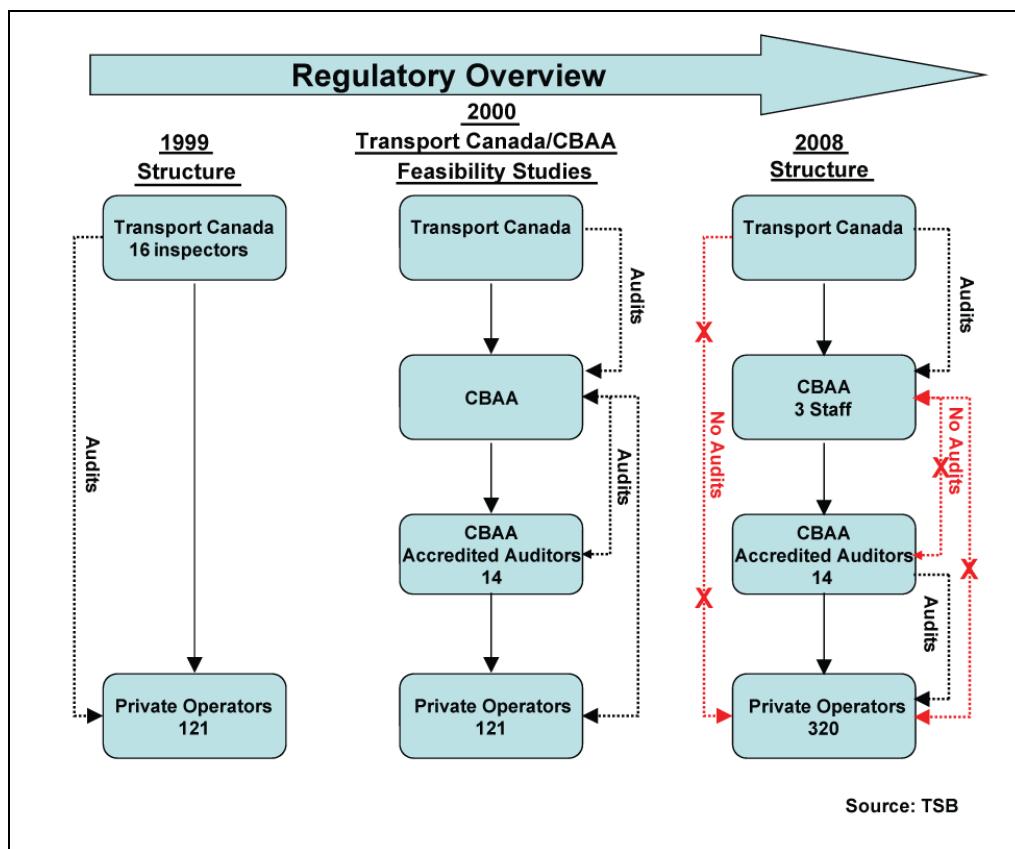
Figure 8. Business aviation safety oversight models

As shown in Figure 8 (1999 Structure), before the inception of the CBAA POC program, Transport Canada was responsible for the regulation, certification and oversight of business operators. The feasibility studies proposed a new oversight model where the CBAA would be responsible for the administration of the POC program, which involved the use of CBAA-accredited auditors.

The model as used (2008 Structure), however, contains none of these mitigation measures. Oversight is left primarily to the accredited auditors. The CBAA does not have a quality assurance program in place to verify the effectiveness of its accredited auditors or its member operators' systems. The current model consists of informal communications between the CBAA and its accredited auditors and operators during liaison visits and trade shows. Pairing an

accredited auditor with insufficient SMS knowledge and an operator still following a traditional safety management scheme could allow the operator to take on unacceptable risks that will go undetected. Transport Canada has not ensured that the CBAA is fulfilling its responsibilities for oversight, therefore increasing the risk that safety deficiencies will not be identified.
